**Devon Energy Production Company, LP**  
**6488 Seven Rivers Hwy**  
**Artesia, NM 88210**  
**575-748-0167**

June 7, 2024

**Re: Remediation Closure Report**  
**Cotton Draw Unit 171H**  
**API No. 30-015-42503**  
**GPS: Latitude 32.1526200 Longitude -103.7320907**  
**ULSTR – N – 1 – 25S – 31E 200FSL 2480FWL Eddy County, NM**  
**NMOCD Incident ID nAB1508251701**

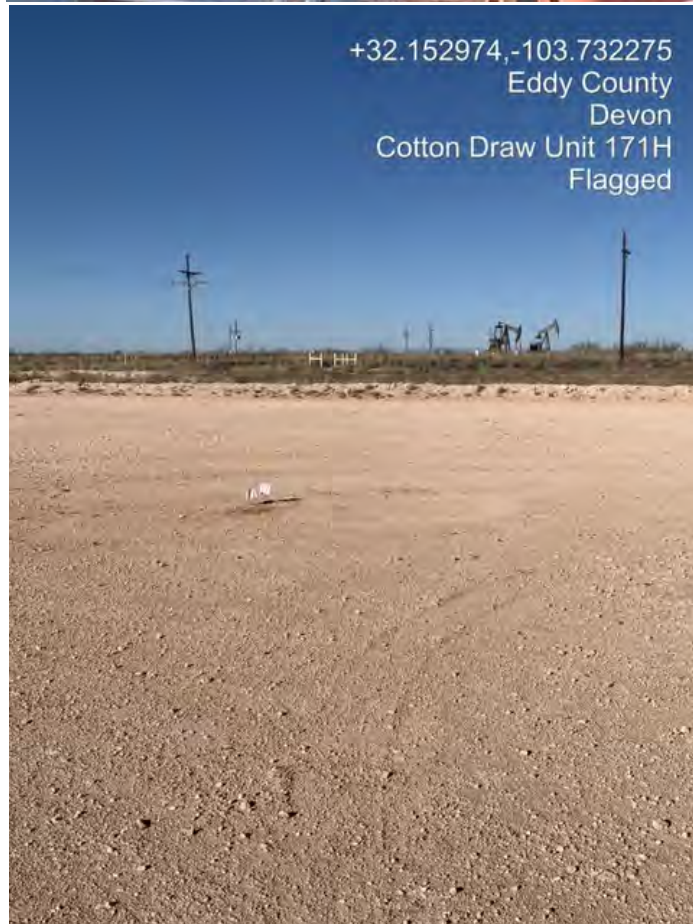
+32.152974,-103.732275  
Eddy County  
Devon  
Cotton Draw Unit 171H  
Flagged

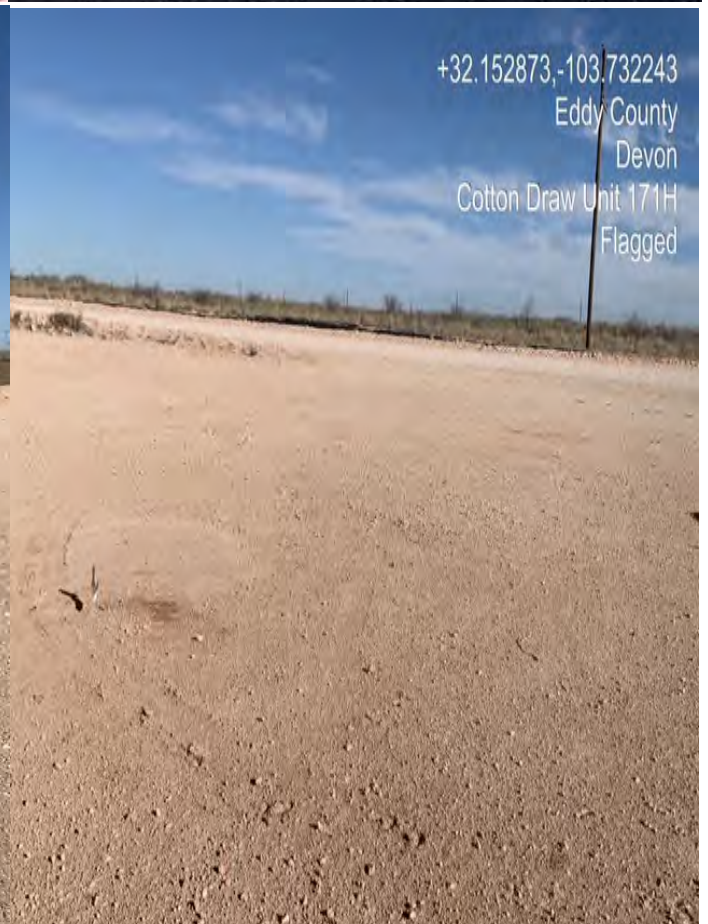
+32.152873,-103.732243  
Eddy County  
Devon  
Cotton Draw Unit 171H  
Flagged
