Poly line feeding Remuda Basin SWD

RE: Remediation/Proposed Sampling Plan Report

Flowline Supplying Remuda Basin SWD

NMOCD Incident ID. nAPP2213647597

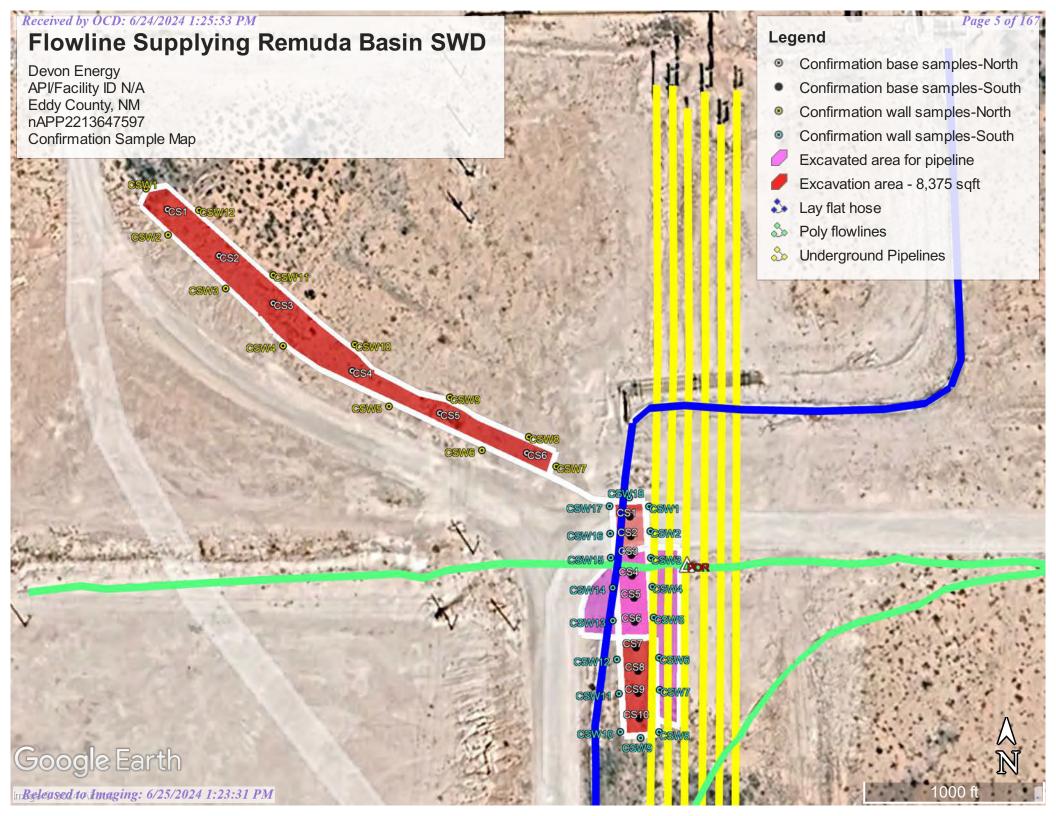
The sample points on the previously submitted report referenced a data table showing Sample ID CSW-4, CSW-9, and CSW-10 being advanced to 4' below grade surface (bgs). This information was incorrectly reported. The walls of the excavation at each of these three sample points were advanced laterally by 1', and the new confirmation samples were collected. The Confirmation Sample Map that can be found in Figure 1, illustrates this change to the excavated area.

On behalf of Devon, Pima proposes to collect additional samples from the release area. The Confirmation Sample Map in Figure 1 also represents the total of all samples that have already been collected. As you can see, the number of base samples collected was insufficient, and the number of wall samples collected was excessive. We offer this proposed sampling plan:

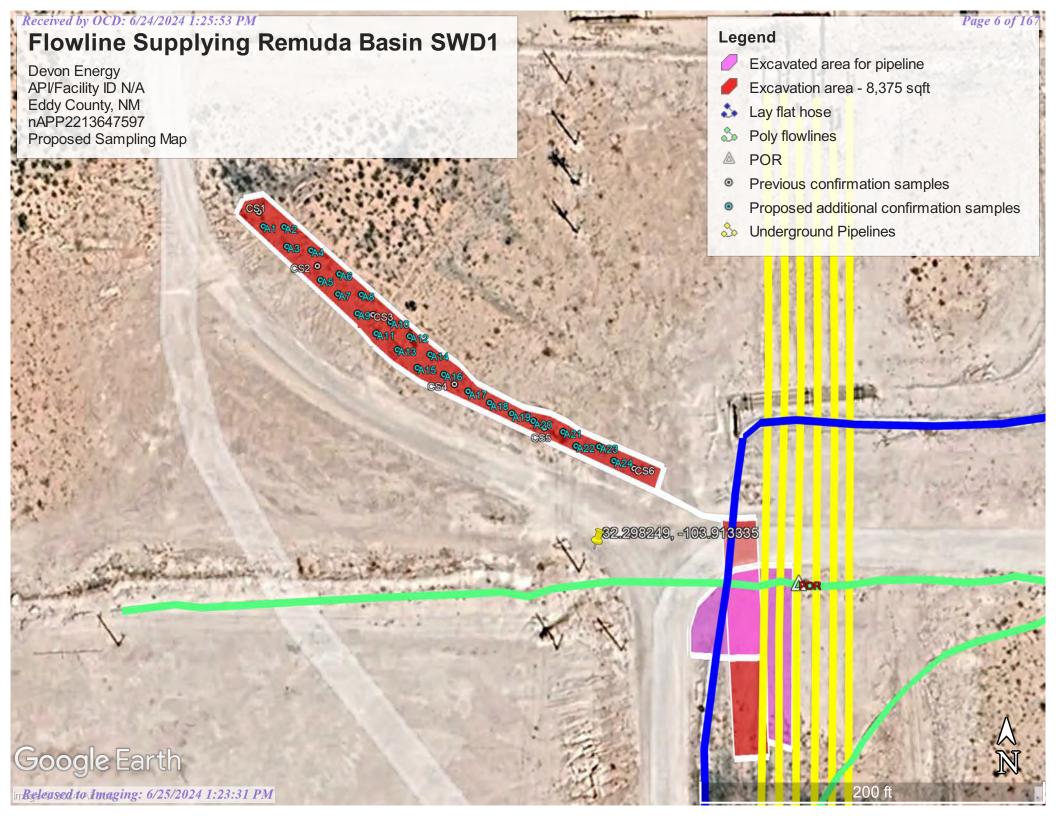
A Proposed Sampling Map can be found in Figure 2. Complete laboratory reports and corresponding data tables can be found in Appendix A. Previously submitted Photographic Documentation with correct labeling can be found in Appendix B.

- 1. Submit a 48-Hour Notification of Sampling Event via NMOCD Portal.
- 2. A total of 24 additional samples will be collected from the northern portion of the release area. Because the excavation has been backfilled, these samples will be discreet samples, each taken from a depth of 3' (bgs).
- Samples collected will be immediately put on ice, then jarred, and delivered to Envirotech Labs where each sample will be analyzed for all constituents as per Table 1 19.15.29.12 NMAC.
- If sample results prove that contamination still exists, Devon will remove it, haul it to an approved, lined disposal facility, and backfill the area with clean, like material.
- If samples results prove that contamination does not exist, a remediation closure report will be drafted and submitted to the NMOCD with all pertinent details of these events.
