Re: Site Assessment, Remediation, and Closure Report
Electra Federal Battery
API No. 30-015-36467
GPS: Latitude 32.85311 Longitude -103.95909
U/L "B", Sec. 10, T17S, R30E
Eddy County, NM
NMOCD Ref. No. nAPP2235342254

Paragon Environmental, LLC (Paragon) has been contracted by Spur Energy Partners (Spur) to perform a spill assessment, conduct remediation activities, and write the closure report for the release site known as the Electra Federal Battery (Electra). Details of the release are summarized below:

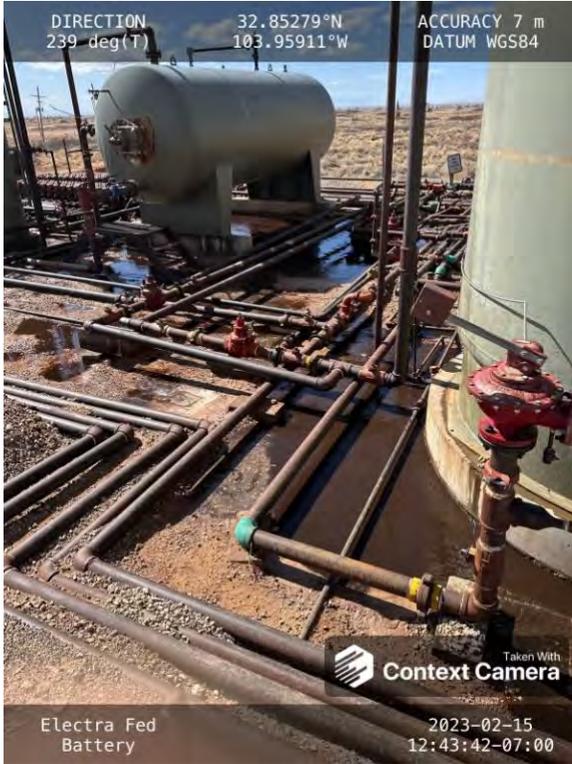
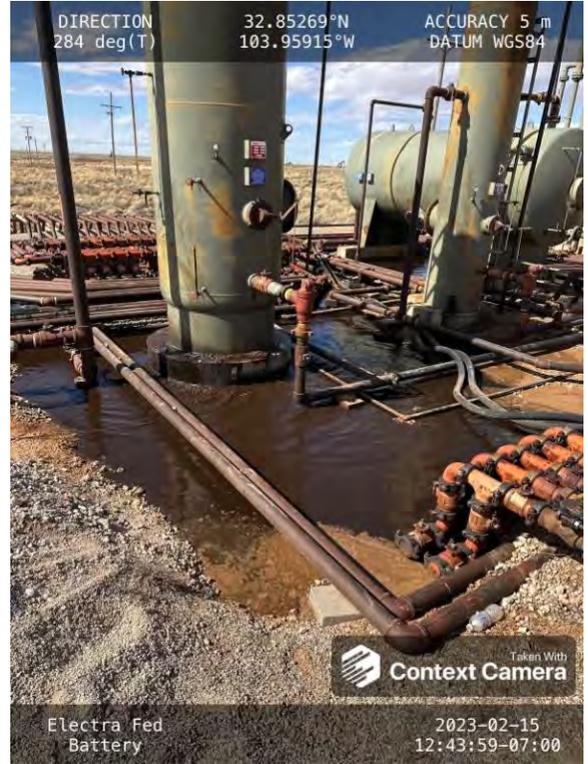
Photographic Documentation Incident Photos

Release Details			
Type of Release:	Crude Oil & Produced Water	Volume of Release:	11 bbls
		Volume Recovered:	10 bbls
Source of Release:	Circulating Line	Date of Release:	12/16/22
Was Immediate Notice Given?	No	If, Yes, to Whom?	
Was a Watercourse Reached?	No	If Yes, Volume Impacting Watercourse:	N/A
Surface Owner:	Federal	Mineral Owner:	Federal
<p>A 3-inch vic tee on a production header corroder and resulted in the release of mixed fluids.</p> <p>This leak happened in the same spot the previous spills in this battery occurred.</p>

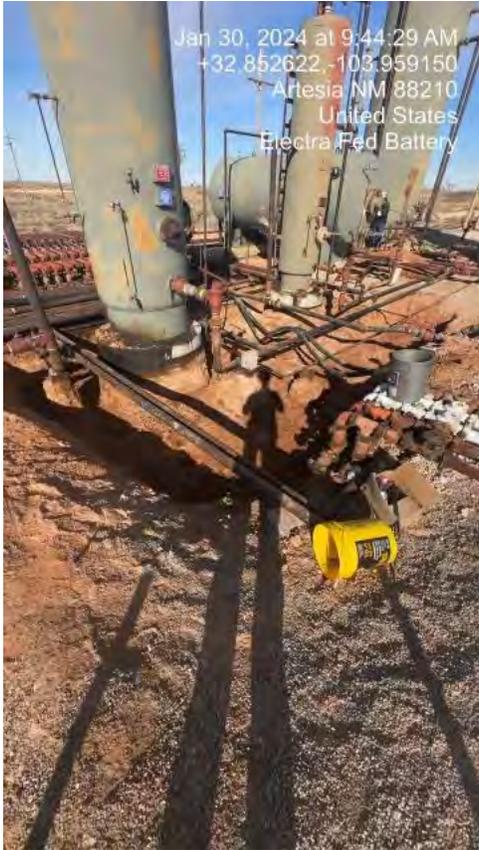
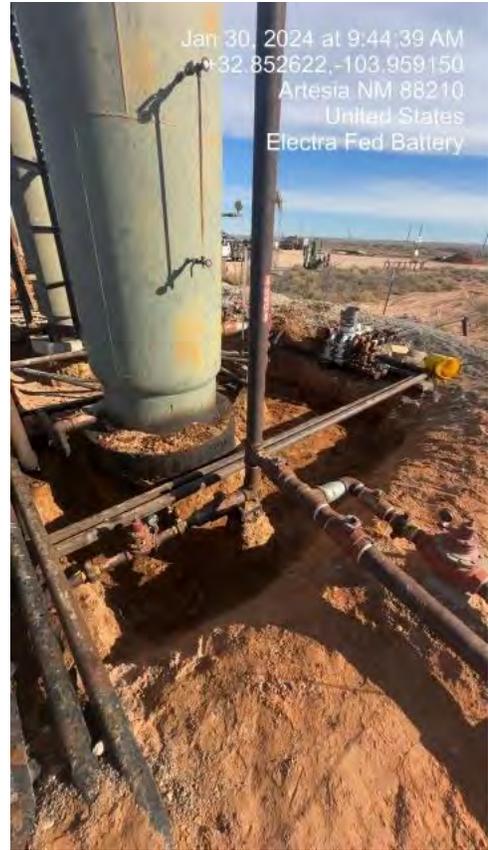
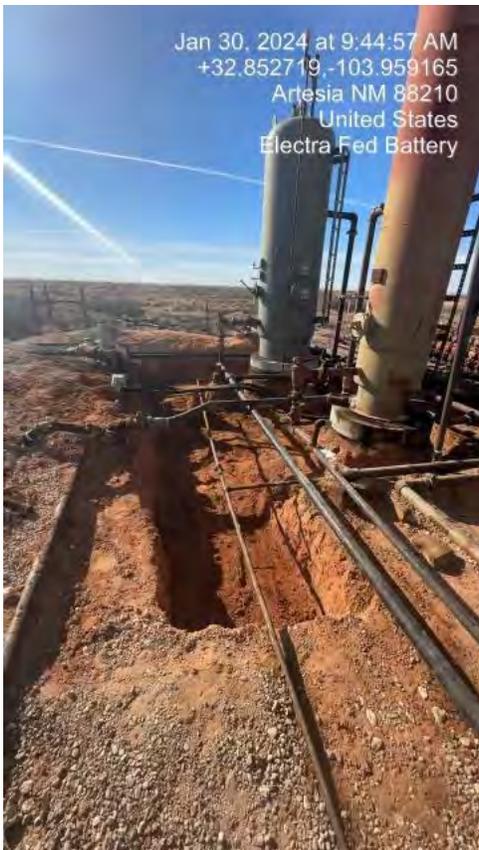
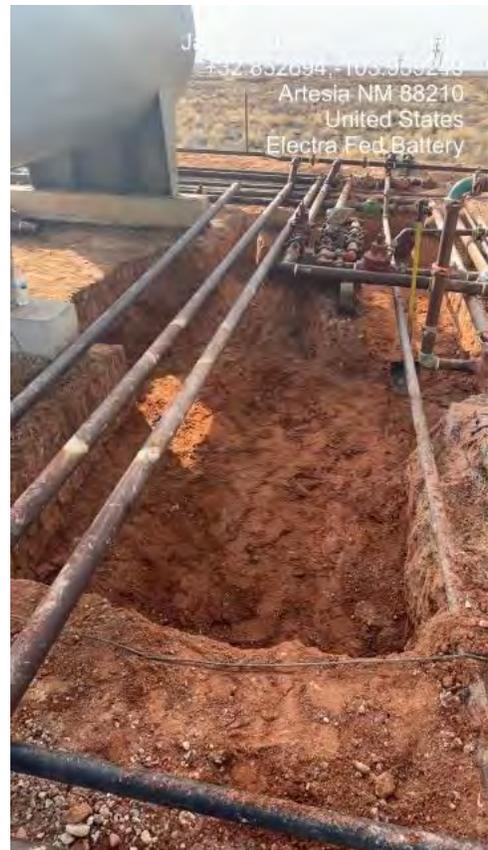
During

- Inside the battery, where the staining from the incident occurred, we manually excavated to a depth of 2 feet BGS. The material was hauled to Lea Land disposal, where clean backfill material was obtained.
