**JACKSON UNIT SWD #006
DEFERRAL REQUEST**

**API NO. 30-025-34623
Unit Letter H, Section 21, Township 24S, Range 33E
LEA COUNTY, NEW MEXICO**

**DATE OF RELEASE: UNKOWN
INCIDENT NO. NAPP2307437229**

Subject: Closure/Deferral Request for Tap Rock – Jackson Unit SWD #006

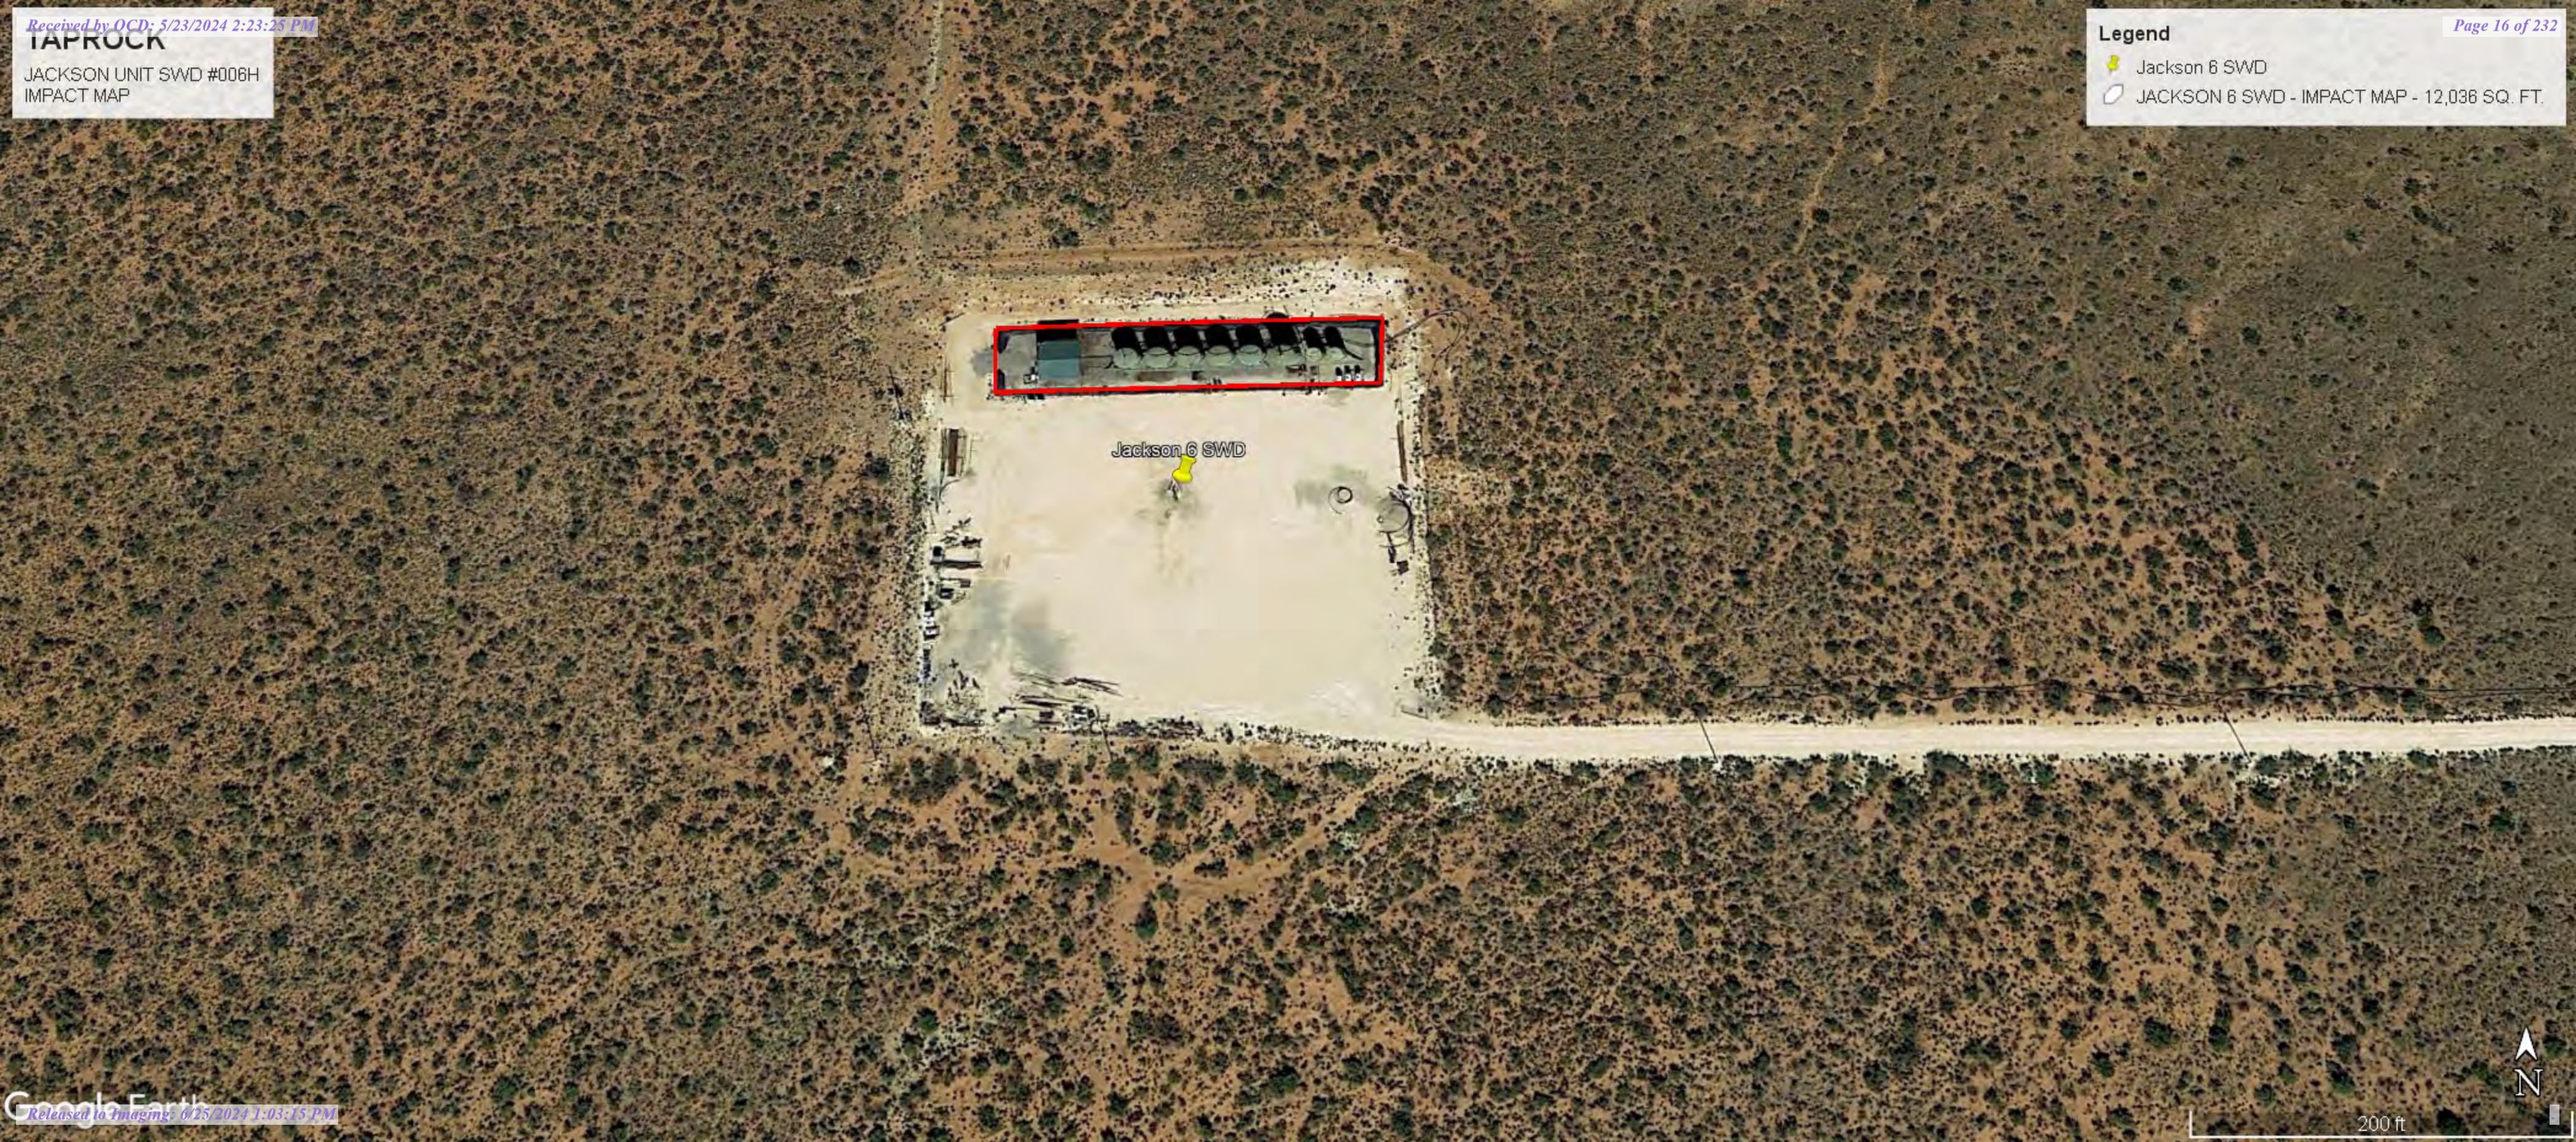
JACKSON 6 SWD - IMPACT MAP - 12,036 SQ. FT.

- 13,262 sq. ft. Outside Wall
- 244' East to West Wall
- 53.5' North to South Wall
- 9497 sq. ft. Inside Wall
- JACKSON 6 SWD BATTERY

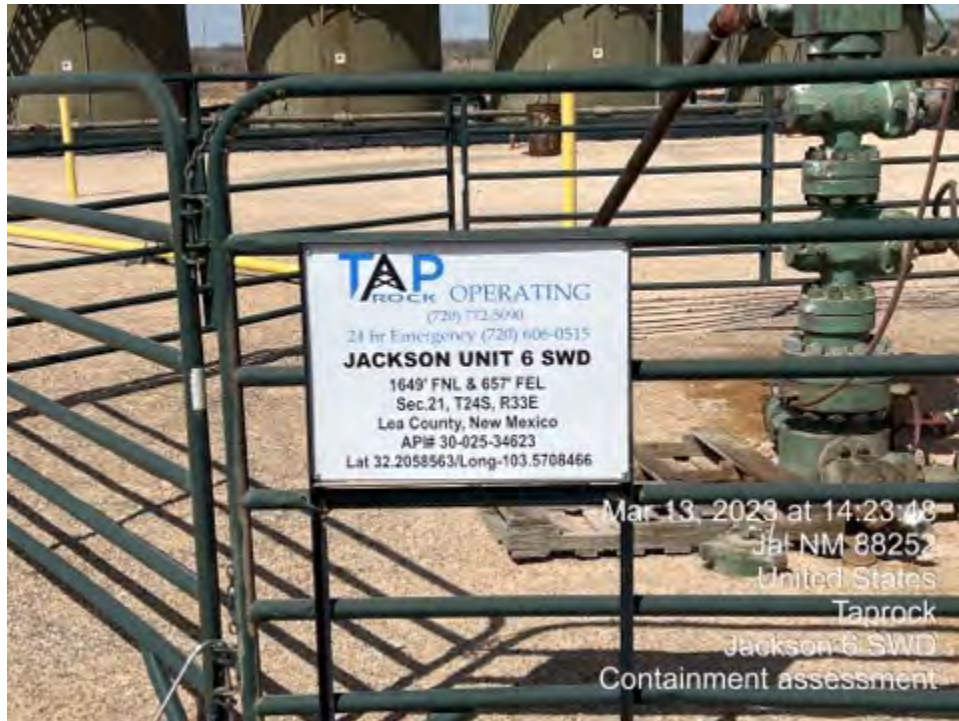
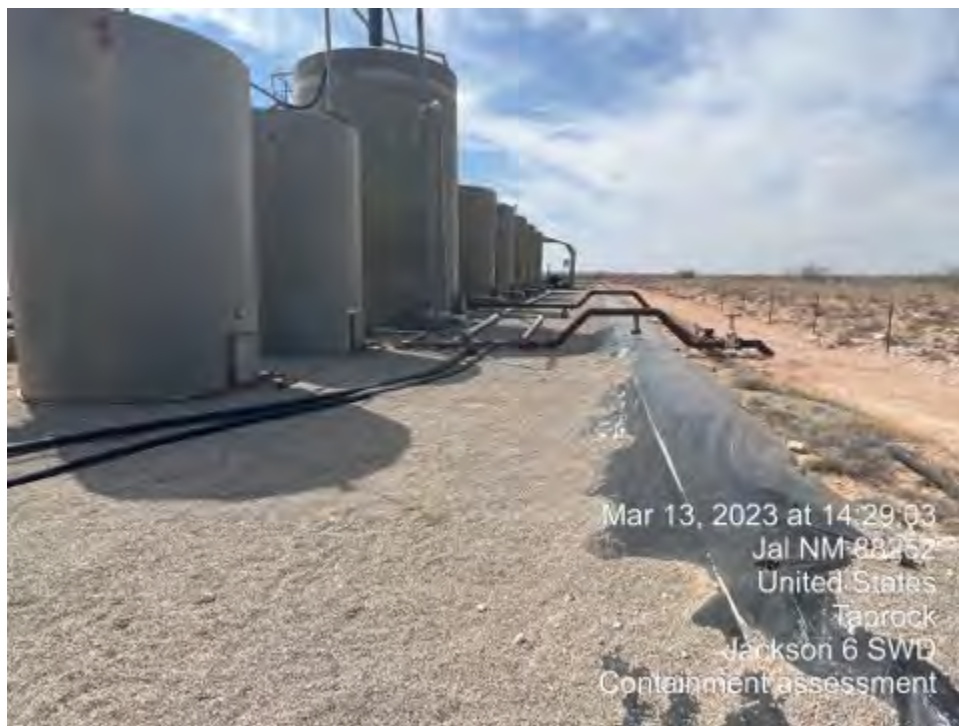
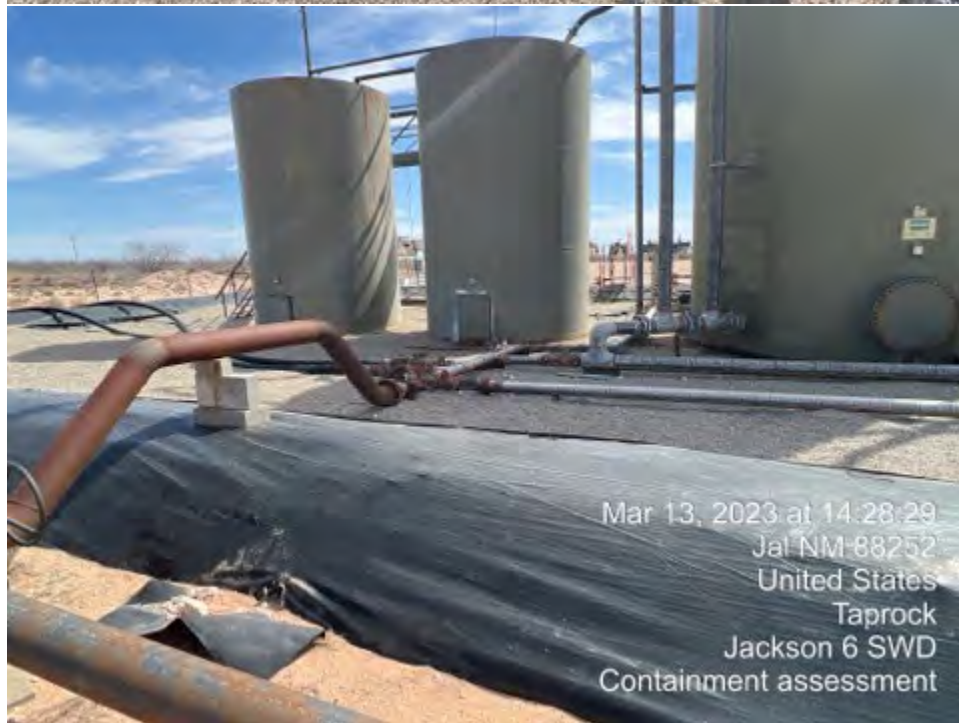
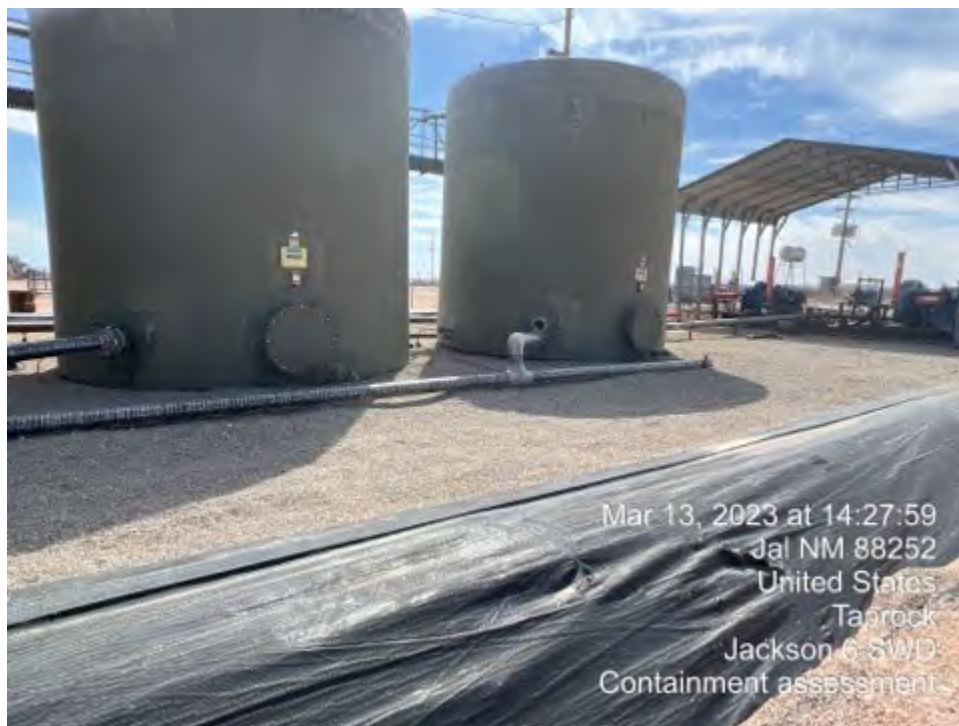
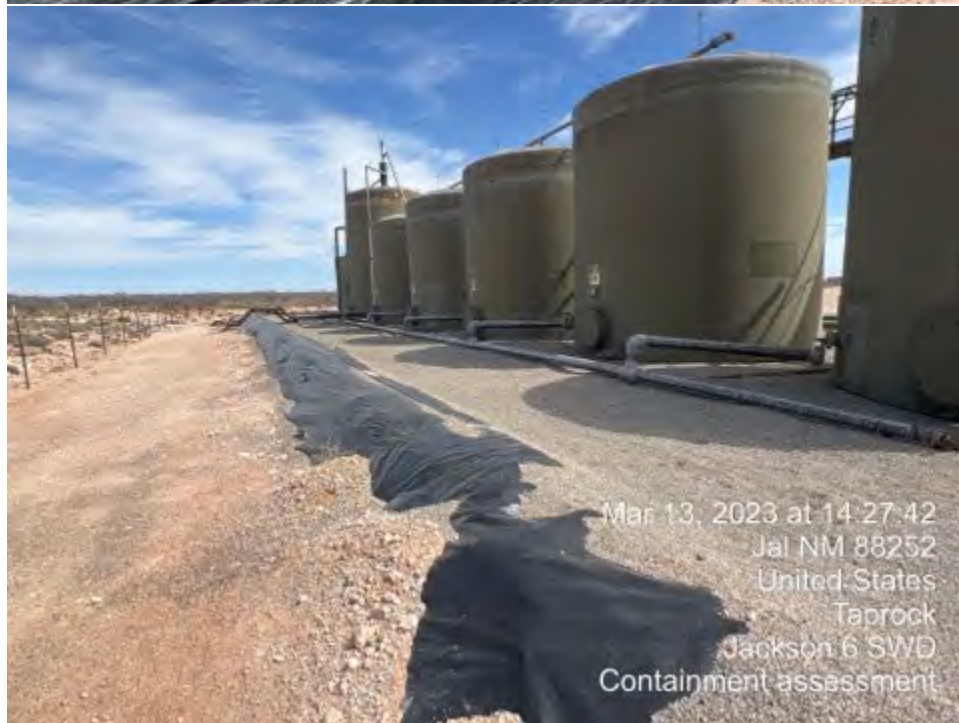
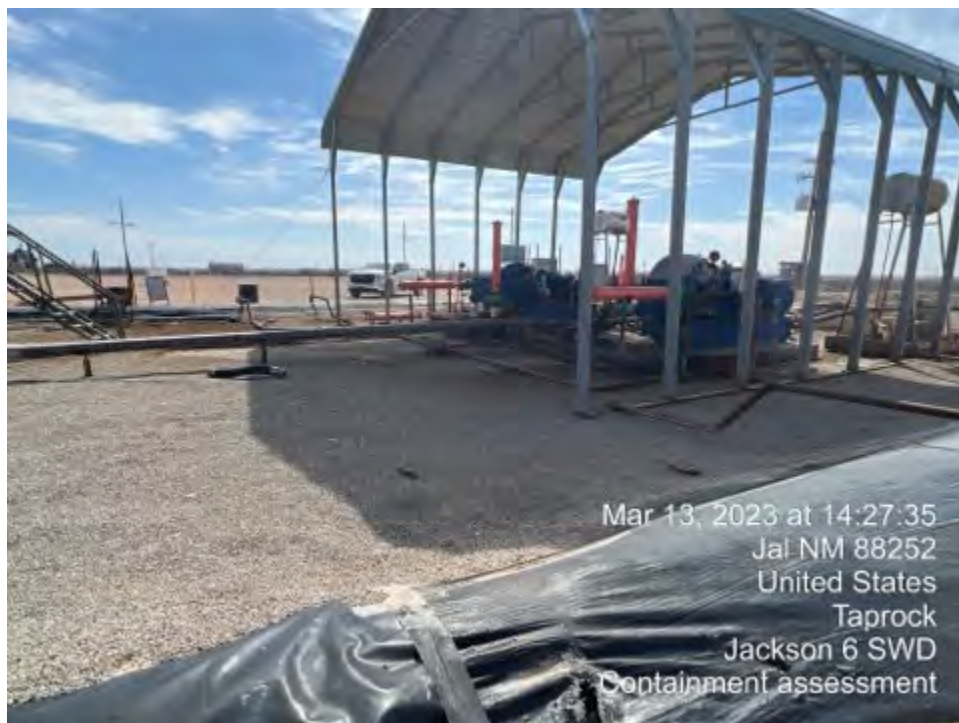
**JACKSON 6 SWD
INITIAL PHOTOS**

During a SLO site inspection on March 15th, 2023, it was found that a historical release was located around the pumps and that the liner had been compromised in several areas. It is unknown of the cause or date of the release, so no fluid recovery was able to take place.

ESS was dispatched to the site and conducted an environmental site assessment of the historical release. It was determined after measuring the area of impact that approximately 8.19bbls was released in the lined containment area. Initial site photos and measuring of the impacted area were conducted. Please see the initial site photos attached.

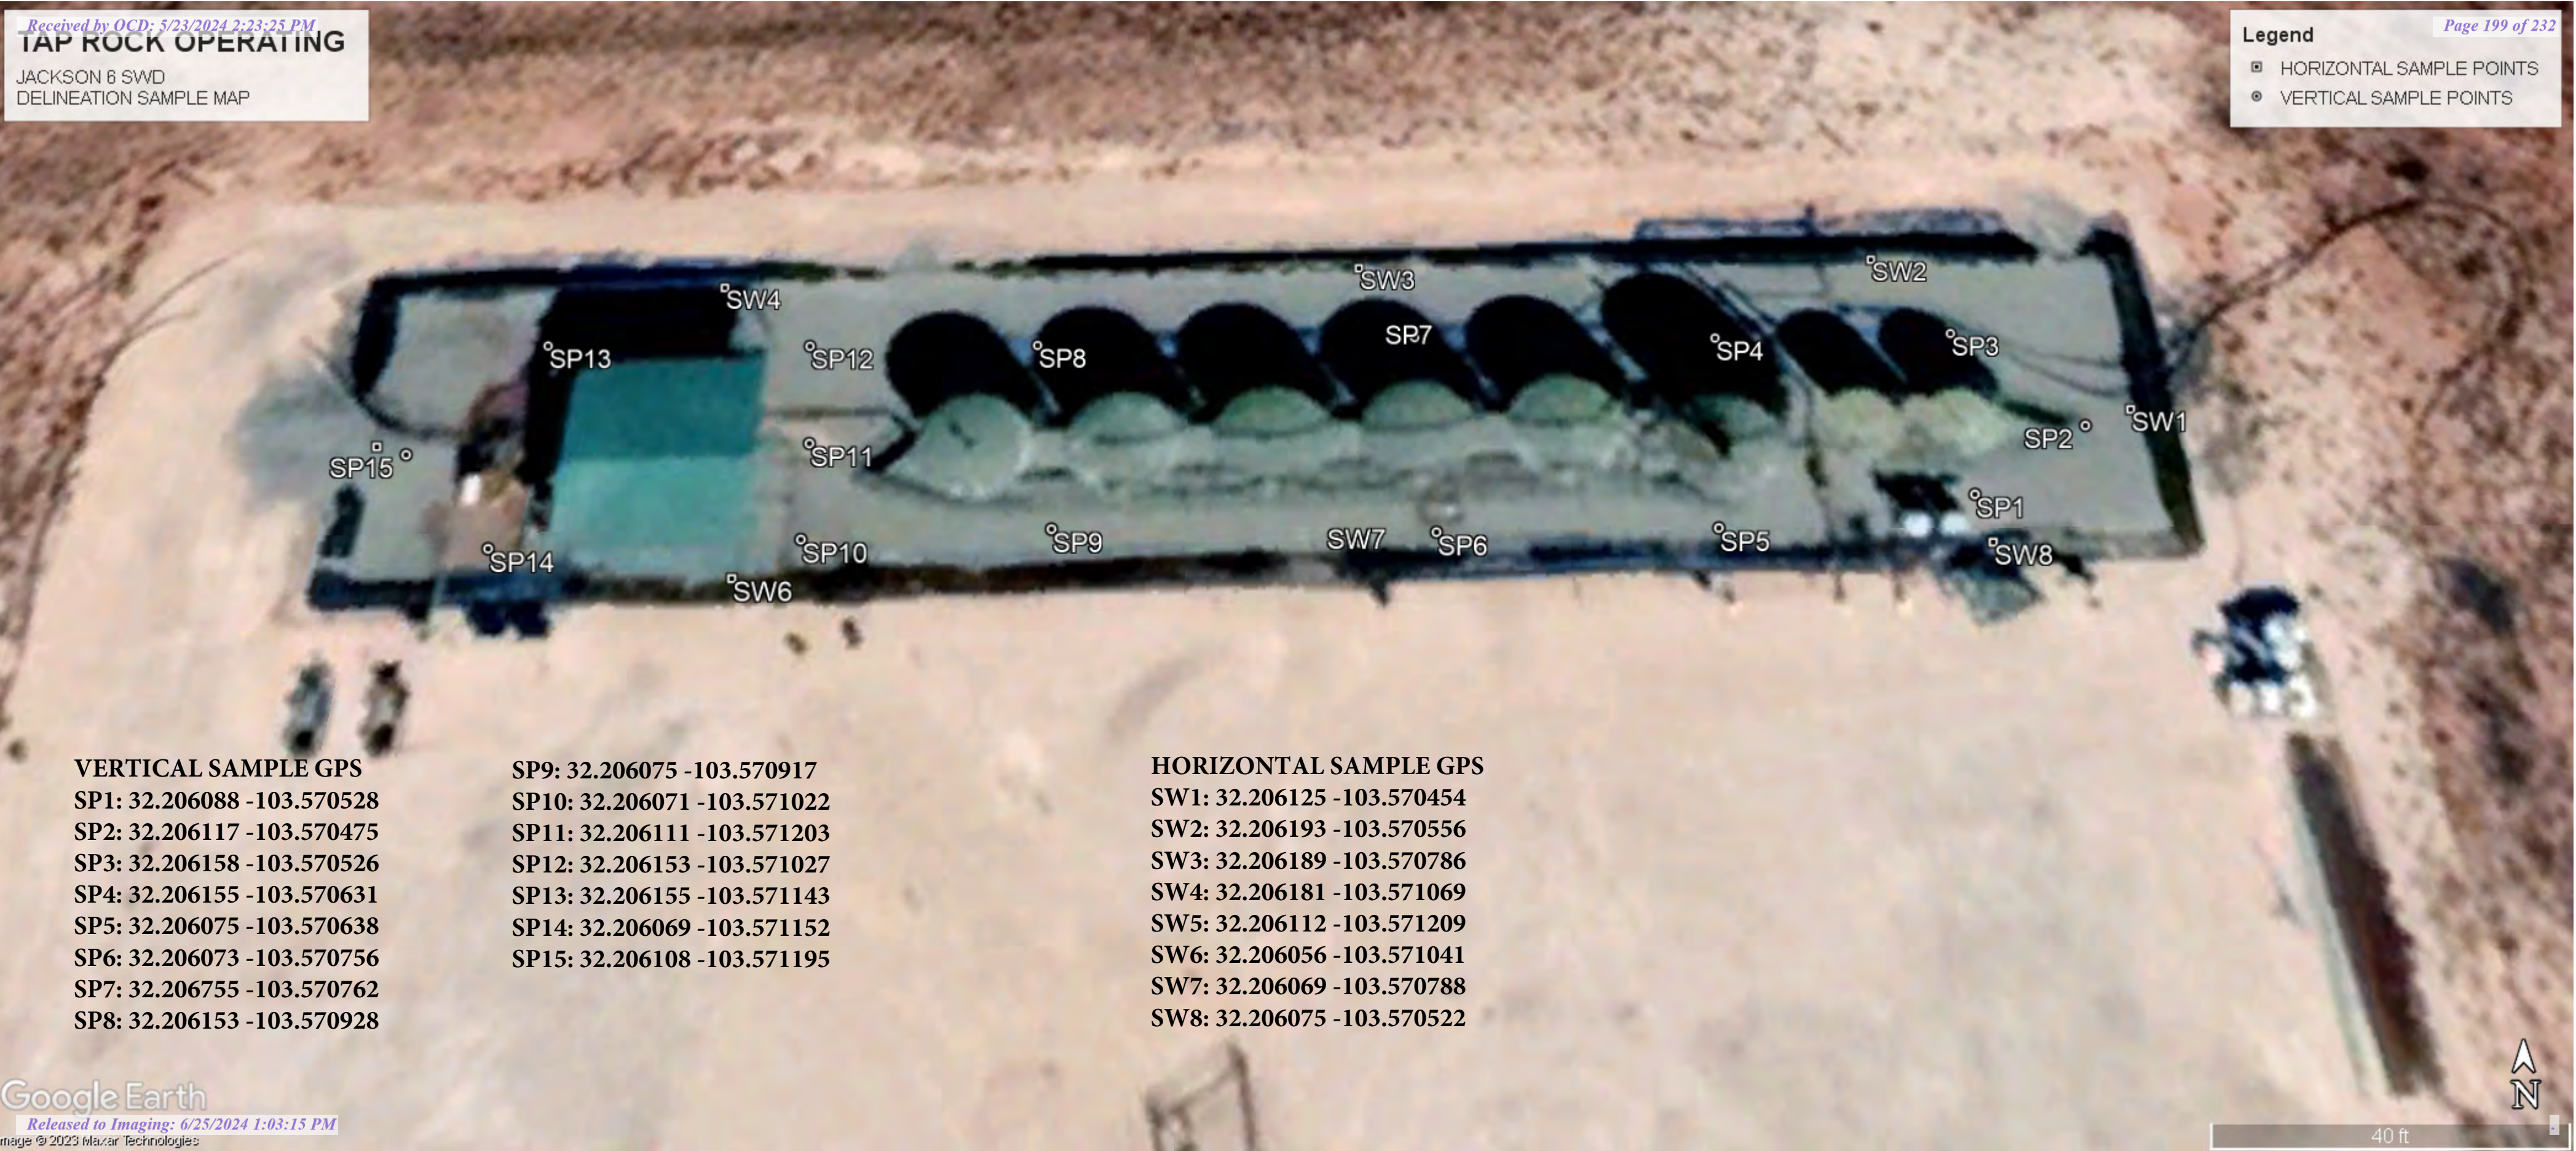
VERTICAL SAMPLE GPS

SP1: 32.206088 -103.570528
SP2: 32.206117 -103.570475
SP3: 32.206158 -103.570526
SP4: 32.206155 -103.570631
SP5: 32.206075 -103.570638
SP6: 32.206073 -103.570756
SP7: 32.206755 -103.570762
SP8: 32.206153 -103.570928
