Re: Remediation Report and Closure Request

Lateral J-2 Pipeline
San Juan County, New Mexico
Harvest Four Corners, LLC
NMOCD Incident No: nAPP2323651745

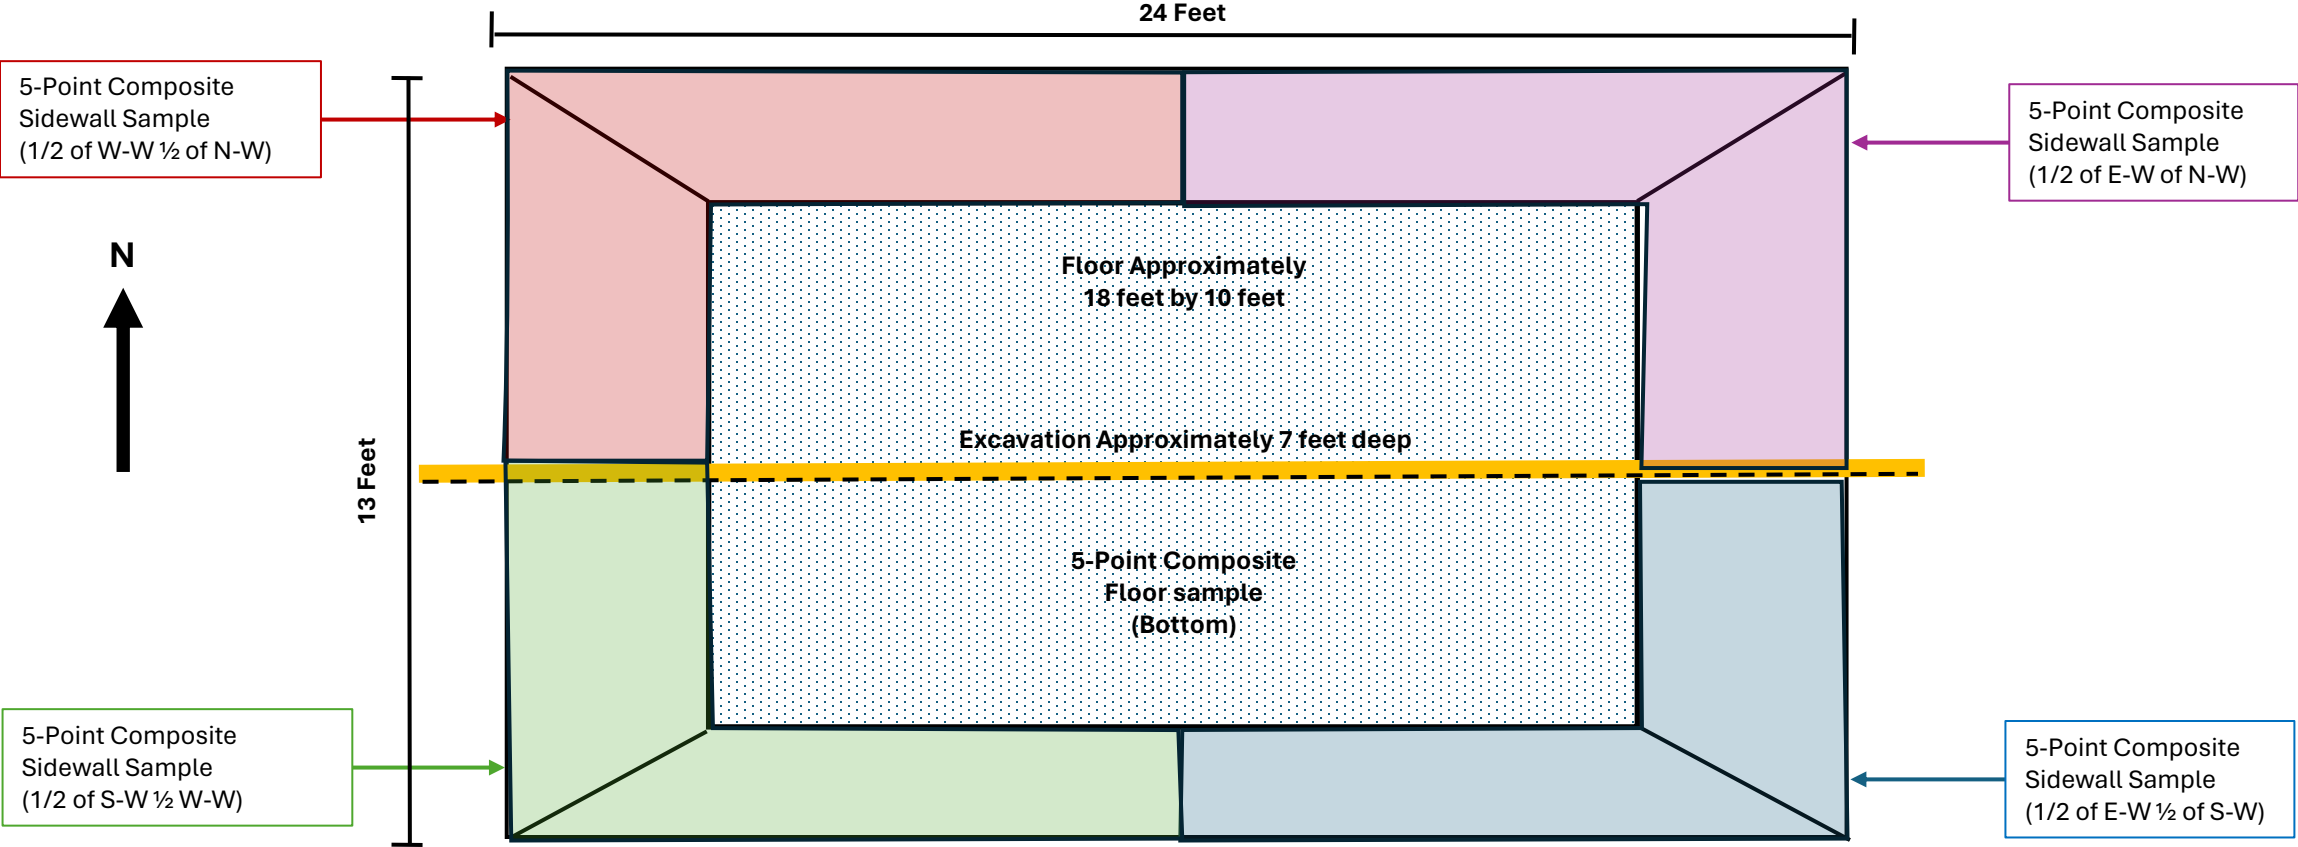
FIGURE 2
SOIL SAMPLE LOCATION MAP
LATERAL J-2 PIPELINE
HARVEST FOUR CORNERS, LLC

The dimensions provided for the excavation extent represented the top of the excavation and did not accurately depict the floor of the excavation which had a smaller footprint due to the sloped sidewalls. A more accurate and scaled sampling diagram is provided as Figure 2 in this report

and shows that the floor of the excavation was less than 200 square feet, due to the sidewalls being sloped. In addition, the photographic log (Attachment 3) shows the smaller footprint of the excavation floor, and the sloped sidewalls. The revised Figure 2 is a more accurate and detailed representation of the excavation and the sample locations and shows that the composite samples collected on November 8, 2023, meet the sampling frequency required to be compliant with 19.15.29.12 D.(1)(c) NMAC.

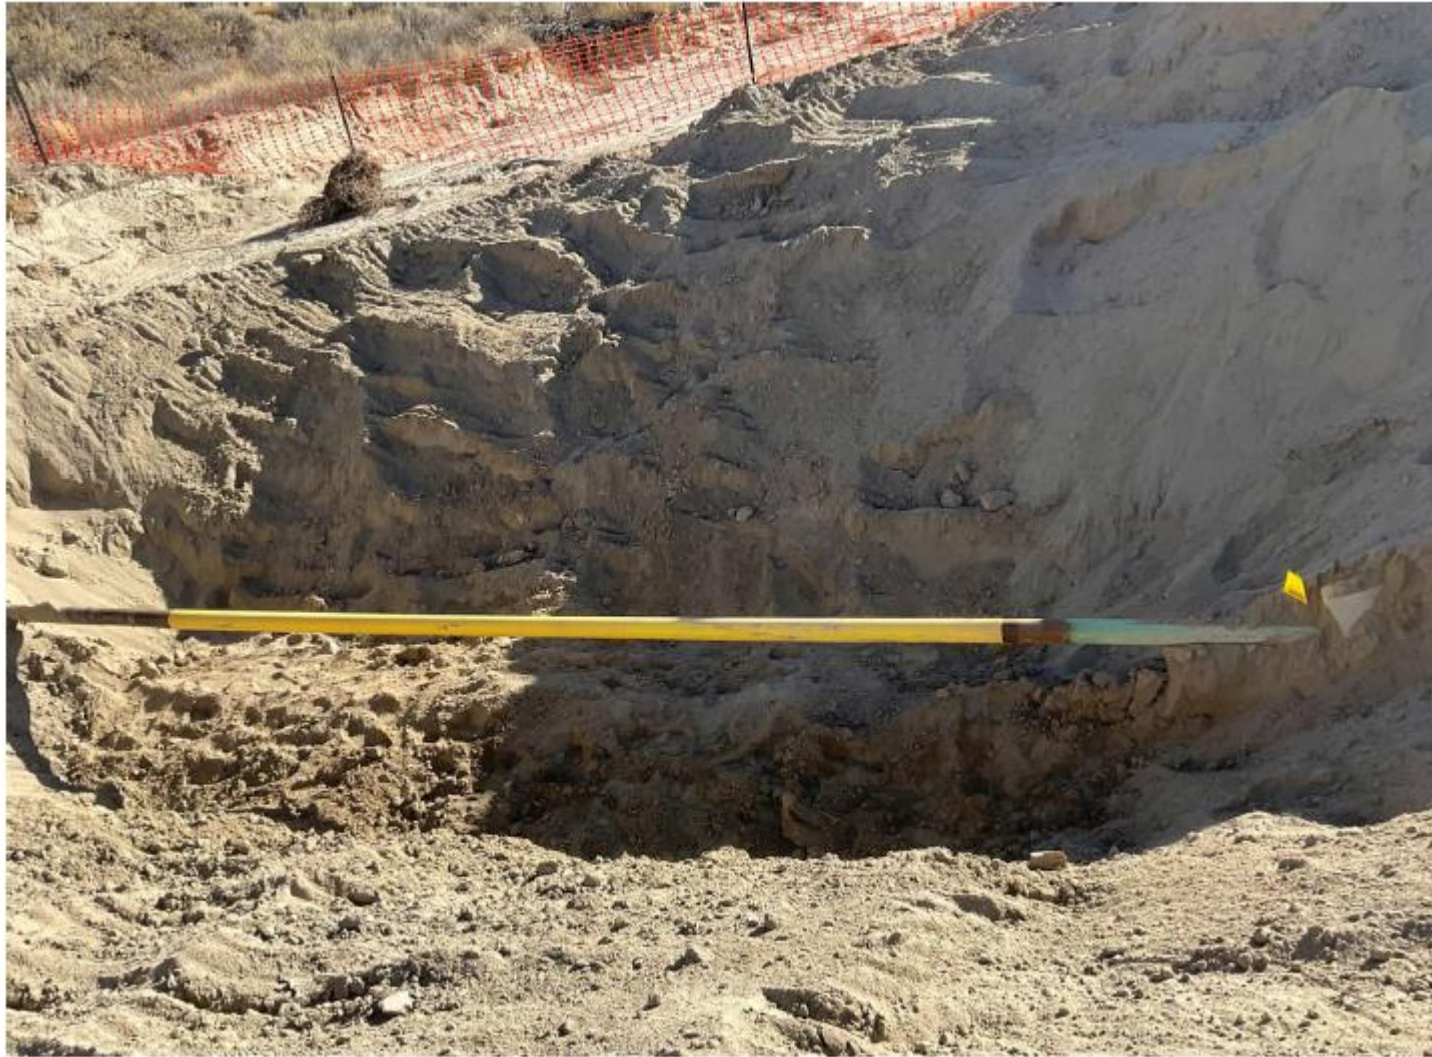
Photo #1

Excavation and J-2 Pipeline – Looking South.
Photograph taken by Harvest on 11/8/2023.

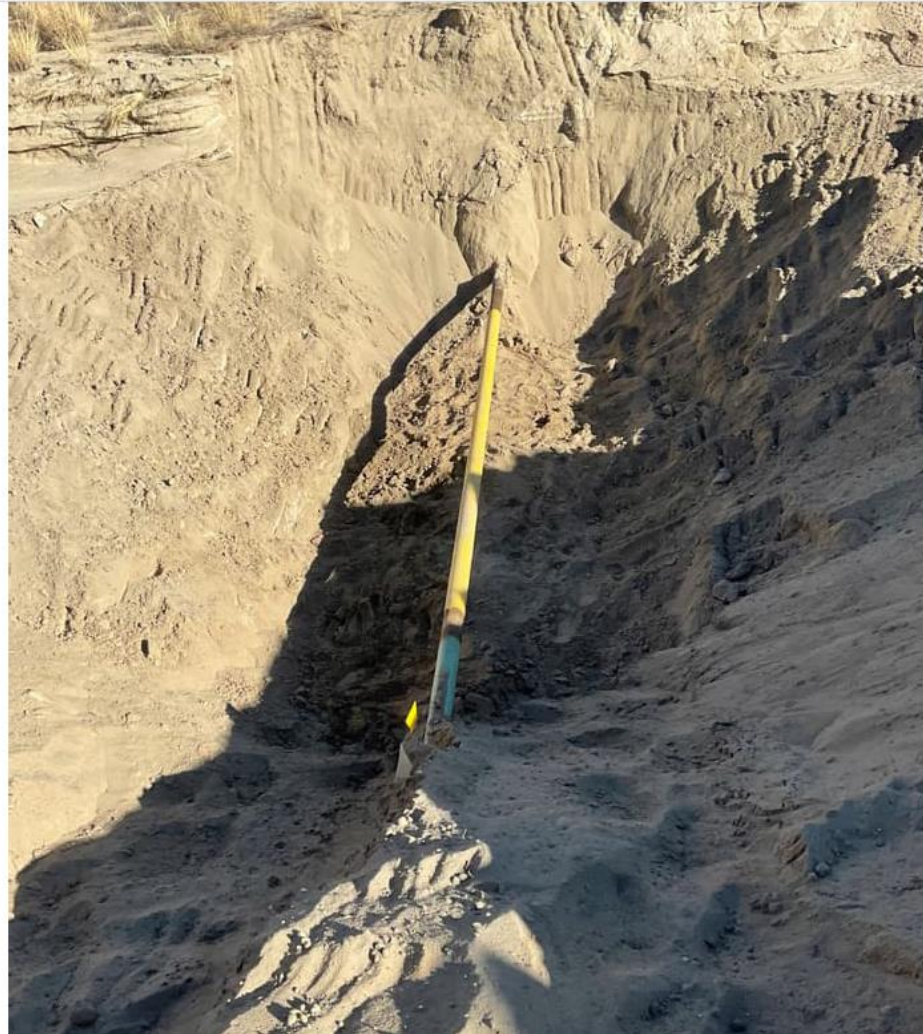
Photo #2

Excavation and J-2 Pipeline – Looking East.
Photograph taken by Harvest on 11/8/2023.

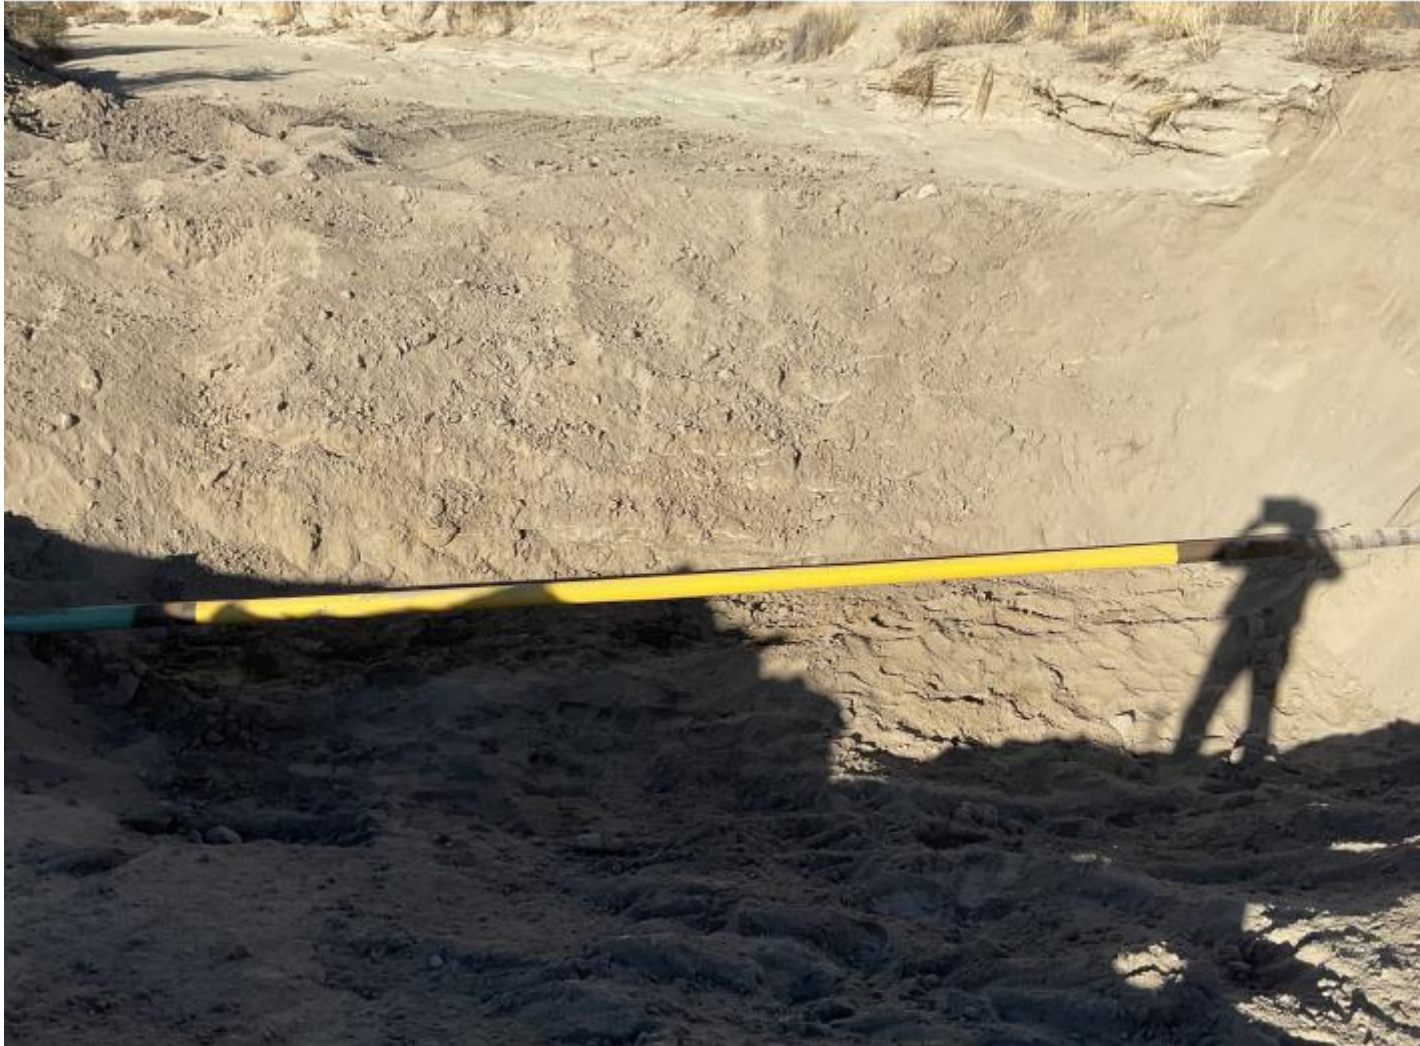
Photo #3

Excavation and J-2 Pipeline – Looking North.
Photograph taken by Harvest on 11/8/2023.

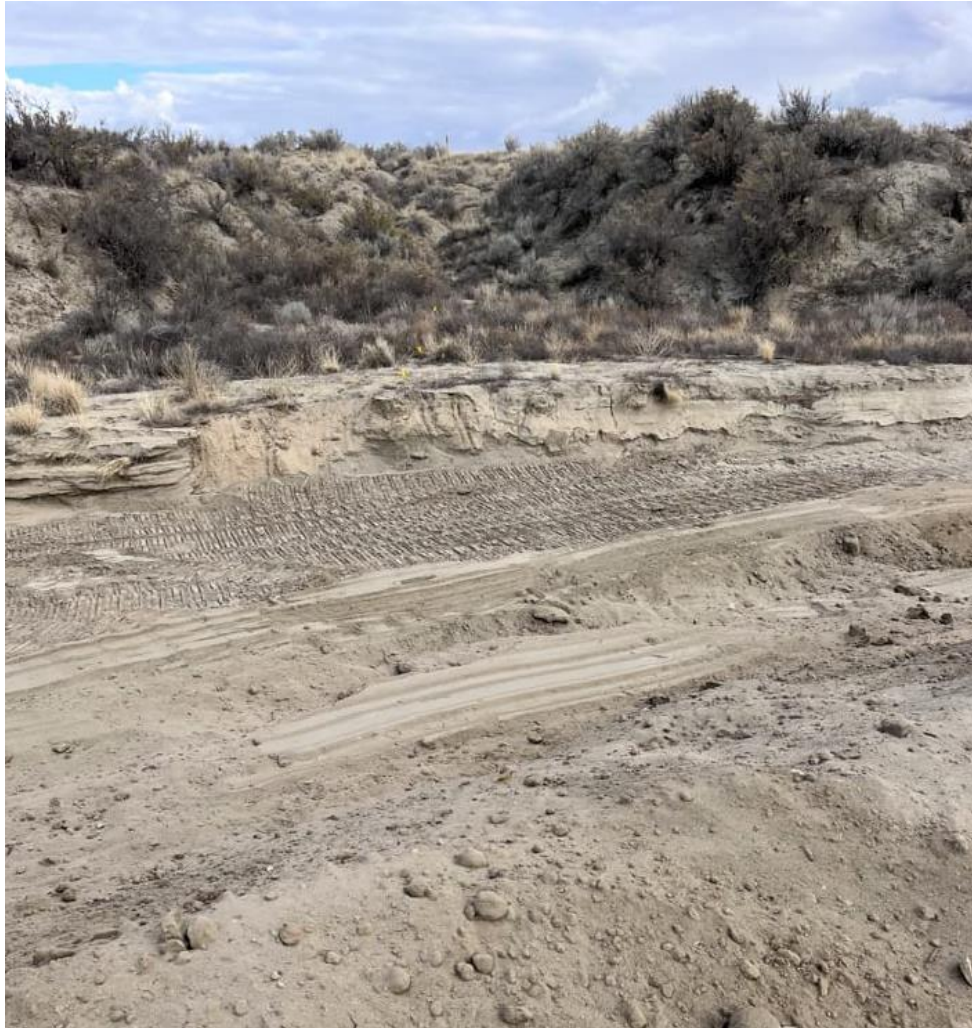
Photo #4

Backfill photo – looking West.

Photograph taken by Harvest on 11/10/2023.
