Closure Report
Baseball Cap Fed 26 (04.16.2024)
Lea County, New Mexico
Incident ID: nAPP2410749827
Unit N Sec 25 T24S R34E
32.18160556°, -103.4256638°

Crude Oil Release

Re: Closure Report

Baseball Cap Fed 26 (04.16.24) Concho Operating, LLC Incident ID: nAPP2410749827

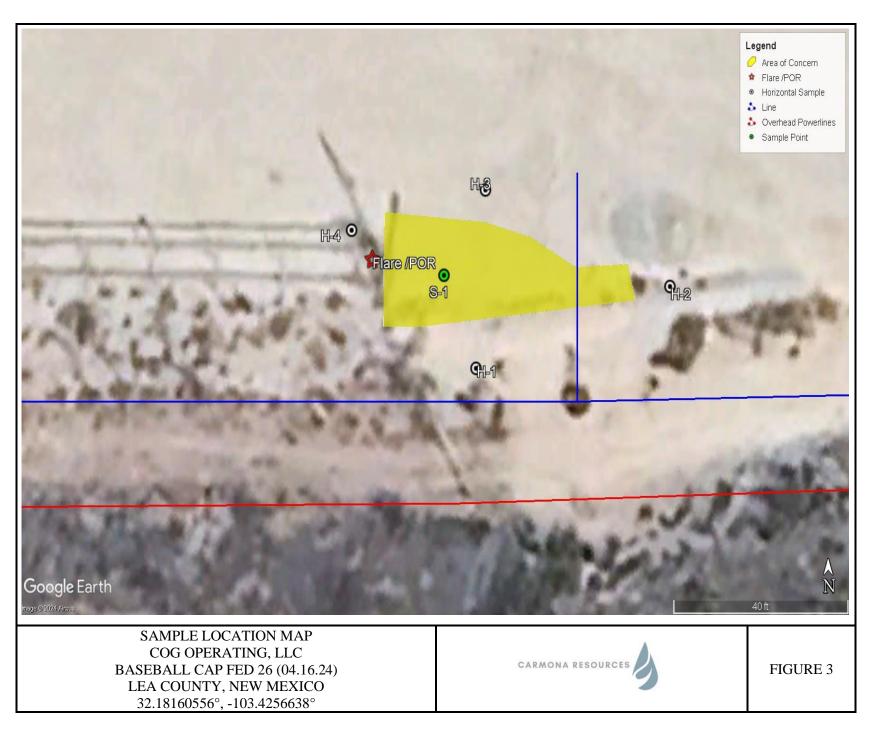
Based on the initial C-141 obtained from the New Mexico Oil Conservation Division (NMOCD), the release was discovered on April 16, 2024, and was caused by an instrumentation failure causing fluid to be released out of the flare leading to a fire. It resulted in approximately zero point zero one (0.01) barrels of crude oil being released and zero (0) barrels of crude oil being recovered. The impacted area occurred on the pad, shown in Figure 3. The initial C-141 form is attached in Appendix C.

On April 23, 2024, Carmona Resources, LLC performed site assessment activities to evaluate soil impacts stemming from the release. A total of one (1) vertical sample point (S-1) and four (4) horizontal sample points (H-1 through H-4) were advanced to depths ranging from the surface to 12" bgs inside the release area to assess the vertical and horizontal extent. See Figure 3 for the sample locations. For chemical analysis, the soil

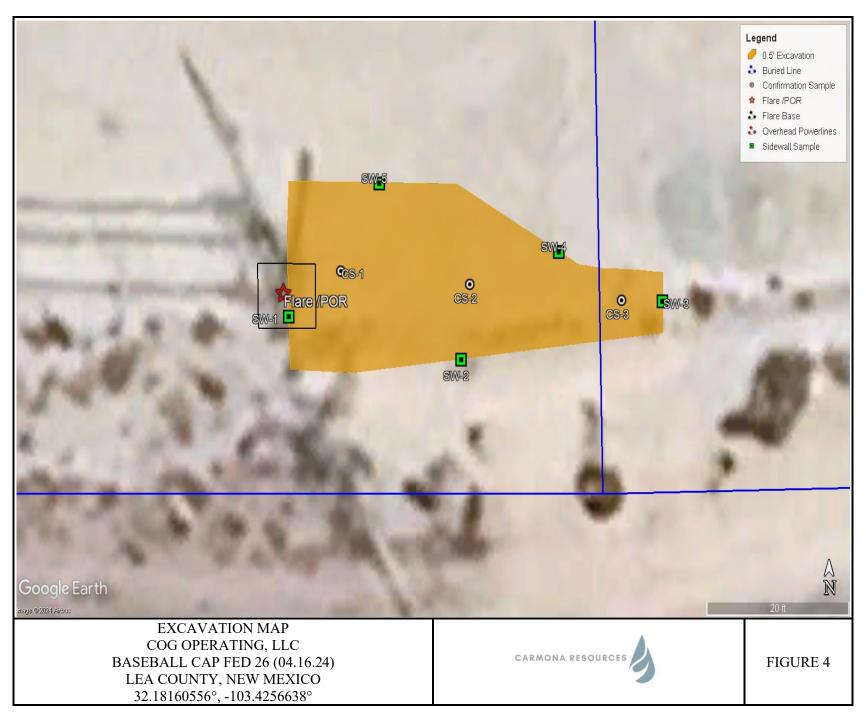
Carmona Resources personnel were on site to oversee excavation activities, collect confirmation samples, and document backfill activities. Before collecting composite confirmation samples, the NMOCD division office was notified via NMOCD web portal on May 3, 2024, per Subsection D of 19.15.29.12 NMAC. See Appendix C. A total of three (3) confirmation floor samples (CS-1 and CS-3) and five (5) sidewall samples (SW-1 through SW-5) were collected every 200 square feet to ensure the proper removal of the contaminated soils. For chemical analysis, the soil samples were collected and placed directly into laboratory-provided sample containers, stored on ice, and transported under the proper chain-of-custody protocol to Cardinal Laboratories in Hobbs, New Mexico. All collected samples were analyzed for TPH by EPA method 8015 modified, BTEX by EPA Method 8021B, and chloride by EPA method 4500. Copies of laboratory analysis and chain-of-custody documentation are included in Appendix E. Refer to Table 2. The excavation depths and confirmation sample locations are shown in Figure 4.

Approximately 10 cubic yards of material were excavated and transported offsite for proper disposal.

Before the excavation was backfilled, a composite sample of the backfill material was collected to ensure it was clean to NMOCD standards. Refer to Table 2 for results. Copies of laboratory analysis and chain-of-custody documentation are included in Appendix E

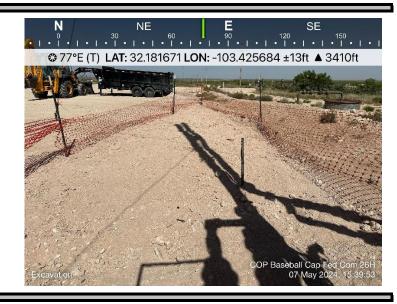
Photograph No. 1

View East, area of CS-1 through CS-3.

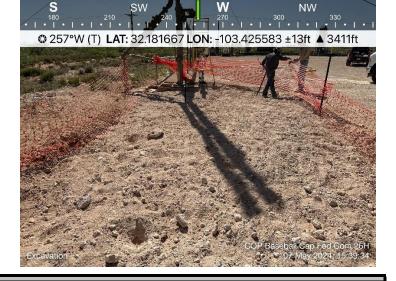
Photograph No. 2

View West, area of CS-1 and CS-2.

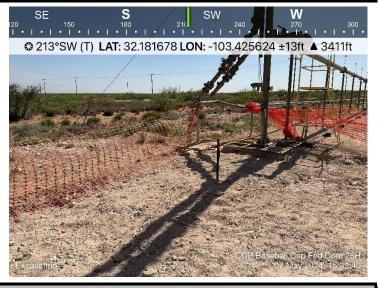
Photograph No. 3

View Southwest, area of CS-1.
