Re: Remediation Closure Report
Cotton Draw Unit 153H API # 30-015-38535
GPS: Latitude 32.1661758 Longitude -103.7636108
ULSTR – B – 3 – 23S – 31E 200FNL 1980FEL Eddy County, NM
NMOCD Incident ID nAB1626342939

This produced water release that occurred at the Cotton Draw Unit 153H (CDU) was initially discovered on September 14, 2016. The initial C-141 was submitted on September 15, 2016. This incident was assigned Incident ID nAB1626342939 by the New Mexico Oil Conservation Division (NMOCD).

Devon Energy
API #30-015-38535
Eddy County, NM
nAB1626342929
Confirmation Sample Map

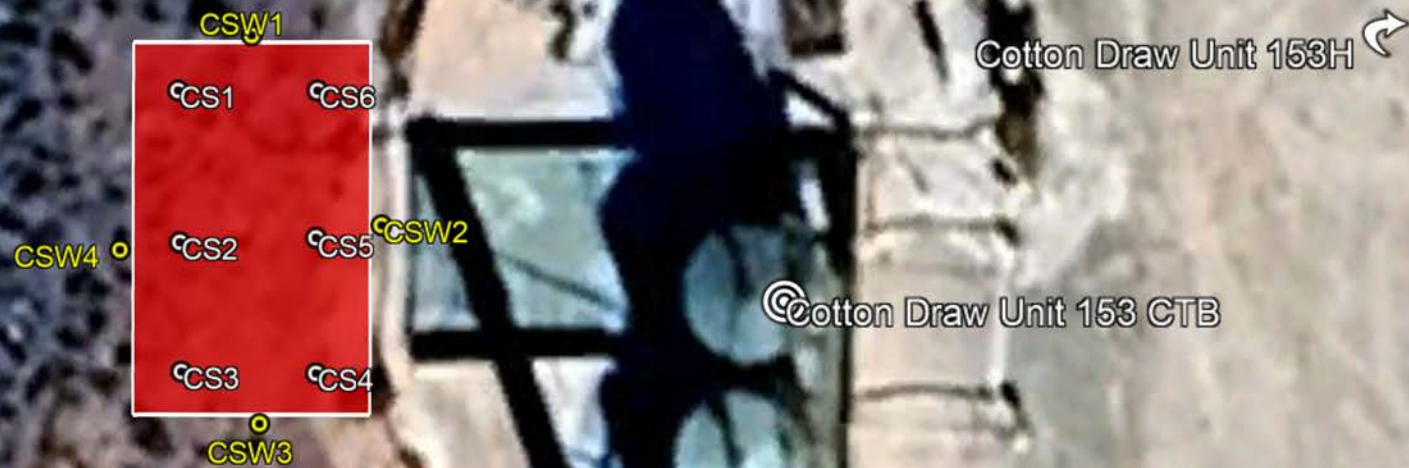
The laboratory results of this sampling event show the contaminants in this release area to be under the regulatory limits as per Table 1 19.15.29 NMAC, depth to groundwater column <50'. A Confirmation Sample Map can be found in Figure 2. A complete Laboratory Report can be found in Appendix D. Current Photographic Documentation can be found in Appendix C.

- Confirmation base samples
- Confirmation sidewall samples
- Release area - 1,244 sqft

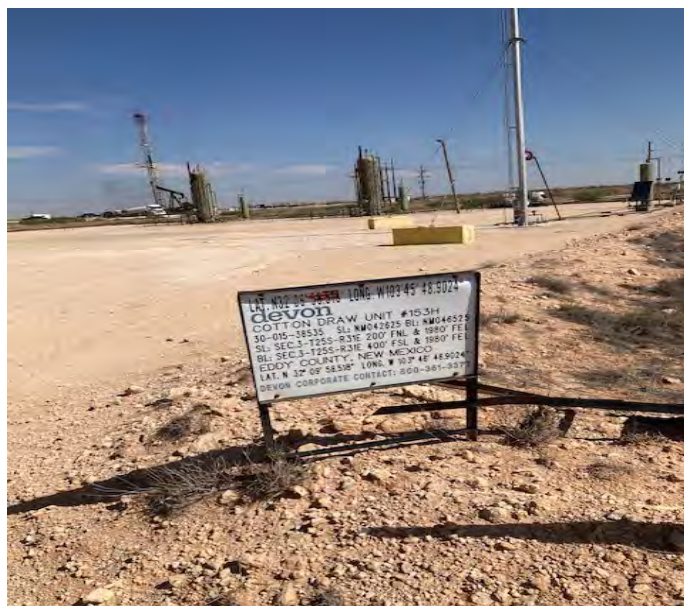
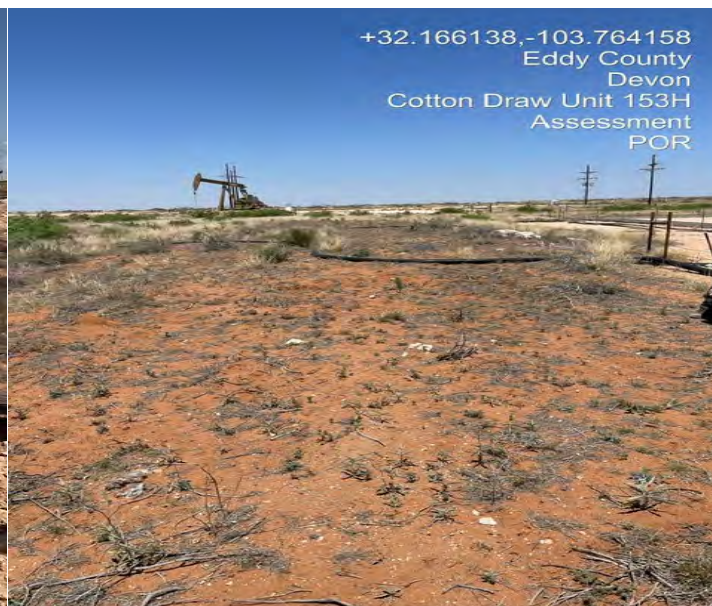
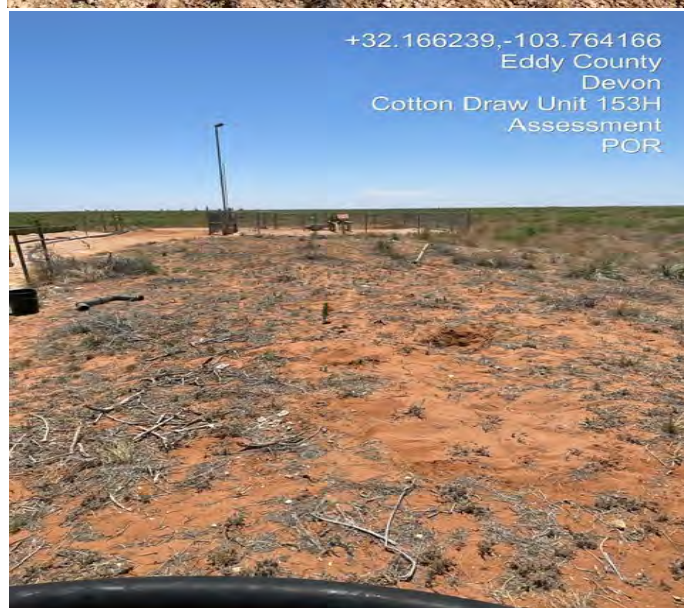
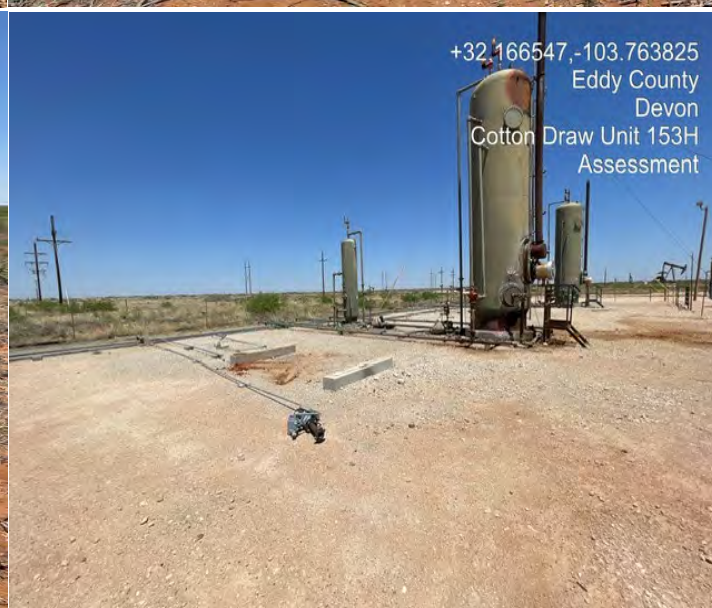
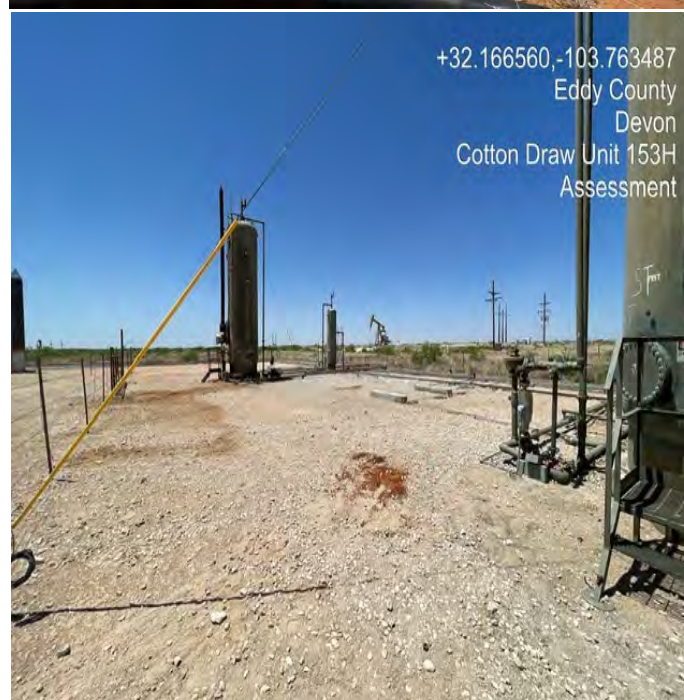
Liner Inspection Form

Visualization	Yes	No	Comments
Is there a tear in the liner?		X	
Are there holes in the liner?		X	
Is the liner retaining any fluids?	X		Rainwater
Does the liner have integrity to contain a leak?	X

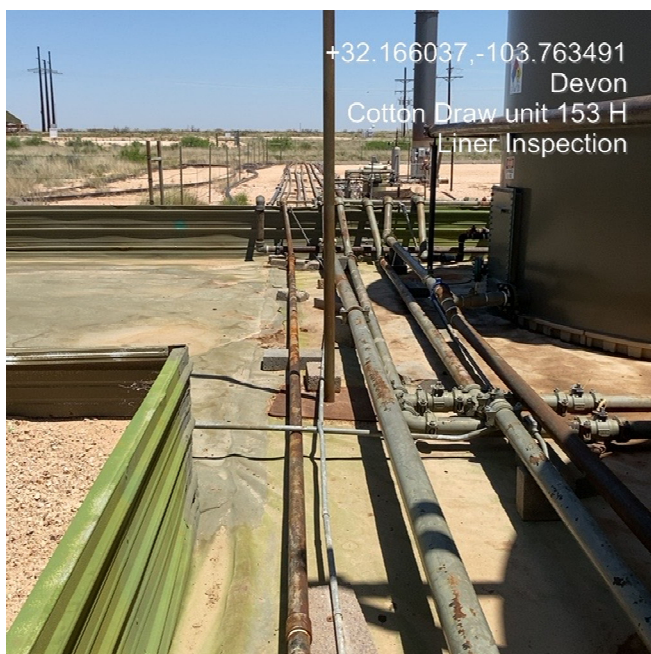
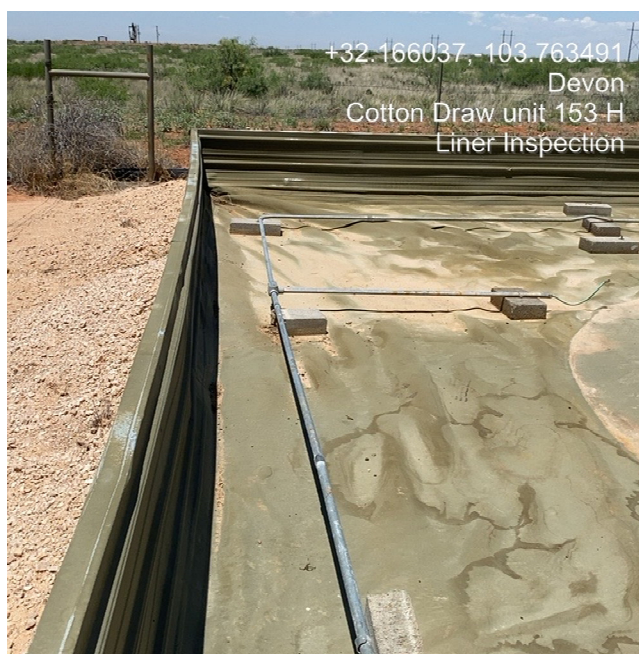
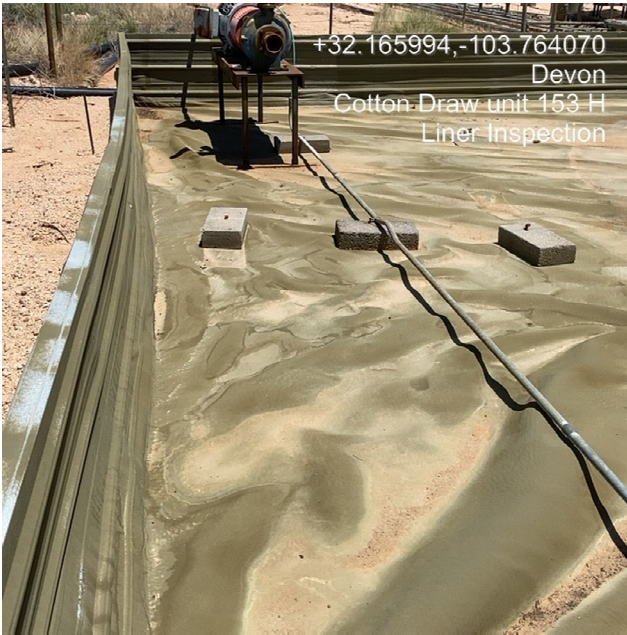
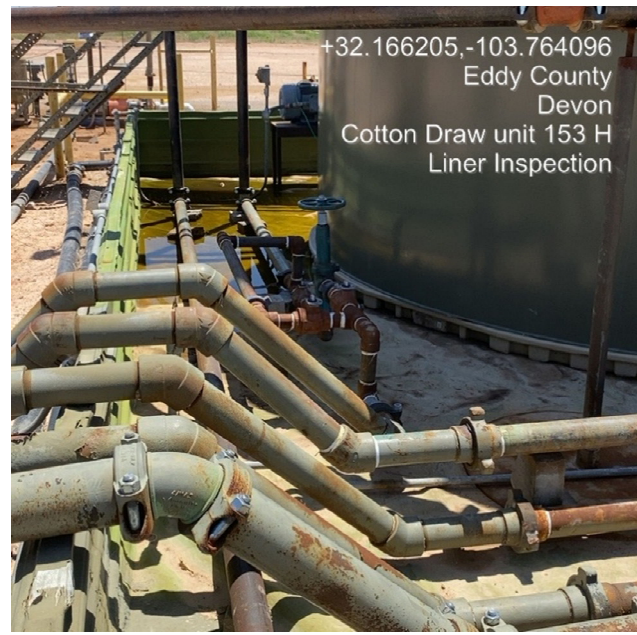
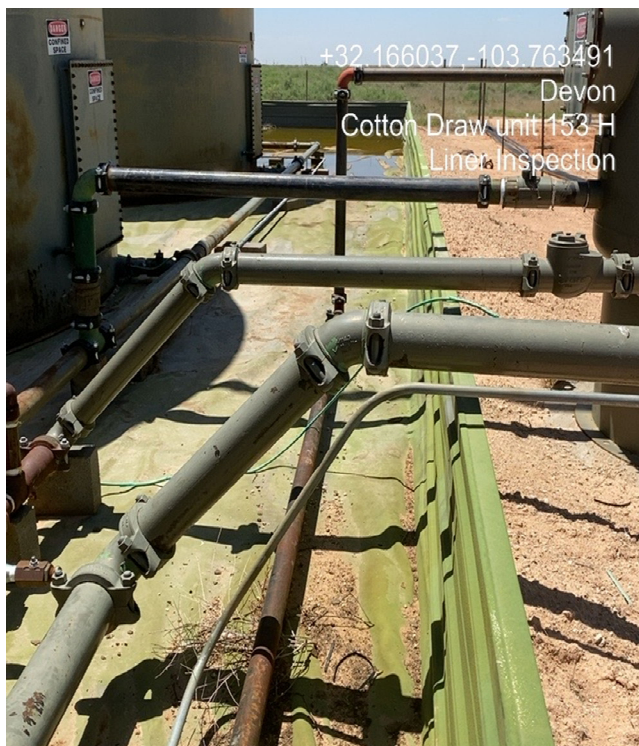
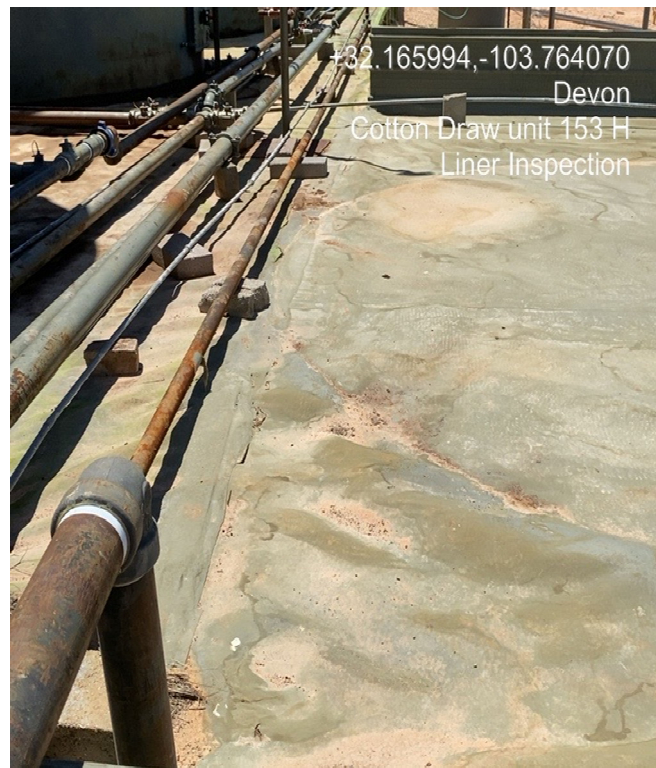
Liner Inspection:

Visualization	Yes	No	Comments
Is there a tear in the liner?		X	
Are there holes in the liner?		X	
Is the liner retaining any fluids?		X	
Does the liner have integrity to contain a leak?	X
