**Re: Remediation Work Plan
Outrider 27 Fed 701H
Incident Number NAPP2410735798
Lea County, New Mexico**

XTO Energy, Inc.
Remediation Work Plan
Outrider 27 Fed 701H

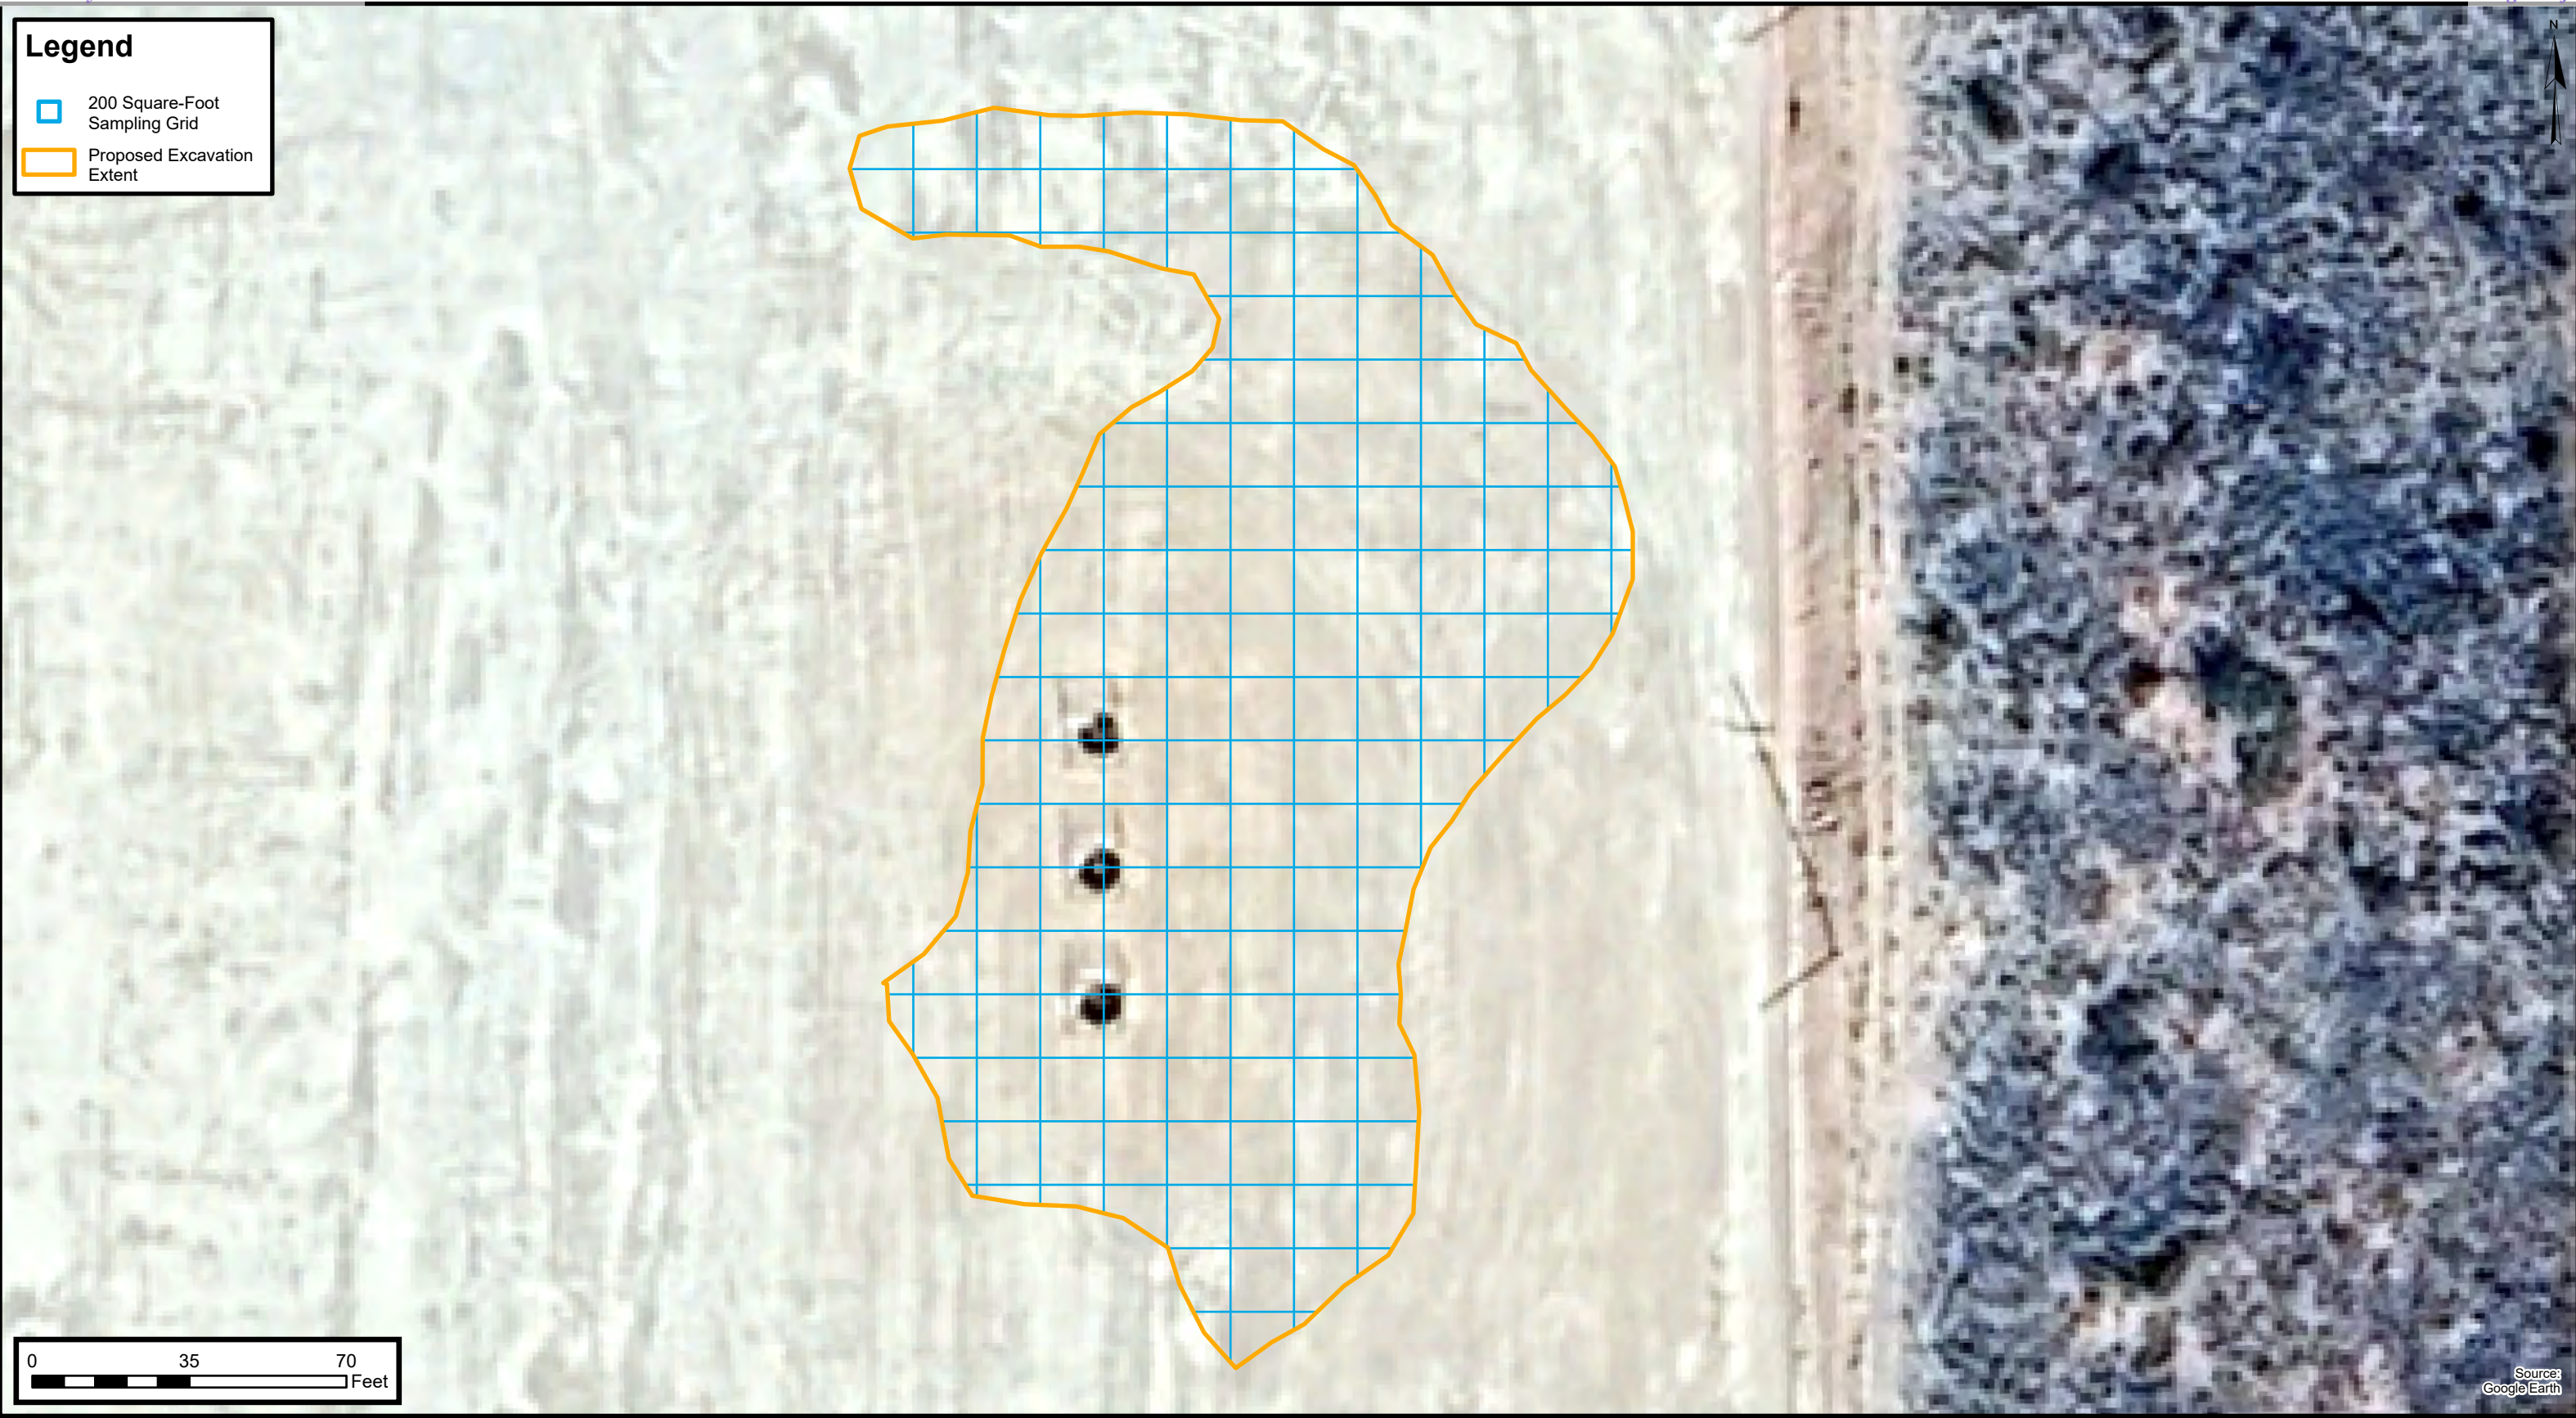
FIGURE
3a

Proposed Excavation Extent with 200 Square Foot Sampling Grid

- Excavation of waste-containing soil to a depth of 2 feet to 3 feet bgs. Excavation will proceed laterally until sidewall samples confirm all COC concentrations are compliant with the reclamation requirement in the top four feet.

- Due to the estimated size of the excavation, XTO requests a variance for the frequency of confirmation soil samples. XTO proposes five-point composite samples to be collected at a sampling frequency of 400 square feet along the excavation floor and sidewalls. The proposed sampling frequency would reduce the total amount of samples from approximately 150 samples (200 square feet) to approximately 76 samples. The soil samples will be handled as described above and analyzed for all COCs. The 200 square foot and 400 square foot sampling grids are depicted in Figure 3a and Figure 3b, based on the anticipated excavation extent.

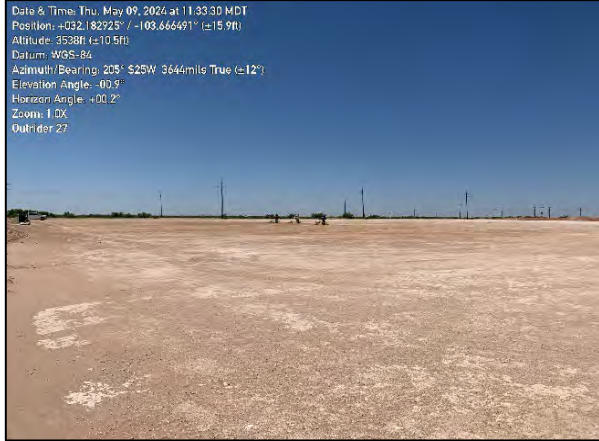
Photograph: 1 Date: 5/9/2024
 Description: Soil staining in release footprint
 View: Southwest

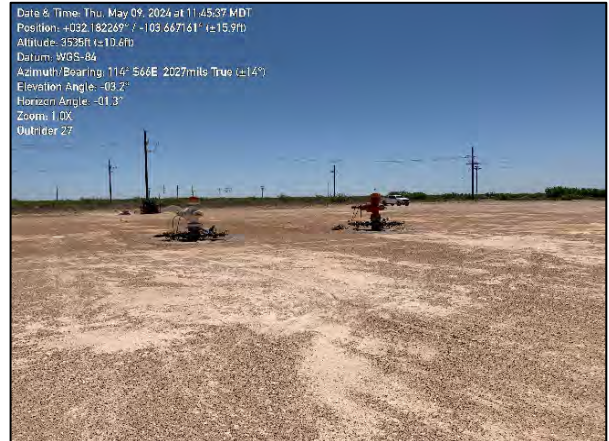
Photograph: 2 Date: 5/9/2024
 Description: Soil staining in release footprint
 View: Southeast

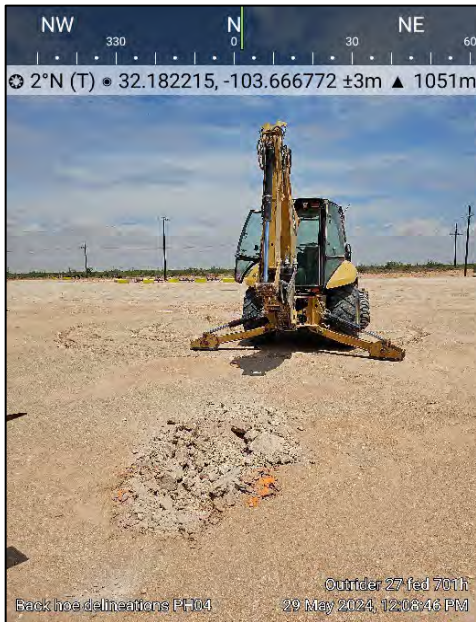
Backhoe delineations PH04
 Outrider 27 fed 701H
 29 May 2024, 12:08:46 PM

Photograph: 3 Date: 5/29/2024
 Description: Delineation activities
 View: North

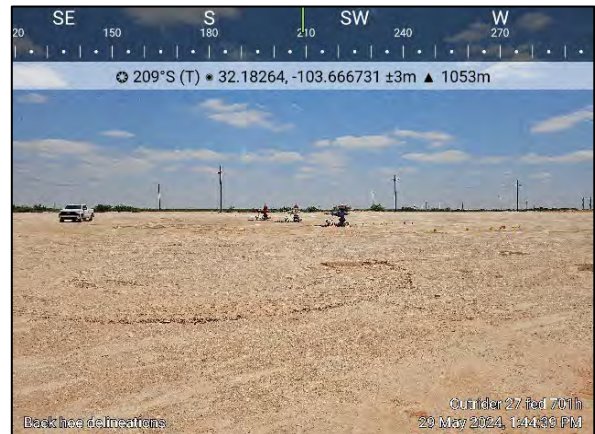
Backhoe delineations
 Outrider 27 fed 701H
 29 May 2024, 1:41:36 PM

Photograph: 4 Date: 5/29/2024
 Description: Delineation Activities
 View: Southwest
