**Devon Energy  
Ross Ranch 10 Fed #001**

**Deferral Request Report  
Section 10, T26S, R31E  
Lea County, New Mexico**

**Incident ID: nAB1915042001 (2RP-5457)**

**June 18, 2020  
Amended July 16, 2024**

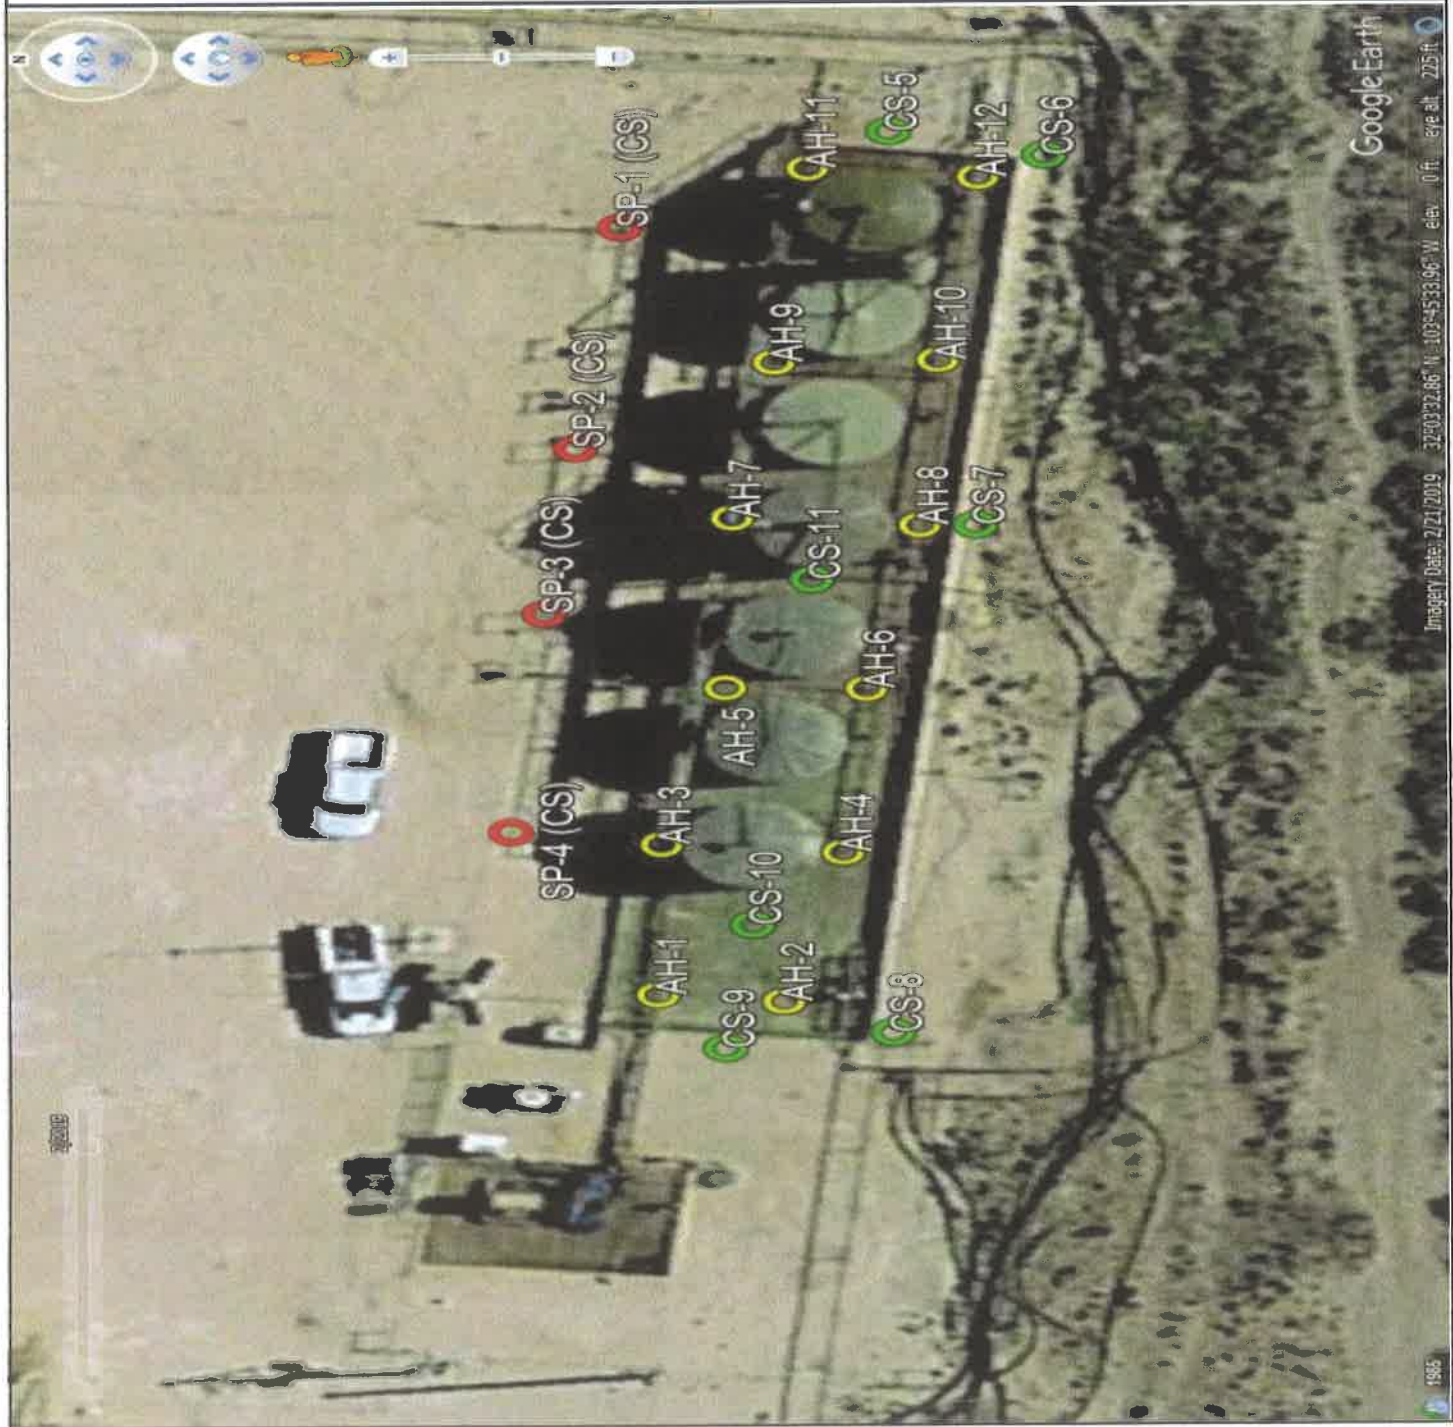
The above sample results are below Table 1 Standards. CS8 was sampled at the surface and in 1 foot intervals up to 4 foot where refusal occurred. If you refer to the attached Map you will notice that CS8 is located immediately adjacent to the southwest corner of the containment wall. Excavation in the area where CS8 is located is not safe due to current infrastructure of the battery.

Yellow – 06/07/19 - AH-1 to AH-12

Red – 09/07/23 – SP-1 to SP-4 (CS)

Green – 06/19/24 – CS-5 to CS-11

The remedial actions taken at the time of the release was to recover the entire volume of the fluid released into the lined containment. No fluids were released to the environment. All of the above sample results that have been provided above meet the Table 1 requirements, except 06/19/2024 CS-8. This sample point is located immediately adjacent to the southwest corner of the containment, current infrastructure causes this area to not be remediated without compromising the integrity of the infrastructure. On behalf of Devon Energy, SESI respectfully requests deferral of the small area at sample point CS8 until closure of the facility.

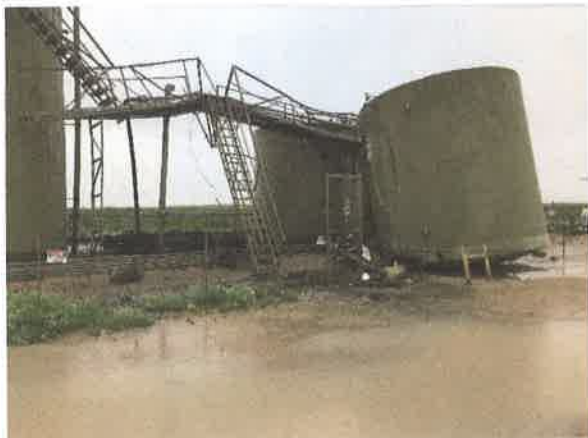
According to the C-141's beginning with the latest incident: Lightning struck the water tank on May 13, 2019. This caused the bottom of the tank to become severed. The tank was located inside the containment. All fluids emptied into the containment. This would create a major reconstruction of this area of the facility, therefore SESI was consulted to remediate the site. Impacted area at the site was remediated in accordance with NMOC and BLM guidelines respectively to close all open remediation permits.

Severed Tank 05-13-19

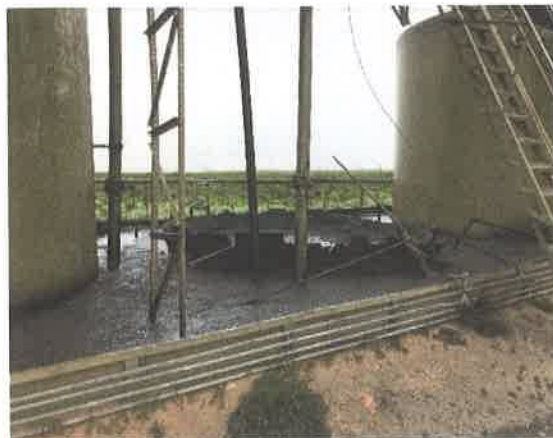
Interior of Containment 05-13-19

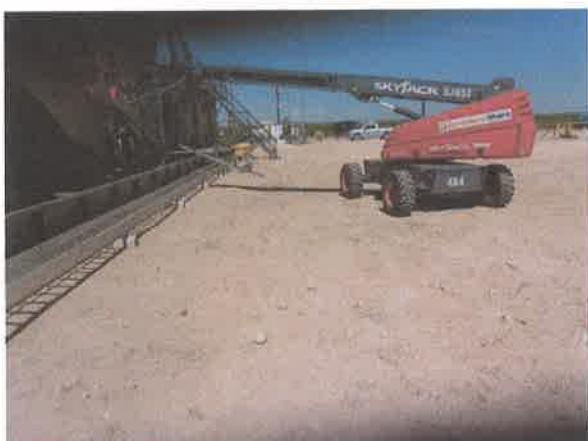
NW Corner of East side at completion 2019

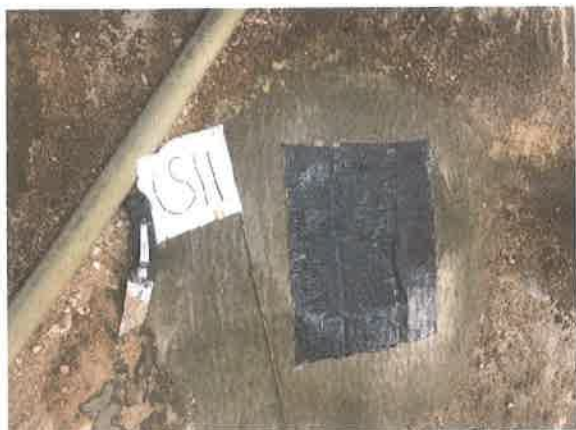
Devon Energy								
Ross Ranch 10 Fed 1 SWD								
Soil Sample Results: Hall Environmental Analysis Laboratory, Inc. Tank Area 06/19/2024								
Sample ID	Chloride (mg/kg)	Benzene (mg/kg)	Toluene (mg/kg)	Ethyl Benzene (mg/kg)	Total Xylenes (mg/kg)	GRO (mg/kg)	DRO (mg/kg)	MRO (mg/kg)
CS5 – Surface	82	ND	ND	ND	ND	ND	ND	ND
CS5 - 1 ft	200	ND	ND	ND	ND	ND	ND	ND
CS6 - Surface	440	ND	ND	ND	ND	ND	ND	ND
CS6 -1 ft	170	ND	ND	ND	ND	ND	ND	ND
CS7 -Surface	170	ND	ND	ND	ND	ND	ND	ND
CS7 - 1 ft	440	ND	ND	ND	ND	ND	ND	ND
CS8 - Surface	2400	ND	ND	ND	ND	ND	ND	ND
CS8 – 1 ft	2100	ND	ND	ND	ND	ND	ND	ND
CS8 – 2 ft	1900	ND	ND	ND	ND	ND	ND	ND
CS8 – 3 ft	1400	ND	ND	ND	ND	ND	ND	ND
CS8 – 4 ft	2200	ND	ND	ND	ND	ND	ND	ND
CS9 – Surface	140	ND	ND	ND	ND	ND	ND	ND
CS9 – 1 ft	170	ND	ND	ND	ND	ND	ND	ND
CS10 – Surface	ND	ND	ND	ND	ND	ND	ND	ND
CS10 – 1ft	ND	ND	ND	ND	ND	ND	ND	ND
CS11 – Surface	ND	ND	ND	ND	ND	ND	11	ND
CS11 – 1 ft	78	ND	ND	ND	ND	ND	ND	ND

06/19/24 CS11 inside lined containment

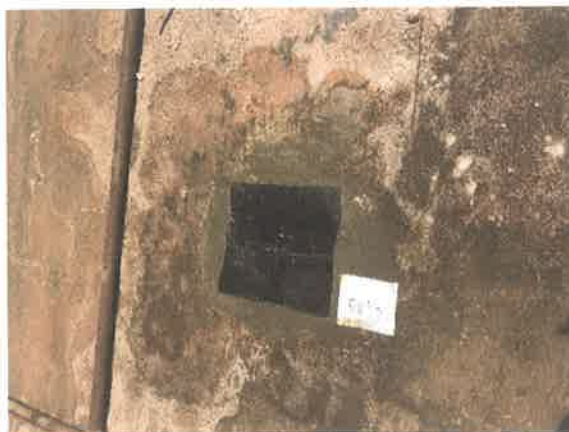
06/19/2024 CS10 inside lined containment

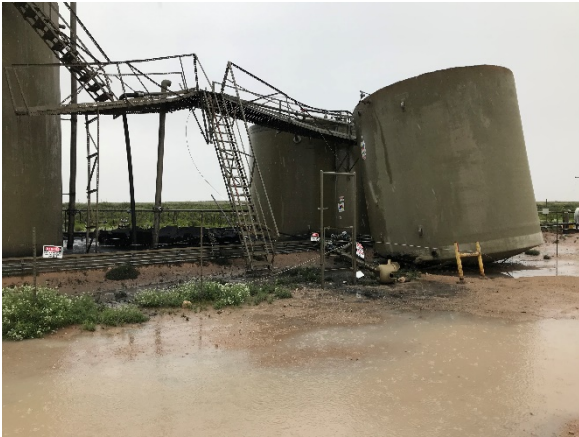
According to the C-141's beginning with the latest incident: Lightning struck the water tank on May 13, 2019. This caused the bottom of the tank to become severed. All fluids emptied into the containment. This would create a major reconstruction of this area of the facility, therefore SESI was consulted to remediate the site. The Remediation Permit number assigned to this incident is **2RP-5457**. Due to the size of spill area; the decision was made to remediate all impacted areas for this location simultaneously.

Severed Tank 05-13-19     **2RP-5457**

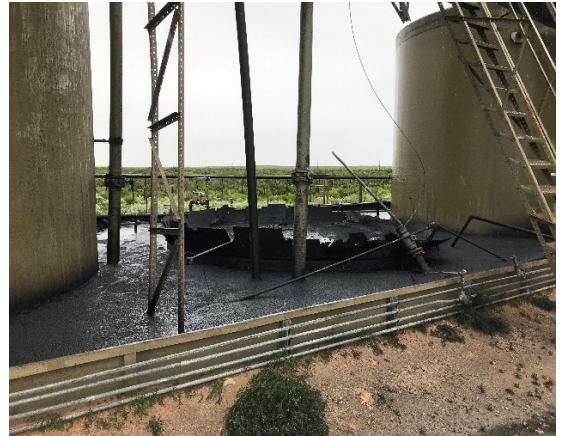
Interior of Containment 05-13-19

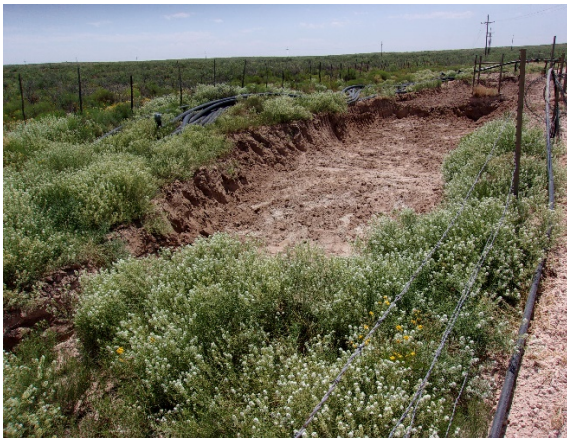
Day 3 Excavation S. Side of location

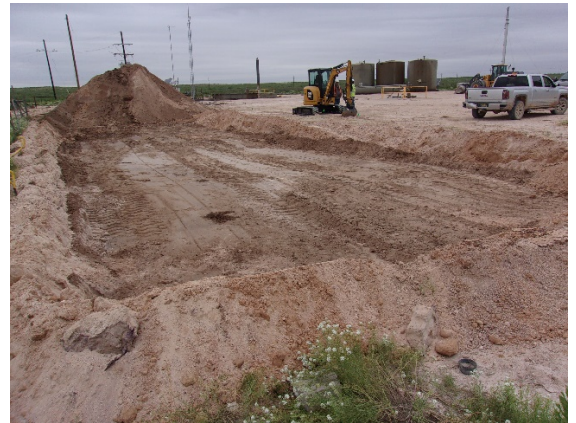
Day 3 Excavation East side of location

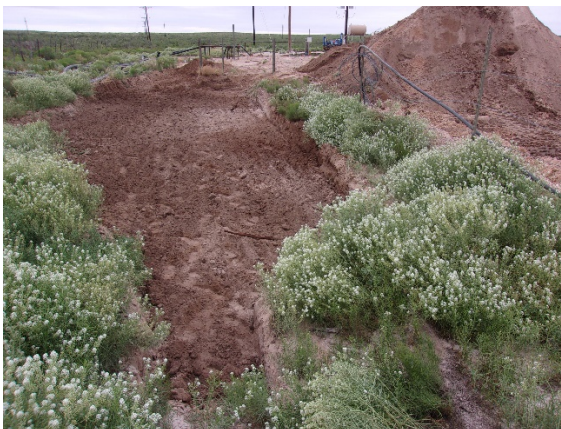
Day 3 SE Corner of Excavation on S side

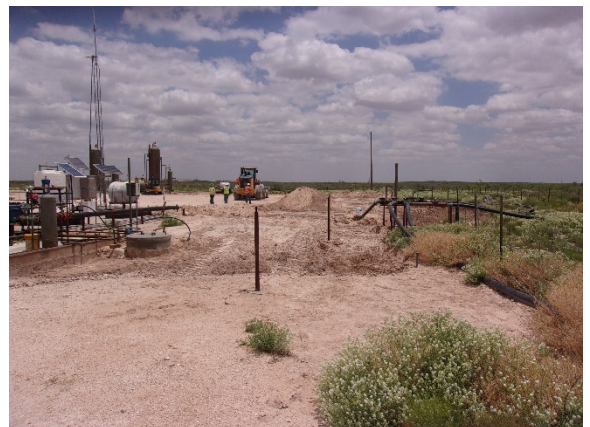
Day 3 South side of Location Excavation

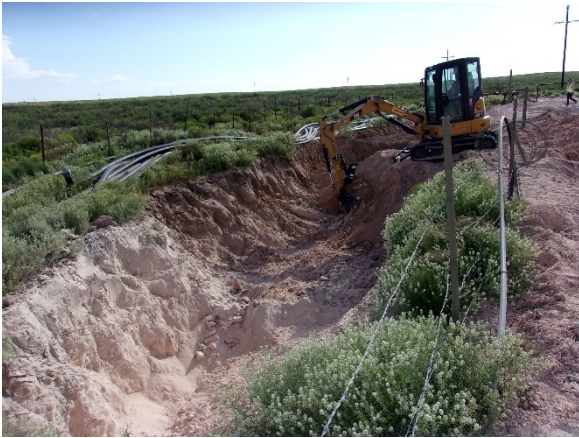
Day 4 East Corner of Excavation S. Side-Location  
(2RP-5457 and 2RP-4009)

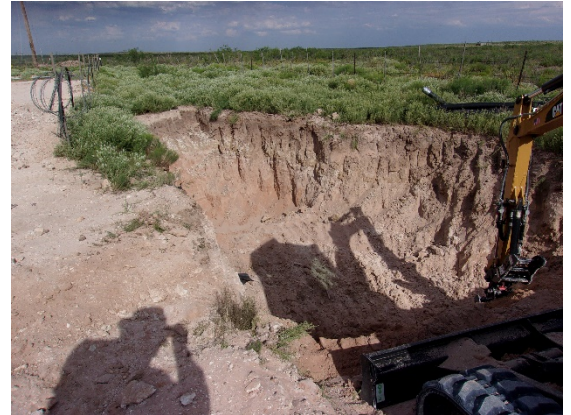
Day 4 Middle of excavation-South Side

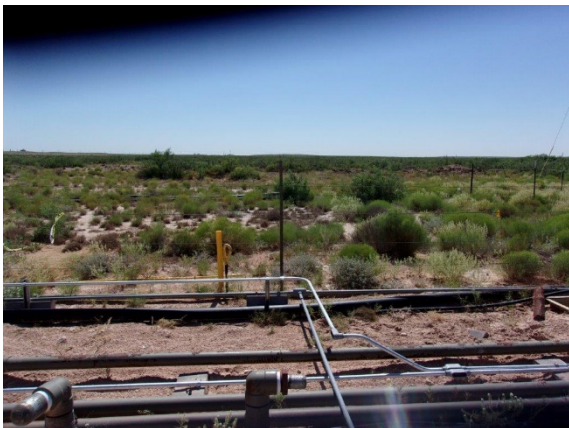
Over Spray from heater treaters-East Side **BLM**

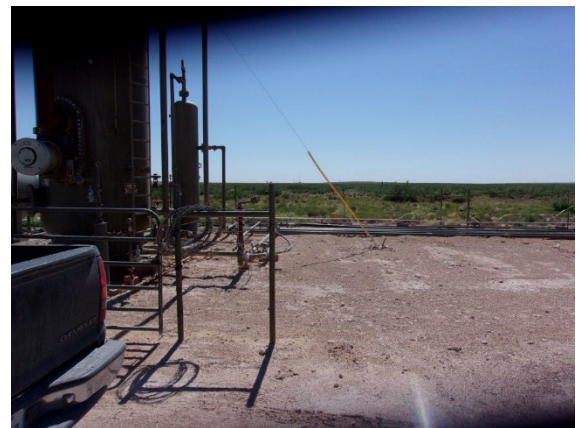
NW Corner of excavation on East side of Location

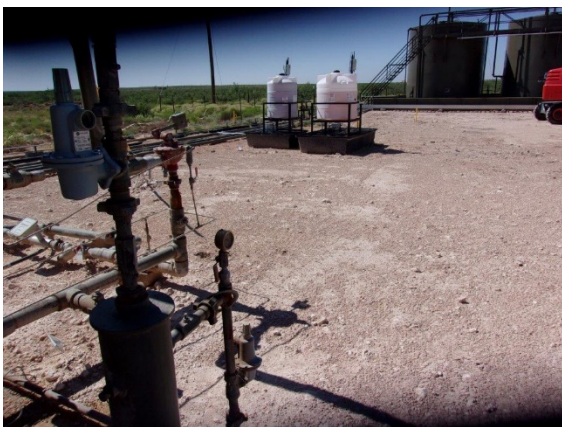
Corner of excavation on East side of location

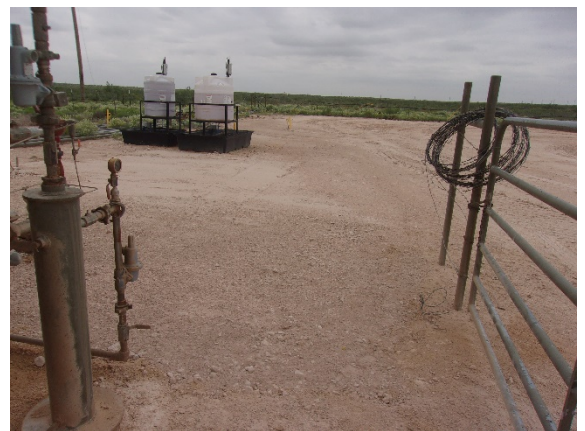
Corner of East side at completion

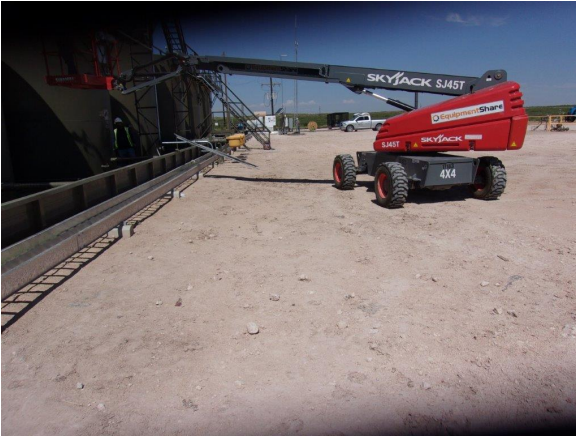
NE Corner at completion **2RP-5457**

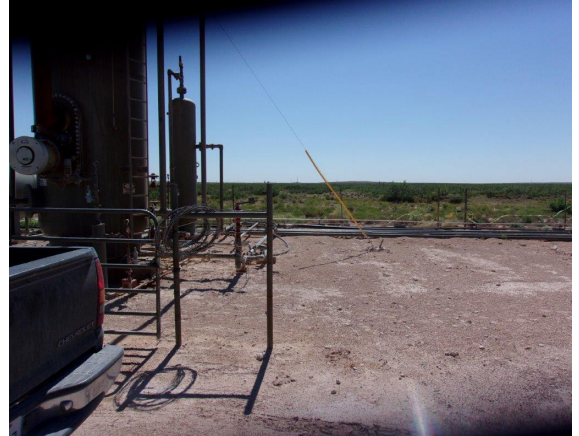
NW Corner on East Side

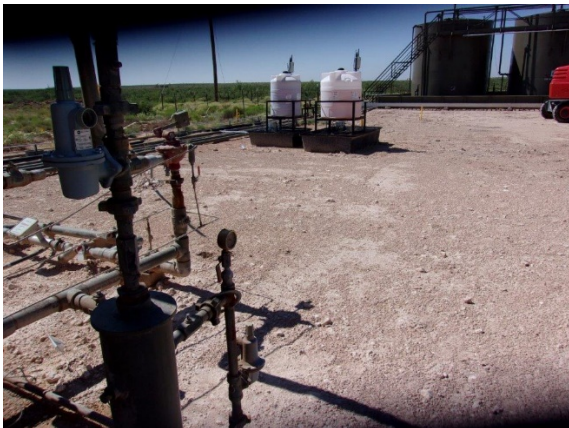
NW Corner of East side at completion

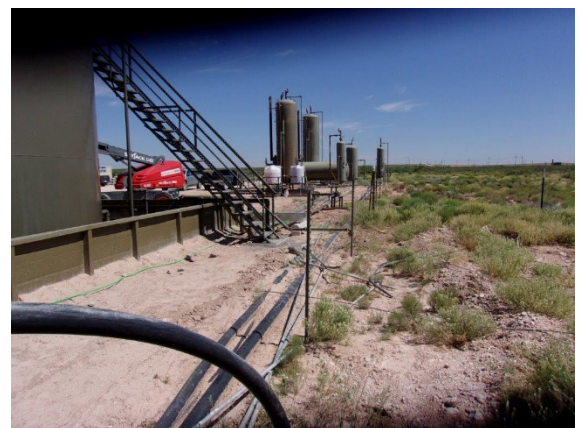
SE Corner of excavation on East side of Location  
**2RP-4009**

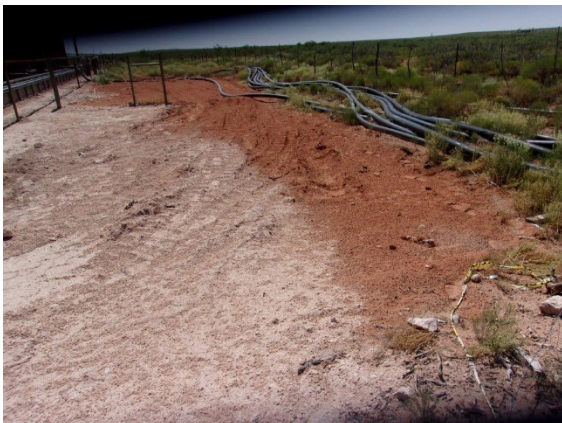
SE Corner of pasture area on South Side of location
