# CLOSURE PLAN

**FOUR PETE'S SAKE #1  
LEA COUNTY, NEW MEXICO**

**OCD Incident # njxk1534849827**

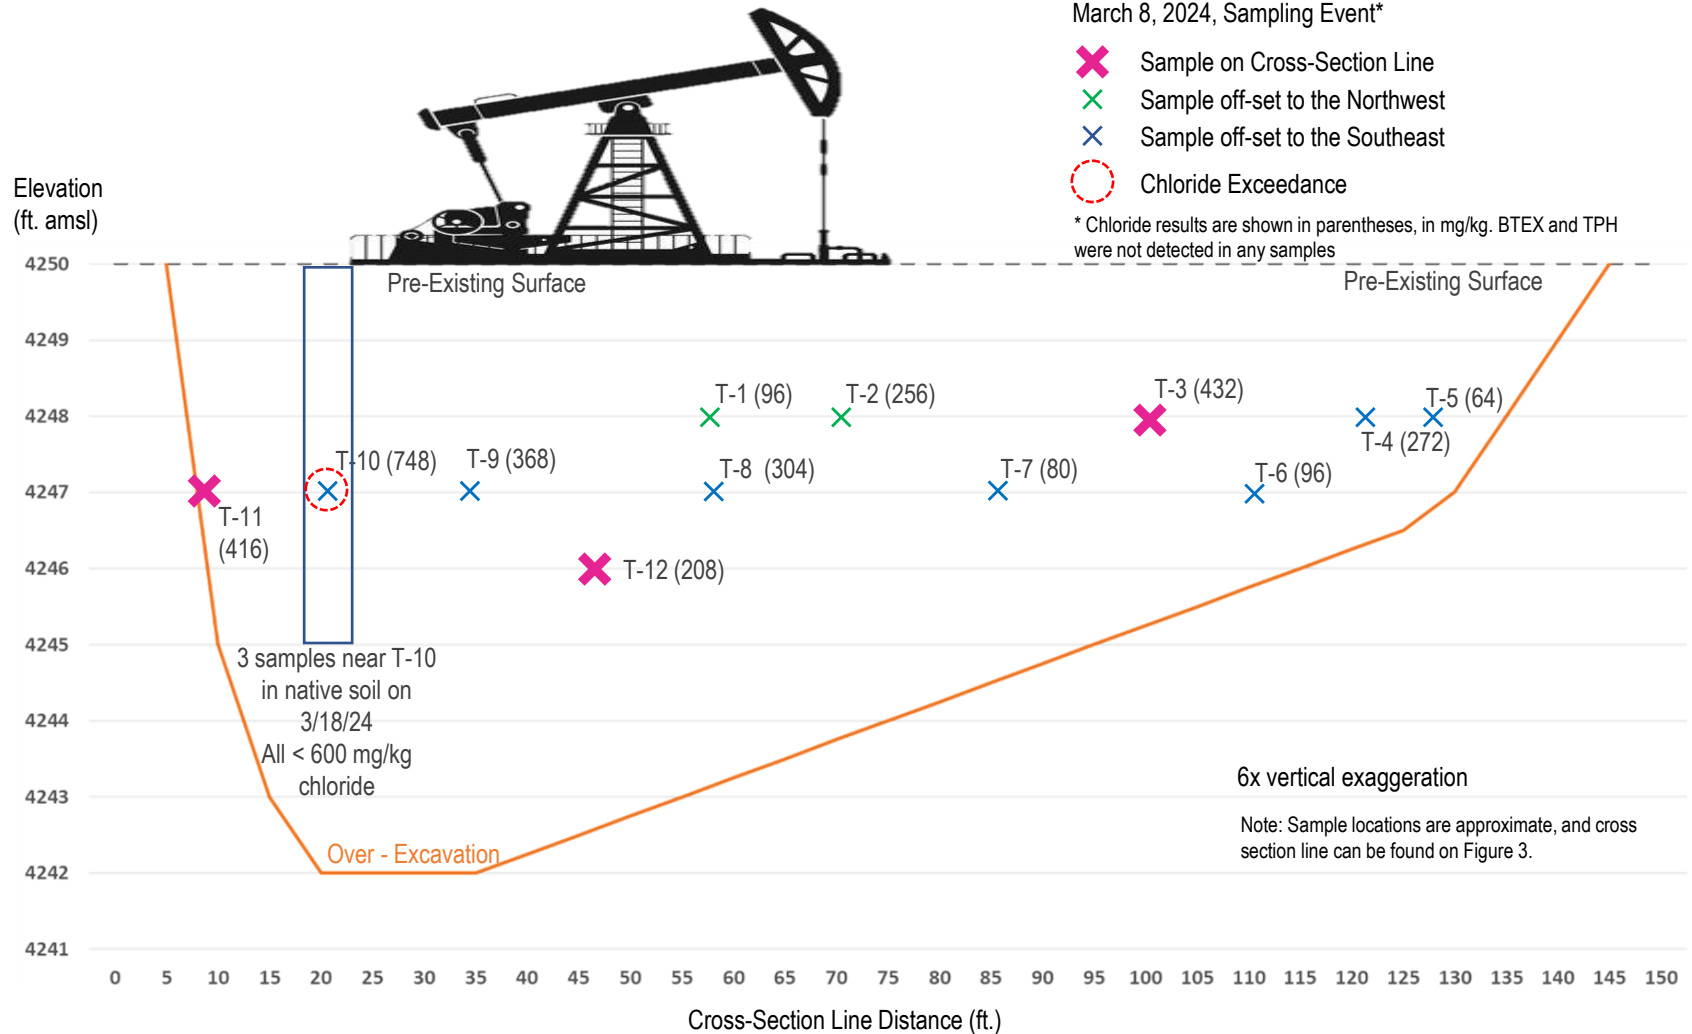
Cross Section A – A

- ✕ Sample on Cross-Section Line
- ✕ Sample off-set to the Northwest
- ✕ Sample off-set to the Southeast
- Chloride Exceedance

\* Chloride results are shown in parentheses, in mg/kg. BTEX and TPH were not detected in any samples

approximately 80 feet bsg. Regardless of the actual depth-to-water, the base of chloride contamination due to the release is restricted to the vadose zone. See also Section 4.0 below and Figure 8.

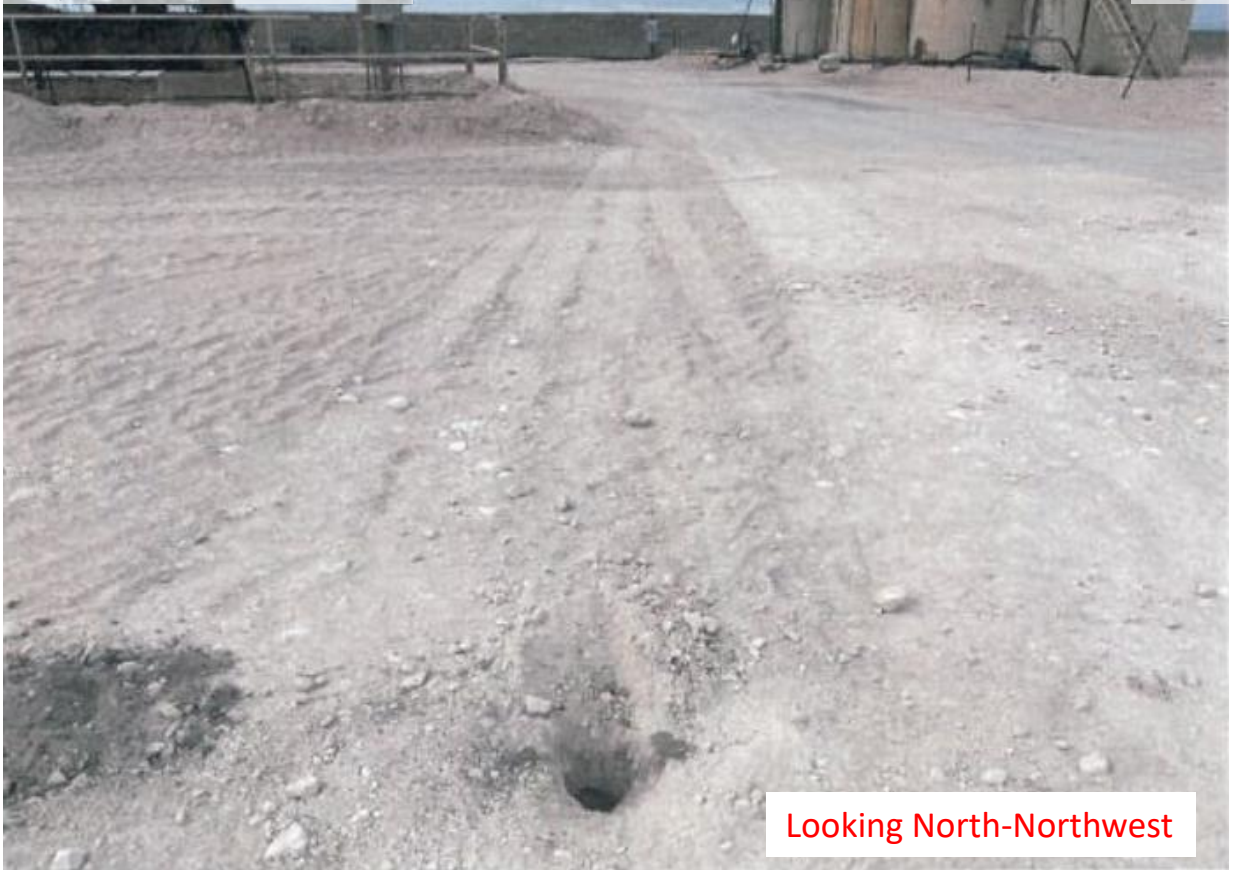
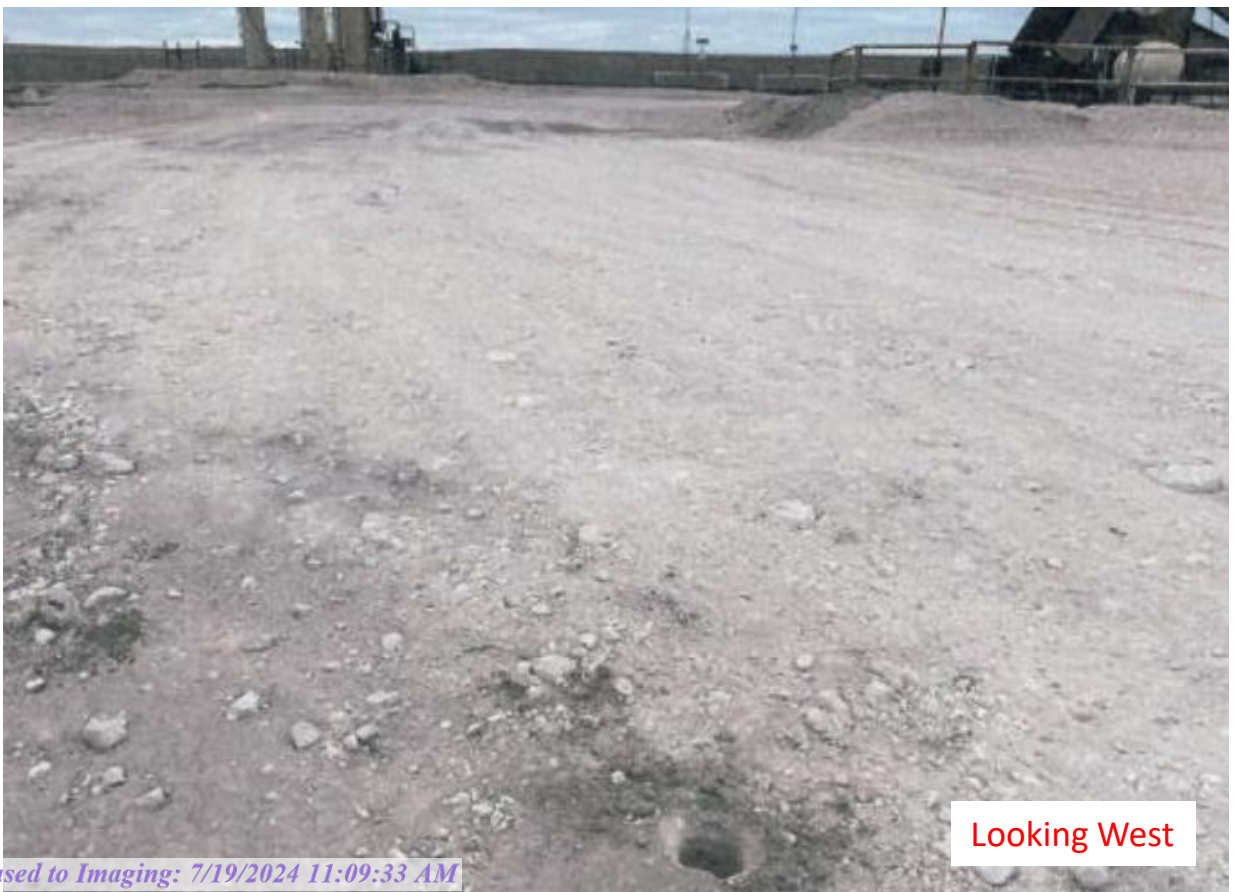
## Hand Augered Holes (2/14/2024)

A preliminary field investigation was conducted on February 14, 2024, using field screening techniques to determine where subsequent excavation and confirmatory sampling would be appropriate. Borings were advanced with a stainless steel hand auger decontaminated before each use with an Alconox® rinse followed by a deionized water rinse. Discreet samples were placed in clean (i.e., new) glass quart glass jars with equal parts sample and deionized water for approximately 30-45 seconds. The probe of a (daily) calibrated Tracer PockeTester® multimeter capable of detecting salts to approximately 10 parts per million (ppm) was immersed in the slurry and the stabilized reading recorded. Representative borings are shown in Attachment B (Photosheets).

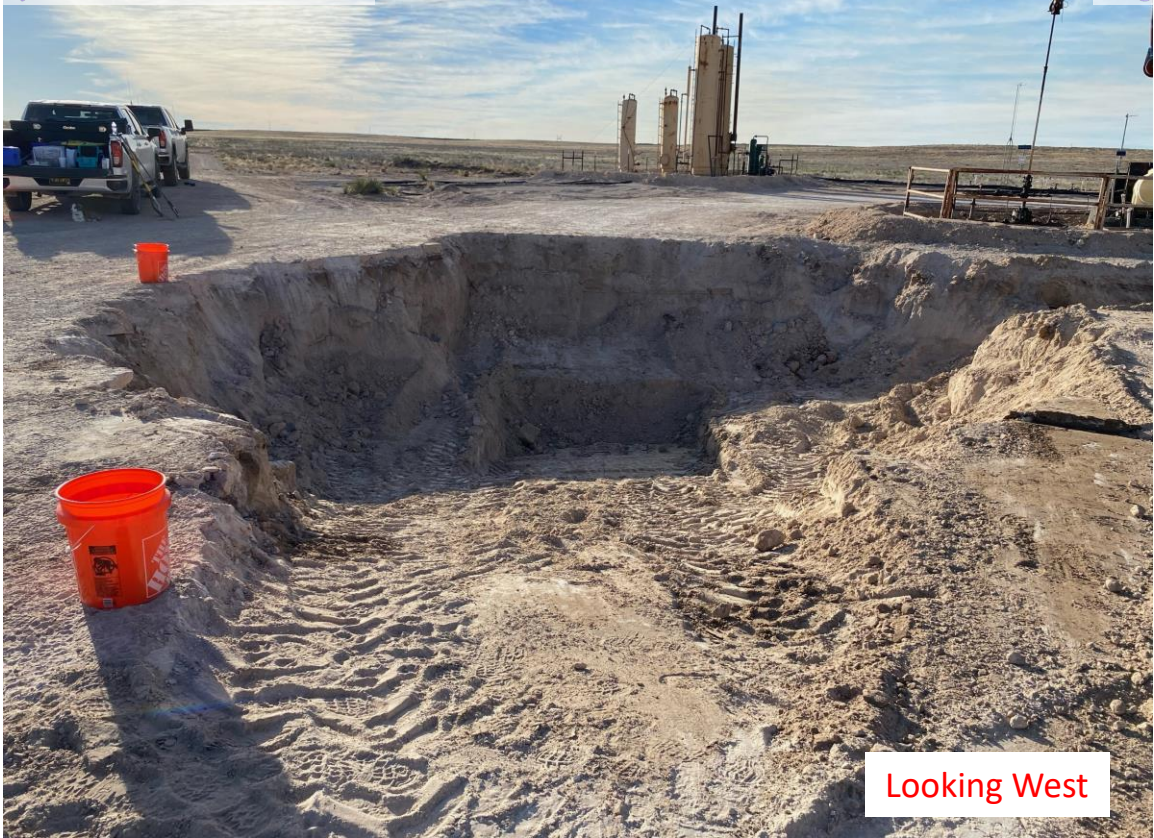
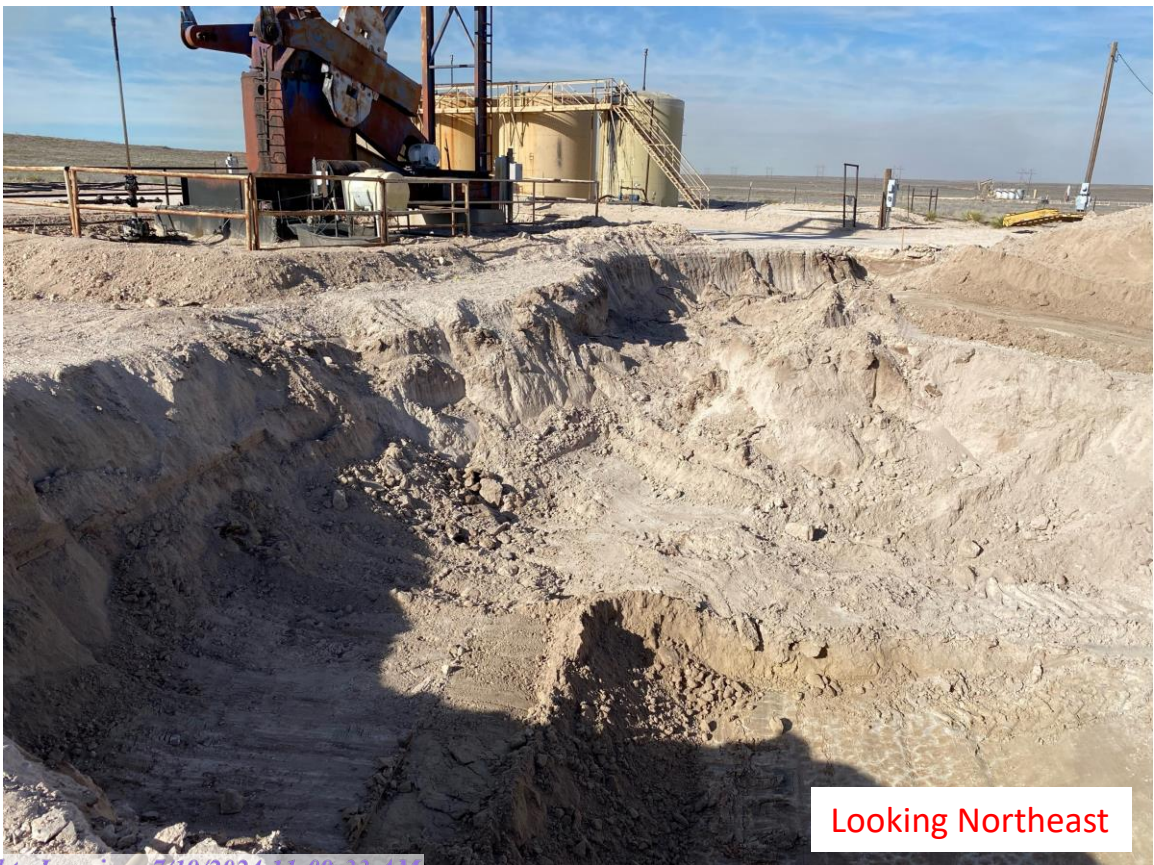
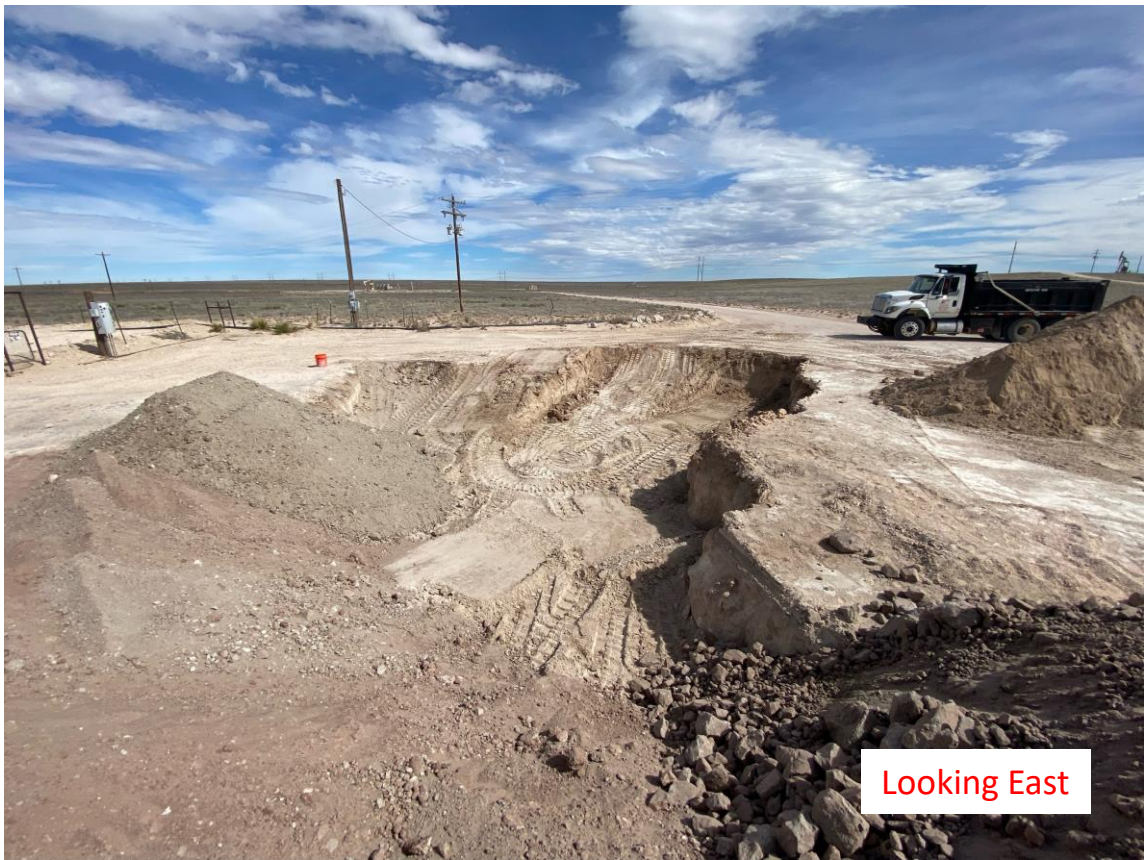
Excavation (3/8/2024)

Confirmatory sampling was conducted during excavation by retrieving discreet samples with a decontaminated stainless steel trowel from the excavator bucket during the removal for both field screening and laboratory analysis at key locations inside and outside the assumed release footprint to confirm that over-excavation achieved the closure criteria for  $\leq 50$  depth-to-water at 19.15.29.12.E NMAC.<sup>1</sup> Samples T-6, T-7, and T-12 are considered "base" samples, as they were located in the centroid of the excavation. All other samples are considered "sidewall" samples. As discussed above, the presumed contaminated area was over-excavated beyond the sample locations. Because the Site is active, clean soil was used to fill and level the excavated area that same day.

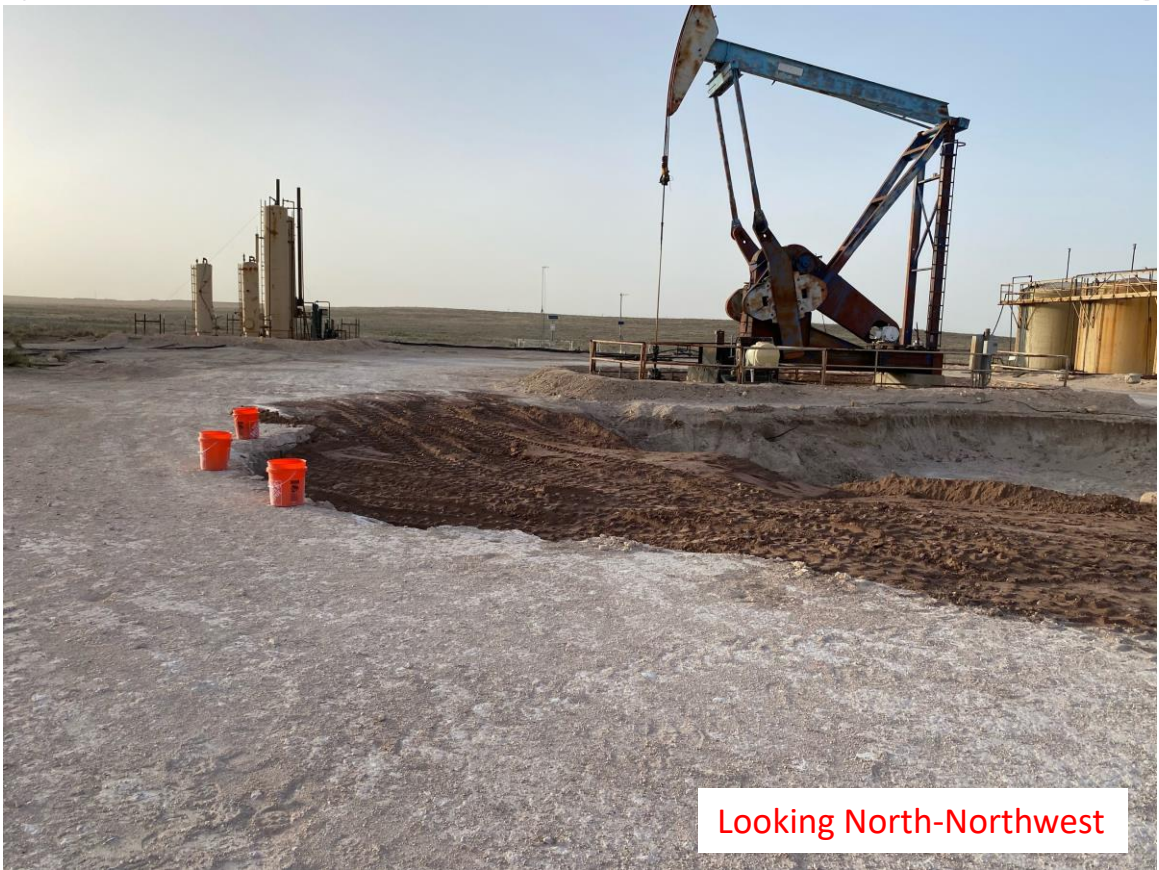
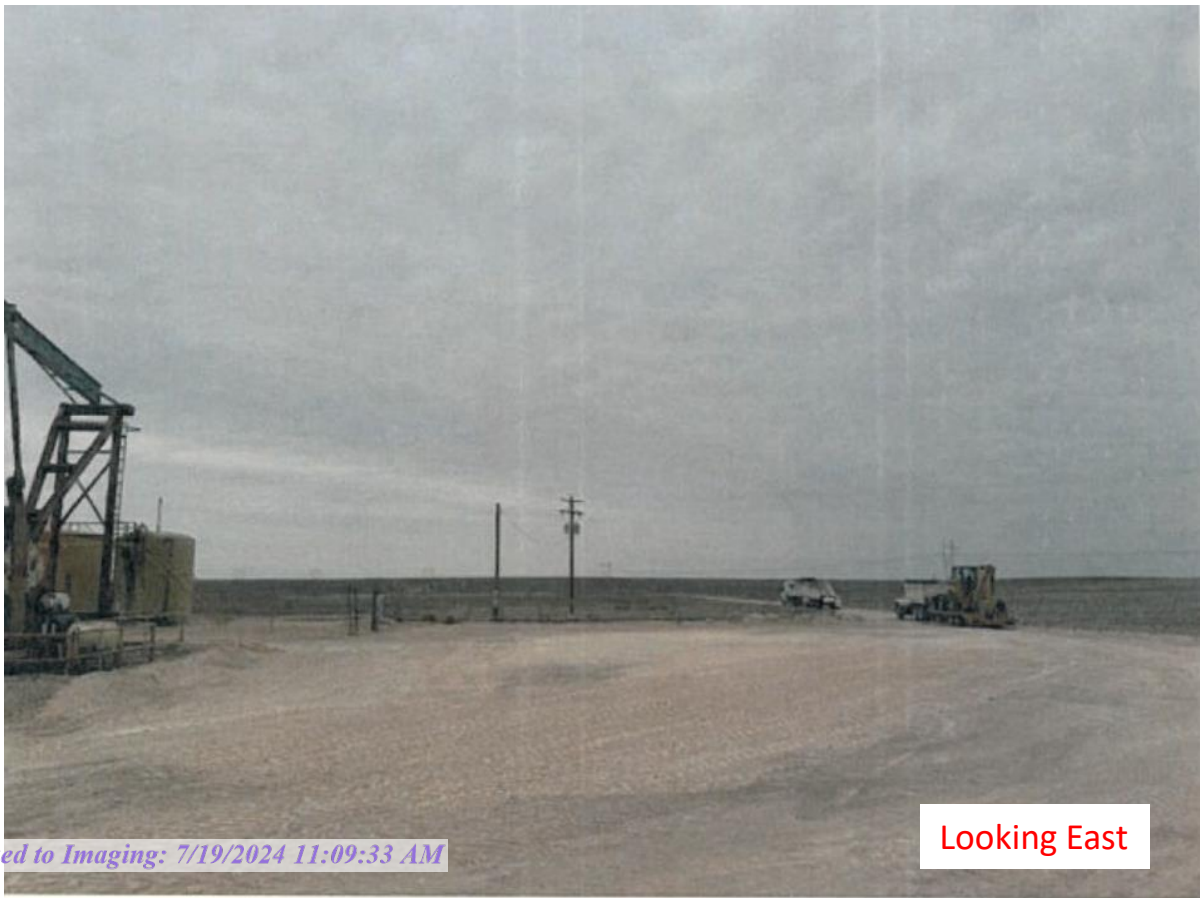
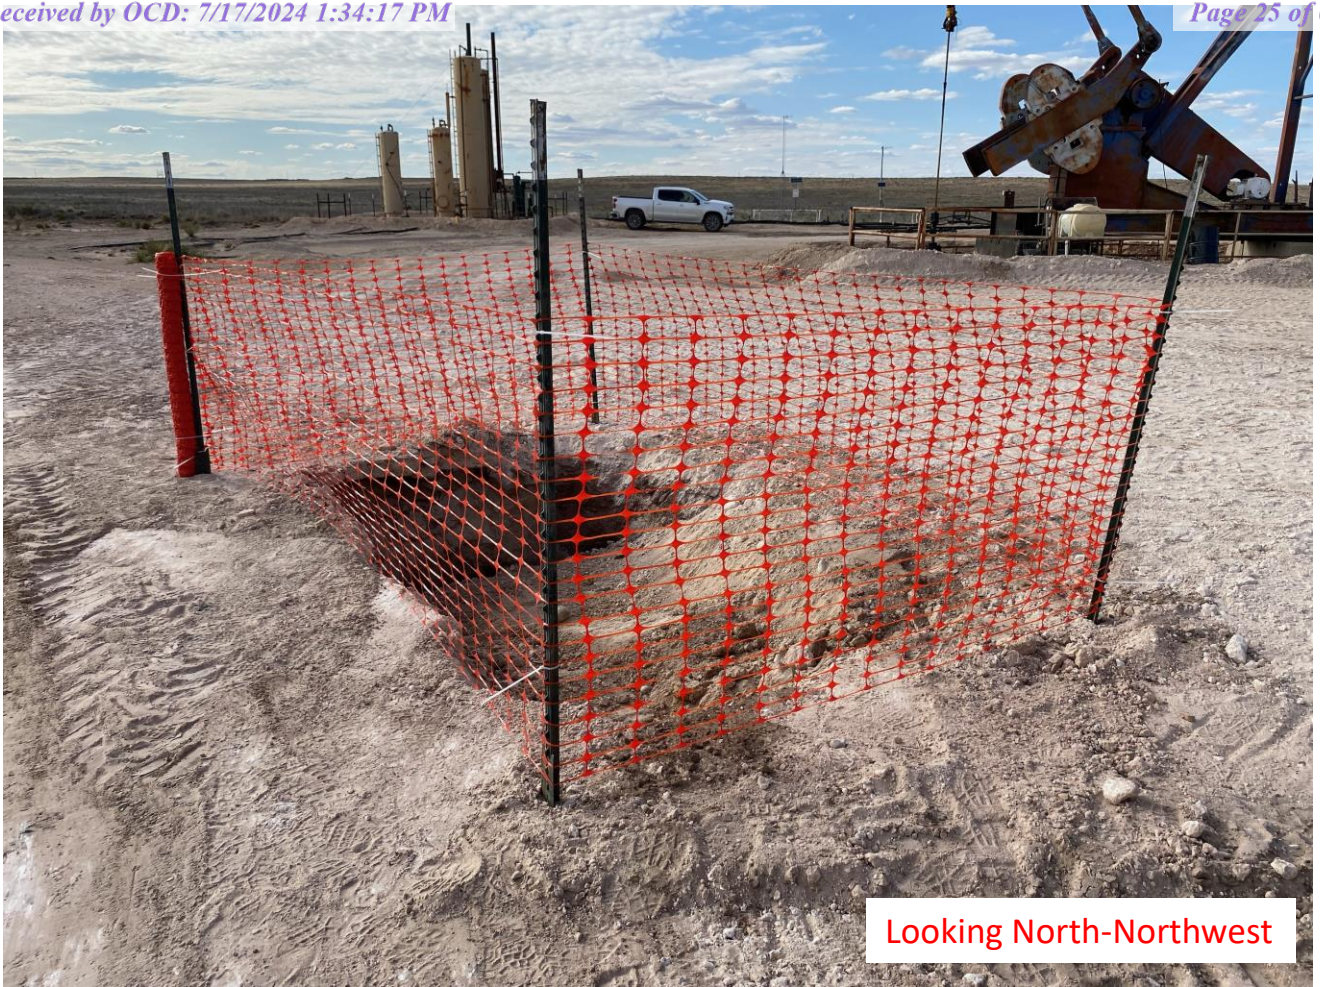
Backfilling with clean soil and site after completion (caliche re-surface)

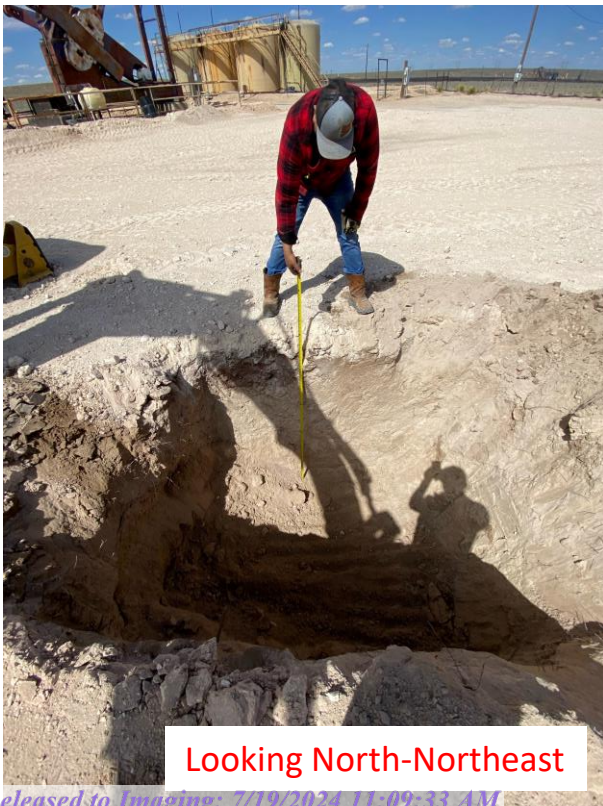
Sampling on 3/18/2024 in 5'x7'x5' (width/length/depth) deep hole within native soil (not clean backfill)
