**Devon Energy
Ross Ranch 10 Fed #001**

**Deferral Report
Section 10, T26S, R31E
Lea County, New Mexico**

Incident ID: nMLB1215052644 (2RP-1136)

July 16, 2024

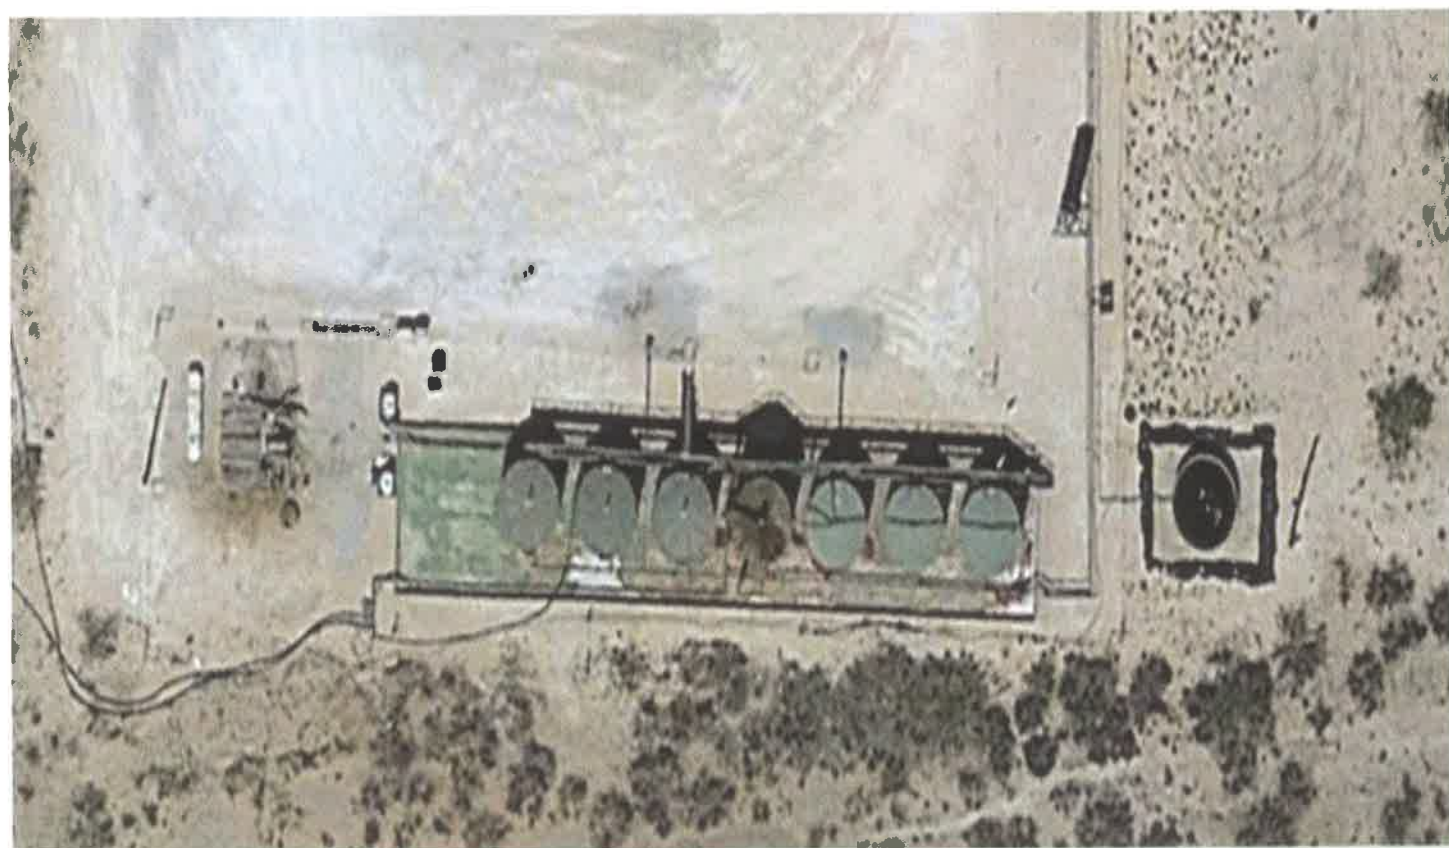
Aerial photograph of location dated 4/2013, source Google Earth
