**Elevate Energy Services, Inc.
Gavilan Road Spill**

**XTO Riser to Potato Basin
Road (Napp2320155626)**

Closure Report

June 10, 2024

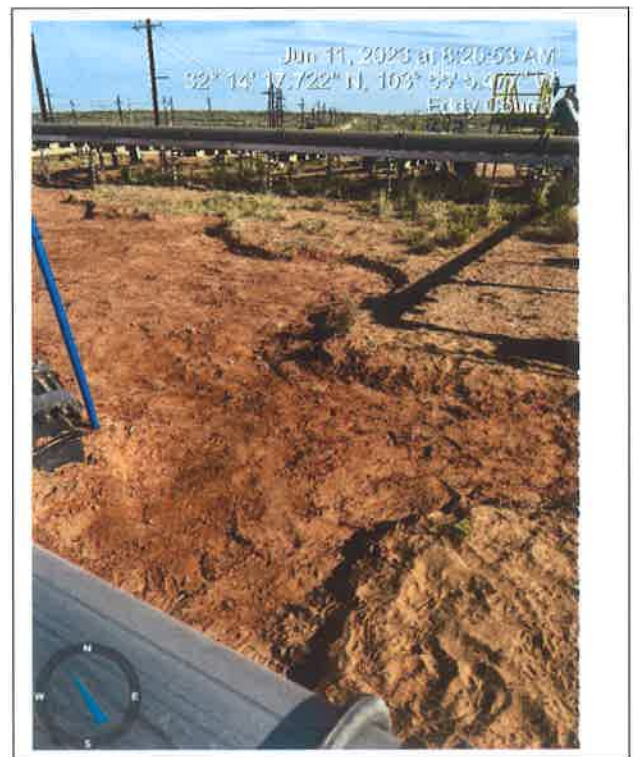
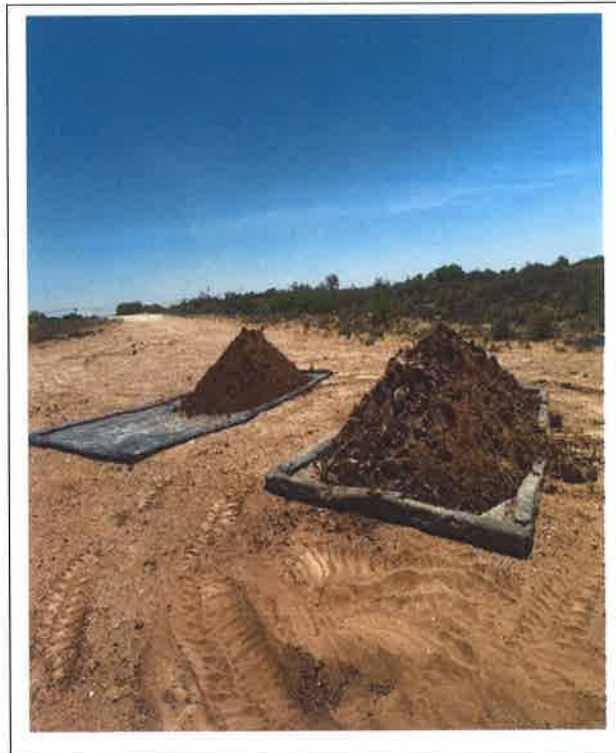
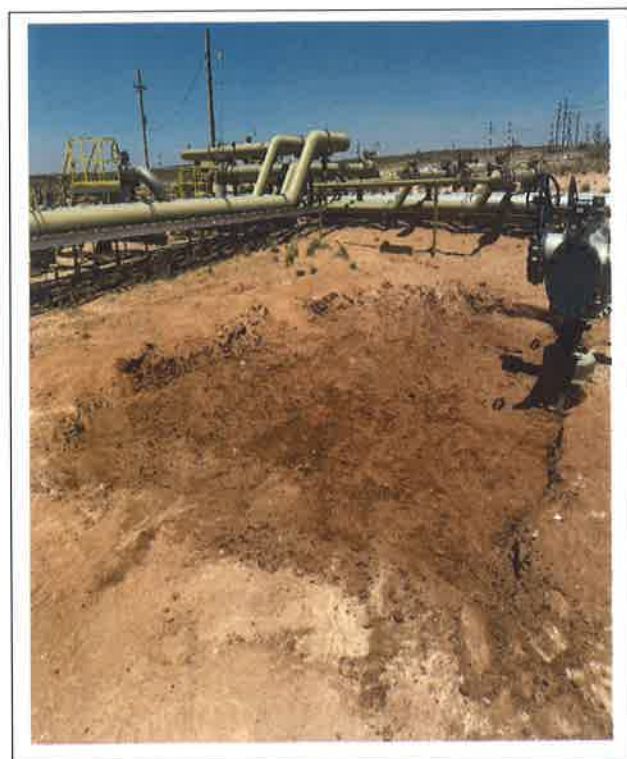
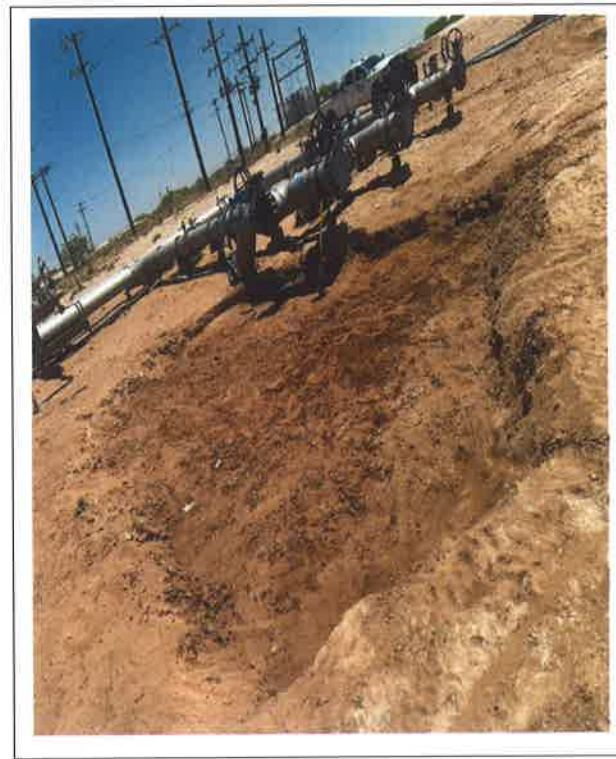
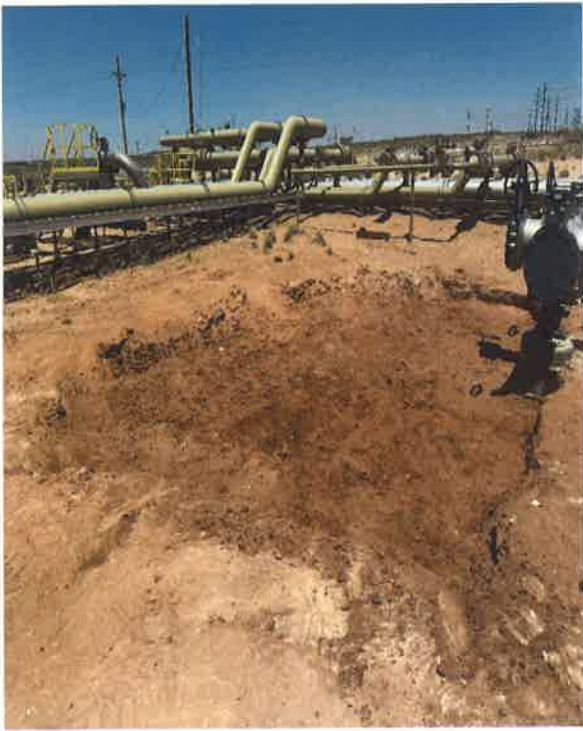
Property Photos

On Sunday, June 11, 2023, SESI personnel arrived at the spill site and photographed and mapped the spill area. The spill areas had been excavated to a depth of approximately 6-8 ". Nine (9) bottomhole and four (4) horizontal samples were taken. The samples were field tested and samples 4, 6 and 8 were over regulatory limits for Chlorides. The samples, except for samples 4, 6, and 8, were properly preserved and transported under Chain of Custody to Cardinal Laboratories in Hobbs, New Mexico to be analyzed for Chloride (CI Method 300.0), Diesel Organics (DRO Method 8015 M/D), Gasoline Range (GRO Method 8015D), Benzene, Toluene, Ethylbenzene, and Xylenes (BTEX Method 8021B). The results are tabulated in the table below:

Remedial actions at this site have been performed in accordance with all New Mexico Oil Conservation Division (NMOCD) requirements. On behalf of Elevate Energy Services, Inc, SESI respectfully requests closure of release nAPP2320155626. Approximately 25 cubic yards of contaminated soil was transported to J & L Landfarm for this release.
