Remediation Summary and Soil Closure Request Report

Bass #4

Case No. 1RP-1196

Incident No. nPAC0704334283

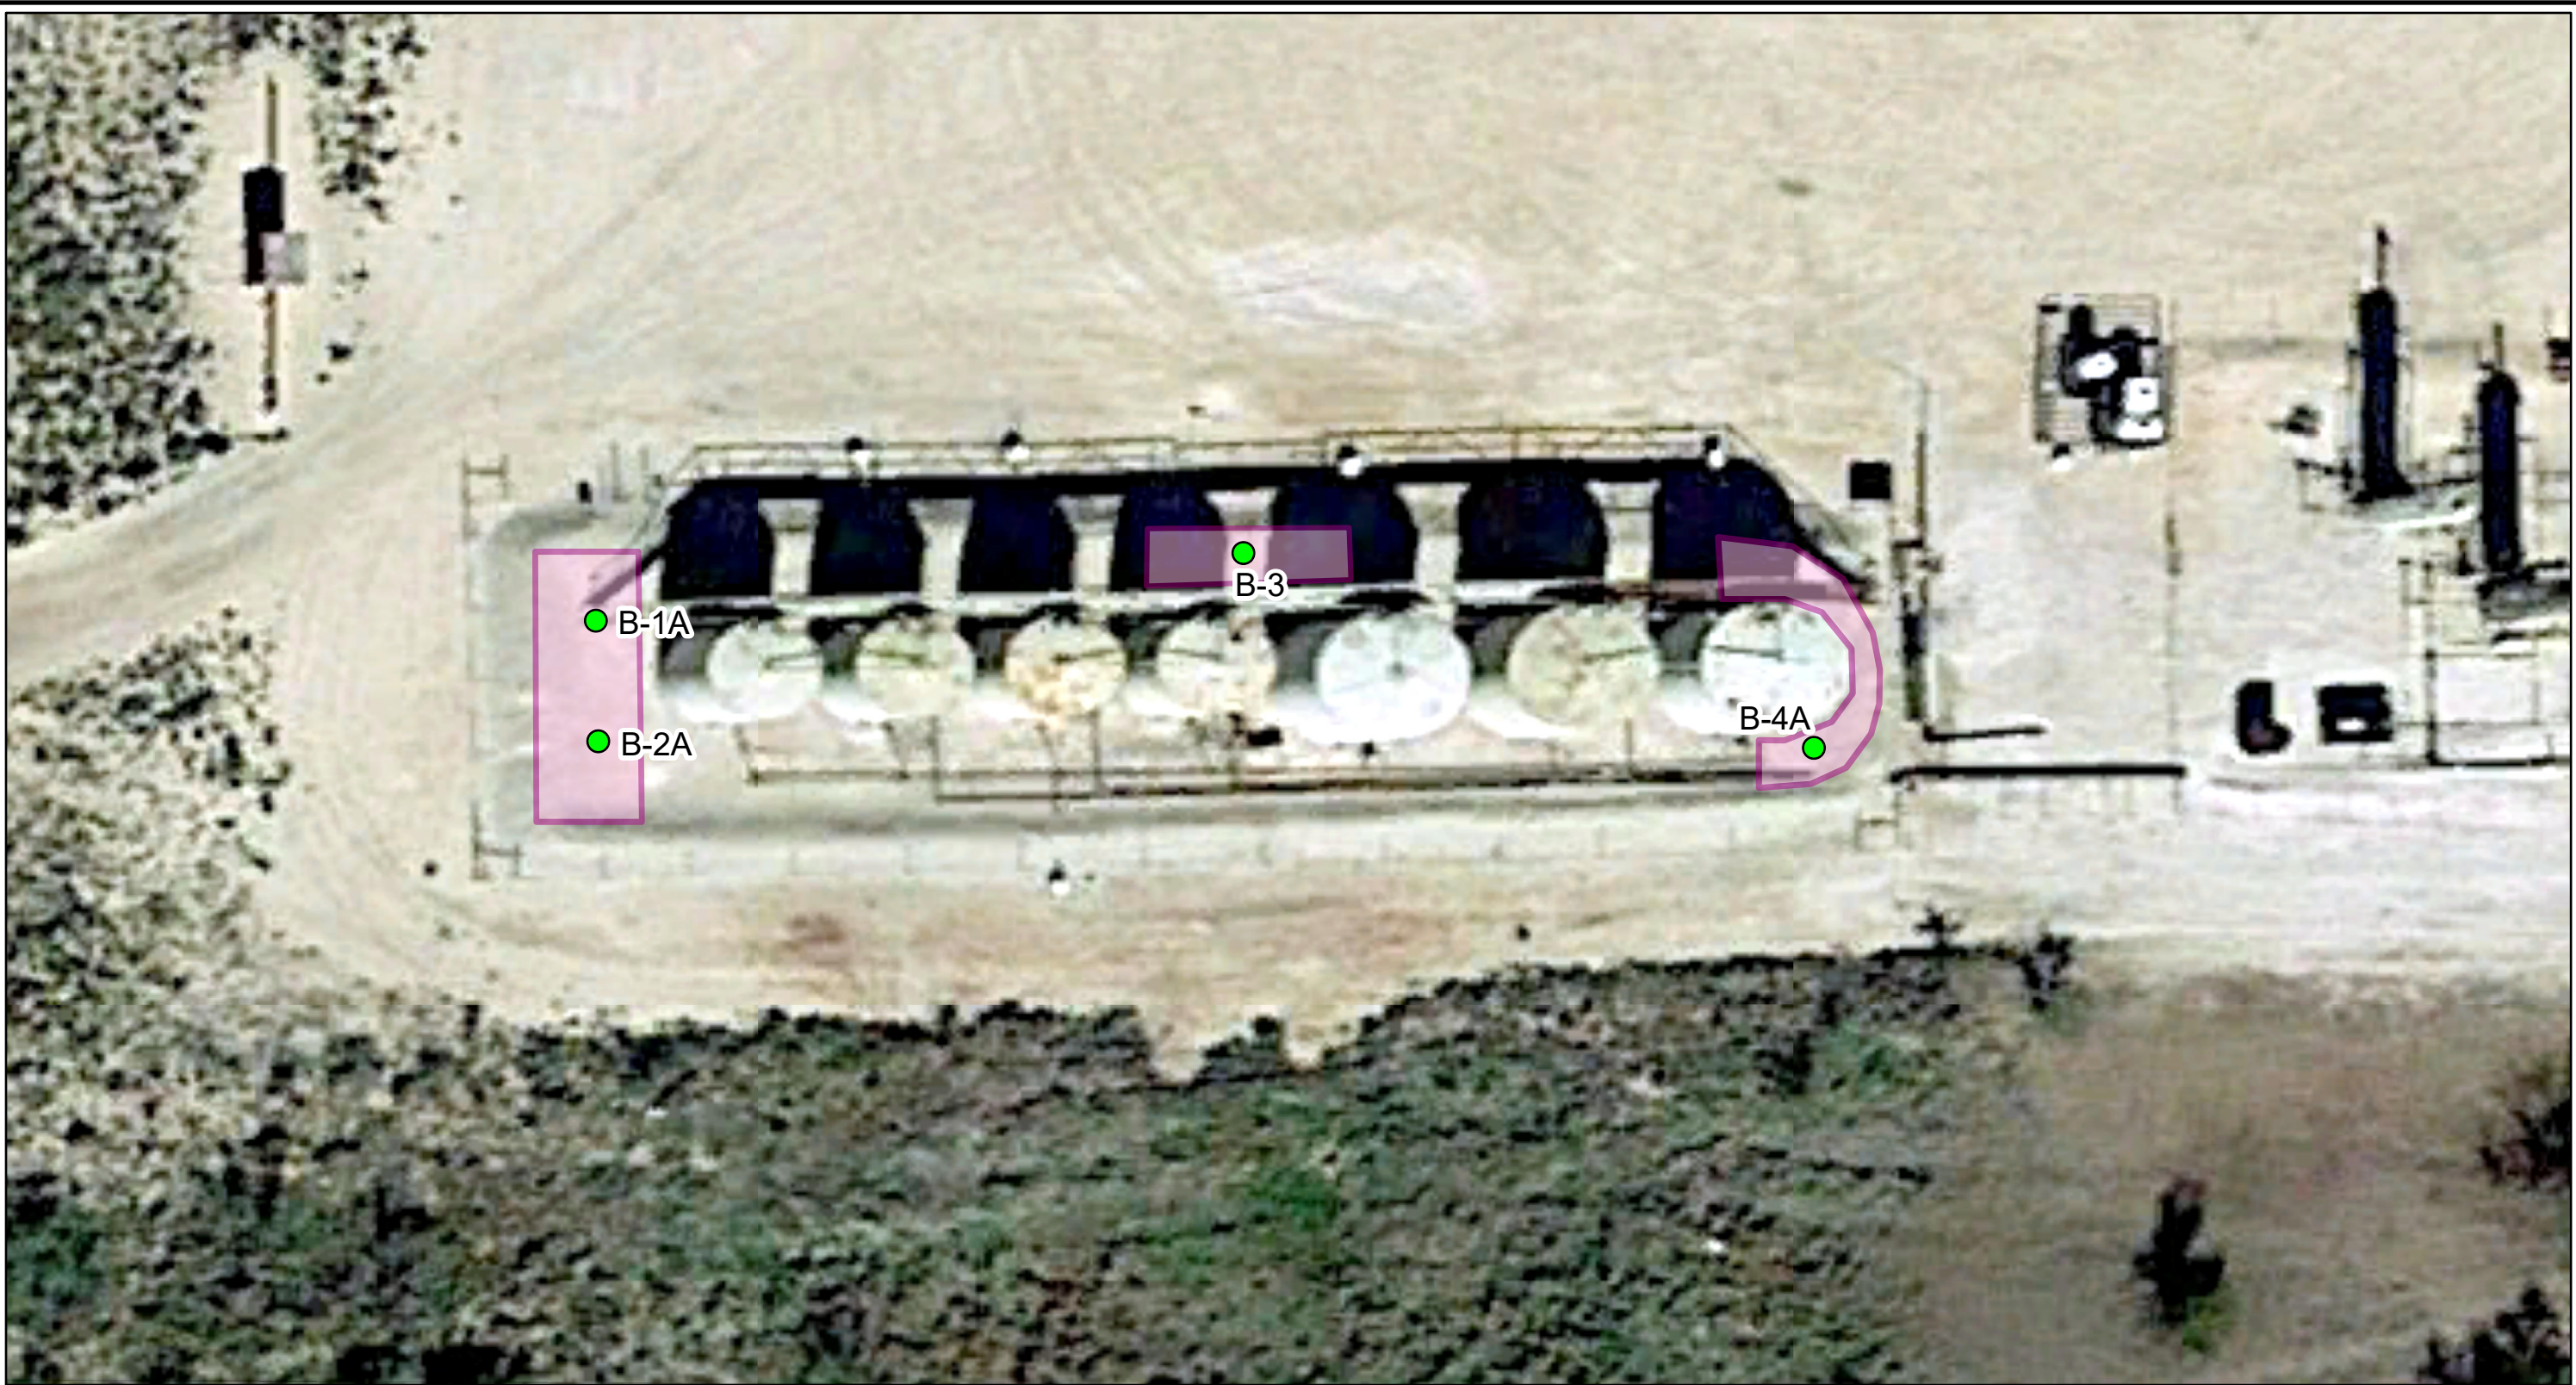
FIGURE
2

Excavation (1 feet)

**EXCAVATION BASE
SOIL SAMPLE RESULTS MAP**

The western excavated area covered an approximate 280 square foot area on west side of tank battery. The center excavated area covered an approximate 125 square foot area on north side of the tank battery. The eastern excavated area covered an approximate 150 square foot area on the east side of tank battery. Excavation activities were conducted from the surface to a maximum depth of approximately 1 foot bgs within the release area. Approximately 18 cubic yards of impacted soil was excavated, stockpiled on-site adjacent to the release area on 20 mil plastic sheeting, and covered with 20 mil plastic sheeting during remediation activities prior to disposal activities. The limits of the excavations are presented on **Figure 2**.

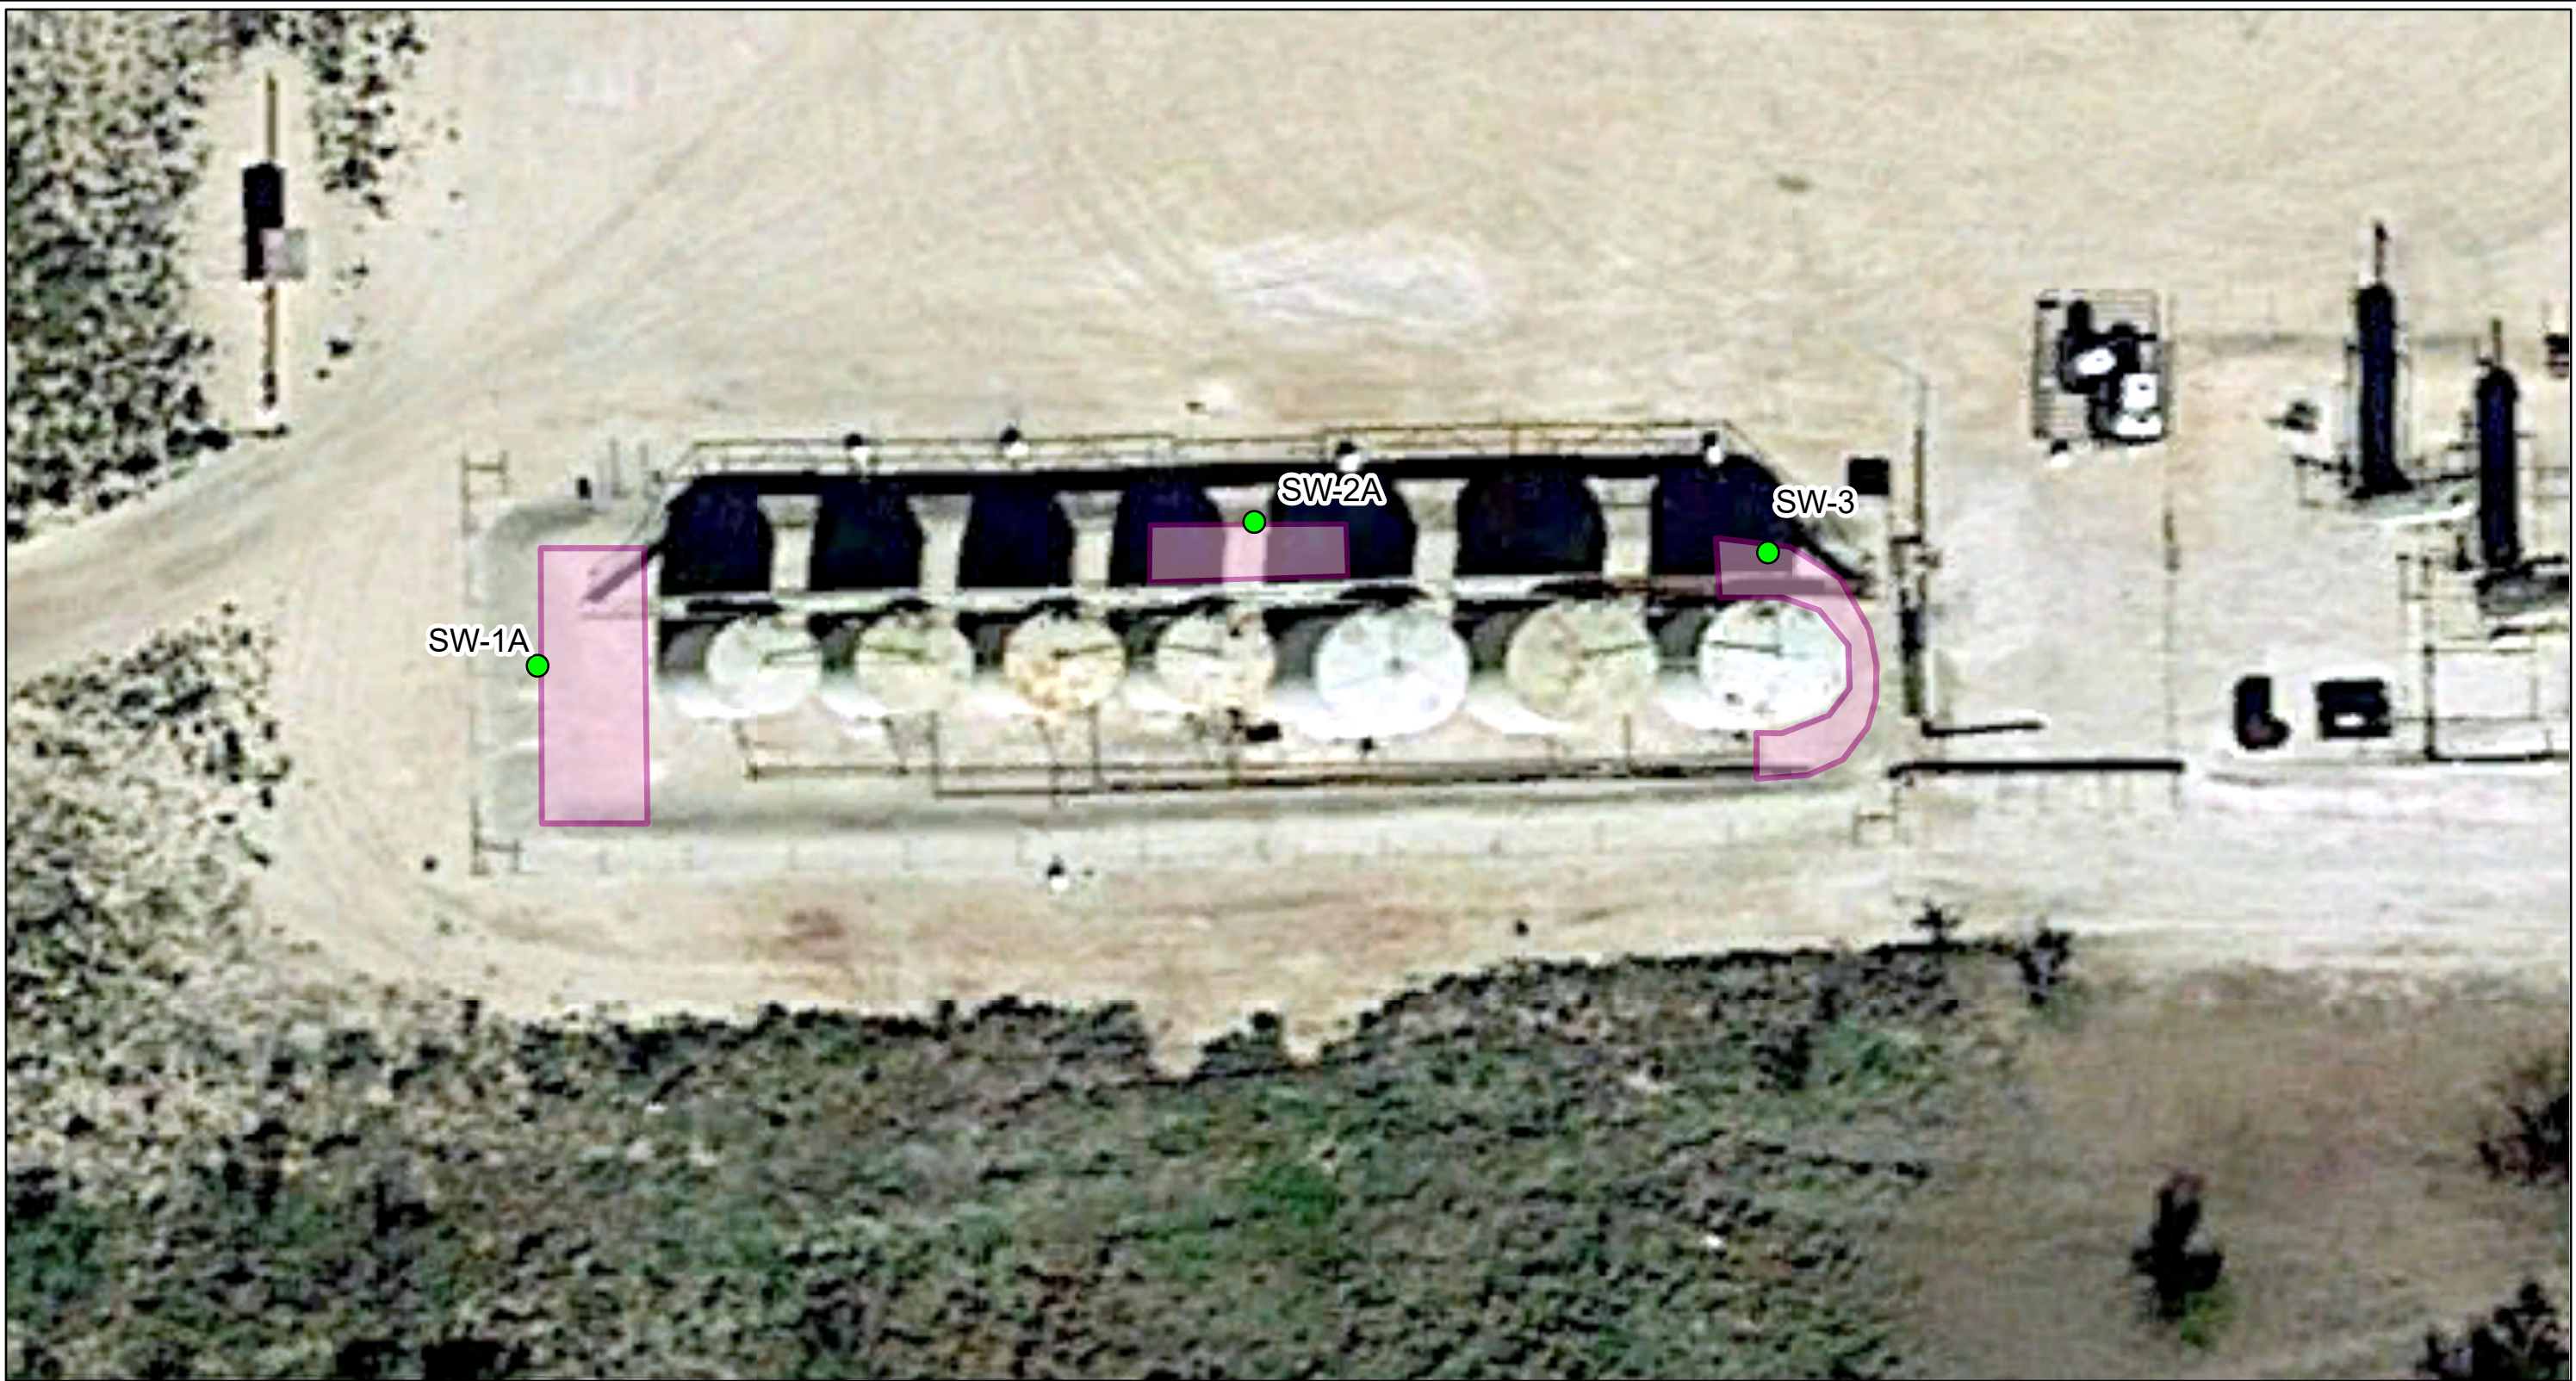
Excavation (1 feet)

**EXCAVATION SIDEWALL
SOIL SAMPLE RESULTS MAP**

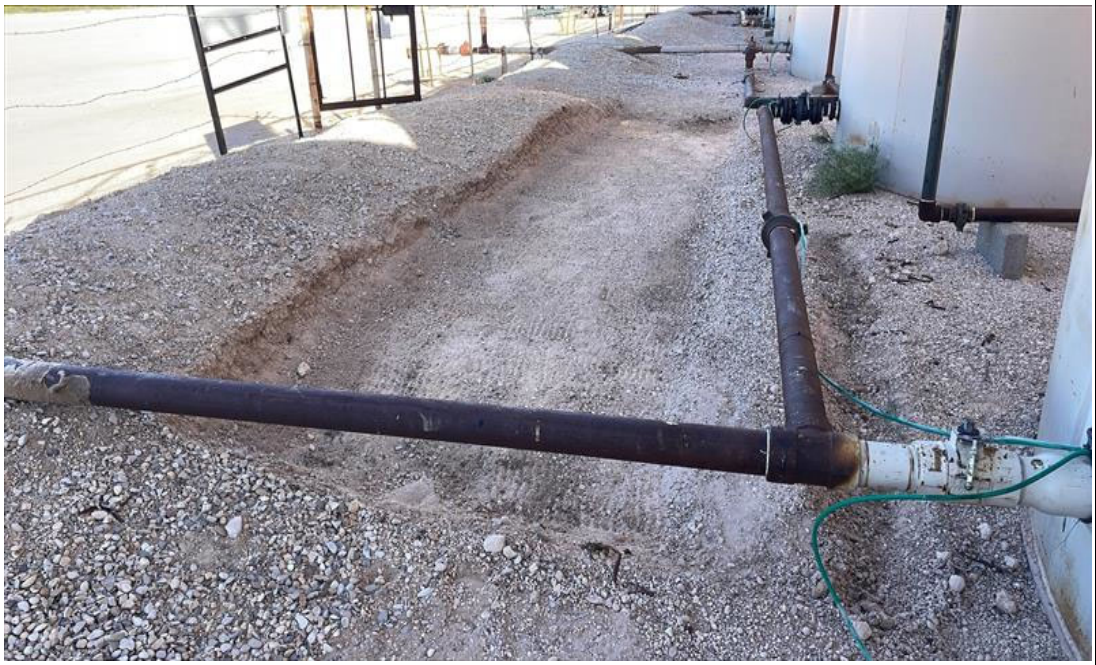
| Photo No. 2 | Date: 10/18/2023 | | |

| Description: Central excavation, north side of tank battery. | | | |

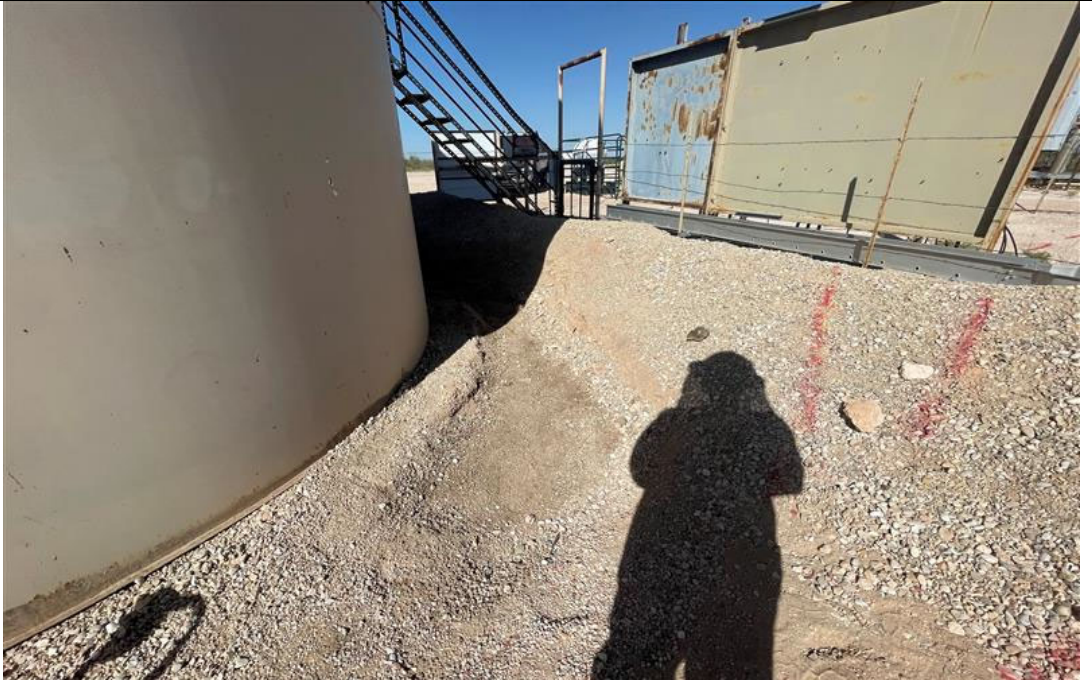
| Description: East excavation. | | | |

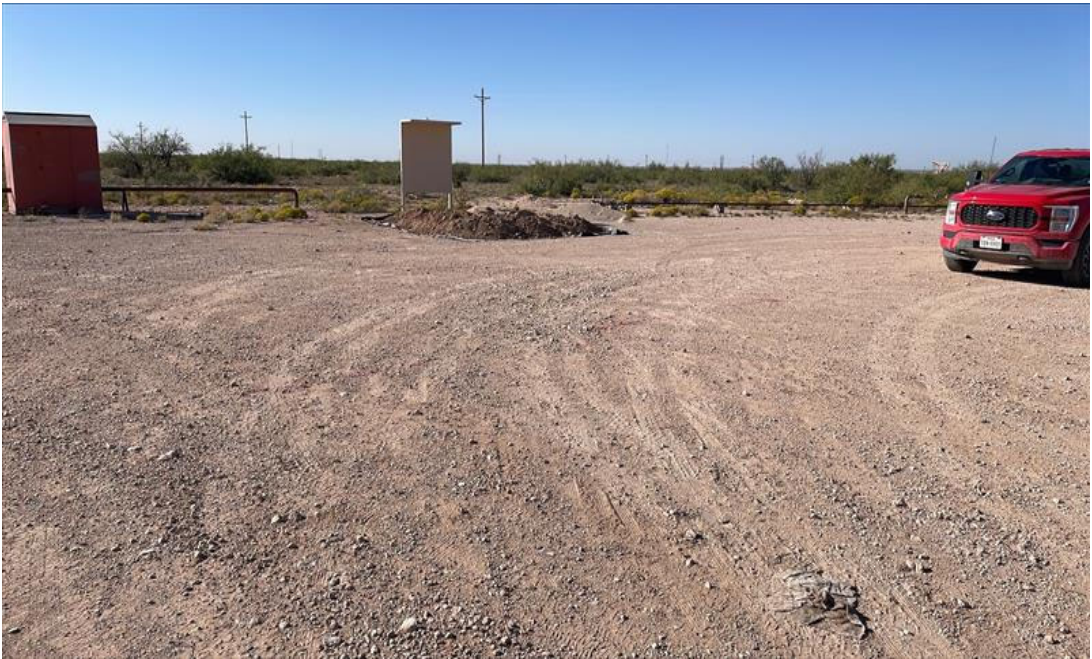
| Description: Excavated soil pile. | | | |

The stockpiled soil was transported off site and disposed of at the Lea Land Landfill facility located at Mile Marker 64, US Highway 62/180 East, Carlsbad, New Mexico as Class 2 non-hazardous material on October 27, 2023. Copies of disposal manifests can be provided upon request. Photographic documentation of the excavation activities is included in **Appendix D**.

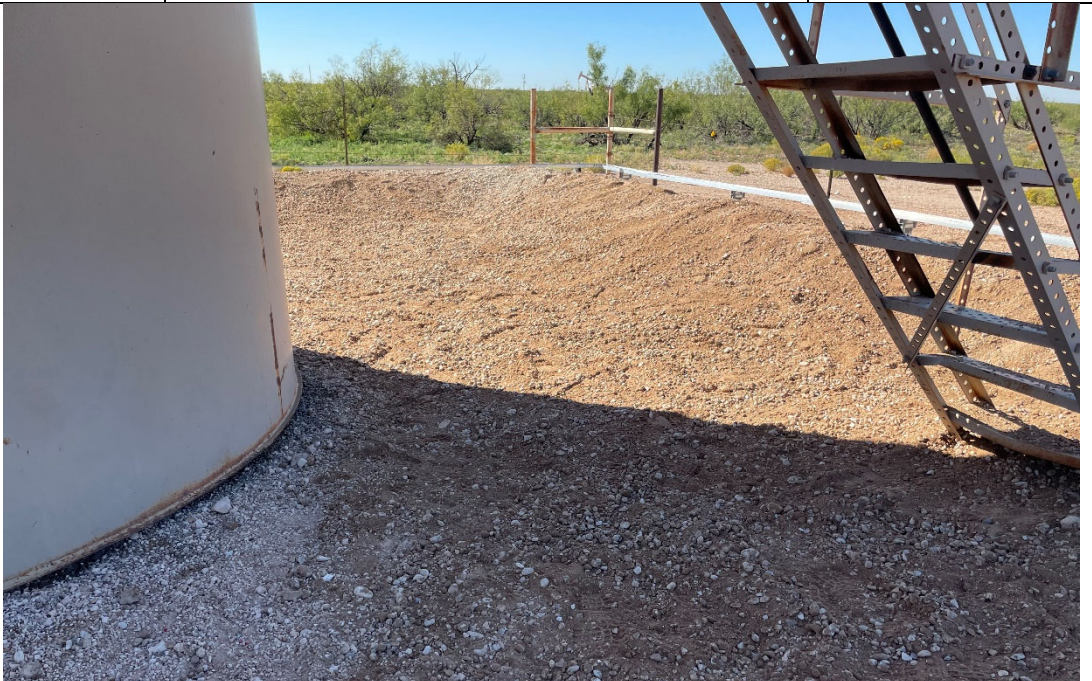
| ARCADIS | | PHOTOGRAPHIC LOG | |
|--|---|--|---|
| Photo No. 5 | Date: 10/19/2023 | | |

| ARCADIS | | PHOTOGRAPHIC LOG | |
|--|---|--|---|
| Description: West excavation backfilled. | | | |

Upon receiving laboratory analytical results from the excavation confirmation soil samples, the excavated areas were backfilled with locally sourced, non-impacted "like" material. The affected area was contoured and compacted to achieve erosion control and stability. Photographic documentation of the excavation areas following backfilling activities is included in **Appendix D**.

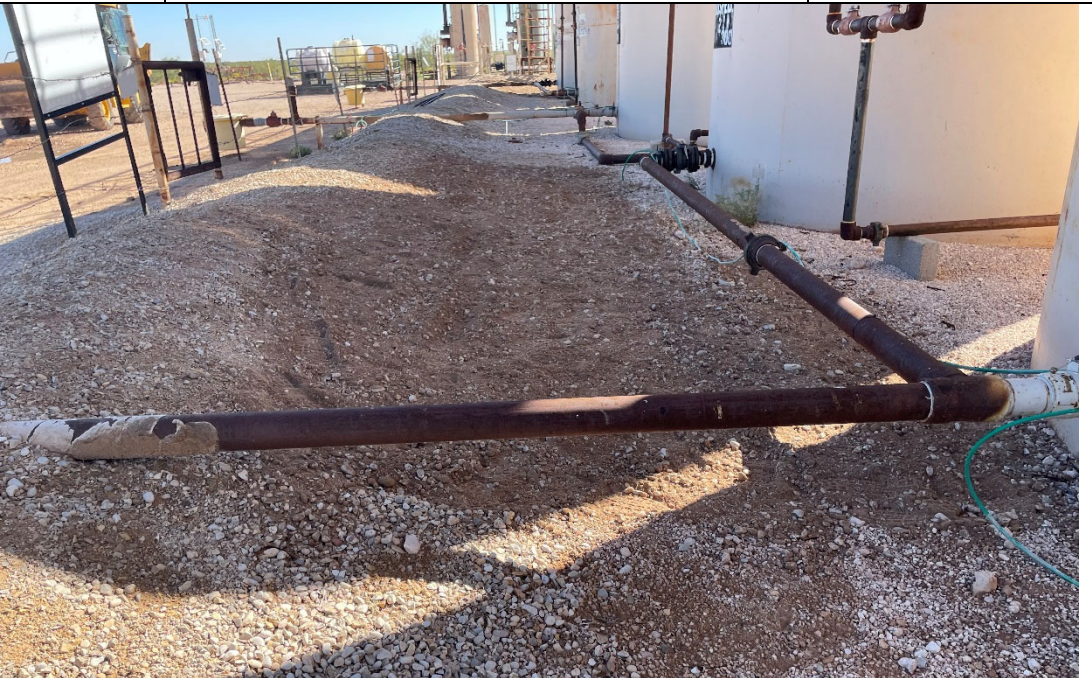
| ARCADIS | | PHOTOGRAPHIC LOG | |
|---|---|--|---|
| Photo No. 6 | Date: 10/19/2023 | | |

| ARCADIS | | PHOTOGRAPHIC LOG | |
|---|---|--|---|
| Description: Central excavation backfilled. | | | |

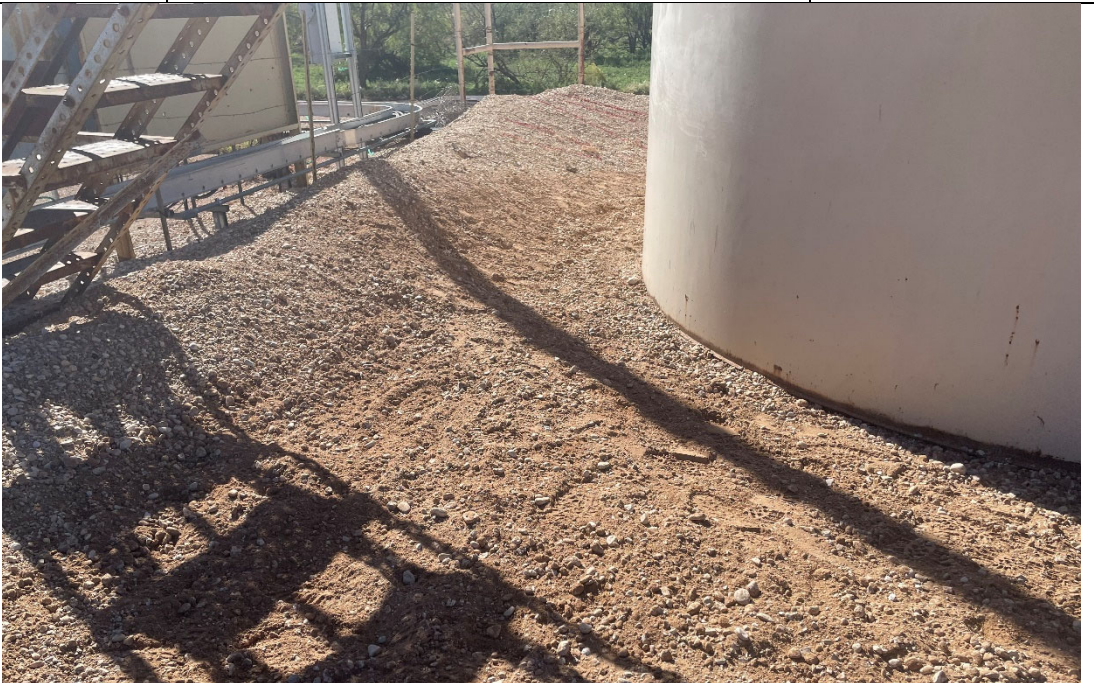
| | | PHOTOGRAPHIC LOG | |
|---|---|--|---|
| Photo No. 7 | Date: 10/19/2023 | | |

| | | PHOTOGRAPHIC LOG | |
|---|---|--|---|
| Description: East excavation backfilled. | | | |

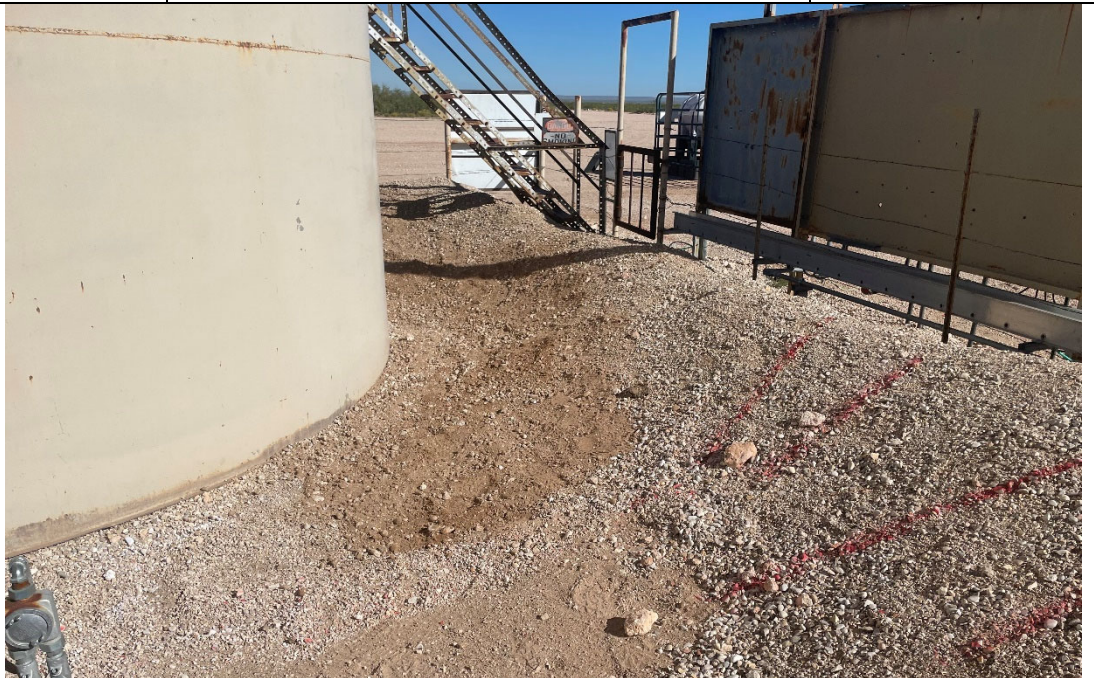
| | | PHOTOGRAPHIC LOG | |
|---|---|--|---|
| Photo No. 8 | Date: 10/19/2023 | | |

| | | PHOTOGRAPHIC LOG | |
|---|---|--|---|
| Description: East excavation backfilled. | | | |
