Site Assessment- Work Plan Remedial Action

Ford State #002
API #30-015-22714
F-02-T22S-R28E

Subject: **Reclamation- Remediation Work**
Plan NAB1701954977
Ford State #002
API # 30-015-22714
Eddy County, New Mexico

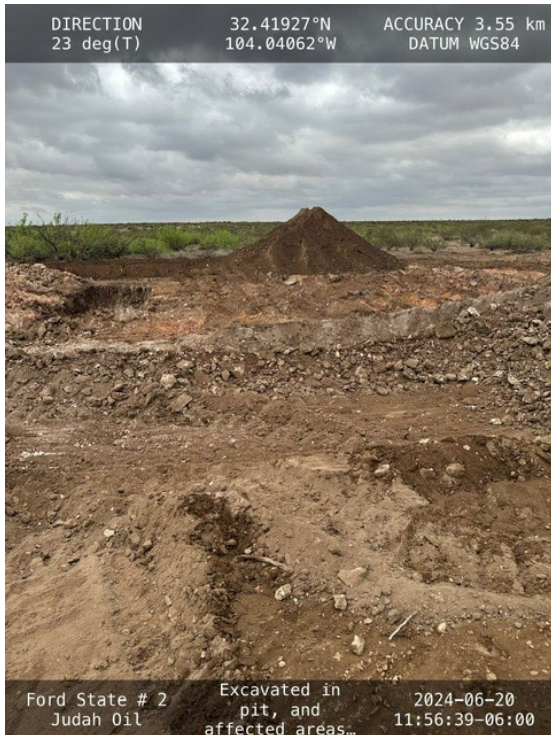
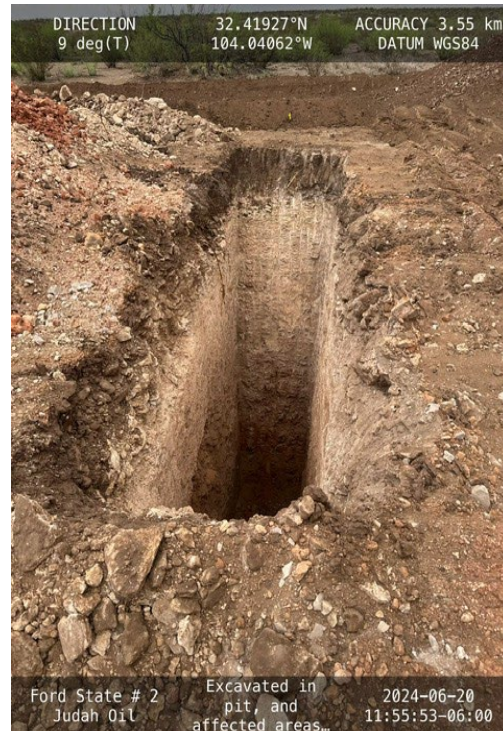
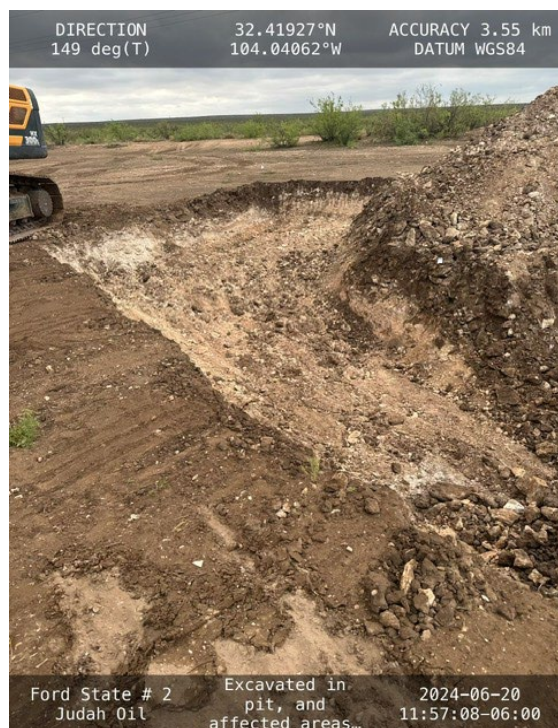
Photo Documentation

- All surface equipment has been removed from the property. A 4 foot well marker has been positioned where the wellhead was located. The current site and access road consists of a caliche surface and conditions appear to be suitable for access. All caliche surfaces will be removed as part of the reclamation of this location. The main easement area appears free of weeds and erosional features.

- On May 28, 2024 personnel from Nighthawk Environmental Services conducted an initial site assessment. staining was noticed where a former possible drill pit was situated. This area was sampled and delineated. The area for incident number **NAB1701954977** was also sampled. Sample Positions are designated on site map Please see recap of data below All samples were properly collected, contained, preserved, and transported to Cardinal Laboratories of Hobbs, NM for analysis of Chlorides (Method SM4500Cl-B), Total Hydrocarbon content (Method TPH 8015M), and BTEX (Method BTEX 8021B). The recap of results of tabled below and a corresponding site map can be seen in Appendix I referencing both areas of concern.
