Remediation Summary and Soil Closure Request

Permian Resources Raider Fed Com 101H

Lea County, New Mexico
Unit Letter A, Section 21, Township 24 South, Range 34 East
Latitude 32.20917 North, Longitude 103.46866 West
NMOCD Reference No. nAPP2219045002

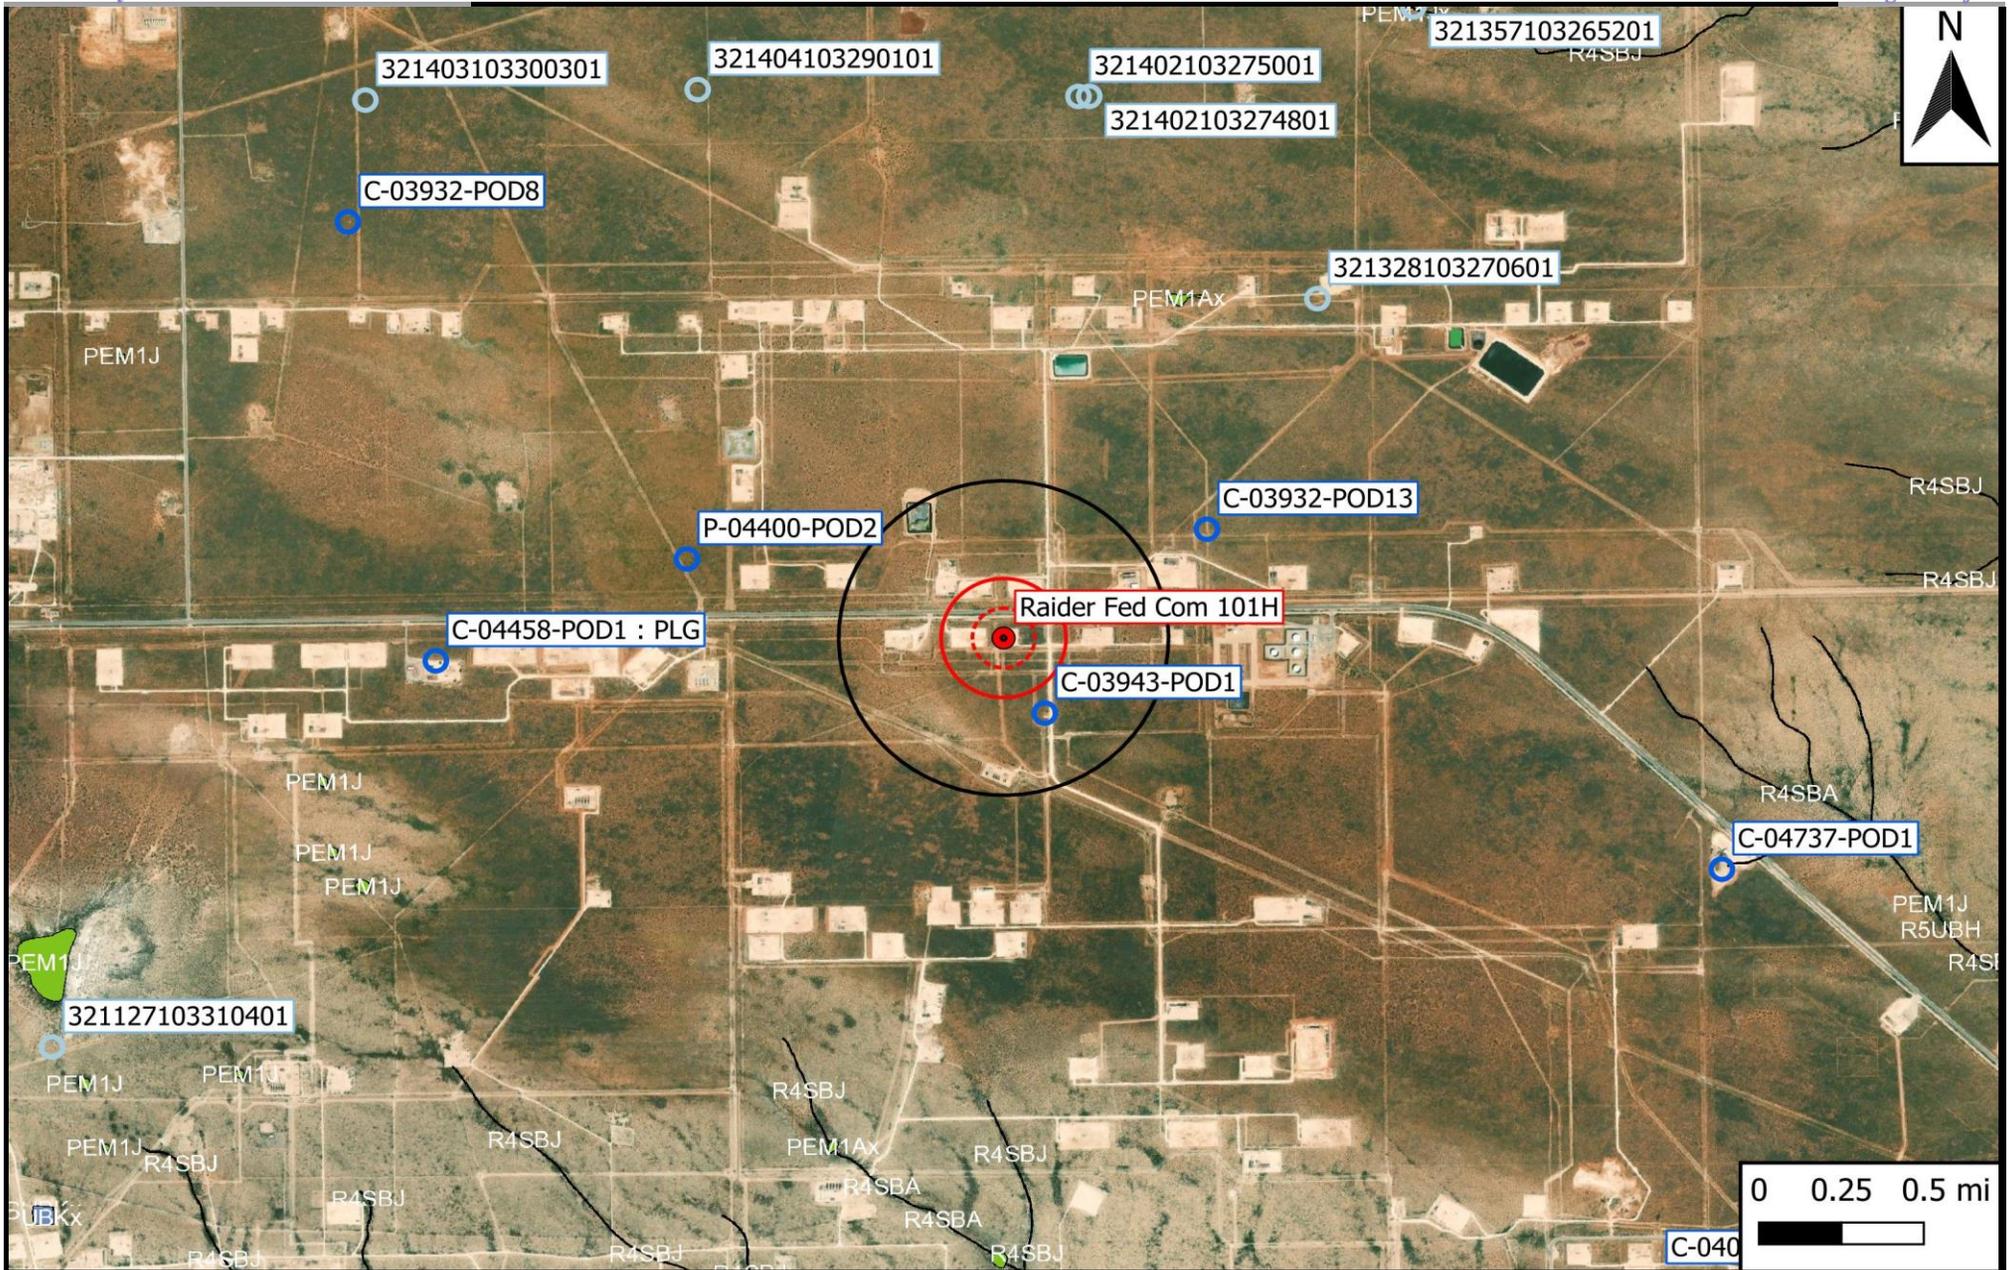
Figure 2
 Aerial Proximity Map
 Permian Resources
 Raider Fed Com 101H
 GPS: 32.20917, -103.46866
 Lea County

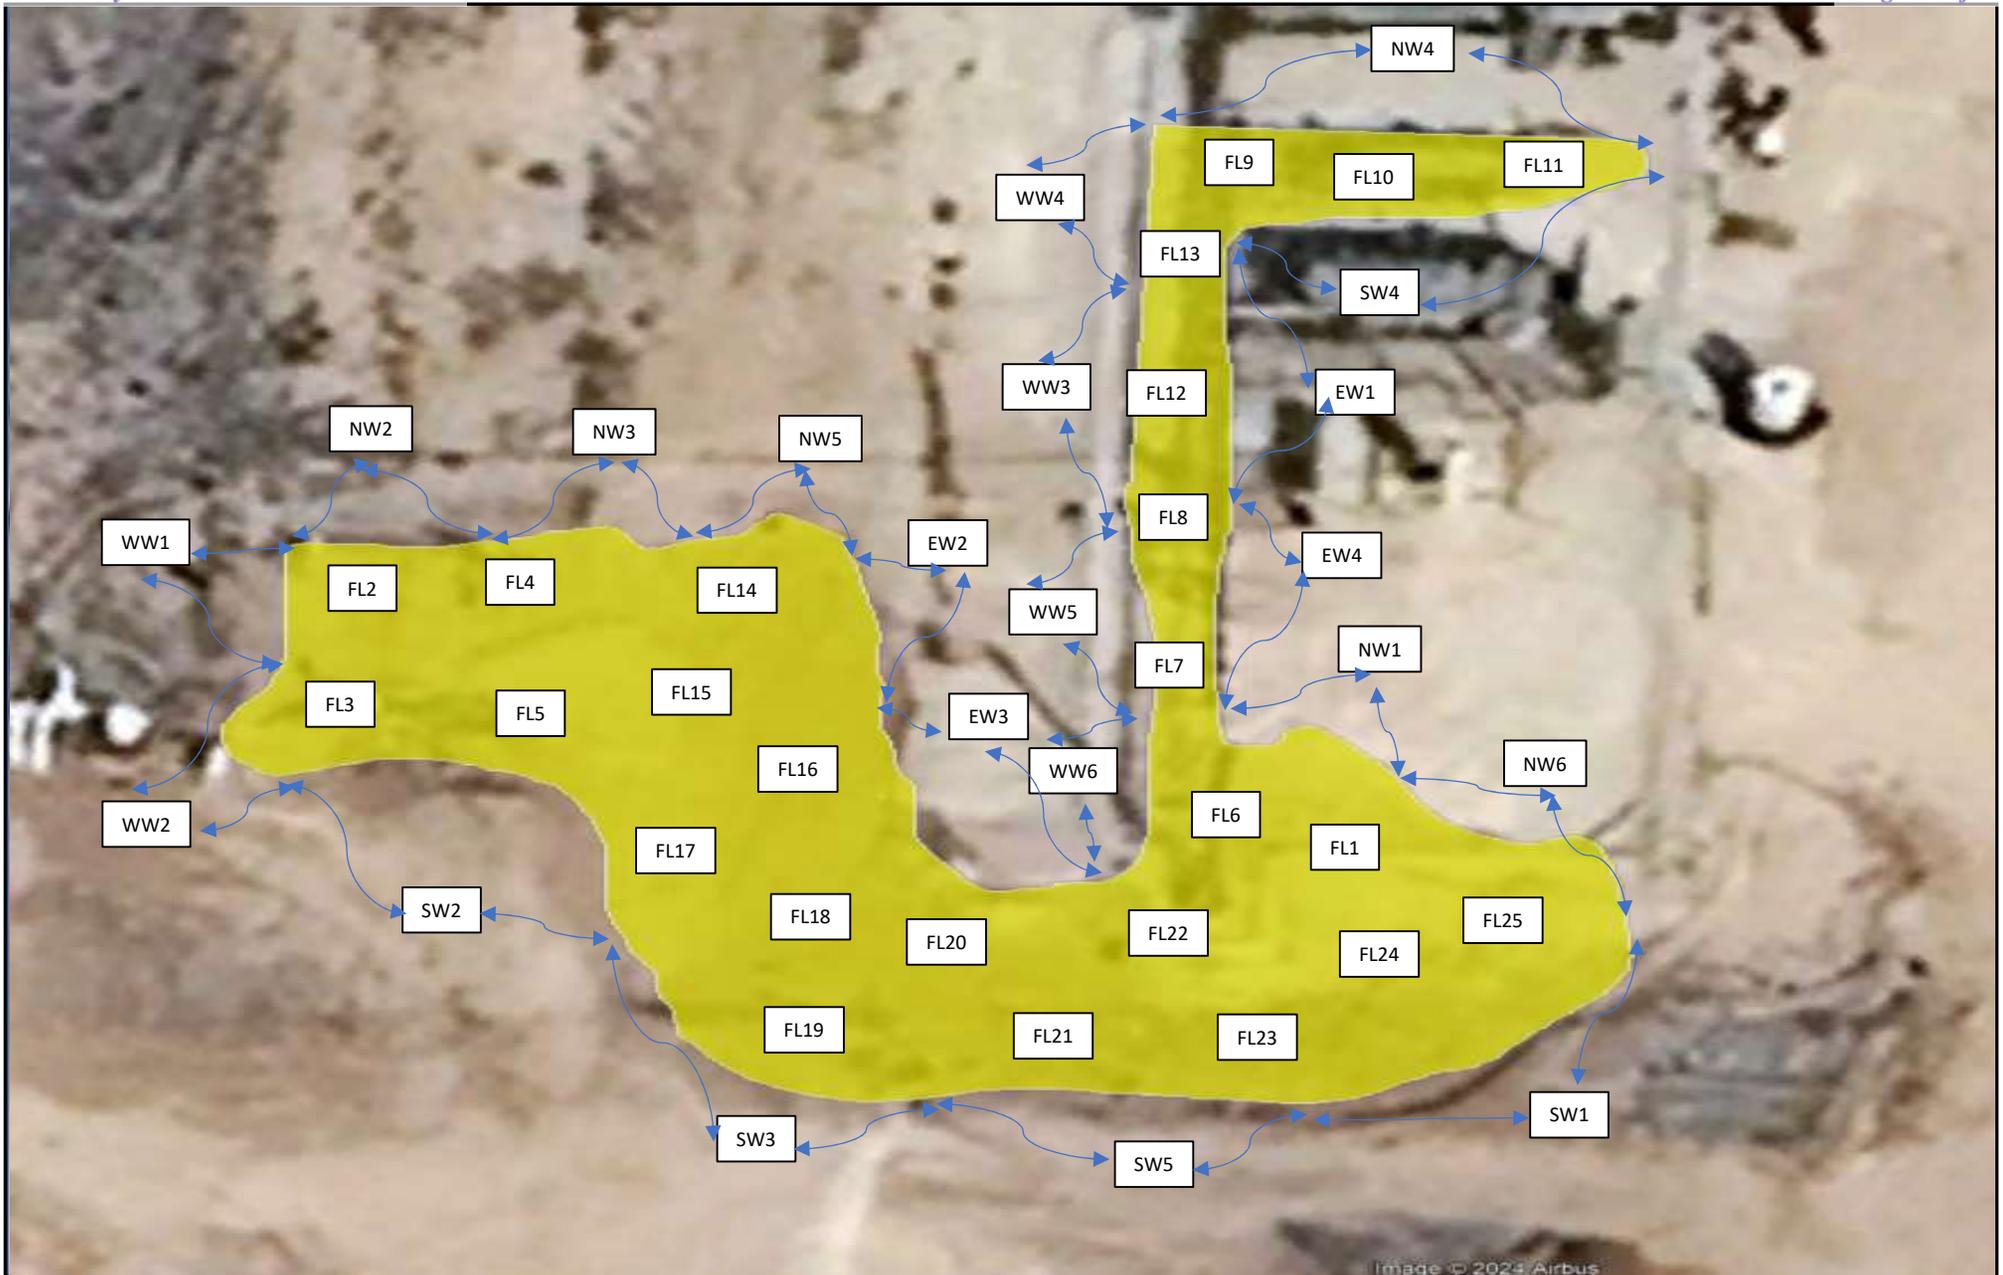
Figure 3

Site and Sample Location Map

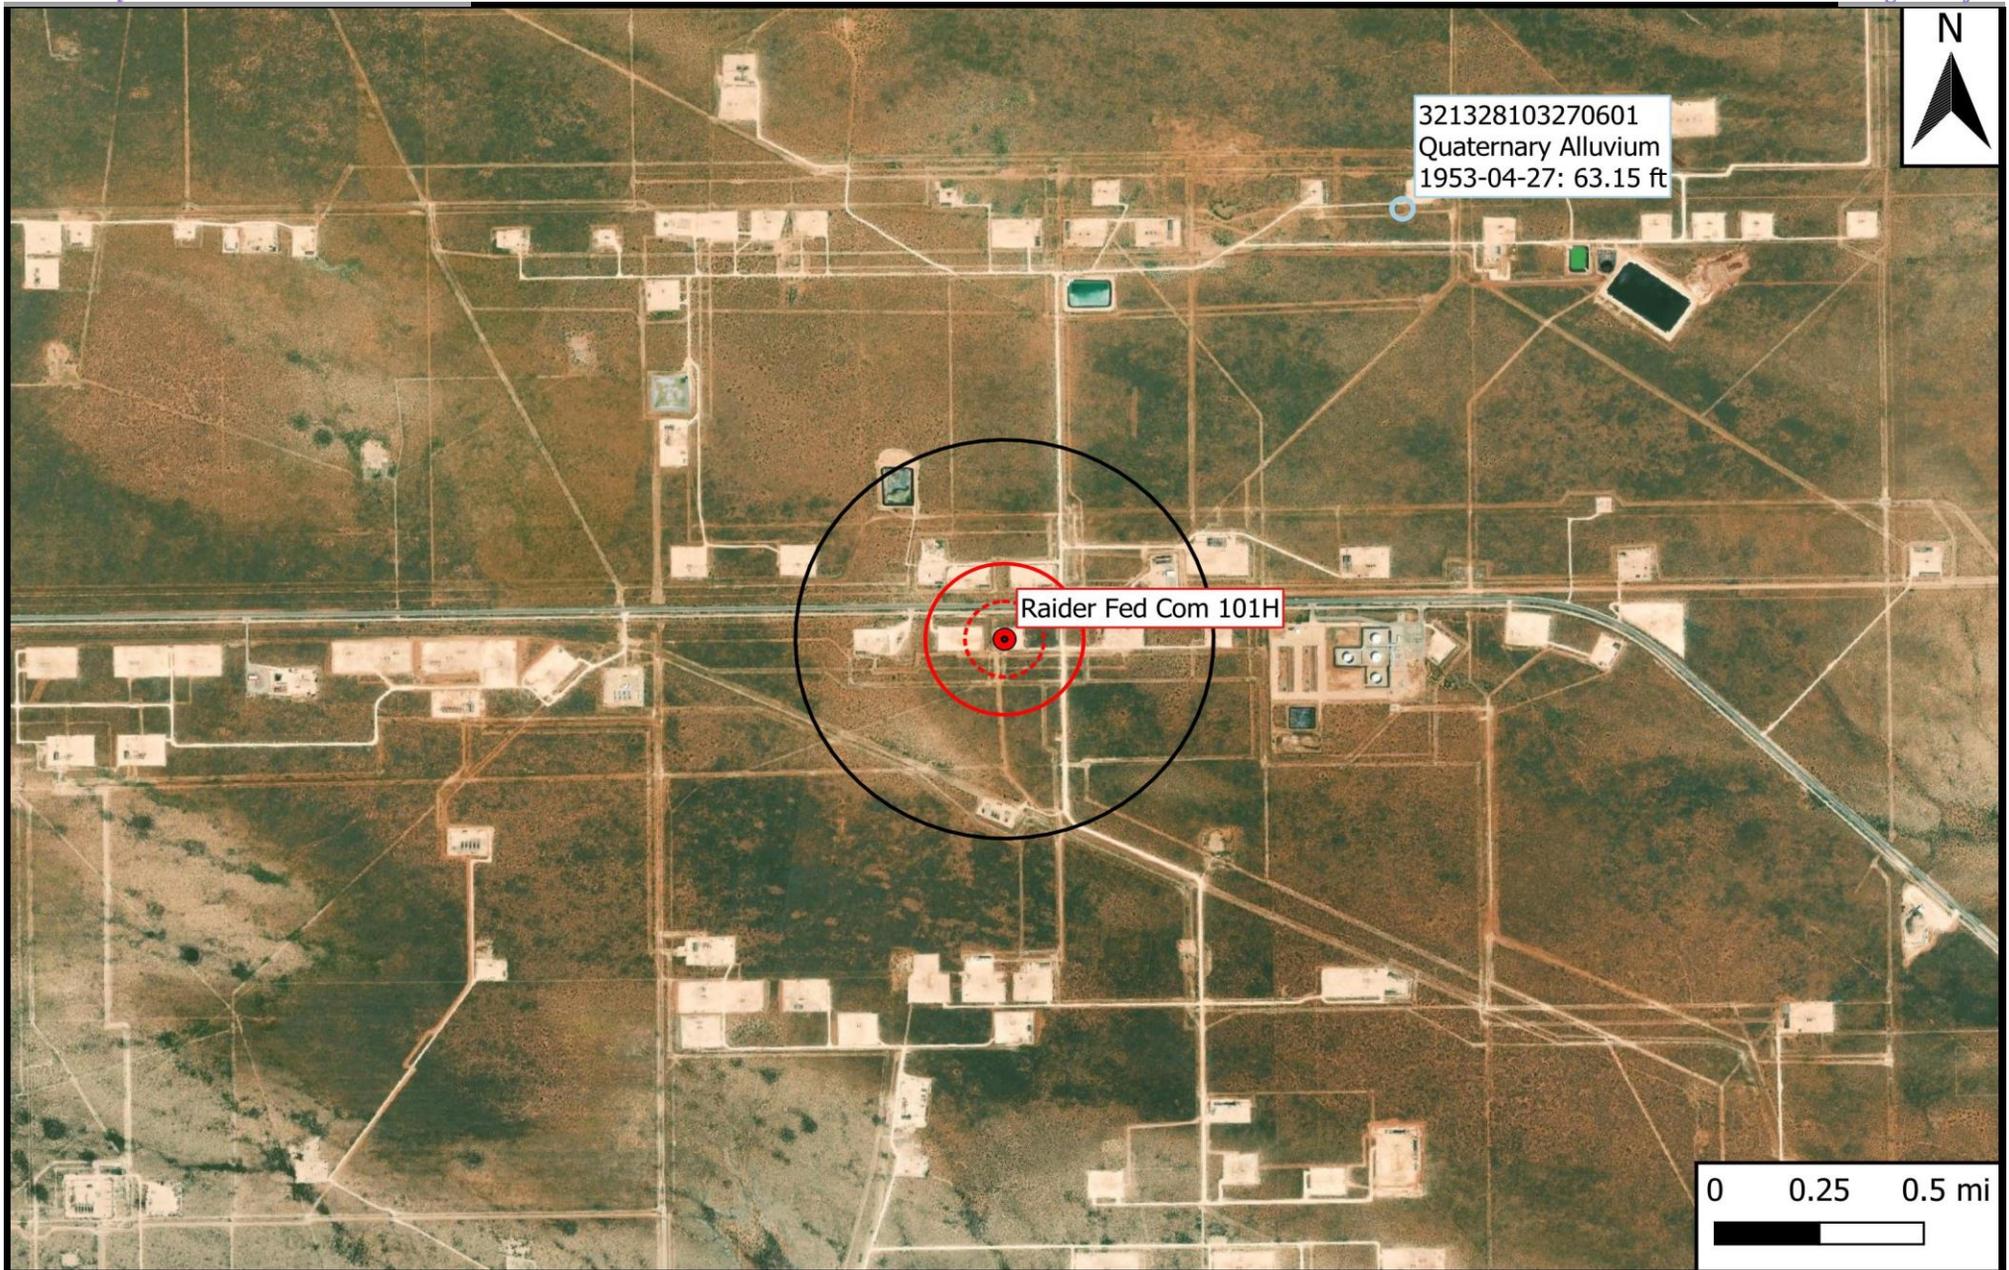
Figure 5
 USGS Well Proximity Map
 Permian Resources
 Raider Fed Com 101H
 GPS: 32.20917, -103.46866
 Lea County

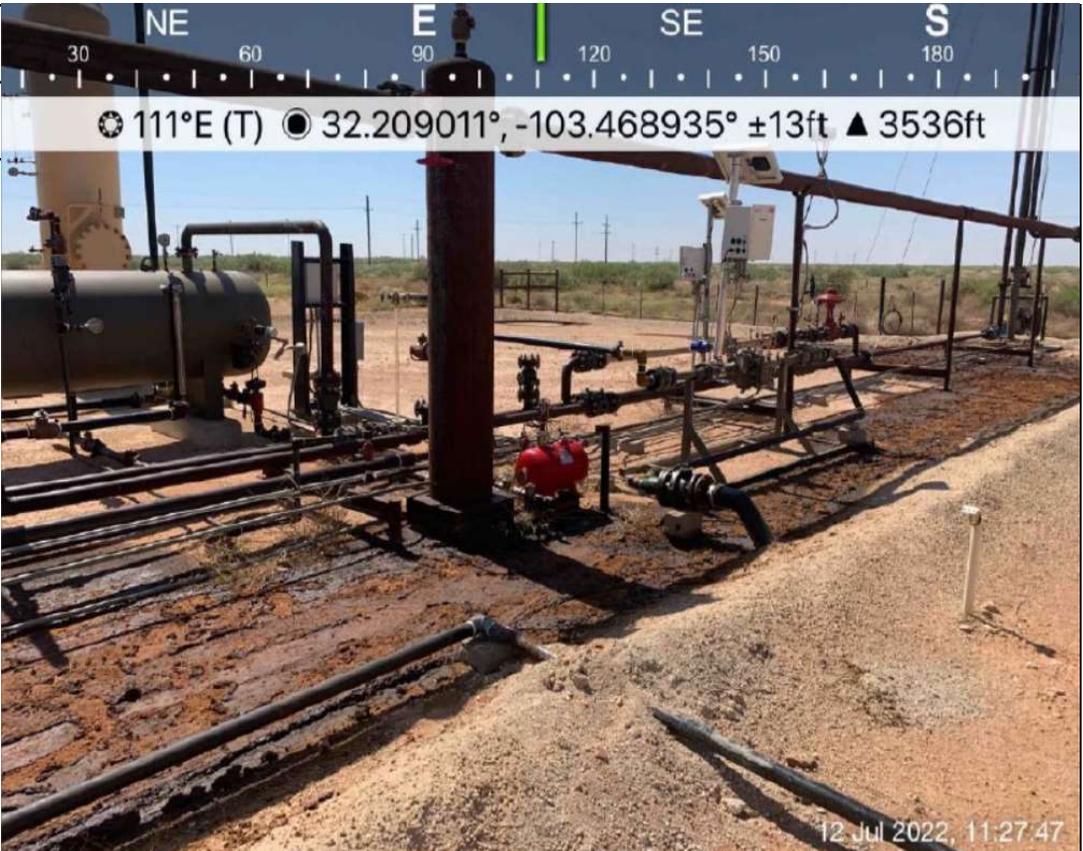
Photo Number: #1

Photo Direction: East Southeast	☀ 111°E (T) ● 32.209011°, -103.468935° ±13ft ▲ 3536ft
Photo Description: Initial Release

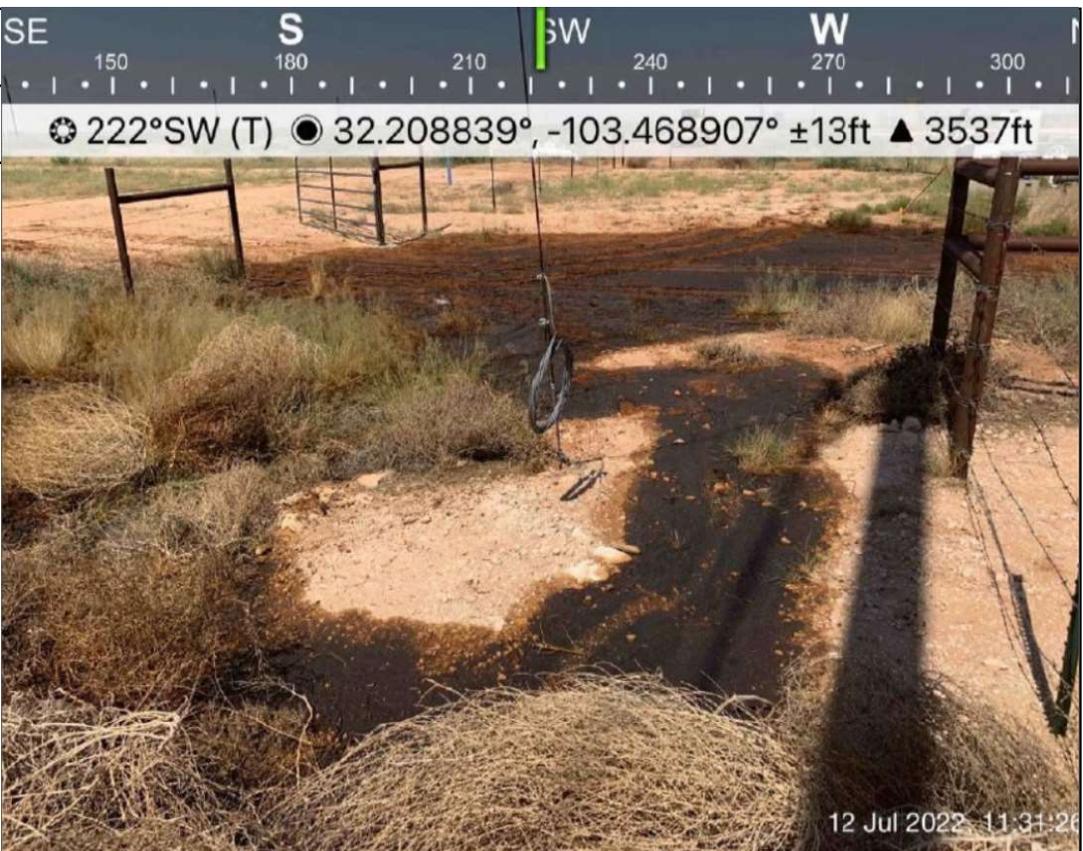
Photo Number: #2

Photo Direction: Southwest	☀ 222°SW (T) ● 32.208839°, -103.468907° ±13ft ▲ 3537ft
Photo Description: Initial Release

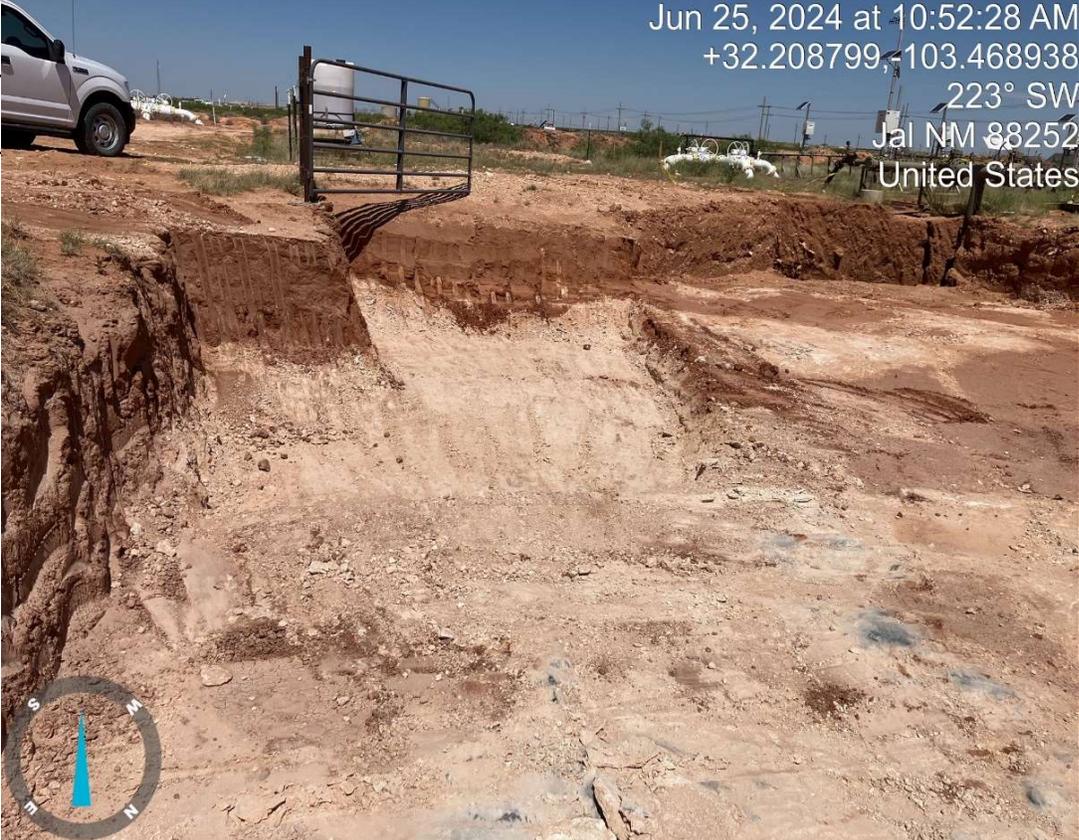
Photo Number: #3

<p>Jun 25, 2024 at 10:52:28 AM +32.208799,-103.468938 223° SW Jal NM 88252 United States</p>
Photo Direction: Southwest	
Photo Description: Excavation

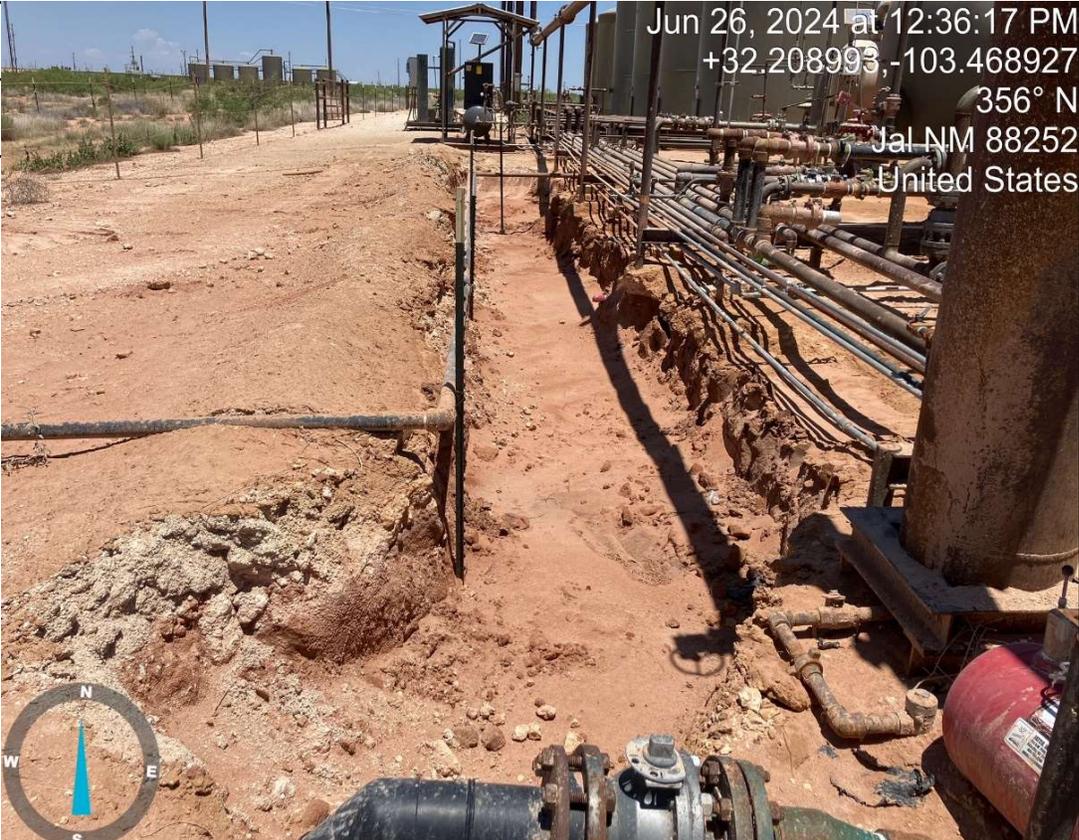
Photo Number: #4

<p>Jun 26, 2024 at 12:36:17 PM +32.208993,-103.468927 356° N Jal NM 88252 United States</p>
Photo Direction: North	
Photo Description: Excavation

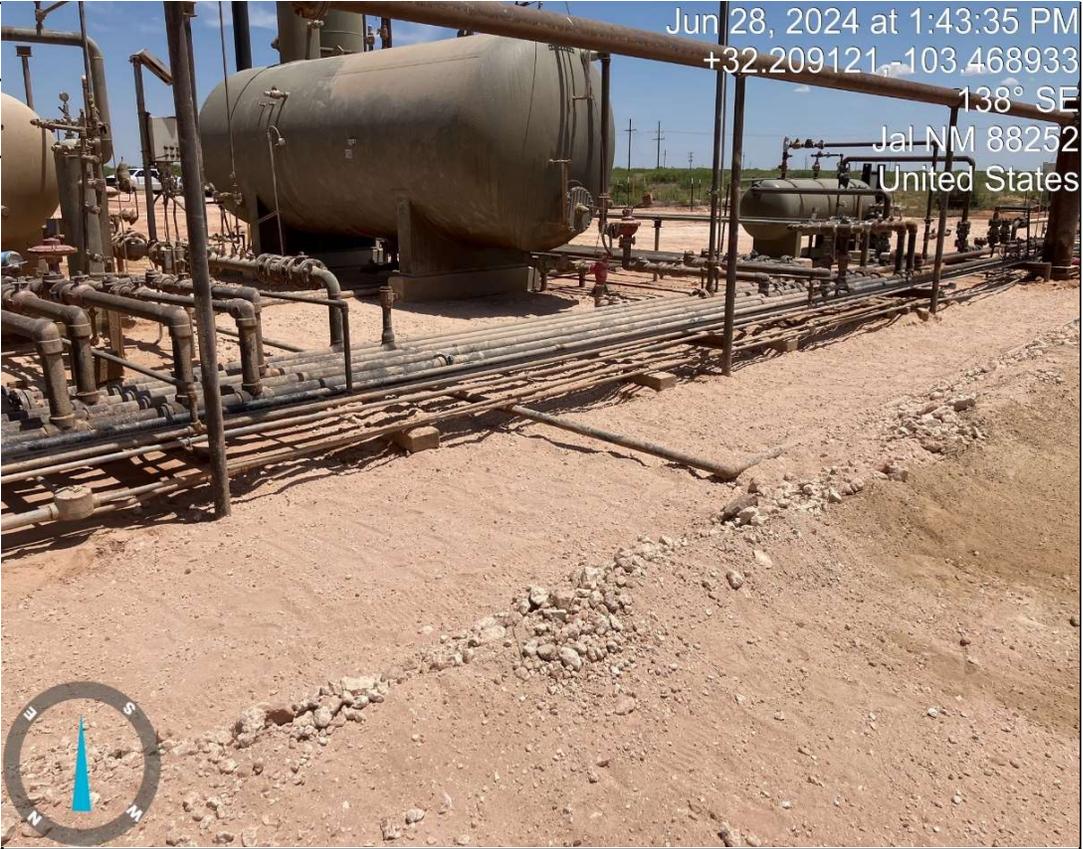
Photo Number: #5

<p>Jun 28, 2024 at 1:43:35 PM +32.209121,-103.468933 138° SE Jal NM 88252 United States</p>
Photo Direction: Southeast	
Photo Description: Backfill

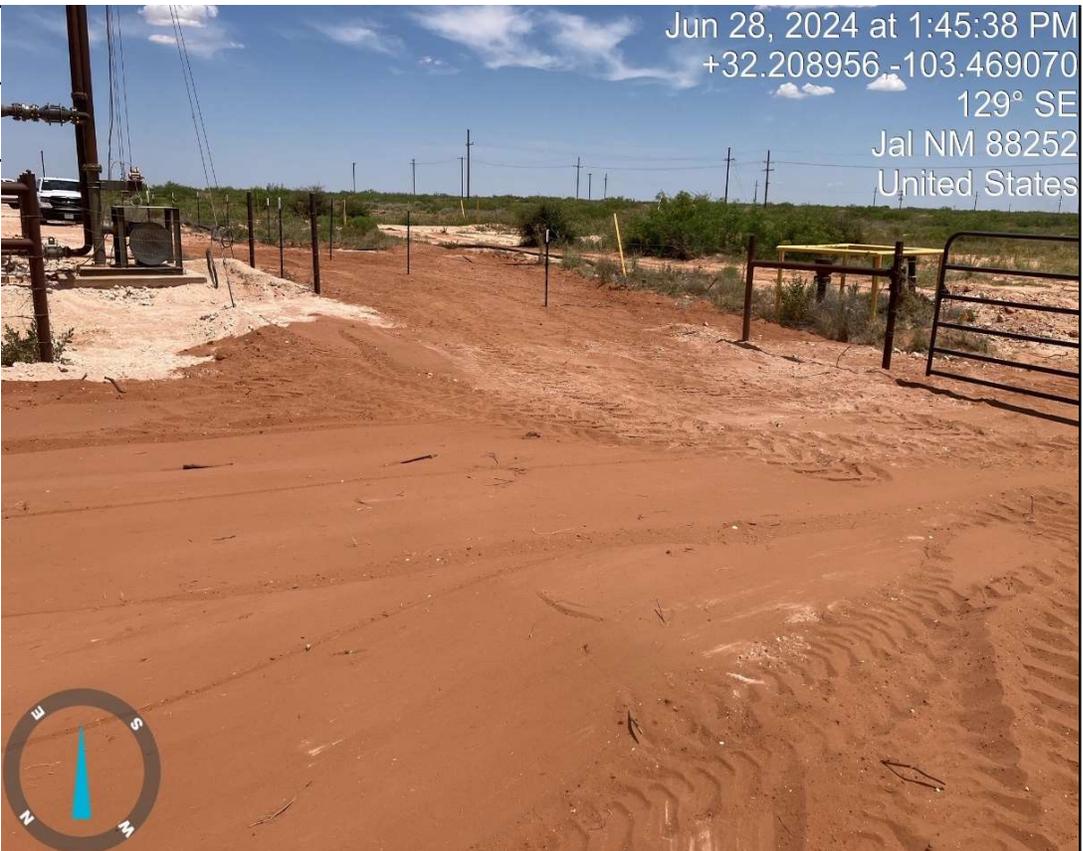
Photo Number: #6

<p>Jun 28, 2024 at 1:45:38 PM +32.208956,-103.469070 129° SE Jal NM 88252 United States</p>
Photo Direction: Southeast	
Photo Description: Backfill
