**Re: Closure Request
PLU 411 Battery
Incident Number nAPP2404456492
Eddy County, New Mexico**

Ensolum, LLC (Ensolum), on behalf of XTO Energy, Inc. (XTO), has prepared this *Closure Request* to document site assessment, excavation, and soil sampling activities at the PLU 411 Battery (Site). The purpose of the site assessment and soil sampling activities was to assess for the presence or absence of impacts to soil following a release of crude oil into a lined containment and onto the well pad. Based on field observations, field screening activities, and soil sample laboratory analytical results, XTO is submitting this *Closure Request*, describing site assessment, excavation, and delineation activities that have occurred and requesting no further action for Incident Number nAPP2404456492.

XTO Energy, Inc
Closure Request
PLU 411 Battery

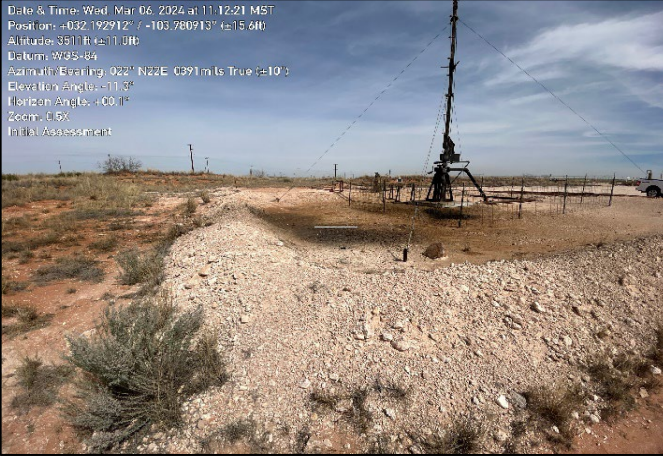
On March 6, 2024, Ensolum personnel visited the Site to evaluate the release extent based on information provided on the Form C-141 and visual observations. The release extent was mapped utilizing a handheld Global Positioning System (GPS) unit and is depicted on Figure 2. Photo documentation was collected during the inspection and a photographic log is included in Appendix B.

Photograph: 1 Date: 3/6/2024
Description: Soil staining in release footprint.
View: Northeast

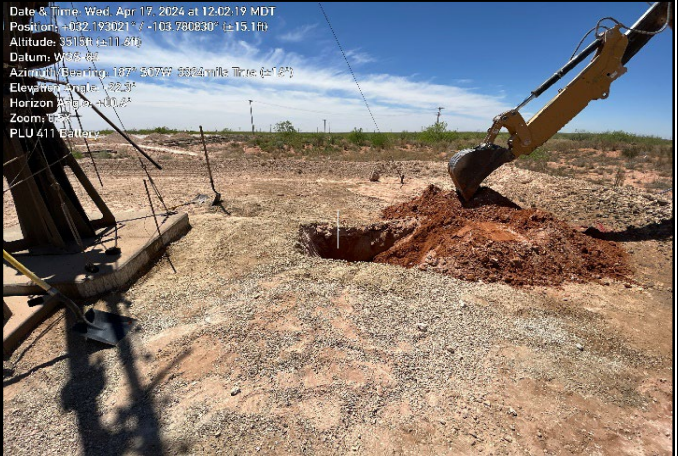
Photograph: 2 Date: 4/17/2024
Description: Excavation activities.
View: Southwest

Visibly stained soil was excavated from the release area using a backhoe and transported for disposal. The excavation occurred on the well pad near the flare and pasture. To direct excavation activities, Ensolum personnel screened soil for VOCs and chloride.

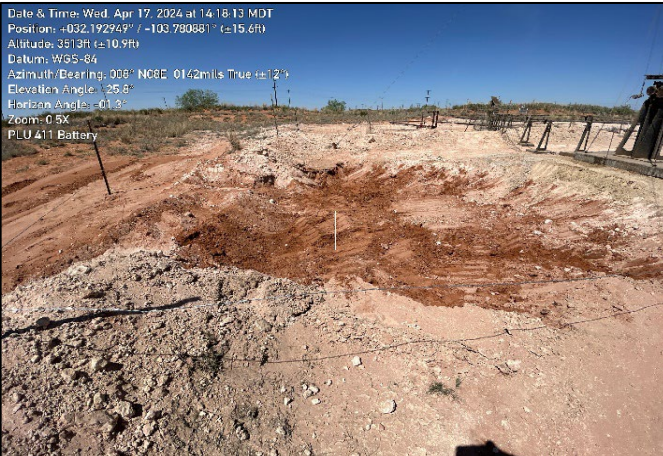
Photograph: 3 Date: 4/17/2024
Description: Final excavation extent
View: Northeast

The final excavation extent measured approximately 350 square feet. A total of approximately 13 cubic yards of impacted soil was removed during the excavation activities. The impacted soil was transported and properly disposed of at the R360 Facility in Carlsbad, New Mexico. After completion of confirmation sampling, the excavation areas were secured with fencing.

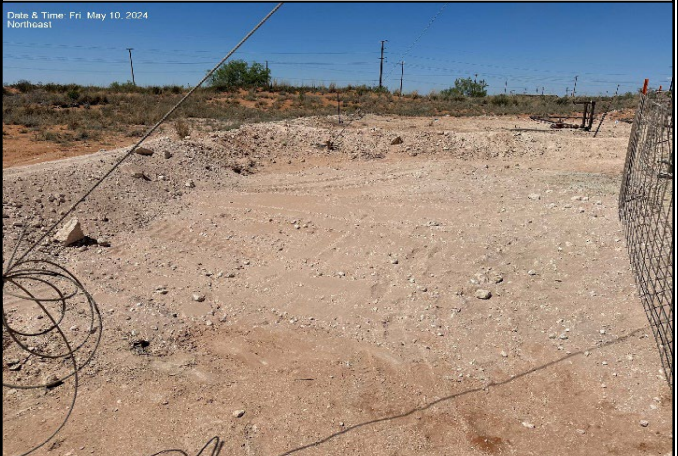
Photograph: 4 Date: 5/10/2024
Description: Backfilling activities
View: Northeast

Site assessment and excavation activities were conducted at the Site to address the January 30, 2024, release of crude oil, caused by a flare fire. Laboratory analytical results for the confirmation soil samples, collected from the final excavation extent, indicated all COC concentrations were compliant with the Site Closure Criteria and reclamation requirement. Based on the soil sample analytical results, no further remediation was required. XTO backfilled the excavation with material purchased locally and recontoured the Site to match pre-existing site conditions.
