## REMEDIATION CLOSURE REPORT

**Sea Snake 35 State #001H**

API: 30-025-41625

**Re: Site Assessment, Remediation, and Closure Report**  
**Sea Snake 35 State #001H**  
**API No. 30-025-41625**  
**GPS: Latitude 32.2544518 Longitude -103.5474319**  
**UL - M, Section 35, T23S, R33E**  
**Lea County, NM**  
**NMOCD Ref. No. NTO1431629657**

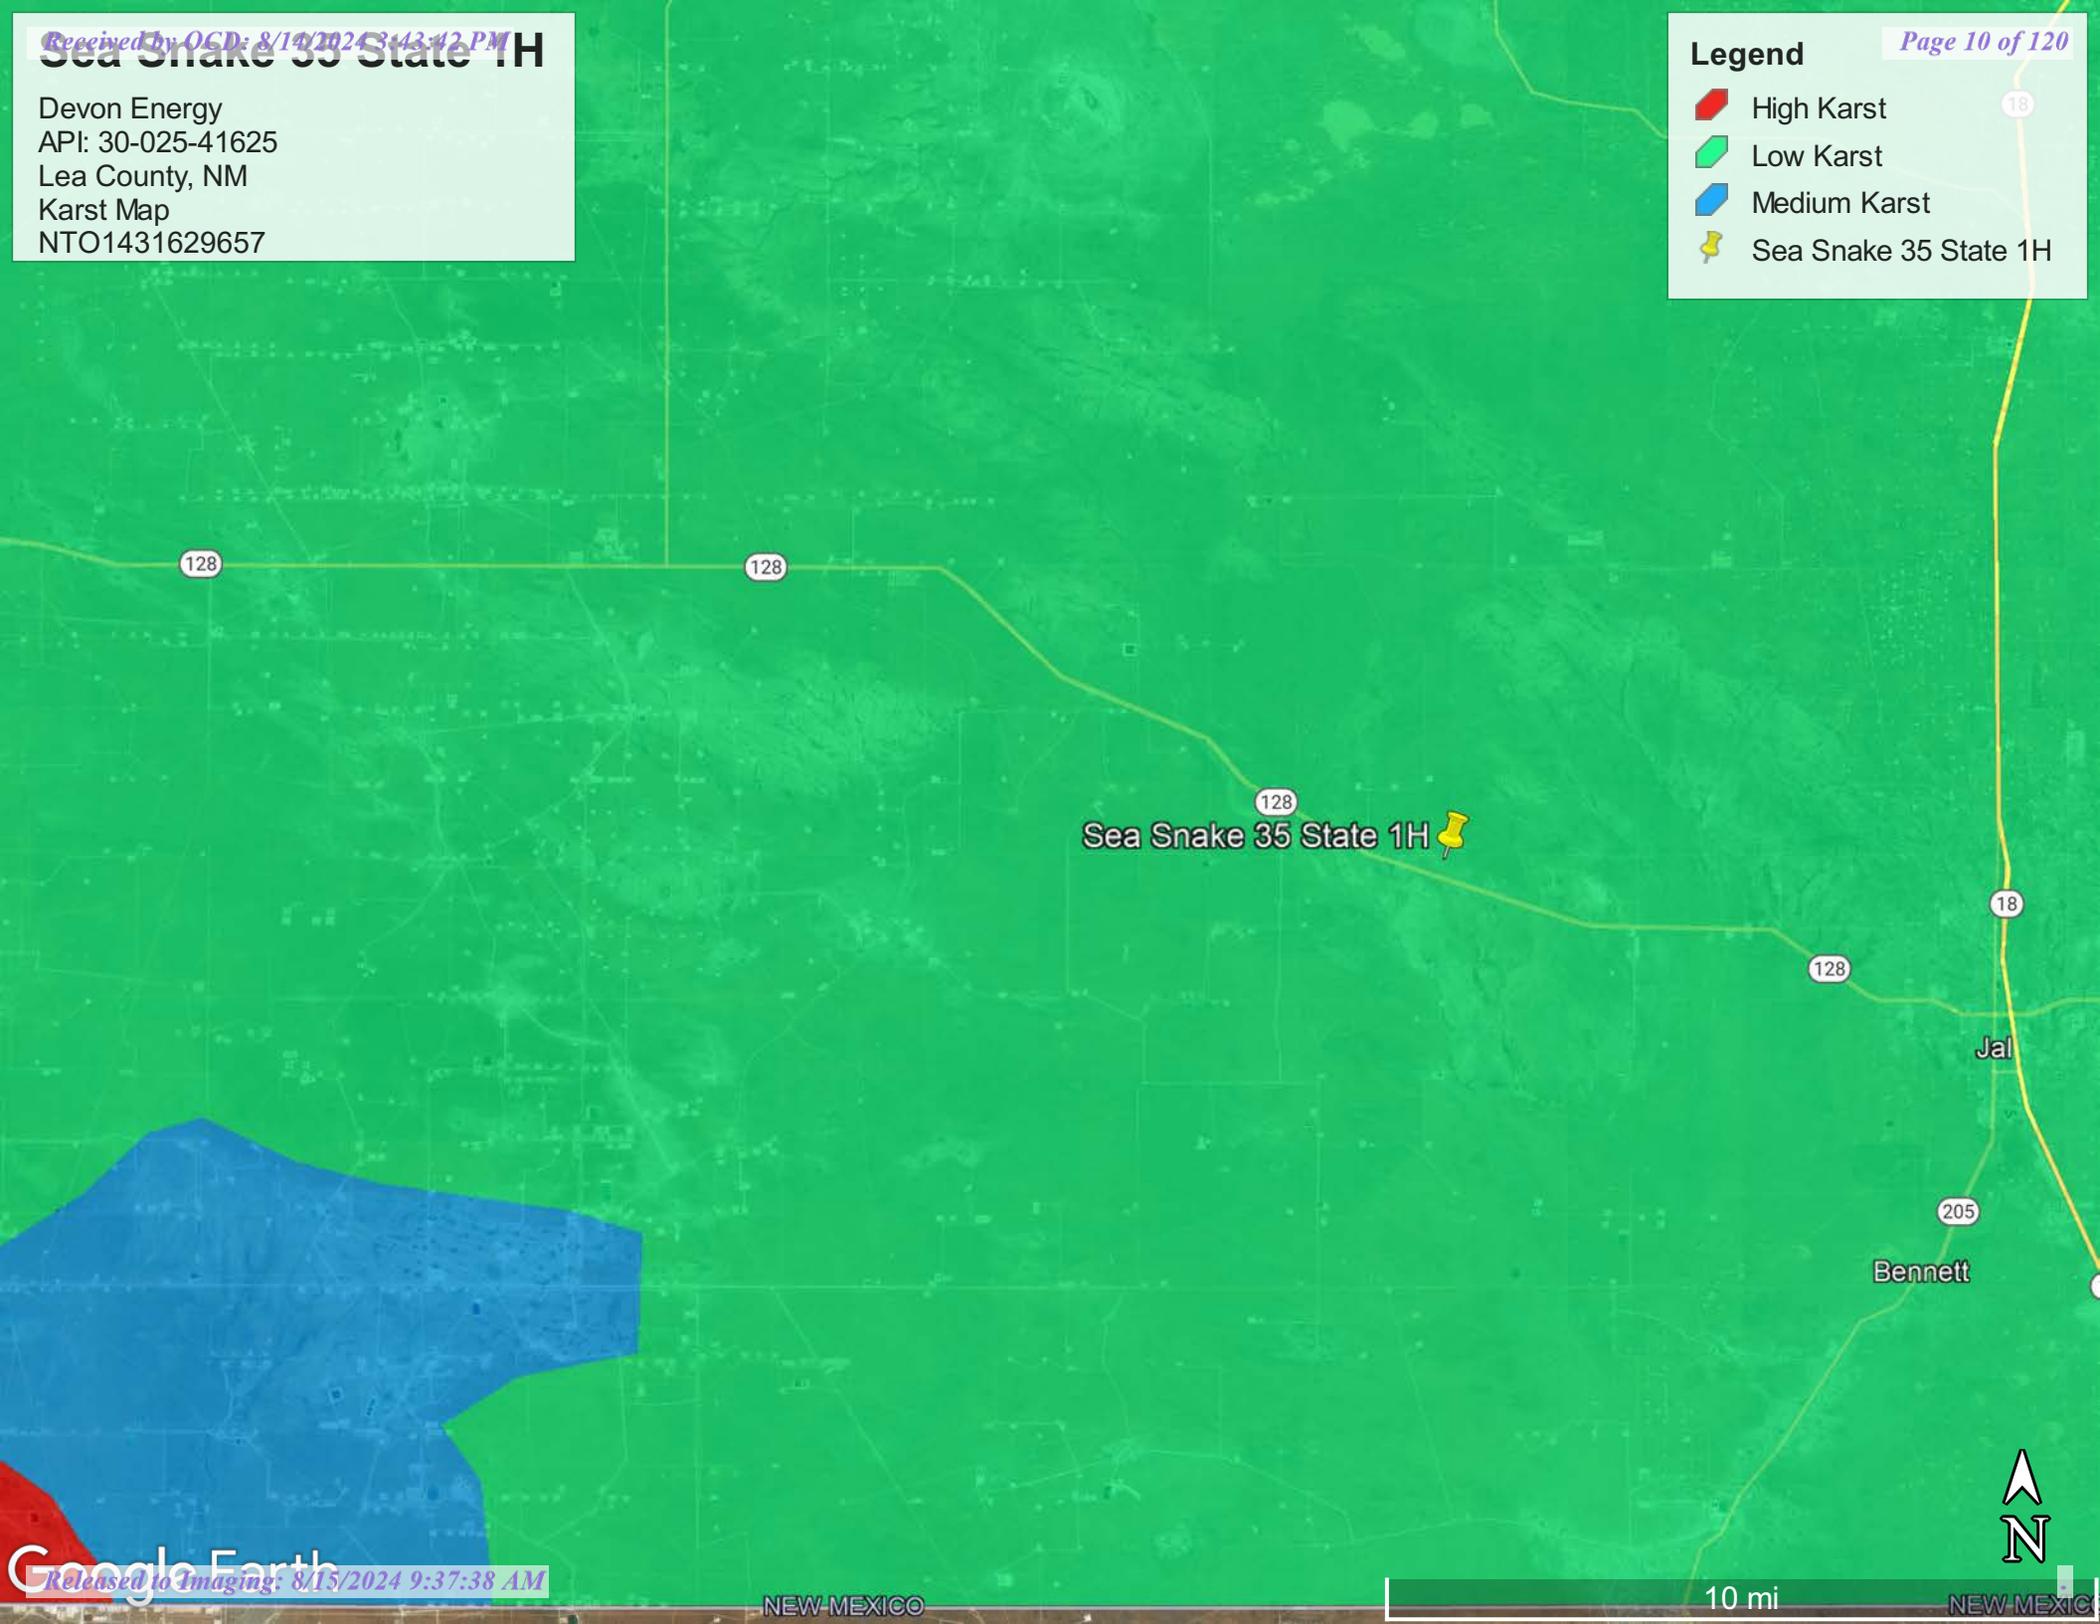
Figure 3- Karst Map

Per the New Mexico Bureau of Geology and Mineral Resources, the geology is made up of interlayered eolian sands and piedmont-slope deposits along the eastern flank of the Pecos River valley, primarily between Roswell and Carlsbad. The area is typically capped by thin eolian deposits. The soil in this area is made up of Berino-Cacique loamy fine sands association, according to the United States Department of Agriculture Natural Resources Conservation Service soil survey (Appendix B). The drainage class in this area is well-drained. There is a low potential for karst geology to be present around the Sea Snake (Figure 3). Reference Figure 2 for a Topographic Map.

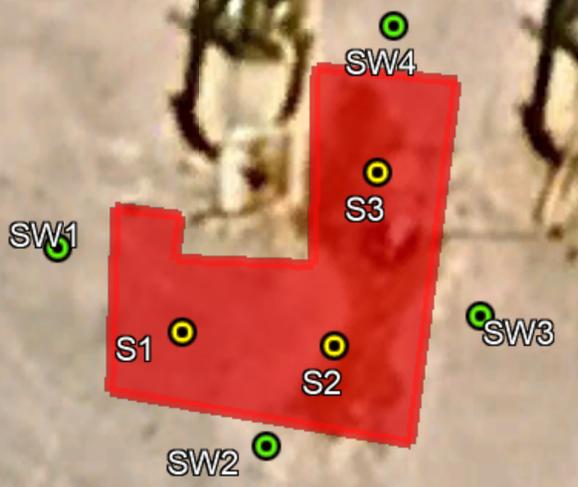
Figure 4- Site Map

On March 21, 2024, Pima mobilized personnel to the site to collect soil samples from the spill area. A hand auger was used to collect the samples from the affected area. The laboratory results of these sampling events are provided in the following data table. A Site Map is available in Figure 4

Spill Area 1,303 Ft

On July 19, 2024, the Devon Construction Department mobilized personnel and equipment to initiate immediate remediation activities. They began excavating the area to a depth of 1 foot below ground surface (BGS). A total of 49 cubic yards of contaminated soil was hauled to North Delaware Basin landfill, an approved, lined disposal facility and clean backfill material was brought in

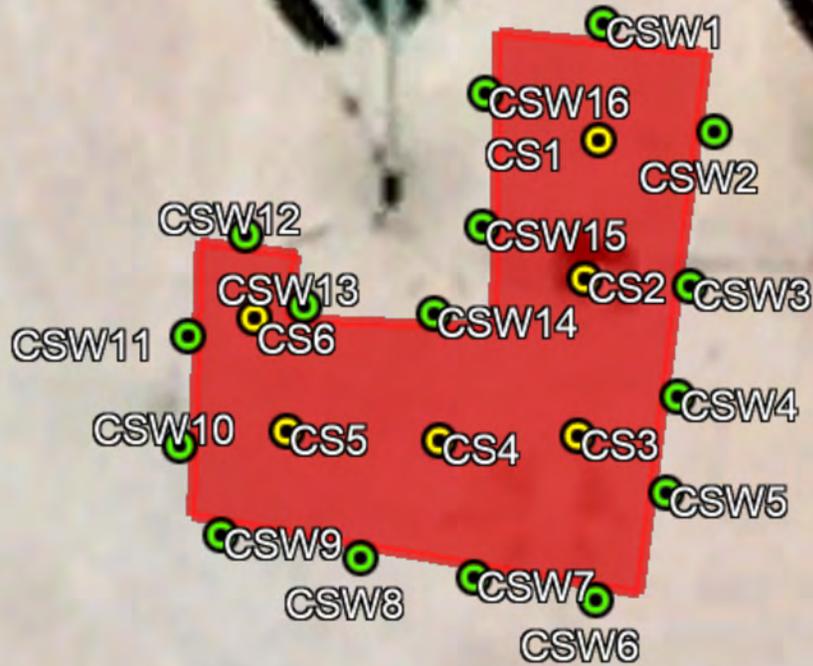
Figure 5- Confirmation Sample Map

On July 26, 2024, after sending a 48-hour notification (application ID: 366444, Appendix C), Pima returned to the site to collect 5-point confirmation samples from the excavation. The 5-point composite samples were taken from the exposed excavation sidewalls and bottom samples were collected at 1 foot deep. The results of this sampling event are provided in the following table, and a Confirmation Sample Map can be found in Figure 5

Based on the sample results, the bottoms and sidewalls were below NMOCD Closure Criteria 19.15.29 NMAC. The contaminated material was sufficiently removed then transported to Northern Delaware Basin Landfill, an NMOCD approved disposal site. See Appendix D for Photographic Documentation.

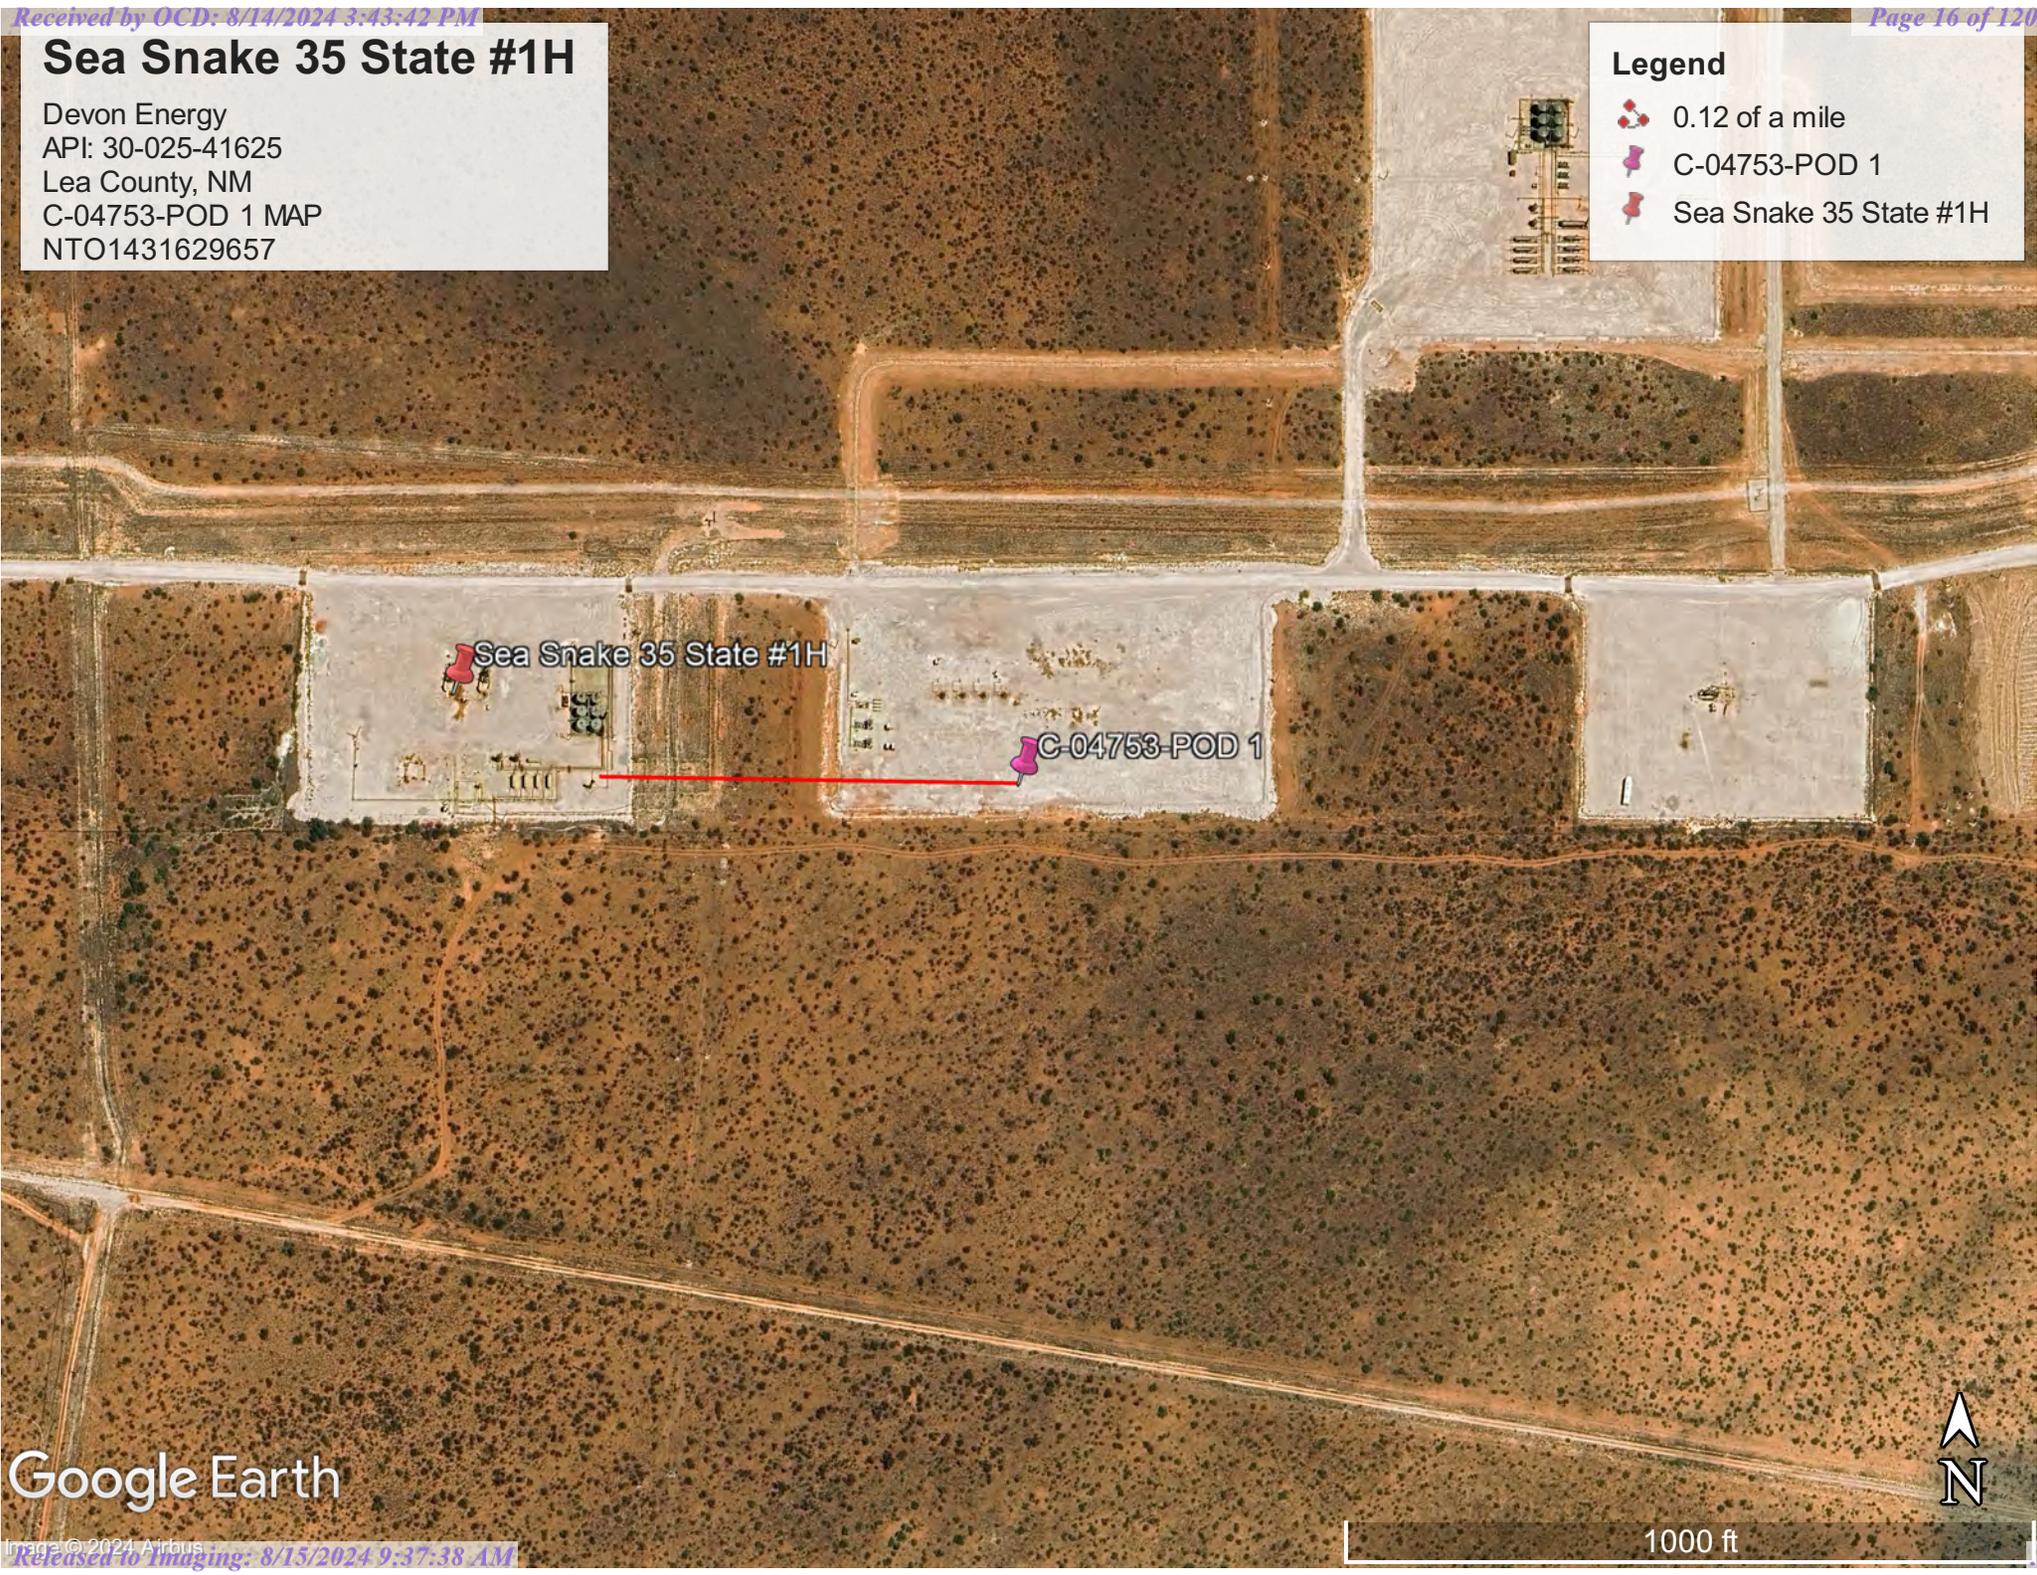
Devon Energy  
API: 30-025-41625  
Lea County, NM  
C-04753-POD 1 MAP  
NTO1431629657

Based on the well water data from the New Mexico Office of the State Engineer water well (C-04753-POD 1), the depth to the nearest groundwater in this vicinity measures 55 feet below grade surface (BGS), positioned 0.12 of a mile away from the Sea Snake. This well was drilled on July 27, 2023. Conversely, as per the United States Geological Survey well water data (USGS321312103395601), the nearest groundwater depth in this region is recorded at 34 feet BGS, situated approximately 7.13 miles away from the Sea Snake, with the last gauge conducted in 2006 (Appendix A).

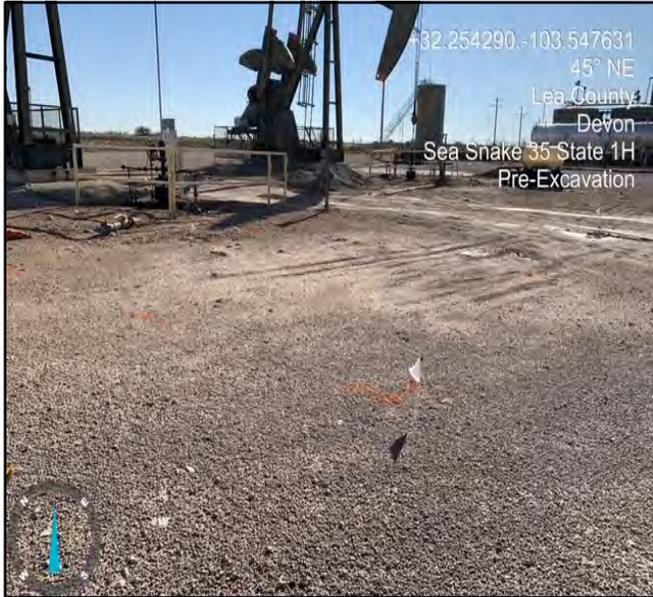
Photo taken prior to excavation, taken facing Northeast.

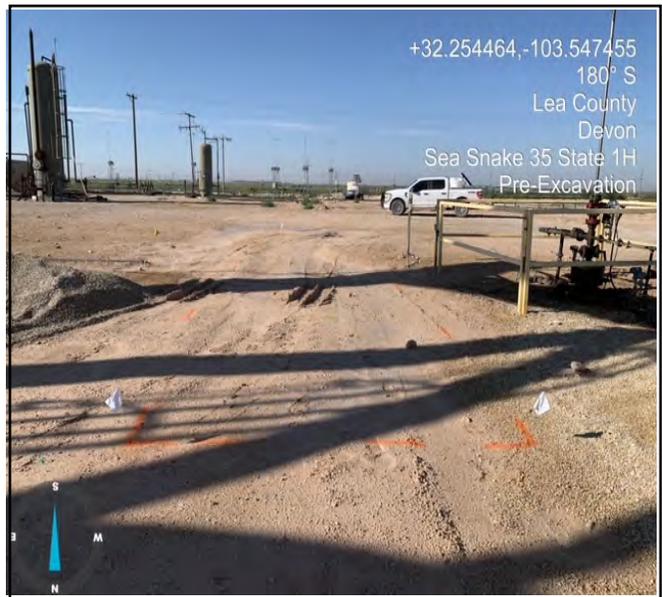
Photo taken prior to excavation, taken facing South.

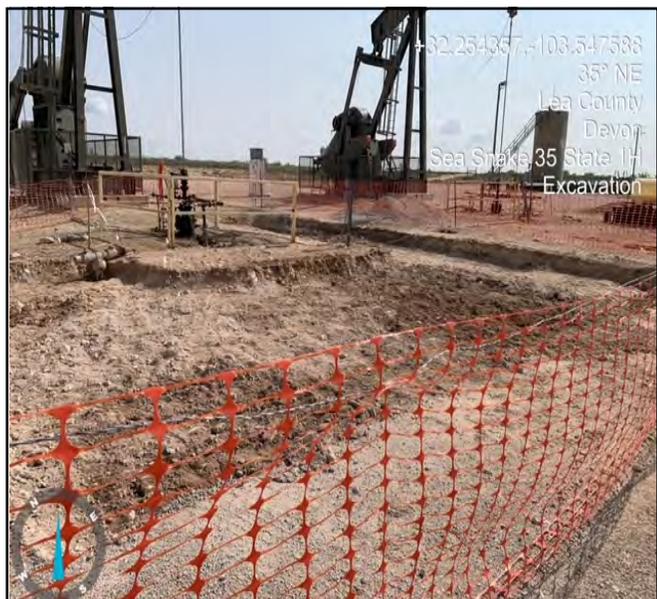
Photo taken during excavation, taken facing Northeast.

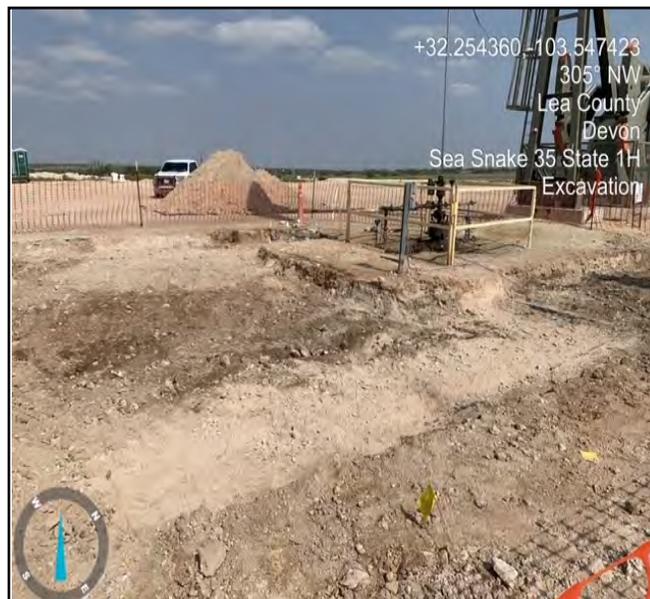
Photo taken during excavation, taken facing Northwest.

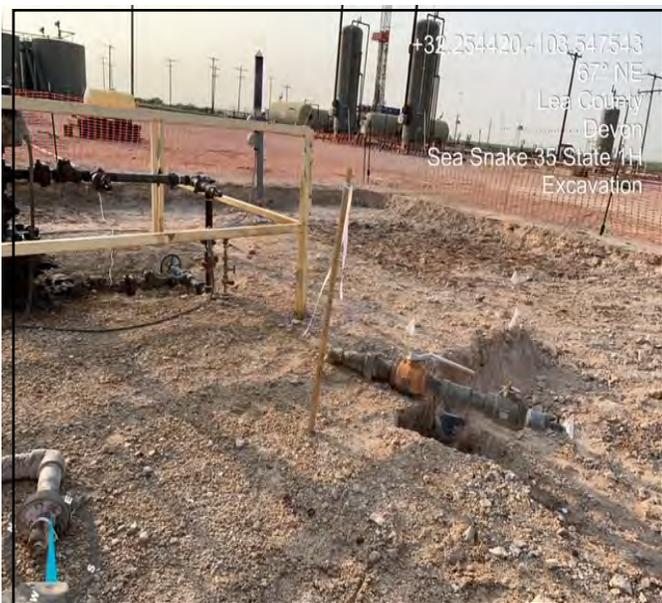
Photo taken during excavation, taken facing Northeast.

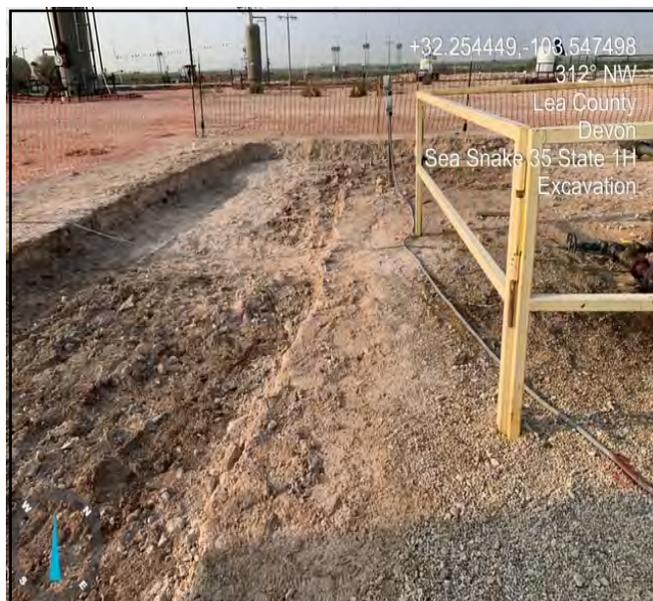
Photo taken during excavation, taken facing Northwest.

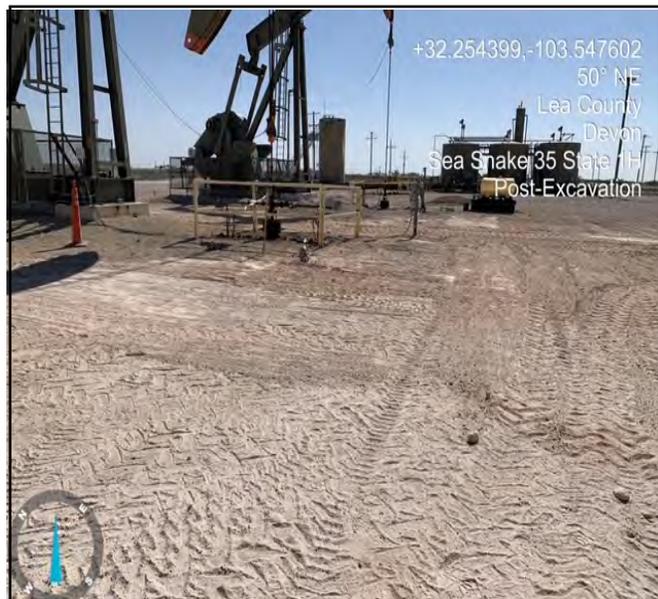
Photo taken pursuant to excavation, taken facing Northeast.

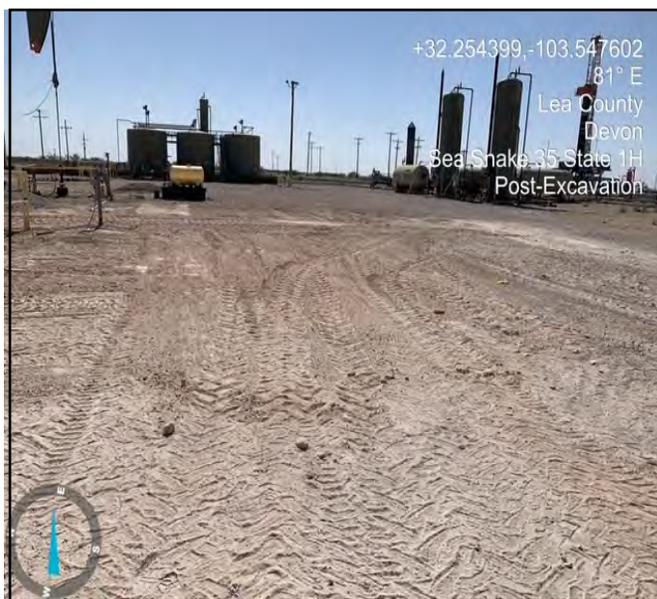
Photo taken pursuant to excavation, taken facing Northeast.

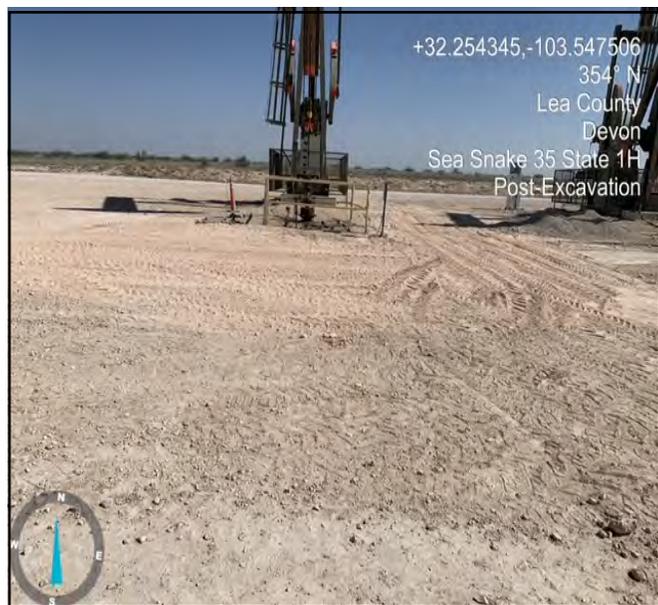
Photo taken pursuant to excavation, taken facing Northwest.

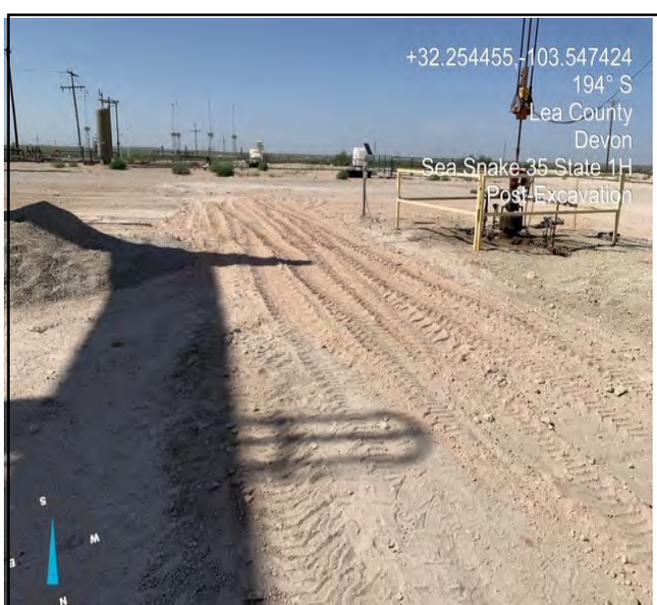
Photo taken pursuant to excavation, taken facing Southwest.
