BD P-4 EOL Remediation Summary & Closure Report

**NMOCD Incident No. nAPP2110241347
UL "P", Sec. 4, T22S, R37E
32.416894°, -103.161316°
Lea County, New Mexico**

BD P-4 EOL - nAPP2110241347
Remediation Summary and Closure Report

Re: Remediation Summary and Closure Report
BD P-4 EOL – BD SWD System
UL “P”, Section 4, Township 22 South, Range 37 East | Lea County, New Mexico
Rice Operating Company Project No. 1R426-06 | Tasman Project No. 2251

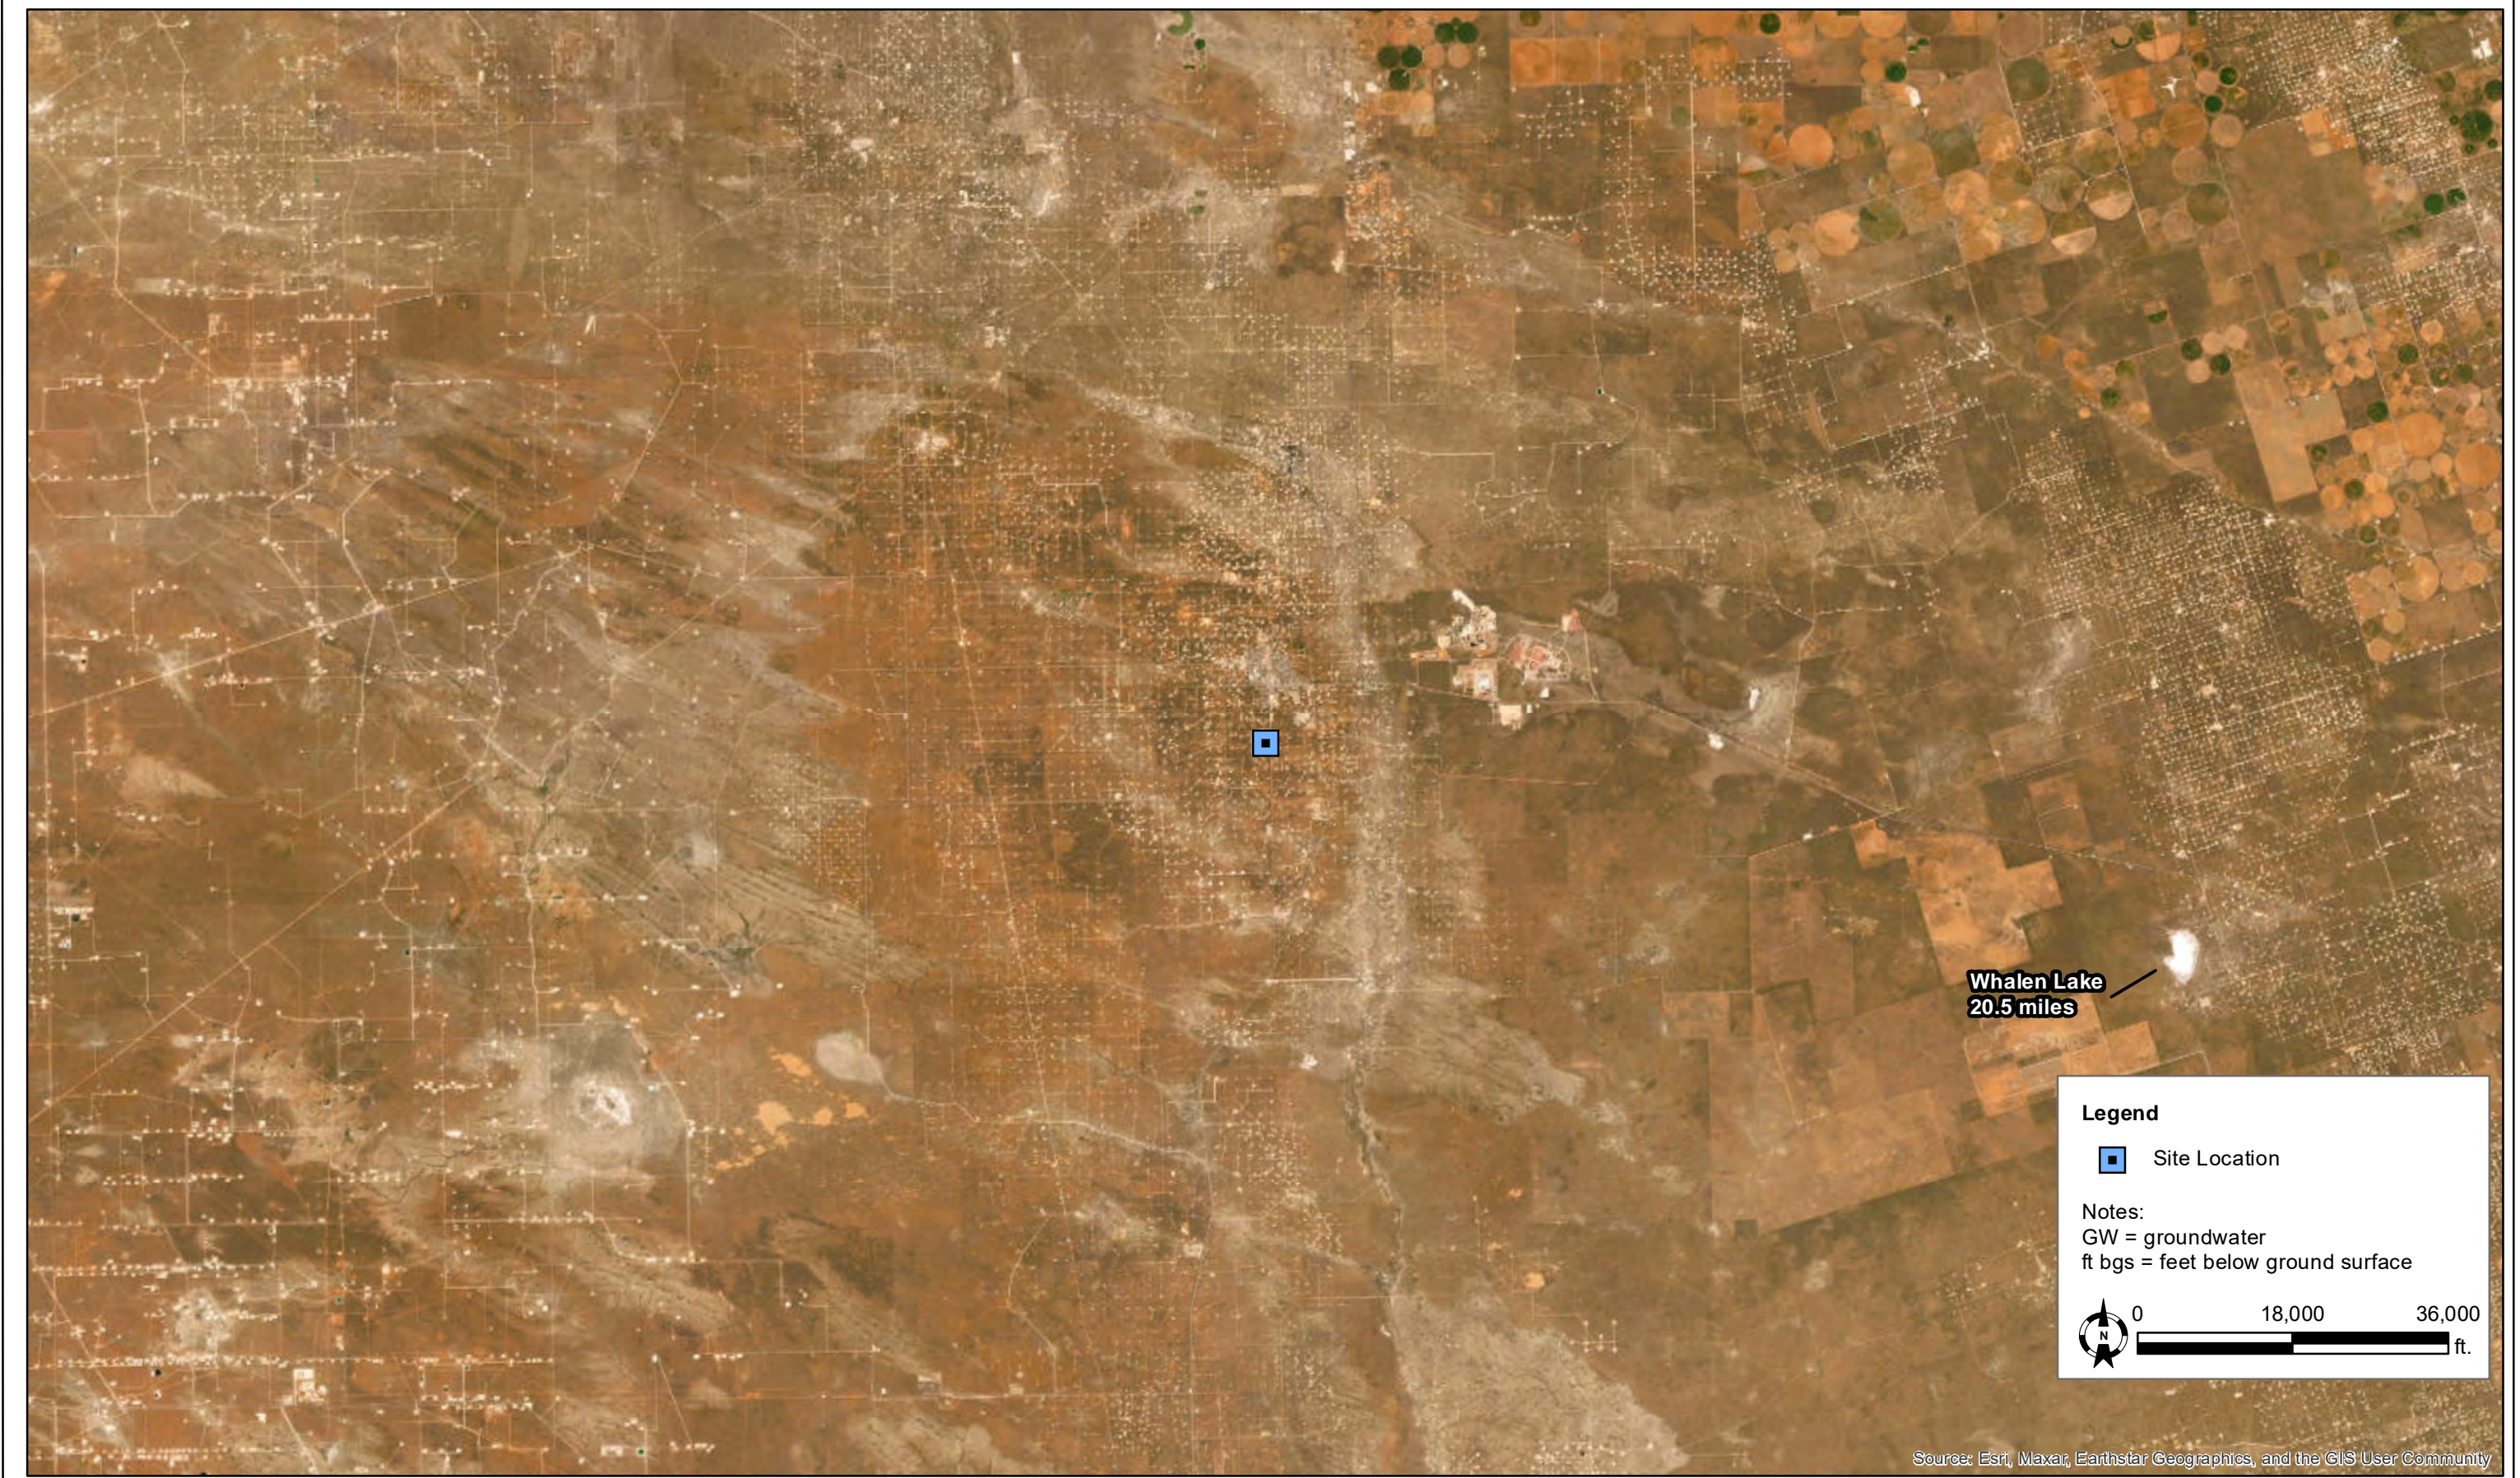
Figure
3

Surface Water Map

Tasman reviewed aerial imagery and the National Wetland Inventory Map, published by the U.S. Fish and Wildlife Service, for wetlands and surface water in the vicinity of the site. The nearest significant surface water was identified as Whalen Lake, located 20.5 miles from the site. One freshwater pond was identified 0.86 miles from the site. The location of the freshwater pond is illustrated on Figure 1 and Whalen Lake is illustrated on Figure 3.

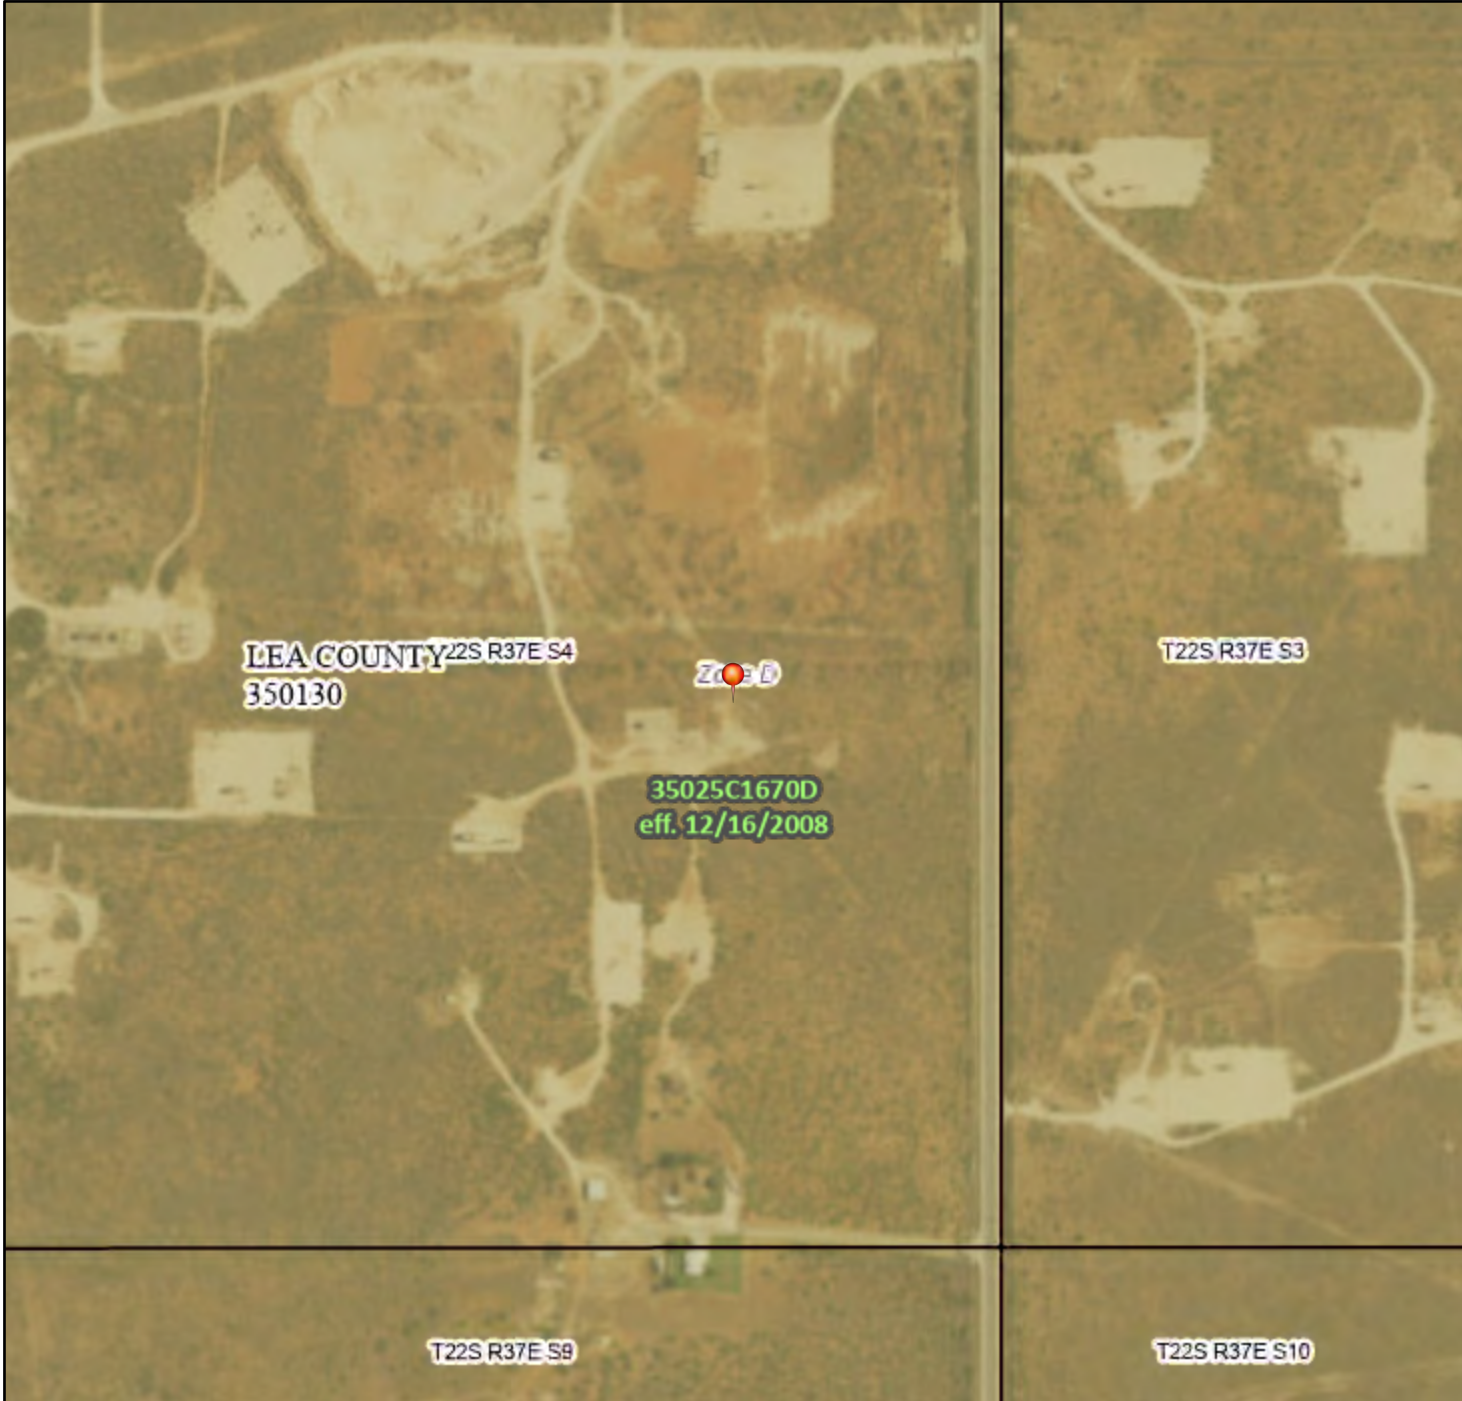
Figure 4

National Flood Hazard Layer FIRMette

Review of flood map data published by the Federal Emergency Management Agency (FEMA) indicates the site is not located within a 100-year floodplain. A copy of the FEMA FIRMette Map can be found attached as Figure 4.

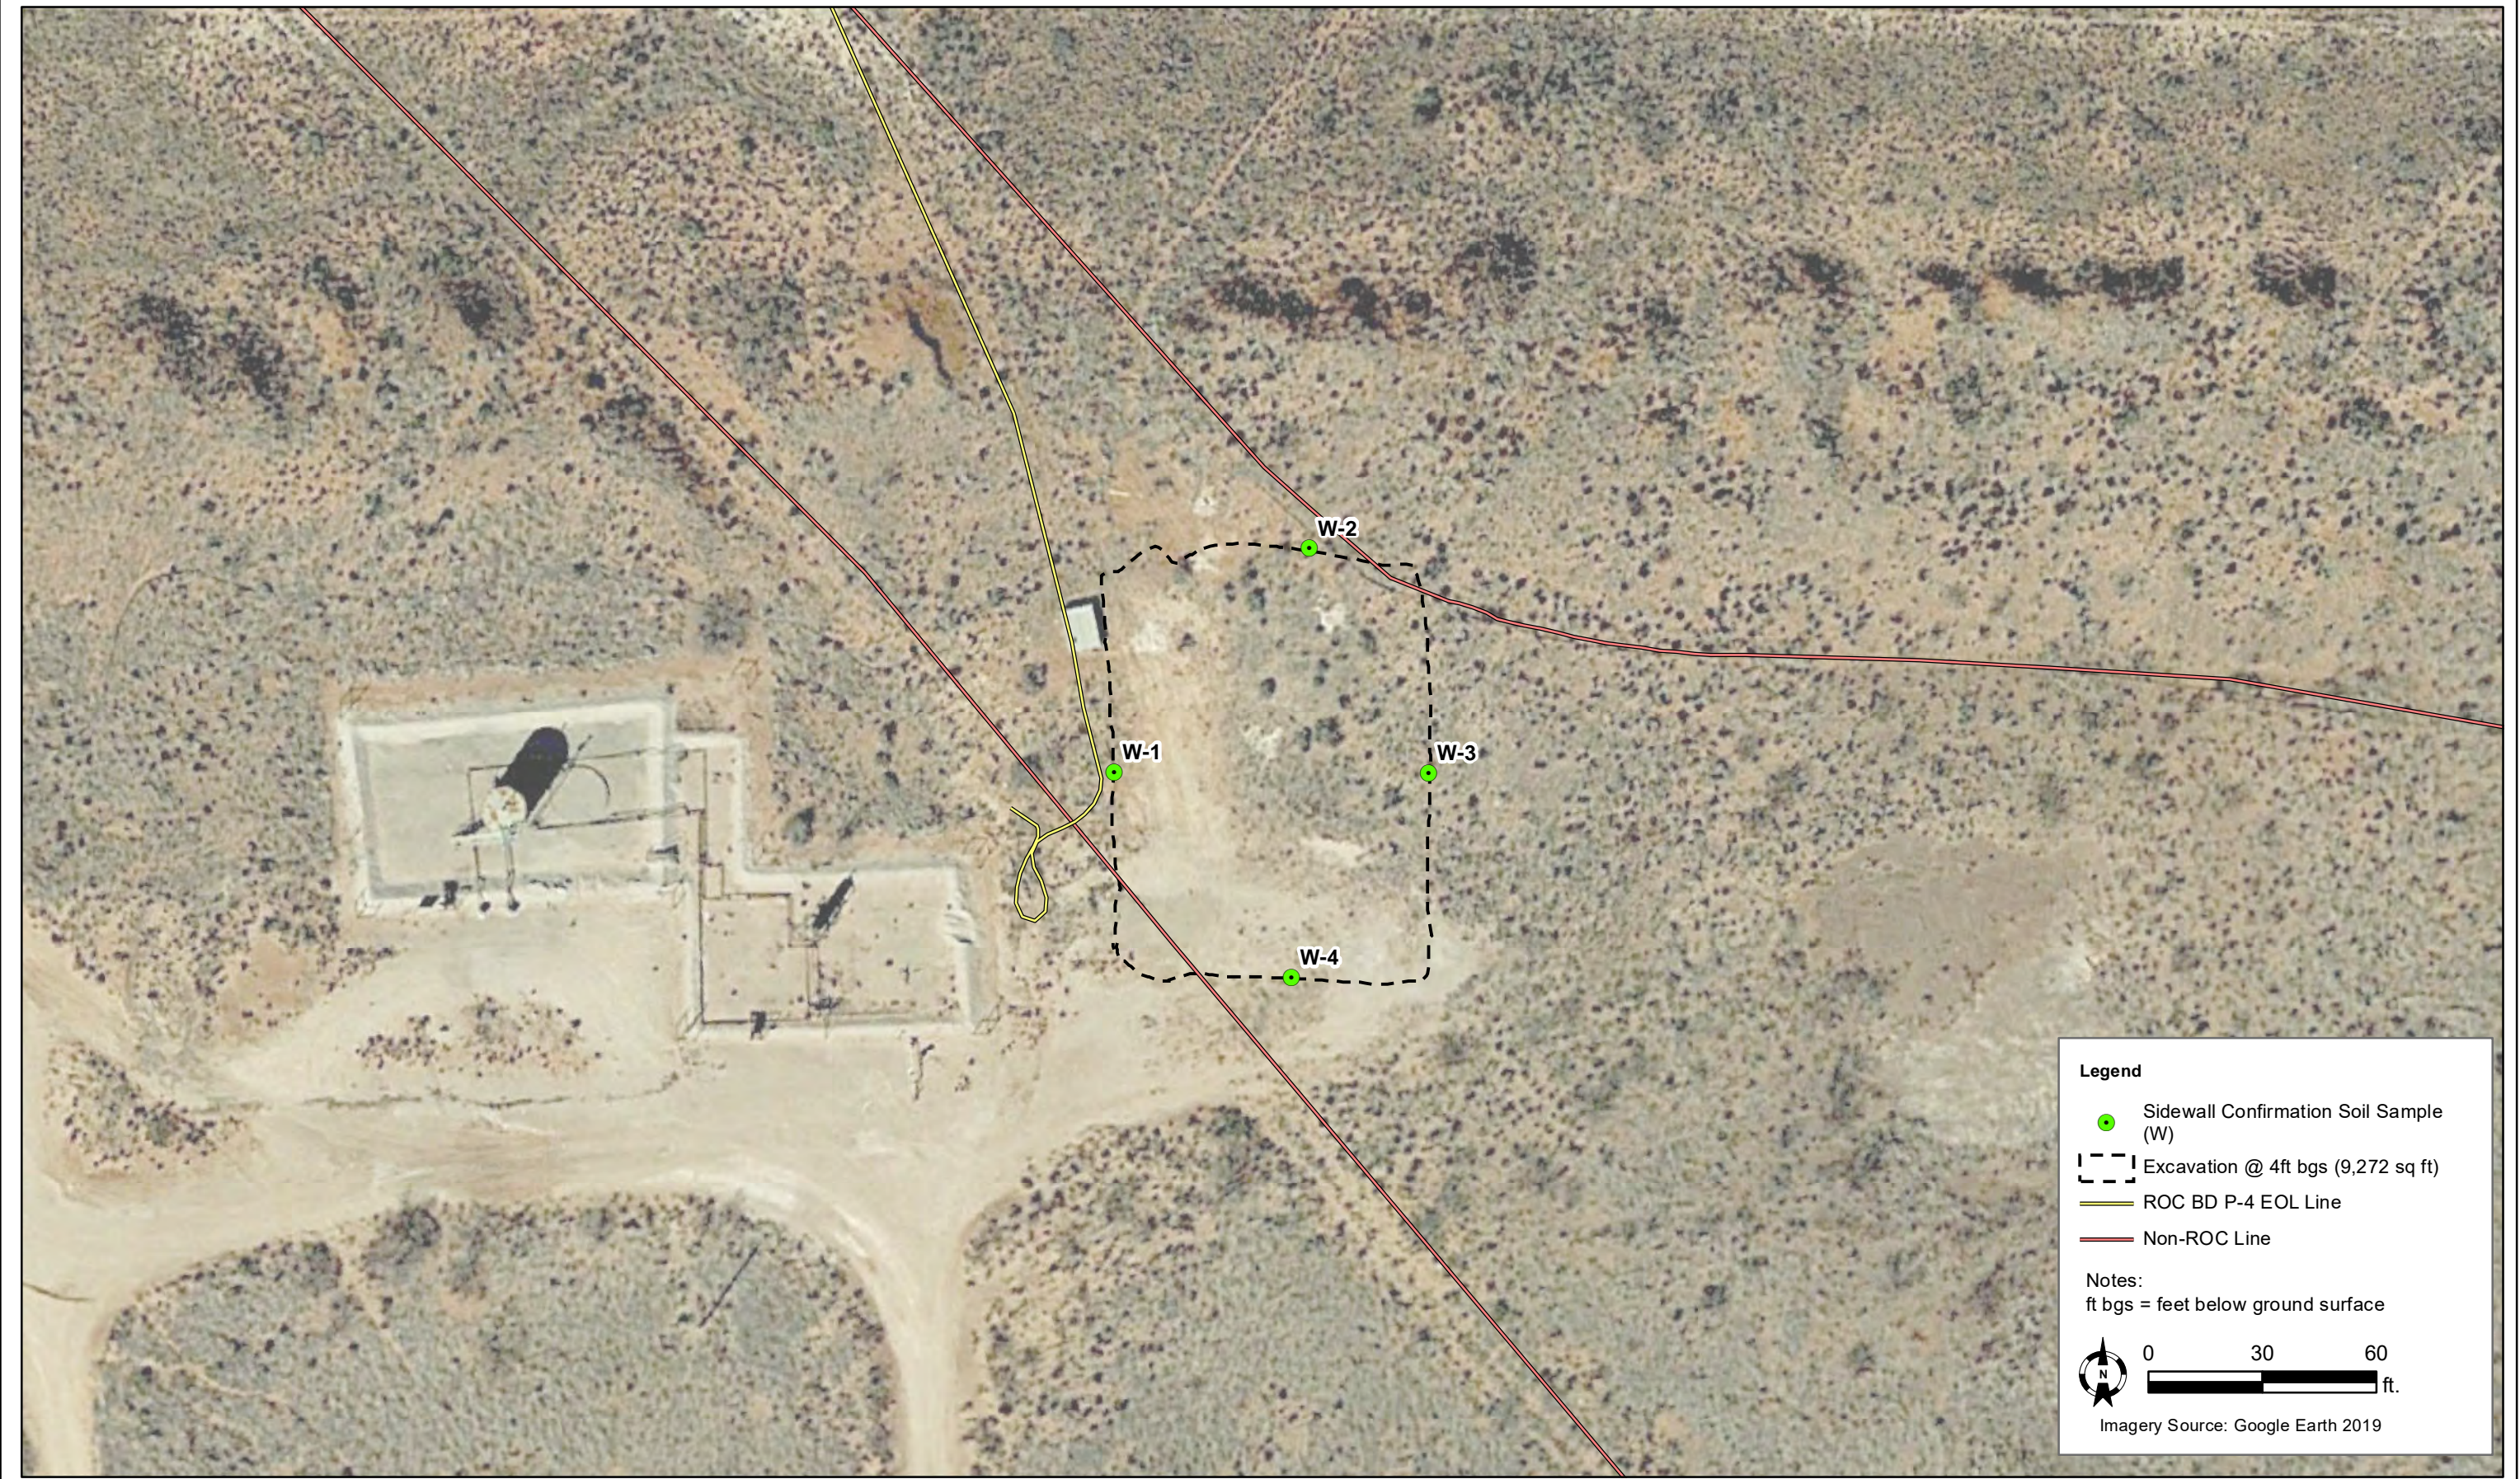
Figure
5

Excavation Overview Map

Due to the results of field testing and confirmation samples, the remedial final excavations measured approximately 93 ft long by 80 ft wide, at an approximate depth of 4 feet bgs. A total of 1,152 cubic yards of excavated material were exported to Sundance Services, Inc. landfill.
