**Re: Closure Request
Carrasco 14-1
Incident Numbers nRM2024742676 and nAPP2313656375
Eddy County, New Mexico**

Ensolum, LLC (Ensolum), on behalf of BTA Oil Producers, LLC (BTA), has prepared this *Closure Request* to document excavation and soil sampling activities performed at the Carrasco 14-1 (Site), in response to the denial of the original *Deferral Request*, dated August 1, 2023.

Based on soil sample laboratory analytical results, BTA is submitting this *Closure Request*, describing excavation activities that have occurred and requesting closure for Incident Numbers nRM2024742676 and nAPP2313656375.

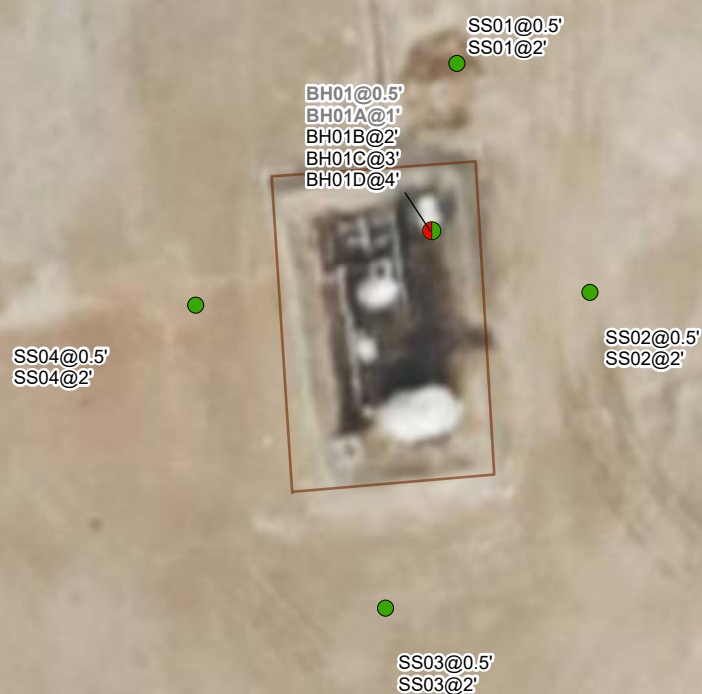
Notes:
 Sample ID @ Depth Below Ground/Surface.
 Samples in bold indicate sample exceeded applicable closure criteria.

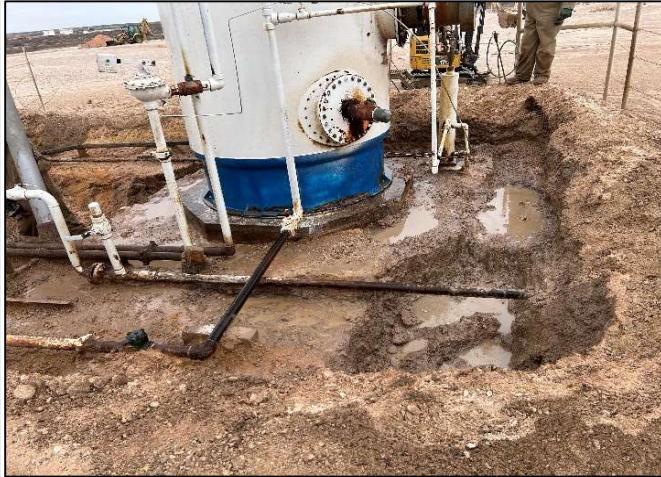
Photograph: 1
Description: Excavation activities
View: West

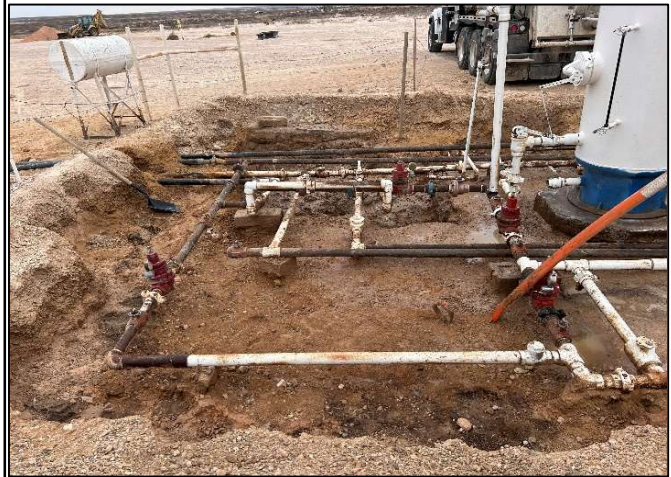
Photograph: 2
Description: Excavation activities
View: West

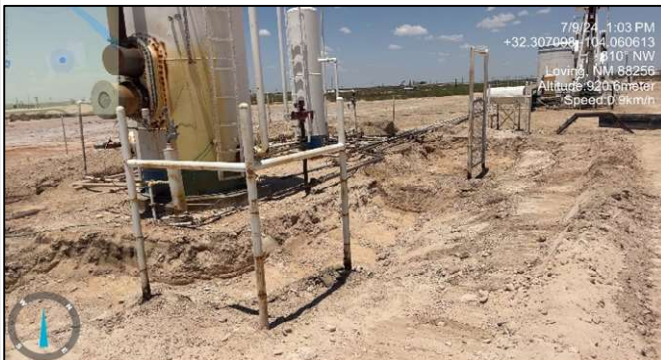
Photograph: 3
Description: Excavation activities
View: Northwest

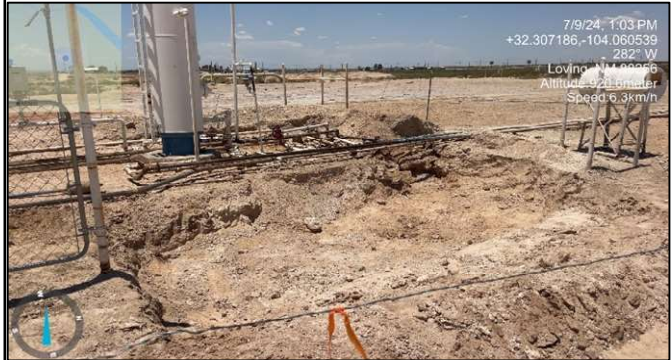
Photograph: 4
Description: Excavation activities
View: West

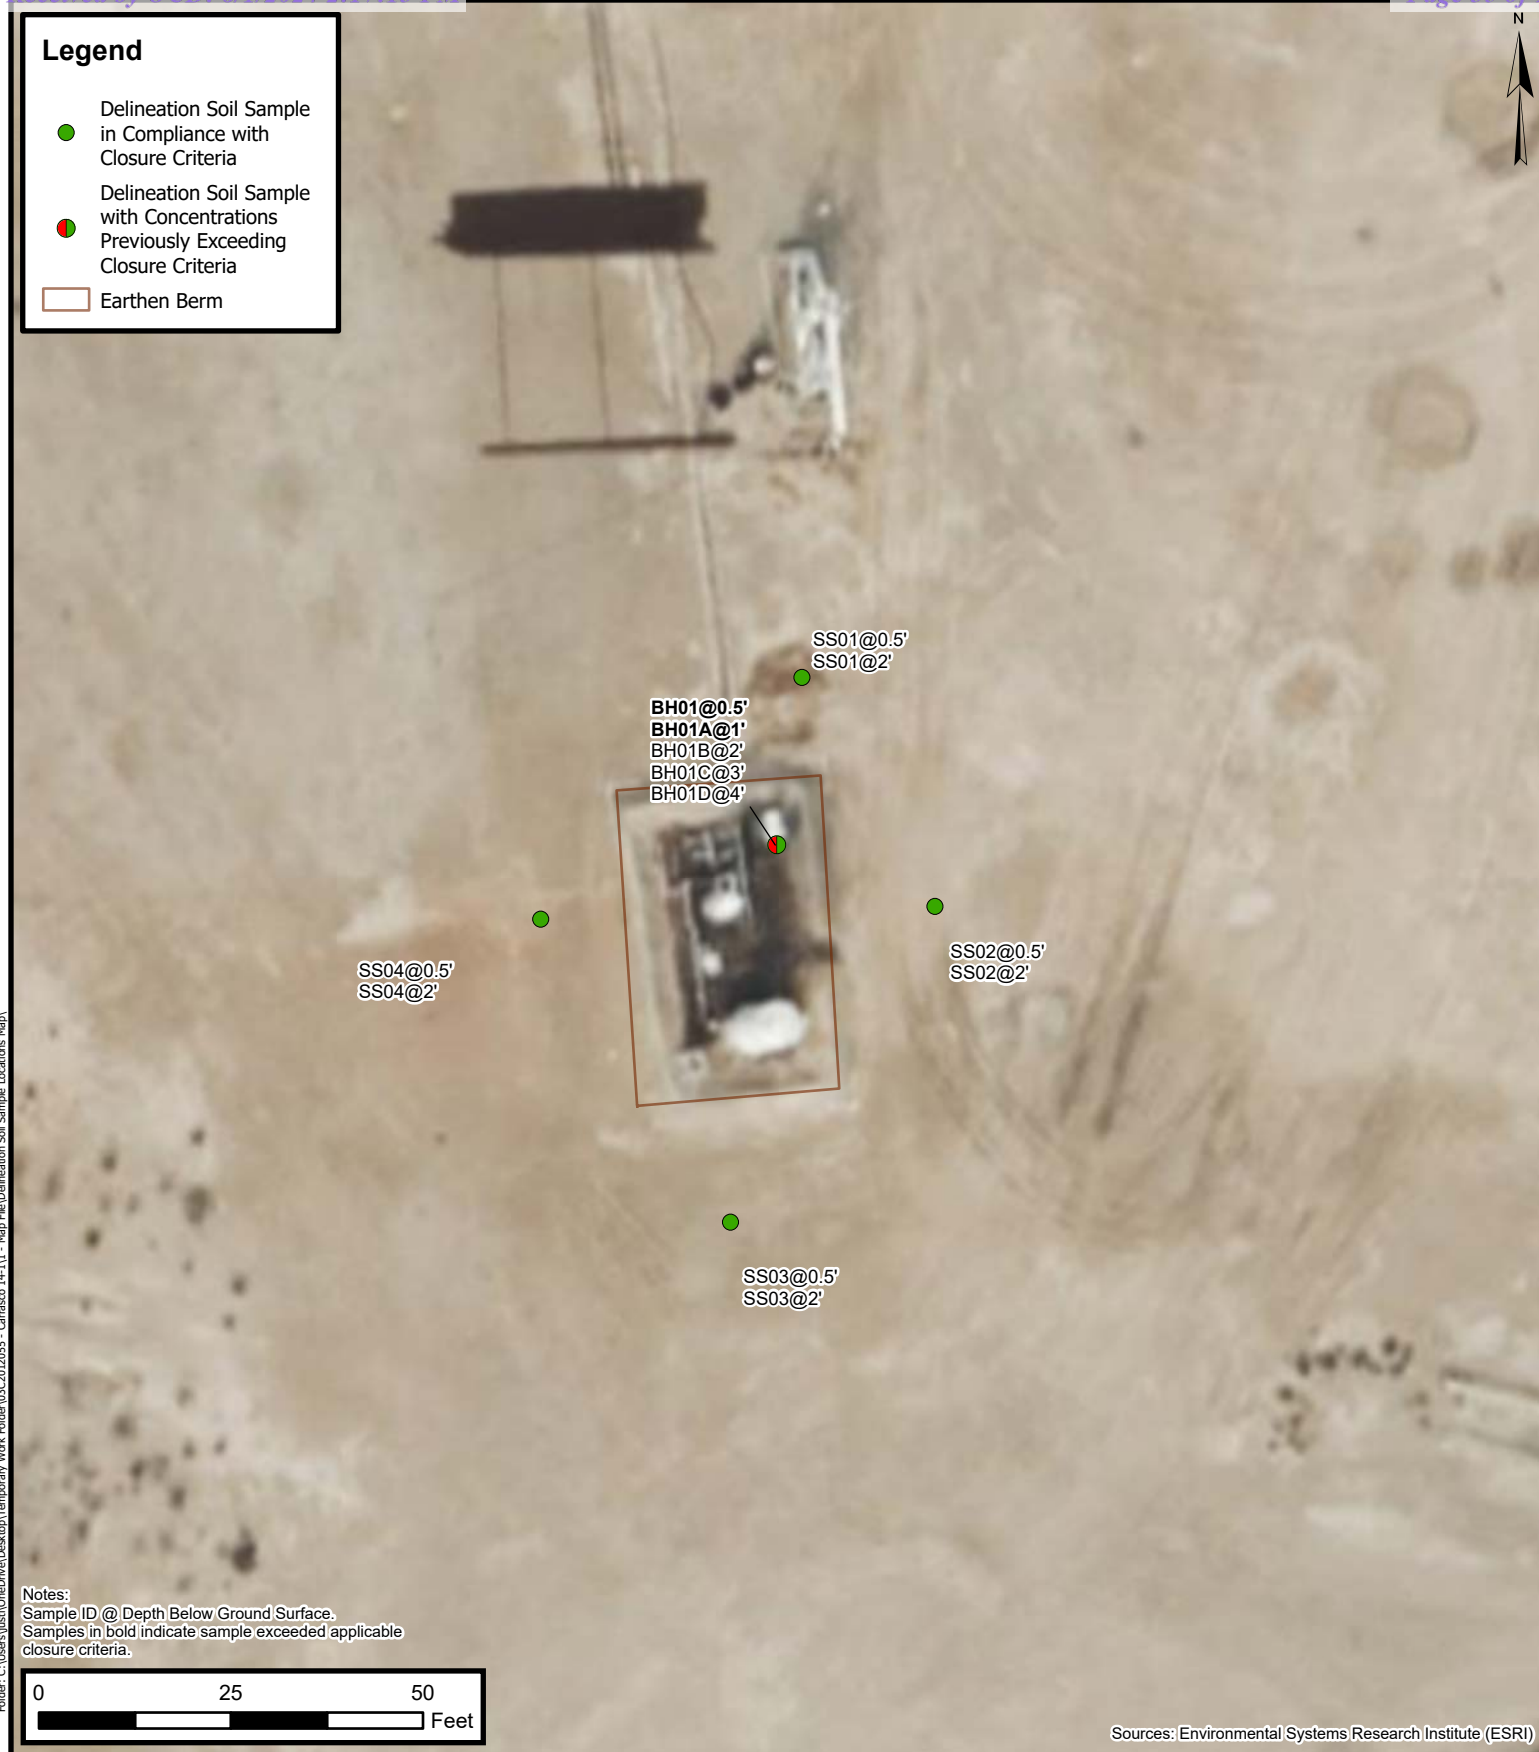
Delineation Soil Sample Locations

BTA Oil Producers
 Carrasco 14-1
 Incident Numbers: NRM2024742676 & nAPP2313656375
 Unit F, Sec 14, T23S, R28E
 Eddy County, New Mexico

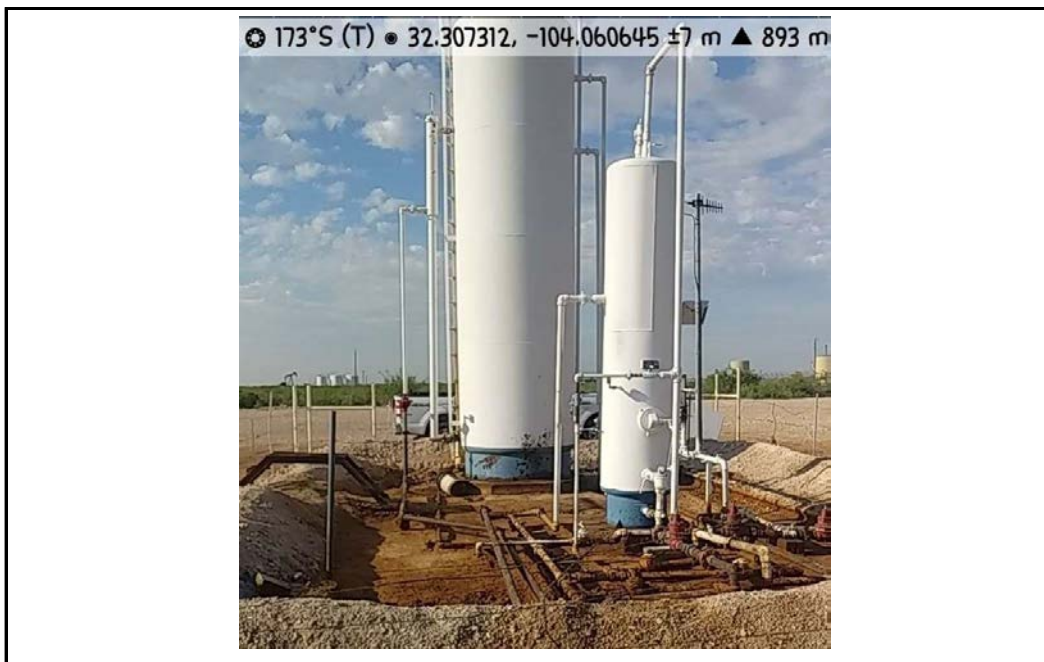
Photograph 1

Description: The earthen containment taken during delineation activities
