Re: Site Assessment, Remediation, and Closure Request

Skelly Unit #968 API No. N/A

NMOCD Ref. No. nAPP2106449127

Paragon Environmental, LLC (Paragon) has been contracted by Spur Energy Partners (Spur) to perform a spill assessment, conduct remediation activities for the release site known as the Skelly Unit #968 (Skelly). Details of the release are summarized below:

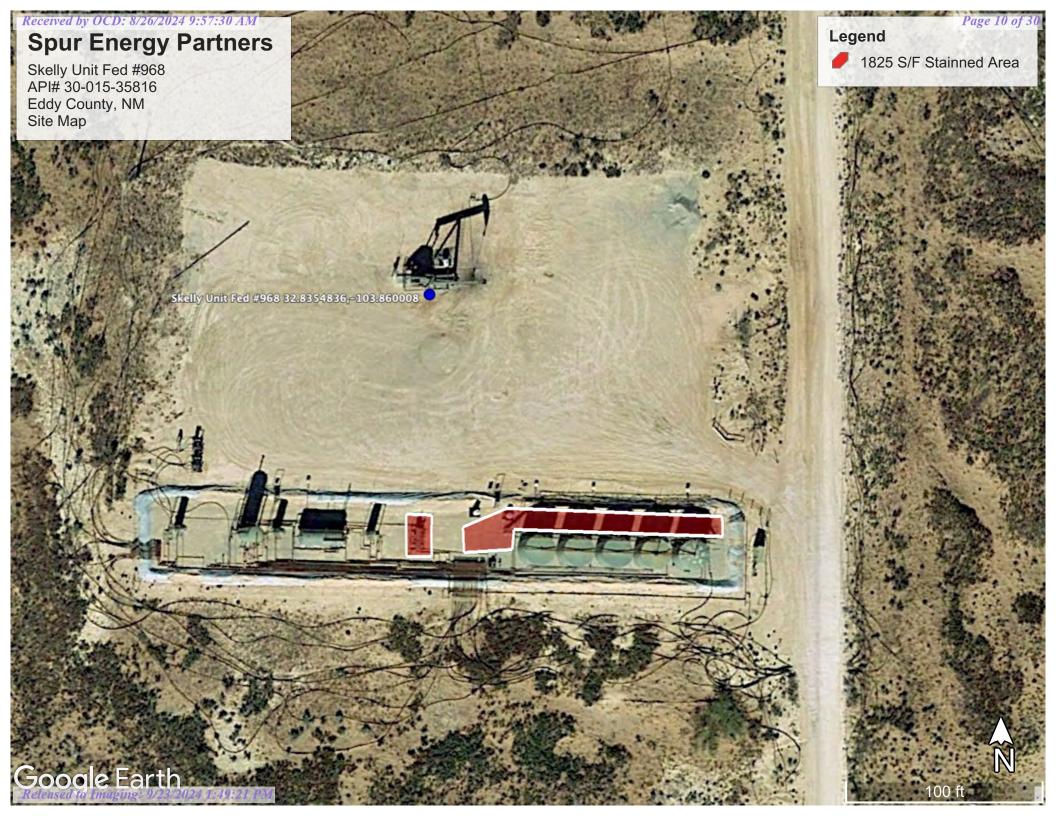
A Site Map is provided in Figure #1.

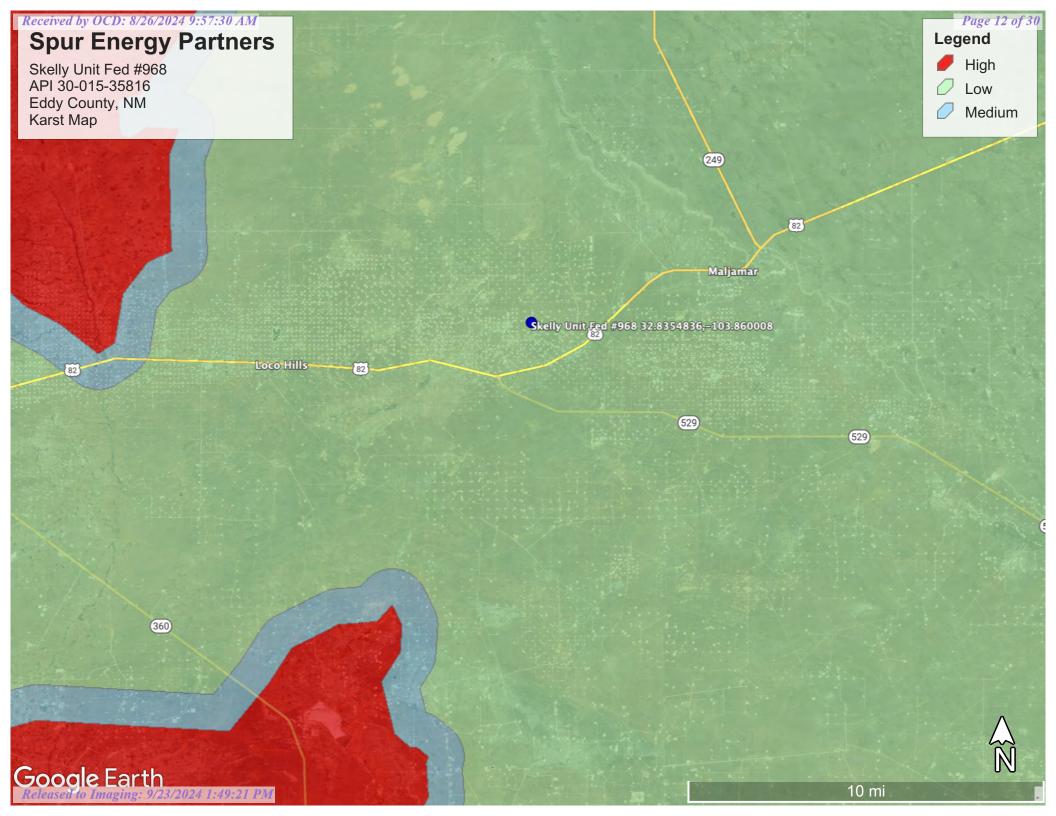
Per the New Mexico Bureau of Geology and Mineral Resources, the geology is in the Eolian and piedmont deposits (Holocene to middle Pleistocene)—Interlayed eolian sands and piedmont-slope deposits along the eastern flank of the Pecos River valley, primarily between Roswell and Carlsbad. Typically capped by thin eolian deposits (QEP). The soil in this area is made up of Kermit-Berino Fine Sands, with 0 to 3 percent slopes, according to the United States Department of Agriculture Natural Resources Conservation Service. The drainage courses in this area are excessively-drained. There is NOT a high potential for karst geology to be present around the Skelly (Figure #3).

The Soil Survey and FEMA Flood Map are provided in Appendix B. A Karst Map is provided in Figure #3.

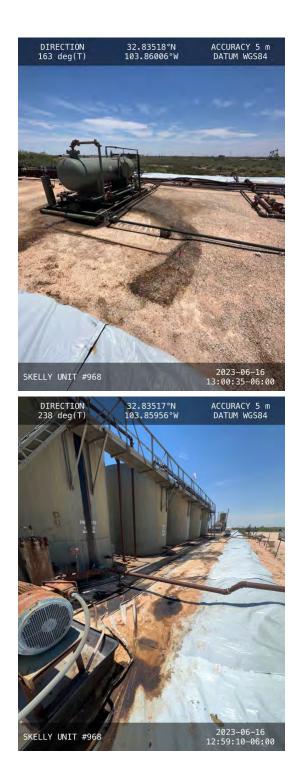
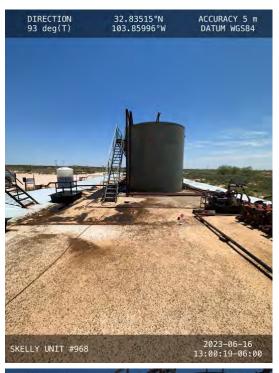
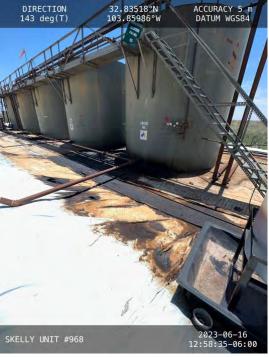
Before Remediation

The water tank overflowed causing a spill into the lined containment.

On June 16, 2023, Paragon conducted a site visit to evaluate the site. Upon arrival, we found that it was a poly-lined with soil on top containment. There was no evidence that any fluids had breached the containment, therefore no samples were taken.

- We utilized a hand crew and bobcat to remove all the contaminated dirt out of the containment and onto a temporary liner.
- The area measured approximately 1,825 S/F, and we removed app. 50 C/Y of material.
- Once the dirt was removed, we hauled all of it off to Lea Land.
- The liner was then cleaned in preparation for the liner inspection.
- A liner inspection was scheduled and conducted to ensure the liner was intact. The liner inspection report is included in Appendix C.

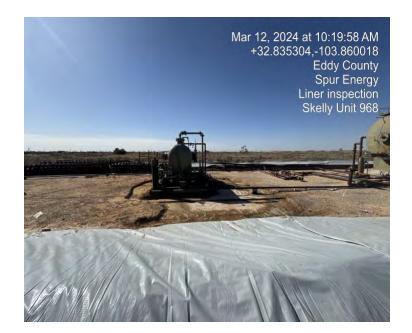
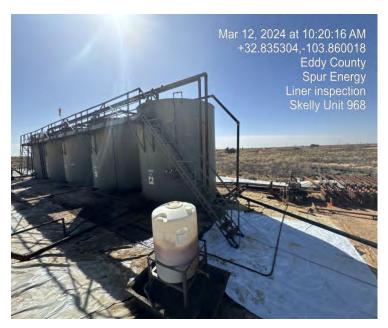
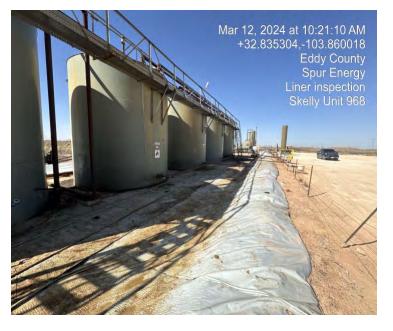
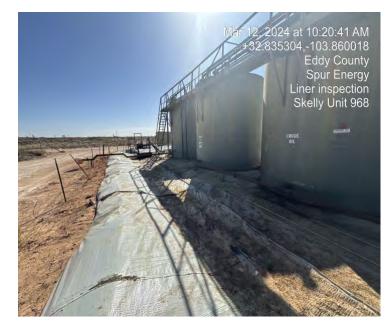
Post Remediation & Liner Inspection

Visualization	Yes	No	Comments
Is there a tear in the liner?		X	
Are there holes in the liner?		X	
Is the liner retaining any fluids?		X	
Does the liner have integrity to contain a leak?	X
