Closure Report
Superfortress 29 Federal 003H (05.21.24)
Incident #: NAPP2416338856
Eddy County, New Mexico
Unit C Sec 29 T19S R31E
32.6379°, -103.8931°

Crude Oil Release
Point of Release: Pressure Loss
Release Date: 05/21/2024
Volume Released: 8.9185 barrels of Crude Oil
Volume Recovered: 8 barrels of Crude Oil

**Re: Closure Report
Superfortress 29 Federal 003H (05.21.24)
Concho Operating, LLC
Site Location: Unit C, S29, T19S, R31E
(Lat 32.6379°, Long -103.8931°)
Eddy County, New Mexico**

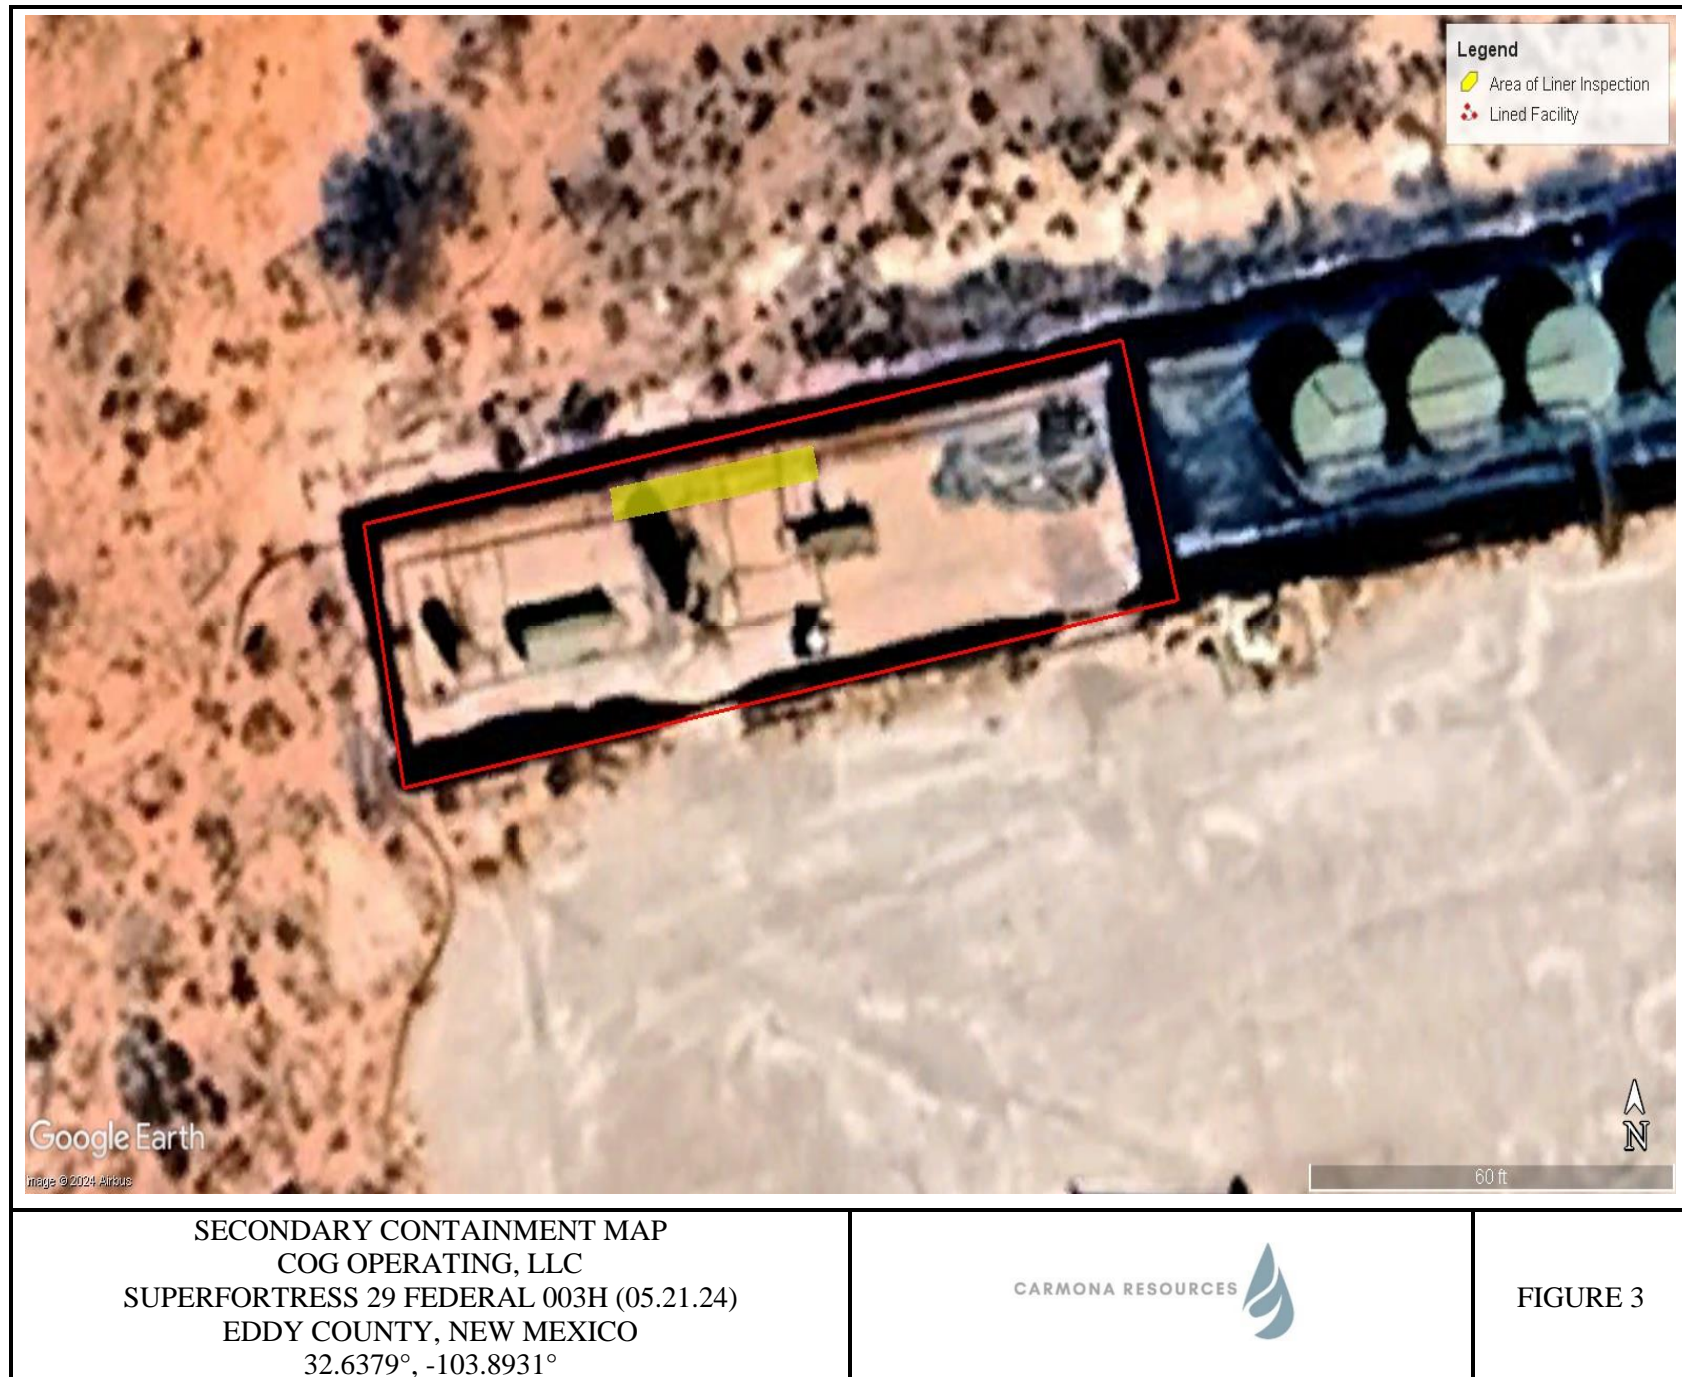
Based on the initial C-141 obtained from the New Mexico Oil Conservation Division (NMOCD), the release was discovered on May, 2024, caused by a pressure loss on equipment. It resulted in the release of approximately eight point nine one eight five (8.9185) barrels of crude oil, and eight (8) barrels of crude oil was recovered inside the lined facility. See Figure 3. The initial C-141 form is attached in Appendix B.

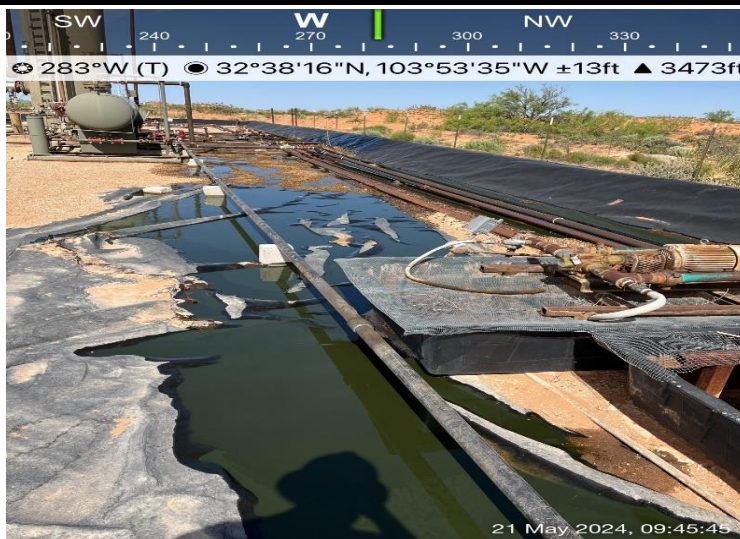
Photograph No. 1

View West of the intact liner after the release.

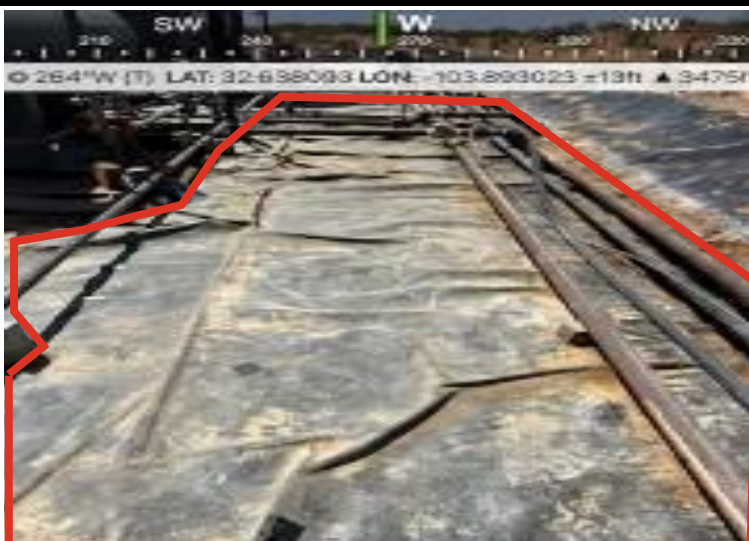
Photograph No. 2

View West of the intact liner after the pea gravel has been removed. Red outline is the area of the liner inspection.

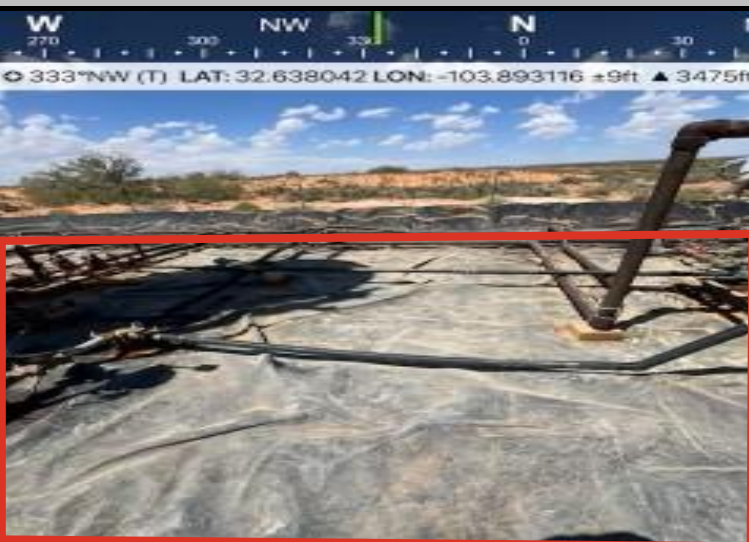
Photograph No. 3

NMAC. See Appendix B. Carmona Resources, LLC personnel inspected the liner visually and determined it to be intact with no integrity issues. Refer to the photolog.

View Northwest of the intact liner after the pea gravel has been removed. Red outline is the area of the liner inspection.
