**Re: Closure Request**  
**PLU 21 Brushy Draw West CTB**  
**Incident Number NAPP2415552477**  
**Eddy County, New Mexico**

Ensolum, LLC (Ensolum) on behalf of XTO Energy, Inc. (XTO), has prepared this *Closure Request* to document site assessment and soil sampling activities performed at the PLU 21 Brushy Draw West CTB (Site). The purpose of the site assessment and soil sampling activities was to assess for the presence or absence of impacts to soil resulting from a rental trash trailer/porta-potty combo catching fire at the Site. Based on field observations, field screening activities, and soil sample laboratory analytical results, XTO is submitting this *Closure Request*, describing soil sampling activities that have occurred and requesting no further action for Incident Number NAPP2415552477.

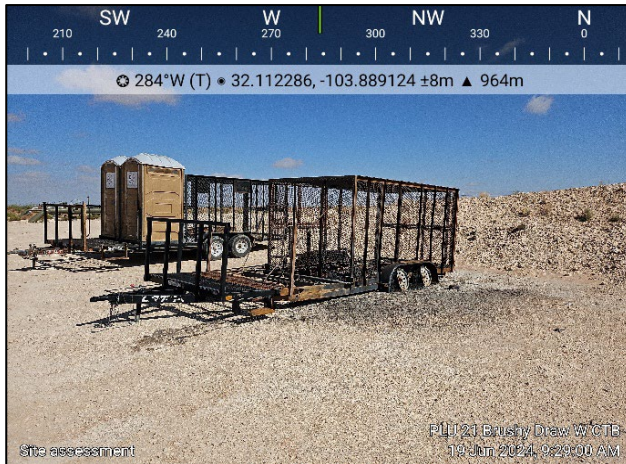
Photograph: 1 Date: 06/19/2024  
Description: Surface charring in area of concern  
View: West

The charred surface area resulting from the fire was scraped using a backhoe. Following the surface scraping, Ensolum personnel collected 5-point composite soil samples representing no more than 200

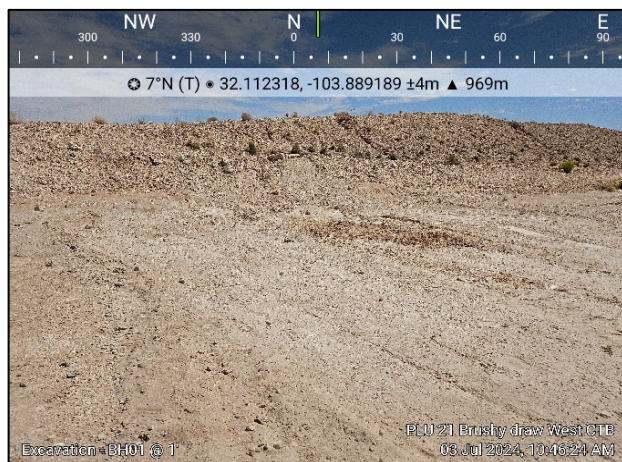
Photograph: 3 Date: 07/03/2024  
Description: Final surface scrape  
View: North

The final surface scrape area was approximately 560 square feet. A total of approximately 10 cubic yards of soil was removed during the surface scraping activities. The soil was transported and properly disposed of at the OWL Landfill Services, LLC disposal facility located in Jal, New Mexico.

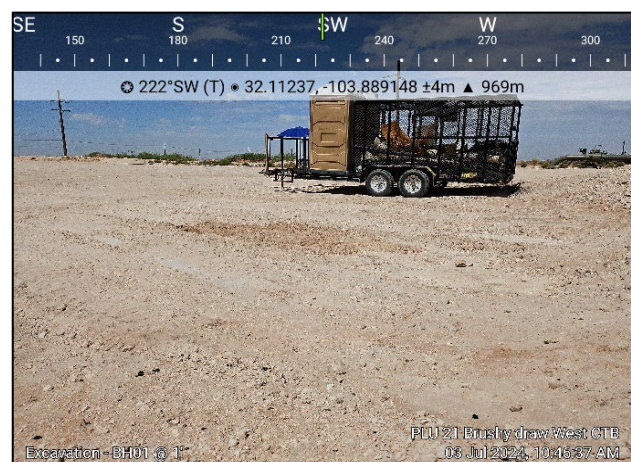
Photograph: 4 Date: 07/03/2024  
Description: Final surface scrape  
View: Southwest
