Republic Backhoe Service, LLC

February 12, 2019

Subject: Site Assessment/Soil Remediation Work Plan for the Saragossa 10 State #3, Eddy County, New Mexico.

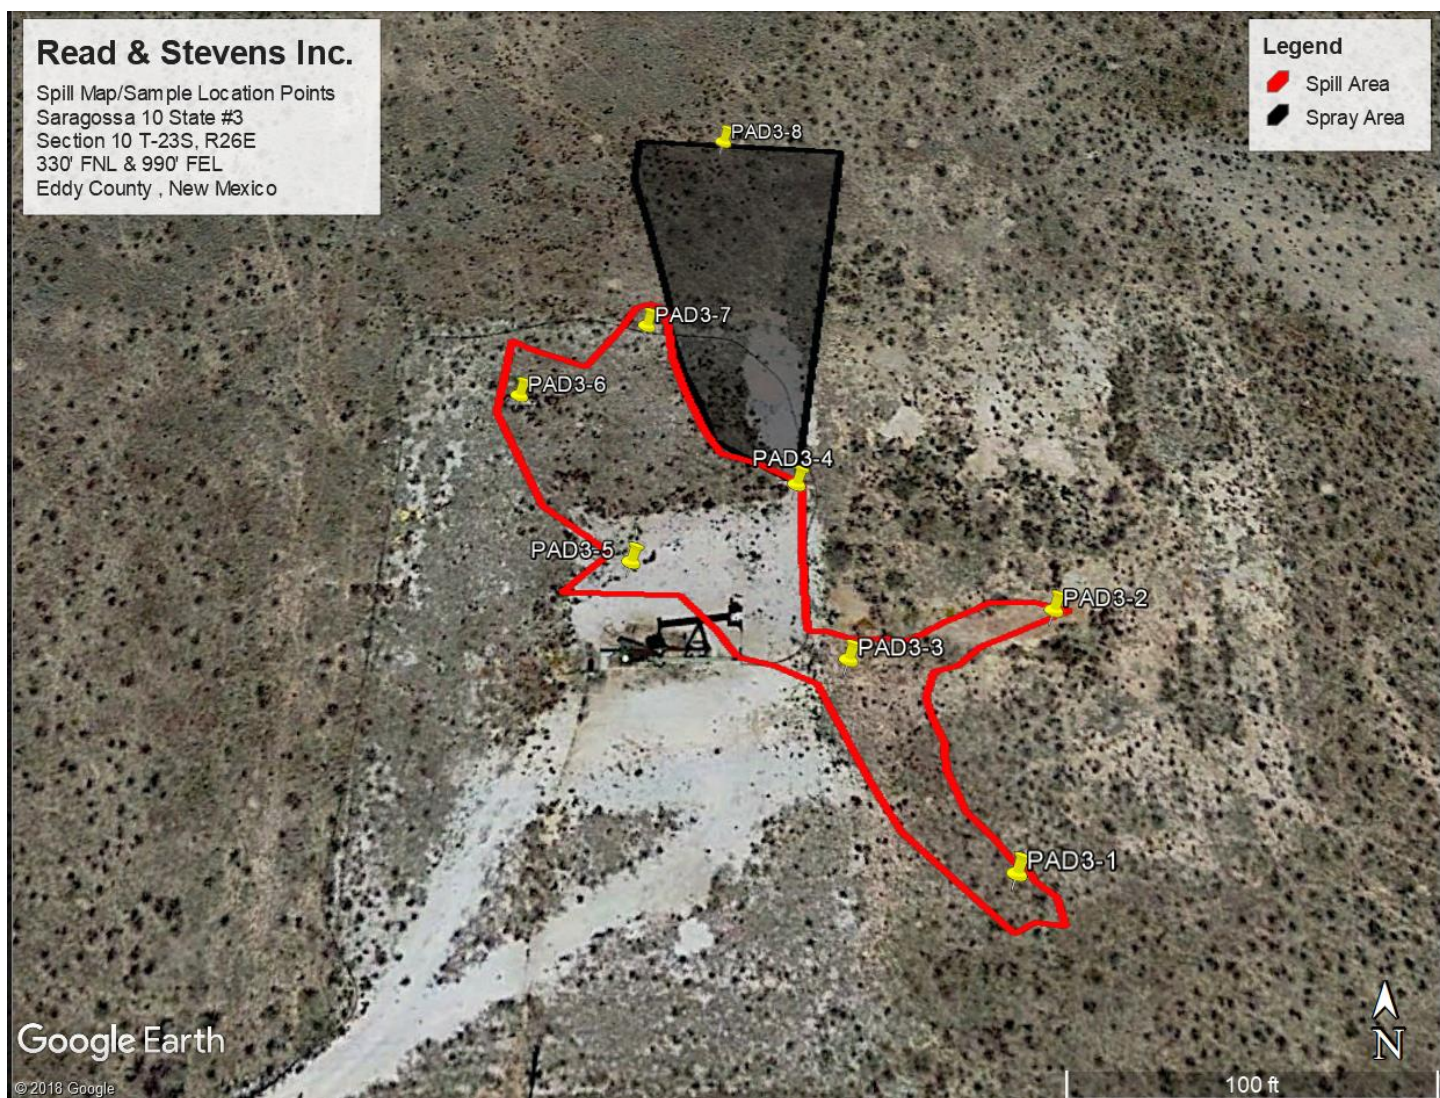
Attachment 2
Spill Map/Sample Location Points

On November 16, 2018, RBS went to the location to delineate the site. According to the Spill Calculations (See Attachment 10) 100% of the release stayed on the well pad (Attachment 11 Spill Calculation Map). The release poses no threat to ground water as laboratory results concluded that no TPH/Chloride concentrations were found at 2' (bgs). Furthermore, soil samples collected and analyzed at 5' (bgs) show constituents level significantly lower than NMOCD permissible levels. A backhoe was used to dig a total of 8 trenches at the site (See Attachment #2). Samples were collected at surface, 2 feet (bgs), and 5 feet (bgs). The following table summarizes the laboratory analytical results from the soil samples collected during the site assessment: Table 4 below.
