**Re: Reclamation Report
Mesa 8105 JVP #3H Produced Water Line
Incident Number NRM2016045357
Lea County, New Mexico**

Ensolum, LLC (Ensolum), on behalf of BTA Oil Producers, LLC (BTA), has prepared the following *Reclamation Report* for the Mesa 8105 JVP #3H Produced Water Line (Site). This *Reclamation Report* documents the Site history, reclamation activities completed to date and proposes a vegetation monitoring plan.

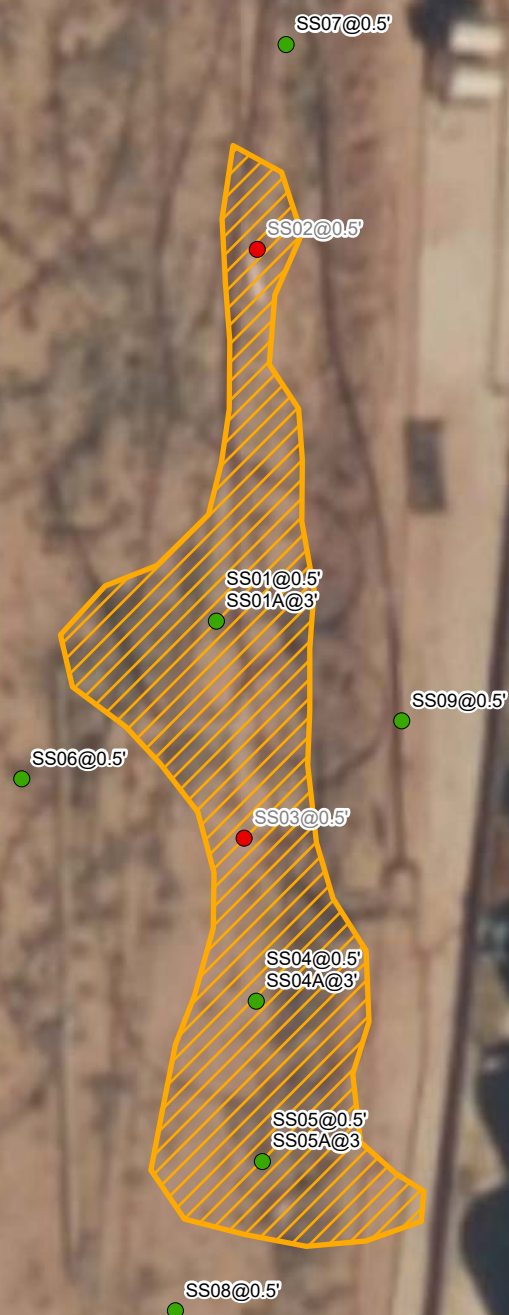
FIGURE
1

- Delineation Soil Sample in Compliance with Closure Criteria
- Delineation Soil Sample with Concentrations Exceeding Closure Criteria
- Release Extent

Sample ID @ Depth Below Ground Surface.
 Samples in bold indicate sample exceeded applicable closure criteria.
 Grey text indicate soil sample was removed during excavation activities.

activities, the disturbed area was graded and contoured to match the surrounding topography. The excavation extent and reclamation area are shown on the attached Figure 1.

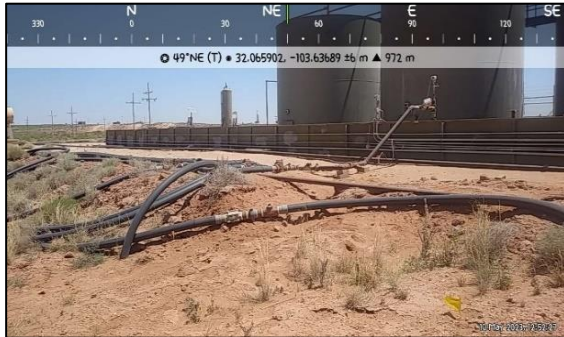
Photograph: 1 Date: 5/10/2023
Description: Historical release area
View: Northeast

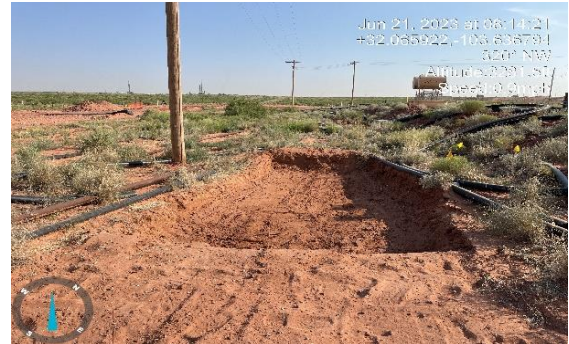
Photograph: 2 Date: 6/21/2023
Description: Completed excavation
View: Northwest

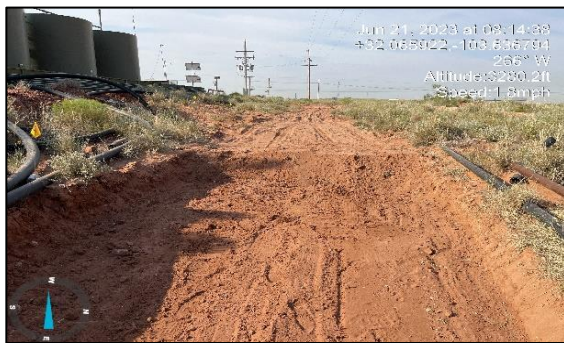
Photograph: 3 Date: 6/21/2023
Description: Completed excavation
View: West

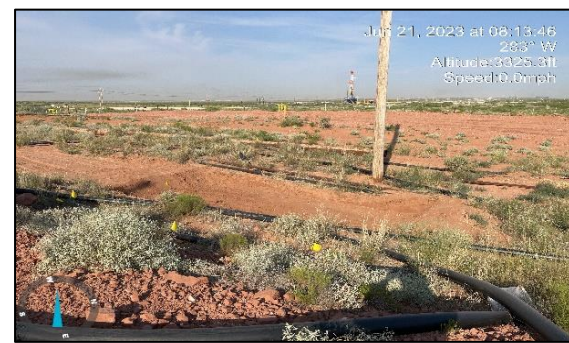
Photograph: 4 Date: 6/21/2023
Description: Completed excavation
View: West

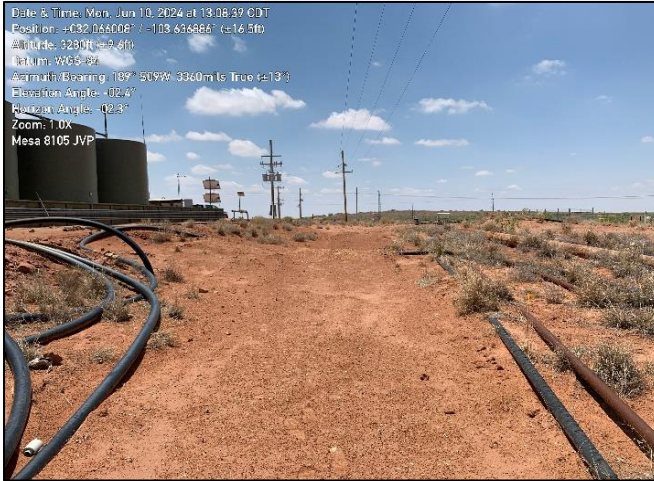
Photograph: 1
Description: Reclaimed area
View: Southwest

Upon completion of excavation activities and receipt of final laboratory analytical results, the excavation was backfilled, and the disturbed area was restored to its original condition. The excavation was backfilled with locally procured topsoil, consistent with the surrounding native soil type. Following backfill

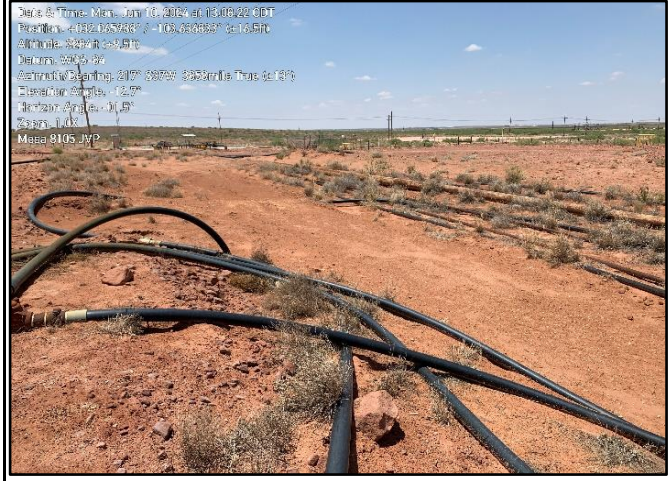
Photograph: 2
Description: Reclaimed area
View: Southwest

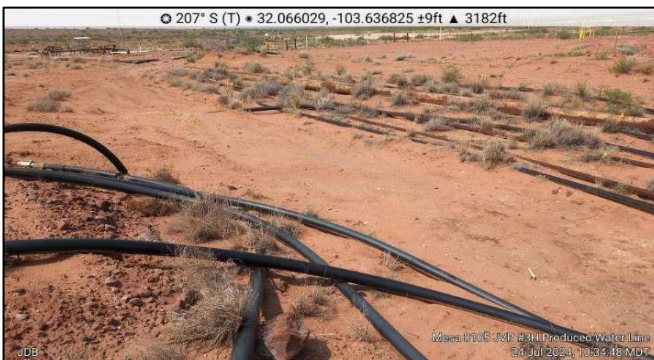
Photograph: 3
Description: Reseeded area
View: South

The disturbed pasture area was seeded with the BLM seed mix #1 for loamy sites at the rate specified in pounds of pure live seed (PLS) per acre.

The seed mix was doubled and distributed with a broadcast seed spreader and harrowed in. Photographs of the backfilled excavation and

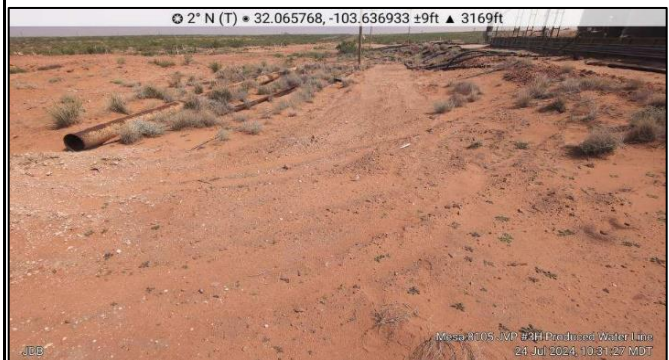
Photograph: 4
Description: Reseeded area
View: North
