Remediation Report and Closure Request
Davidson 1A
Section: 22 Township: 28N Range: 10W
Lat: 36.647000 Long: -107.889979
San Juan County, New Mexico

Harvest discovered a leak on the Davidson 1A pipeline at 8:30am. The pipeline was shut in and blown down at 8:45am terminating the release. The release was discovered to be in a dry wash/runoff area classifying this release as a major release. An NOR was submitted to the NMOCD at approximately 10:00am. An email notification was sent to Nolan Craun and Emmanuel Adeloyle with the BLM at approximately 11:22am.

A crew was onsite to excavate and repair line leak. A hole was found at the 8 o'clock position of the pipe that had been formed due to external corrosion. Approximately 25 ft of piping was cut out and replaced with new. Size of the excavation measured to be 35 feet in length, 5 feet wide and 4 feet in depth. Gas loss was calculated to be 0.78 Mcf.

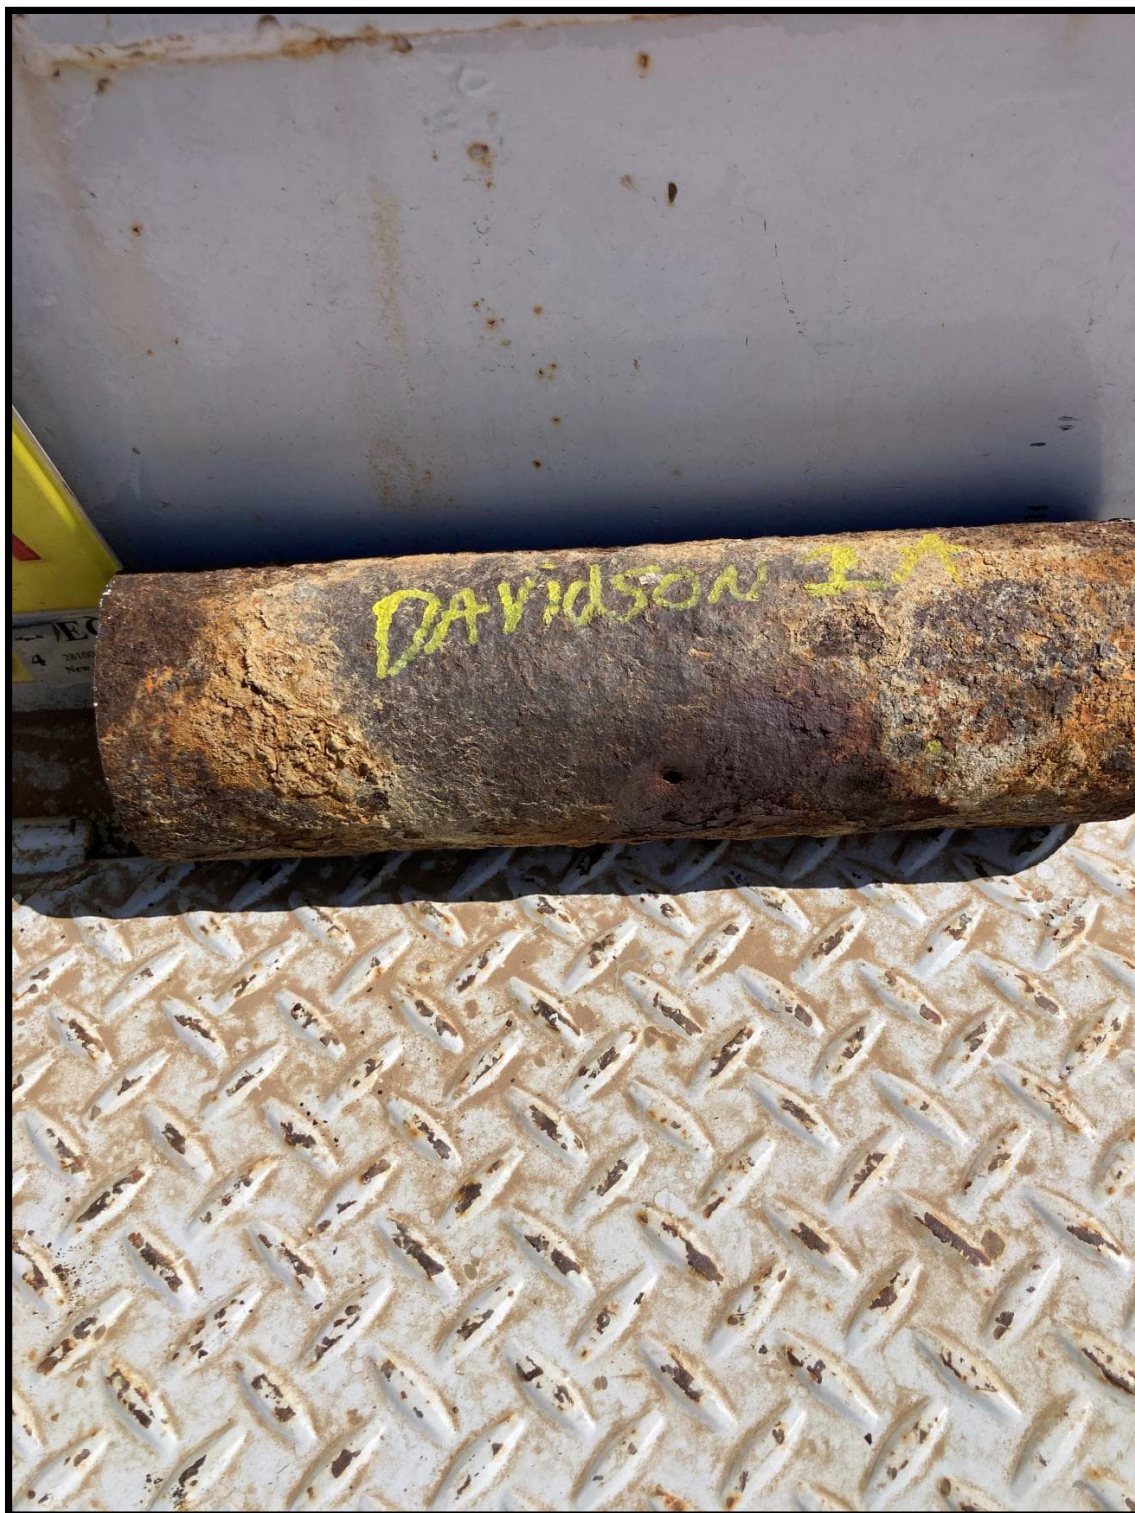
Photo Page
Davidson 1A

Harvest environmental was onsite to collect soil samples. A total of three five-point composite samples were collected from the excavation and sent in for analysis of BTEX, GRO, DRO, MRO, and Chlorides. The "Bottom" sample was collected from the bottom of the excavation measuring 35 feet long by 5 feet width equaling 175 square feet. "SW 1" was collected from an area of 40 feet in length by 4 feet wide equaling 160 square feet. "SW 2" was collected from an area of 40 feet in length by 4 feet wide equaling 160 square feet. See attached "Sample Map" and "Photo Page" for reference.

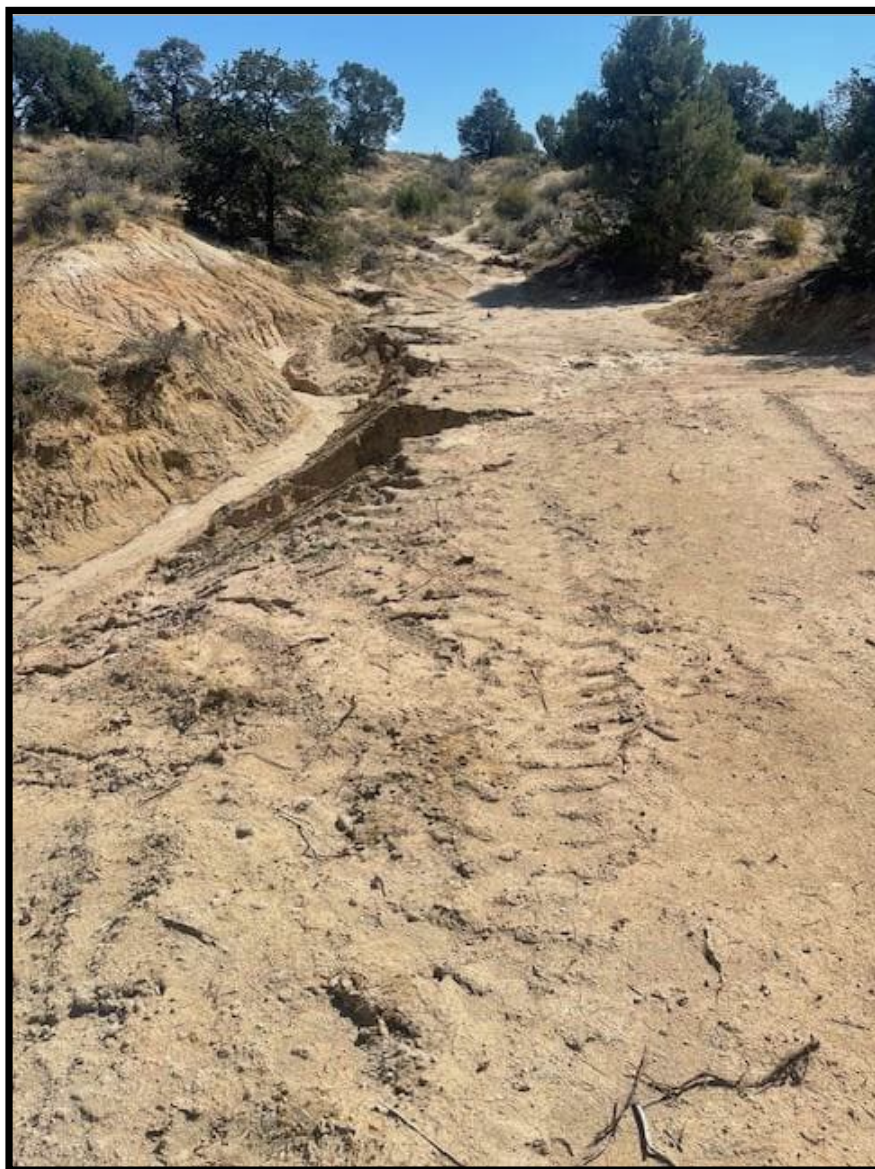
Photo Page

Excavation was backfilled and no further action is required at this time. See attached "*Photo Page*" for reference.
