Closure Report
Hudgens #001 (01.01.2008)
Incident #: NPAC0801736858
Lea County, New Mexico
Unit J Sec 11 T16S R36E
32.9349823°, -103.3231506°

Produced Water Release
Point of Release: Valve froze and popped the ball valve releasing produced water
Release Date: 01.01.2008
Volume Released: 40 Barrels of Produced Water
Volume Recovered: 32 Barrels of Produced Water

**Re: Closure Report
Hudgens #001 (01.01.2008)
Chevron U.S.A., Inc.
Site Location: Unit J, S11, T16S, R36E
(Lat 32.9349823°, Long -103.3231506°)
Lea County, New Mexico**

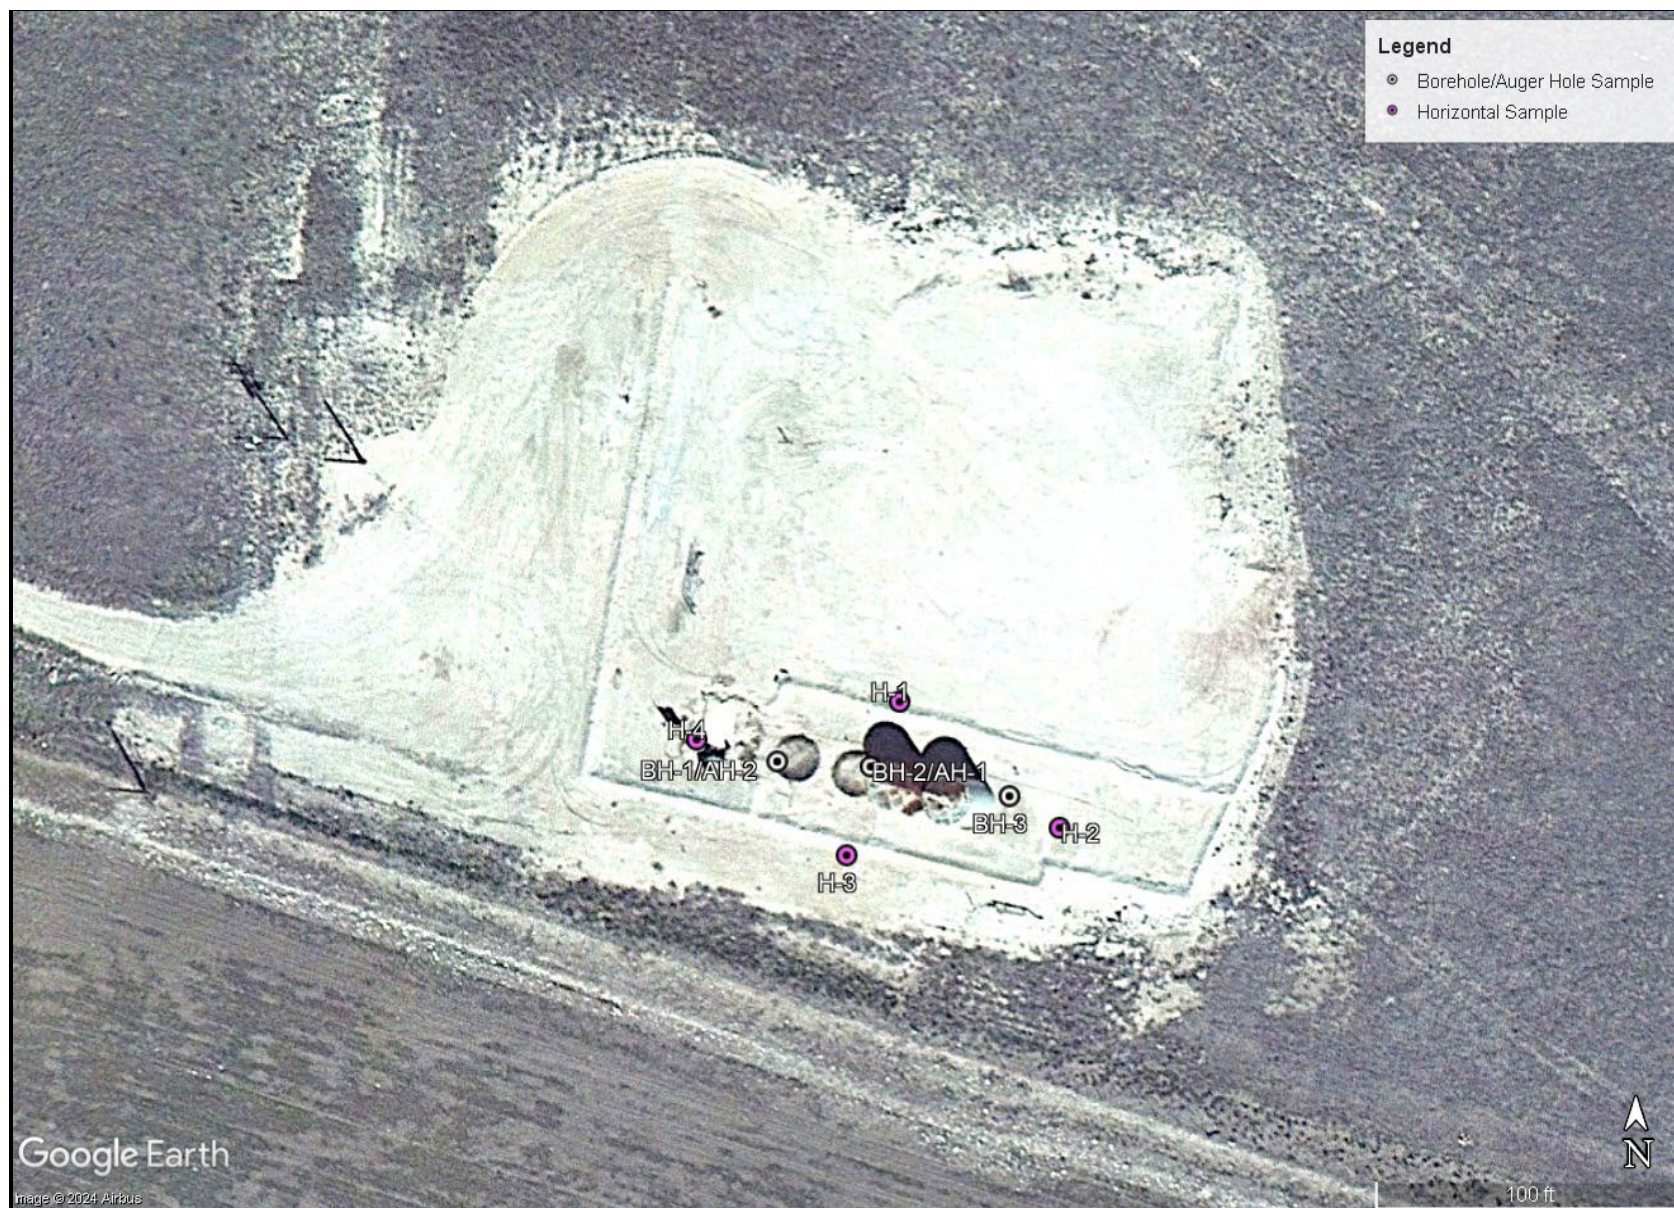
FIGURE 2

TOPOGRAPHIC MAP
 CHEVRON U.S.A., INC.
 HUDGENS #001 (01.01.2008)
 LEA COUNTY, NEW MEXICO
 32.9349823°, 103.3231506°

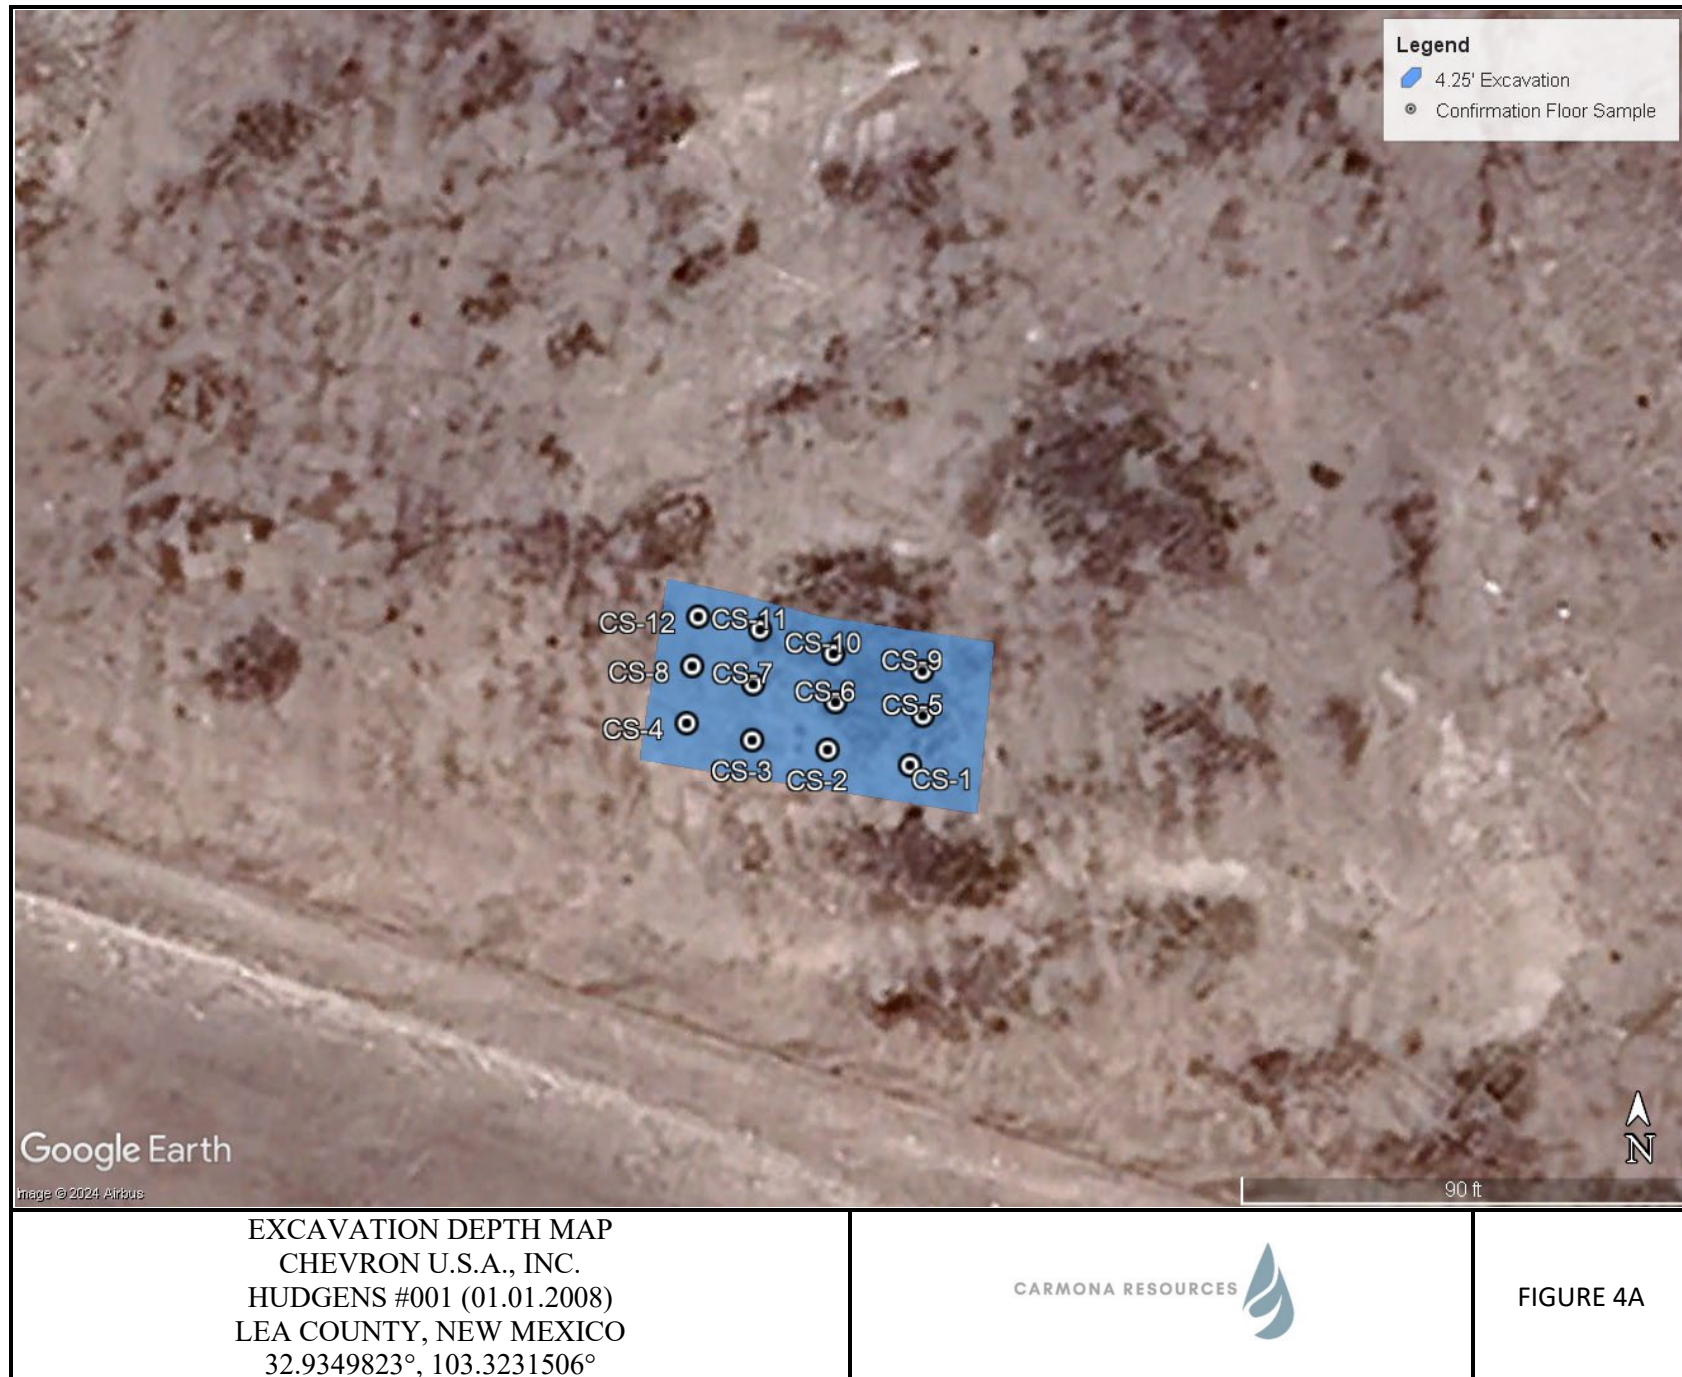
FIGURE 3

SAMPLE LOCATION MAP
CHEVRON U.S.A., INC.
HUDGENS #001 (01.01.2008)
LEA COUNTY, NEW MEXICO
32.9349823°, 103.3231506°

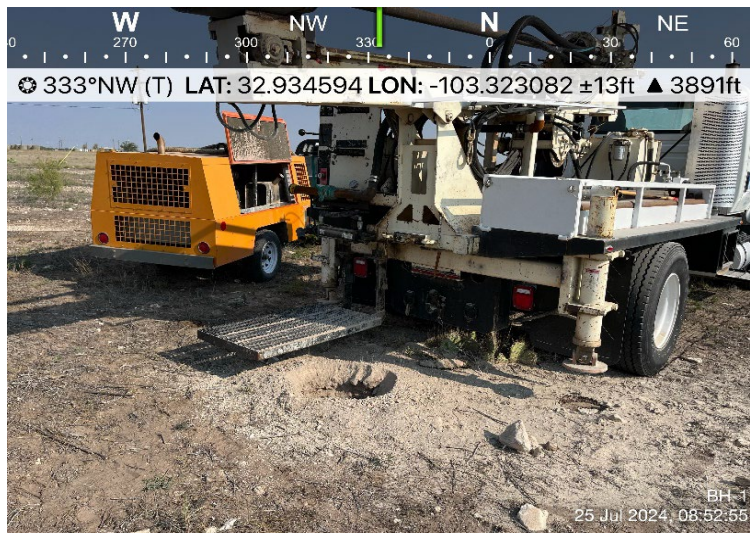
Photograph No. 1**Facility:** Hudgens #001**County:** Lea County, New Mexico**Description:**

View Northwest, area of BH-1.

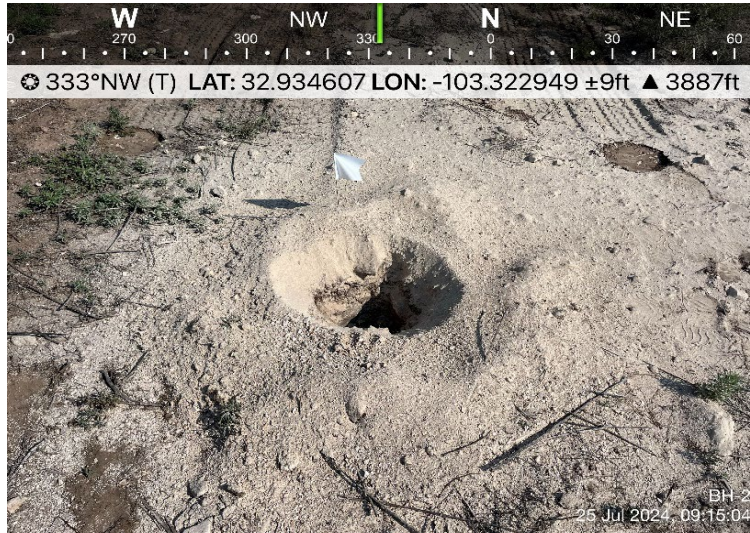
**Photograph No. 2****Facility:** Hudgens #001**County:** Lea County, New Mexico**Description:**

View Northwest, area of BH-2.

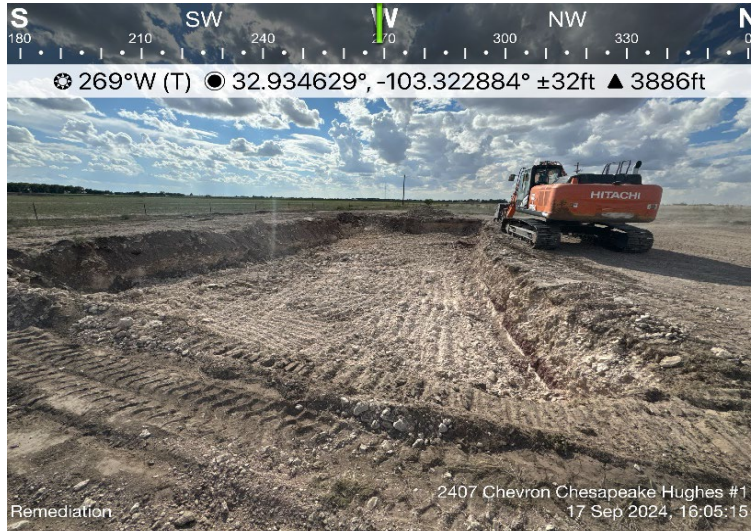
Photograph No. 4**Facility:** Hudgens #001**County:** Lea County, New Mexico**Description:**

View West, area of CS-1 through CS-12.

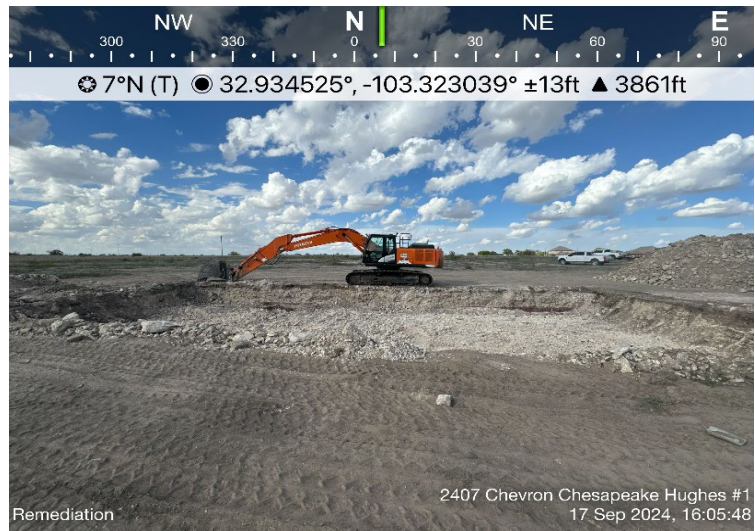
**Photograph No. 5****Facility:** Hudgens #001**County:** Lea County, New Mexico**Description:**

View North, area of CS-1 through CS-12.

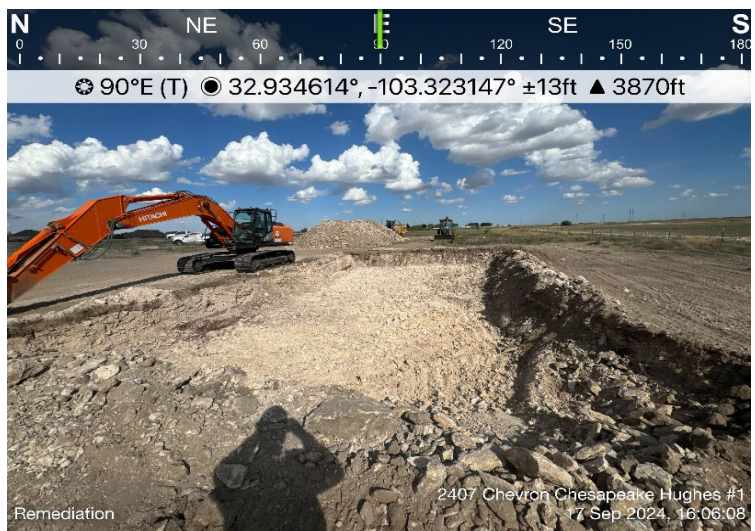
**Photograph No. 6****Facility:** Hudgens #001**County:** Lea County, New Mexico**Description:**

View East, area of CS-1 through CS-12.

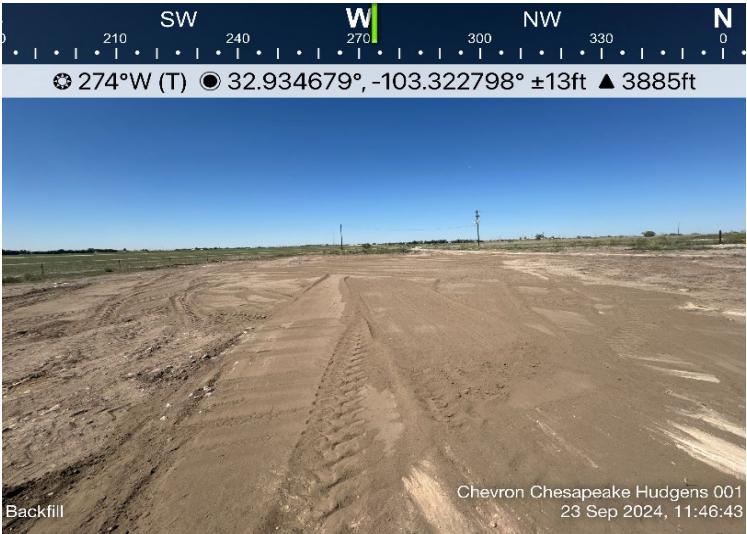
Photograph No. 7

Description:
View West, backfilled and reclaimed area.

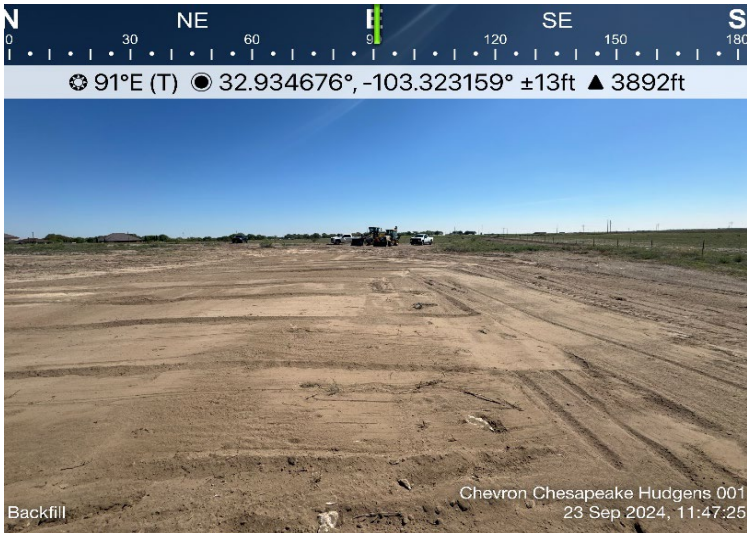
Photograph No. 8

Description:
View East, backfilled and reclaimed area.

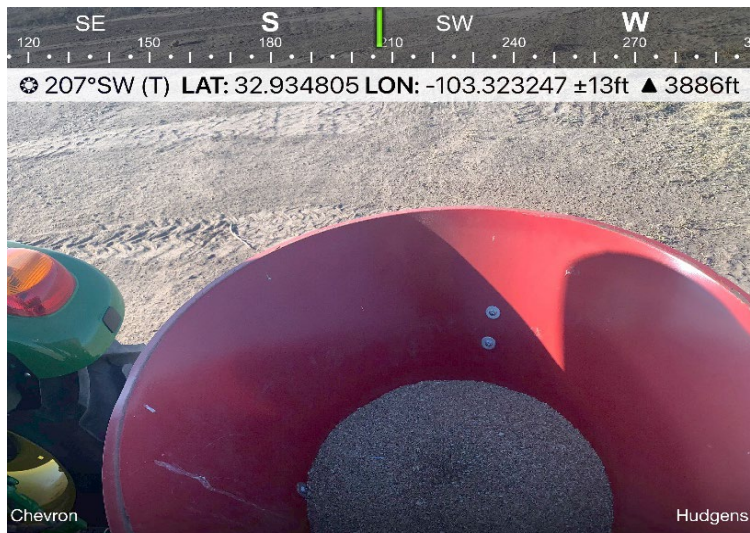
View South, reseeding operation in progress.

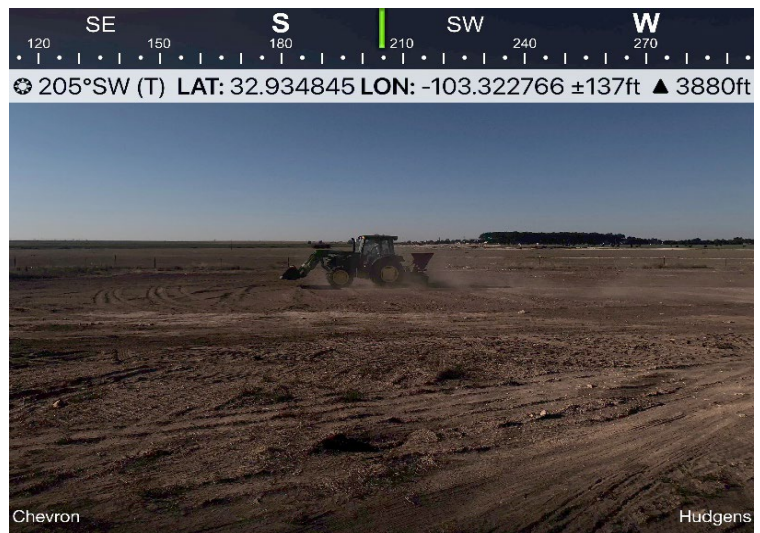
Photograph No. 11

View South, reseeding operation in progress.

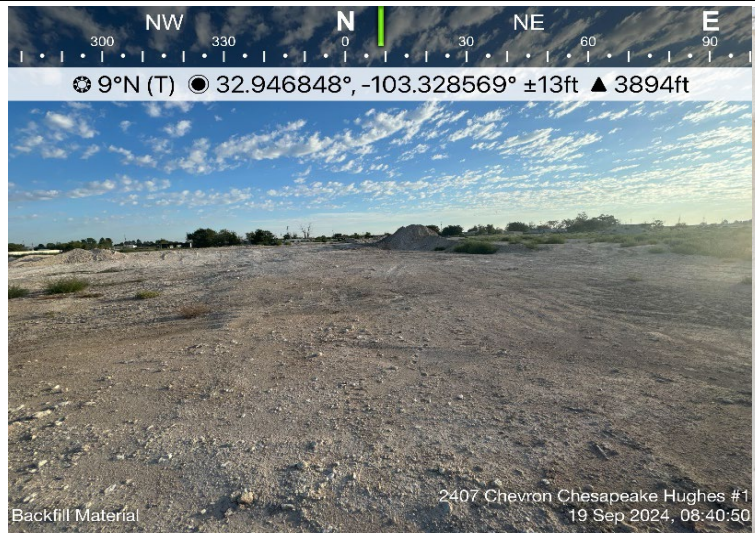
Photograph No. 12

View North, area of backfill material.

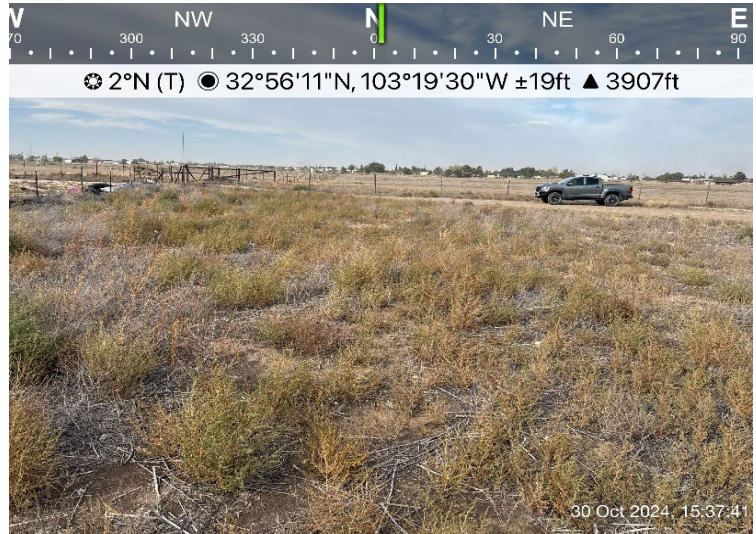
View North, area of the historic water well under permit No. L-04005.

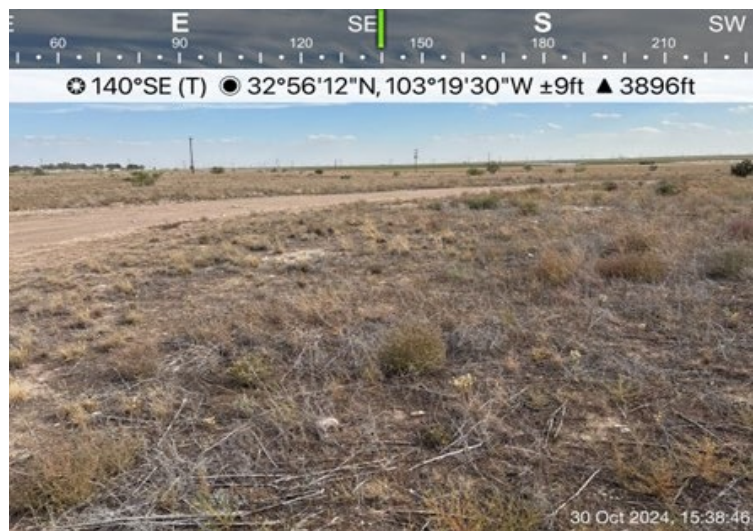
Photograph No. 3

View Southeast, area of the historic water well under permit No. L-04005.

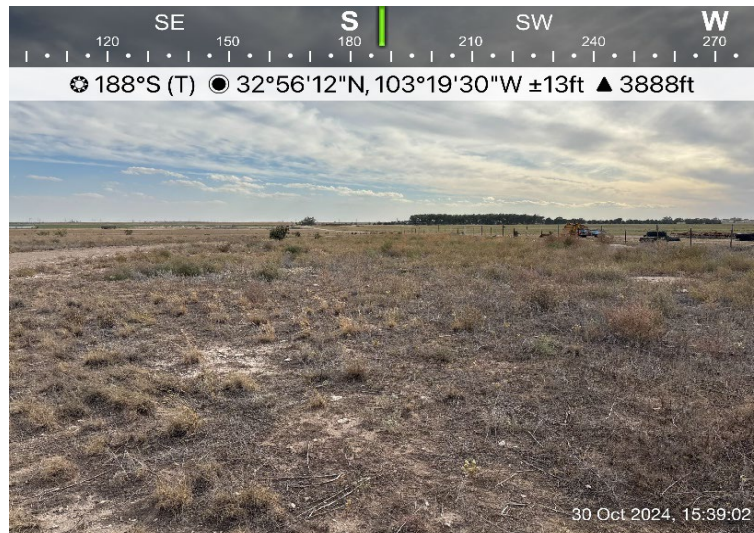
Photograph No. 5

View South, area of the historic water well under permit No. L-04005.

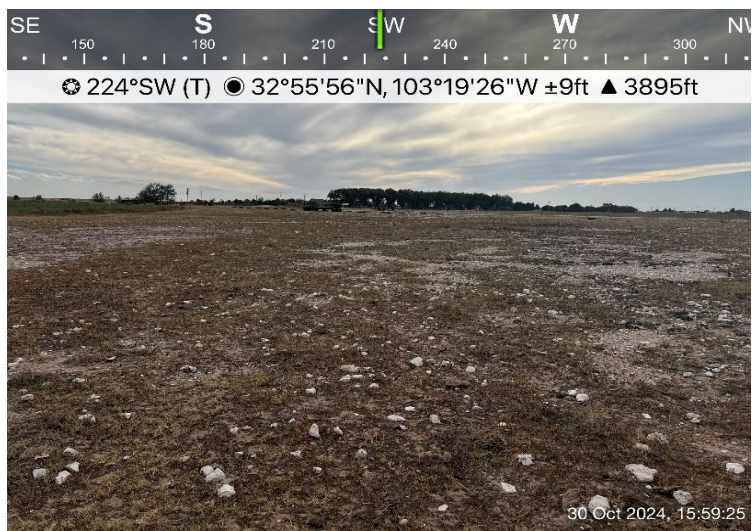
Photograph No. 6

View Southwest, area of the historic water well under permit No. L-678.

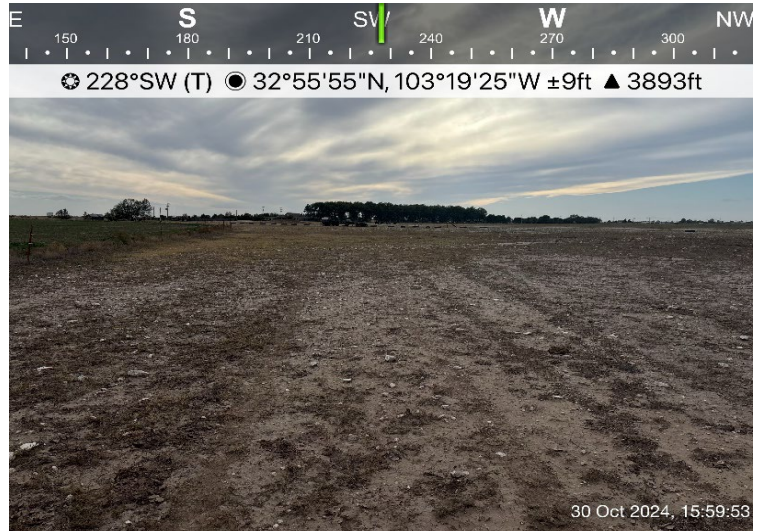
View Southwest, area of the historic water well under permit No. L-678.

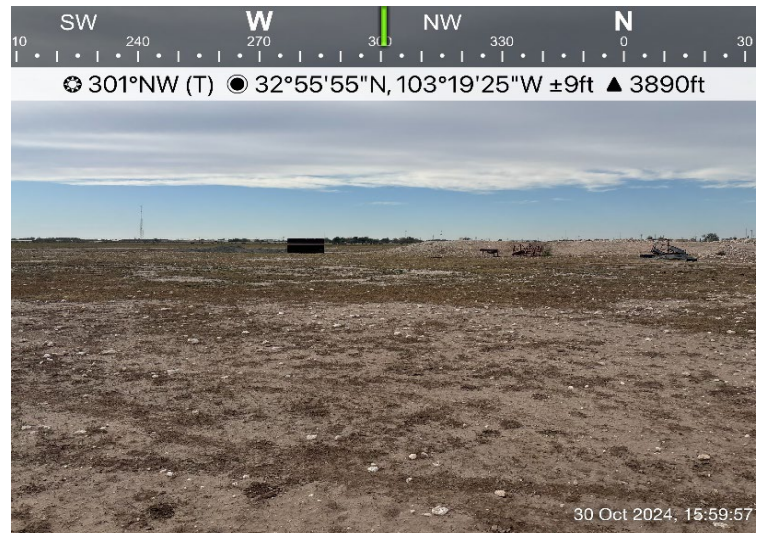
Photograph No. 8

View Northwest, area of the historic water well under permit No. L-678.

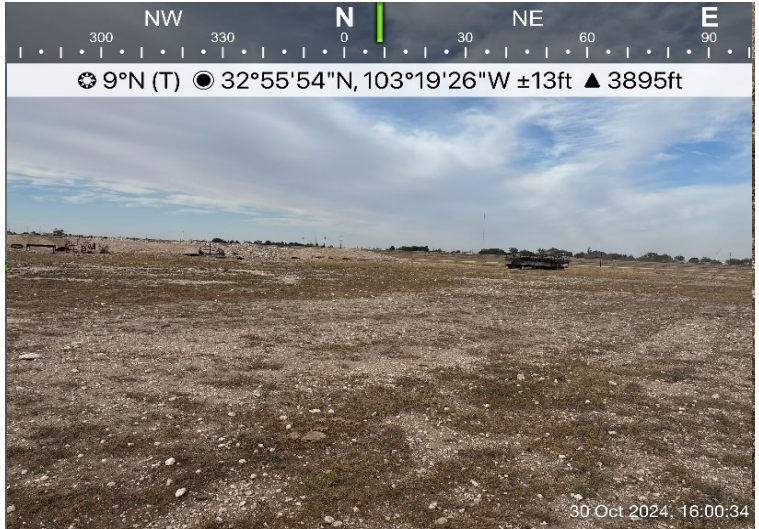
Photograph No. 9

View North, area of the historic water well under permit No. L-678.
