Closure Report
MARKHAM #001 (06.09.2005)
Incident #: NCLB0523732298
Eddy County, New Mexico
Unit C Sec 22 T23S R28E
32.2971802°, -104.0764694°

Crude Oil & Produced Water Release

Re: Closure Report
Markham #001 (06.09.2005)
Incident ID: NCLB0523732298
Chevron U.S.A., Inc.
Site Location: Unit C, S22, T23S, R28E
(Lat 32.2971802°, Long -104.0764694°)
Eddy County, New Mexico

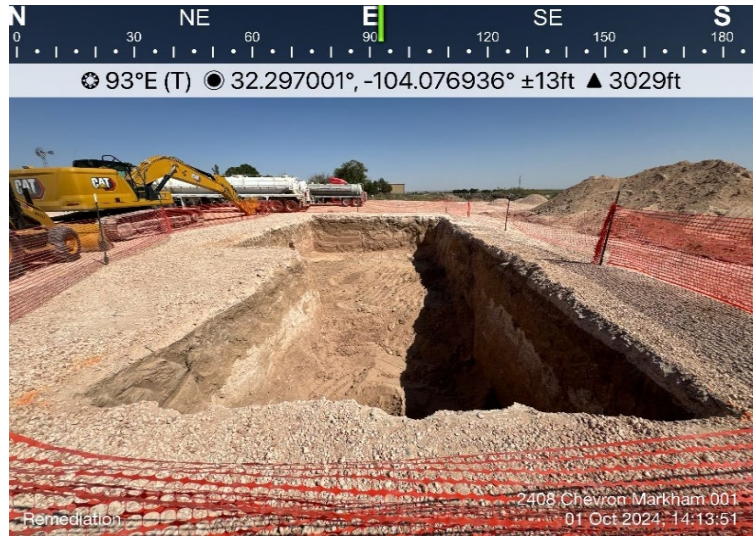
Photograph No. 1**Facility:** Markham #001**County:** Eddy County, New Mexico**Description:**

View East, Area of CS-8 through CS-1

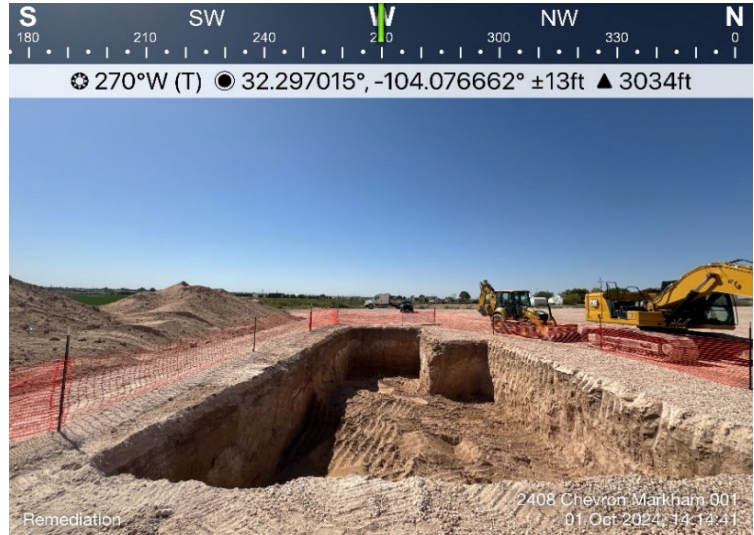
**Photograph No. 2****Facility:** Markham #001**County:** Eddy County, New Mexico**Description:**

View West, area of CS-1 through CS-8

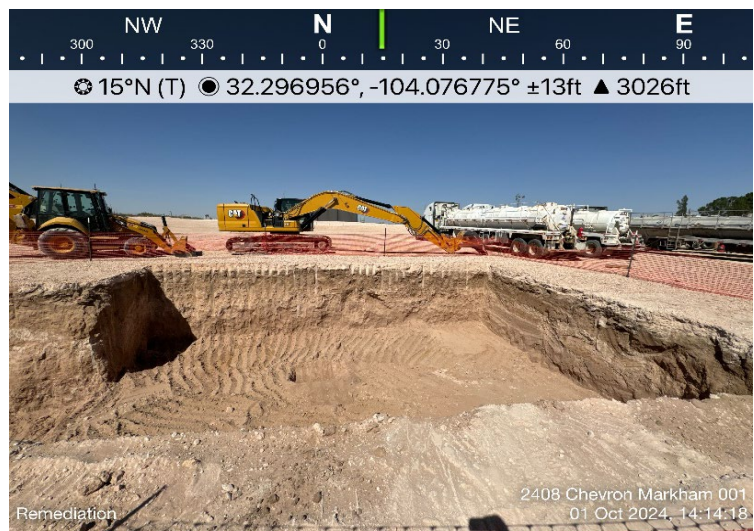
**Photograph No. 3****Facility:** Markham #001**County:** Eddy County, New Mexico**Description:**

View North, area of CS-1 through CS-8

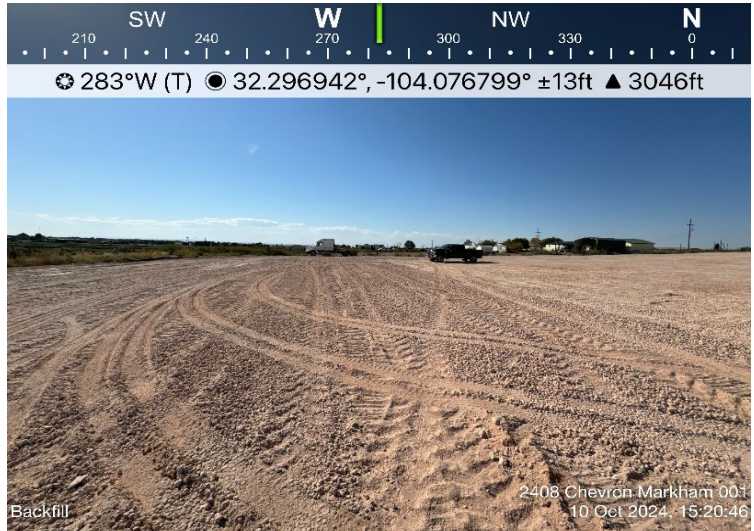
View West, Area Backfilled to Landowner Specifications.

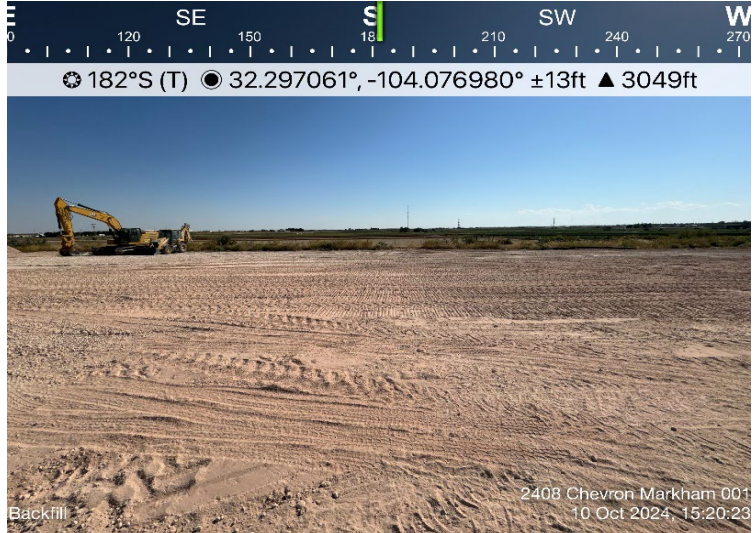
Photograph No. 5

View South, Area Backfilled to Landowner Specifications.

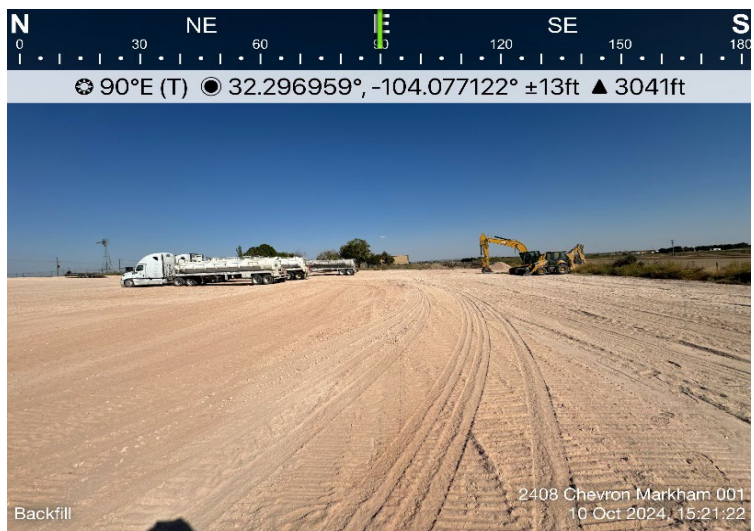
Photograph No. 6

View East, Area Backfilled to Landowner Specifications.

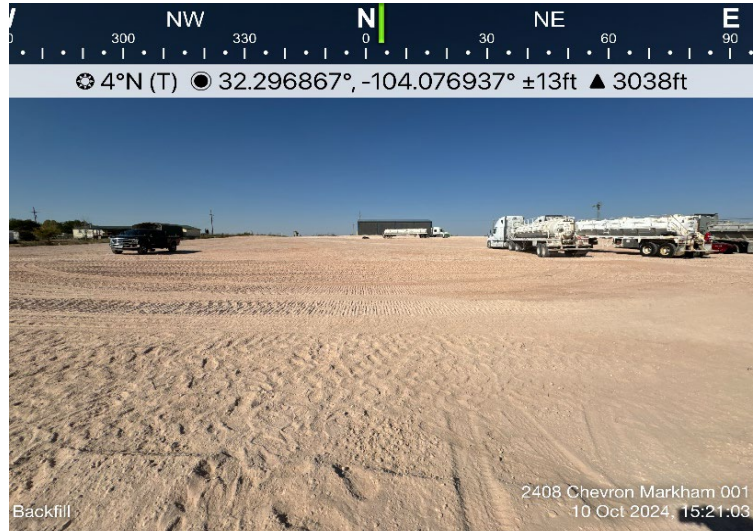
View West, Area Backfilled to surface..

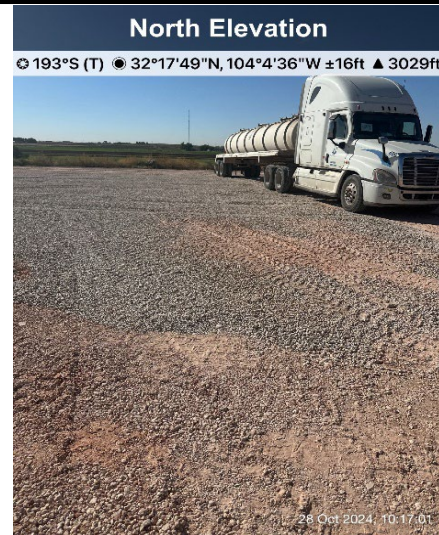
Photograph No. 8

View South, Area Backfilled with additional gravel to Landowner Specifications.

Since our last conversation, We have covered the previous remediation area with gravel per your specifications for your business. Updated photos can be found on pages 19 & 20.

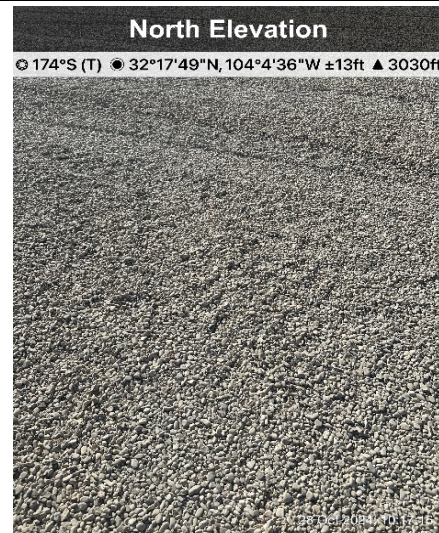
Photograph No. 9

View South, Area Backfilled with additional gravel to Landowner Specifications.

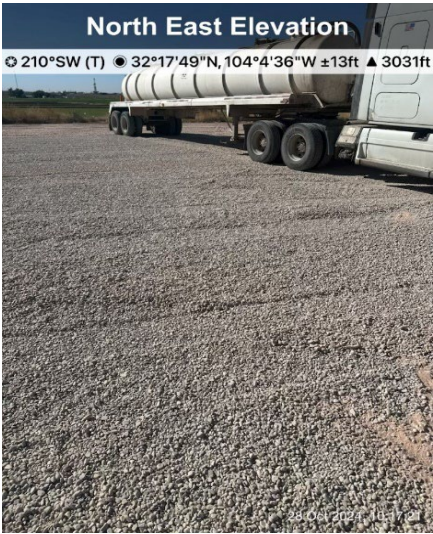
Photograph No. 10

Description:
View Southwest, Area Backfilled with additional gravel
to Landowner Specifications.
