Re: Closure Report  
Chevron North America Exploration and Production Company  
Hayhurst NM Section 12 CTB  
Unit G, Section 12, Township 26S, Range 27E  
Site Coordinates: 32.05915845, -104.1430482  
Eddy County, New Mexico  
Incident ID: nAPP2415939361

**SITE LOCATION MAP**  
**SITE CHARACTERIZATION AND REMEDIATION WORKPLAN**  
HAYHURST NM SECTION 12 CTB  
CHEVRON NORTH AMERICA EXPLORATION AND  
PRODUCTION COMPANY  
EDDY COUNTY, NEW MEXICO

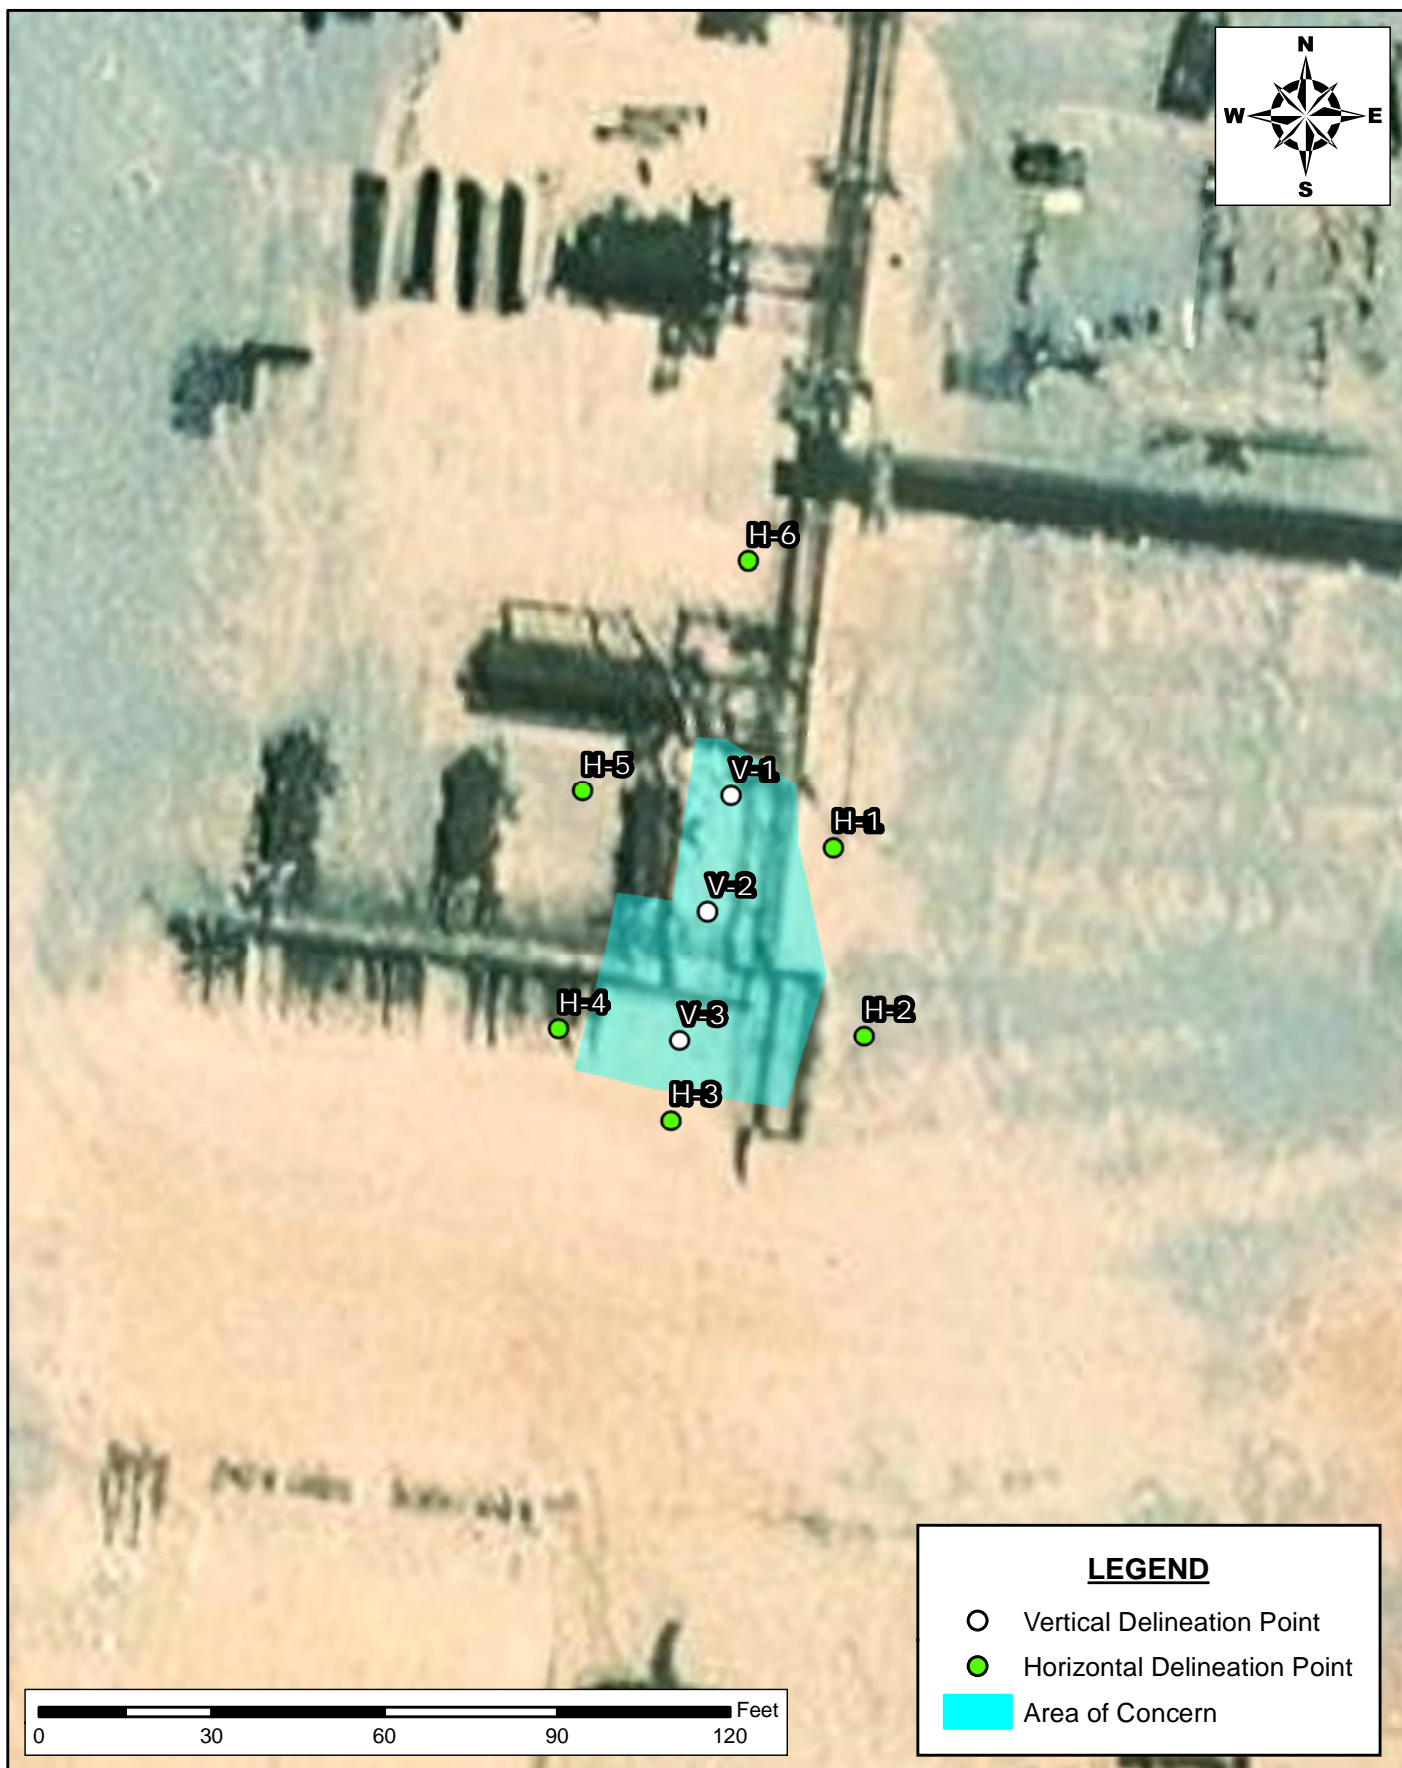
**FIGURE 3**

Based on the Release Notification C-141 Form, the release was discovered on June 01, 2024, and was due to corrosion. Upon discovery, the Site was shut-in and repairs ensued. The spill resulted in a release of approximately two (2) barrels (bbls) of crude oil and five (5) bbls of produced water of which none were recovered for an approximate net loss of two (2) bbls of crude oil and five (5) bbls of produced water. Chevron had the saturated soils removed and disposed of at an approved disposal facility. The release area is shown on Figure 3.

Analytical results are included in Table 1, while soil boring locations are shown on Figure 3. Laboratory reports containing analytical methods and chain-of-custody documents are attached to the report.

Based on the Site assessment activities and analytical results, Chevron proceeded with remedial action activities at the Site to include the excavation and disposal of impacted soils above regulatory limits for V-2.

After the excavation of impacted soil was completed by Hydro-Con, on October 16, 2024, composite confirmation samples were collected by NTGE throughout the base and sidewall areas to ensure impacted soil was removed. A total of one (1) composite bottom hole confirmation sample (CS-1) and one (1) composite sidewall confirmation sample (SW-1) were collected. The confirmation samples were collected in accordance with the one sample per 200 ft<sup>2</sup> guideline established in the regulatory criteria. Samples were placed directly into laboratory provided sample containers, placed on ice, and transported under chain-of-custody protocol to Eurofins Laboratory in Carlsbad, New Mexico for analysis of BTEX, TPH, and chloride. Analytical results indicated that all samples were below NMOCD regulatory criteria for the site. The final excavation extent removed seventeen (17) cubic yards of impacted material, which was disposed of at the Red Bluff R360 disposal facility near Orla, Texas. The manifests are not included in this report but are available upon request. Confirmation sample locations are shown on Figure 4, while analytical results are included in Table 2 with laboratory reports attached.

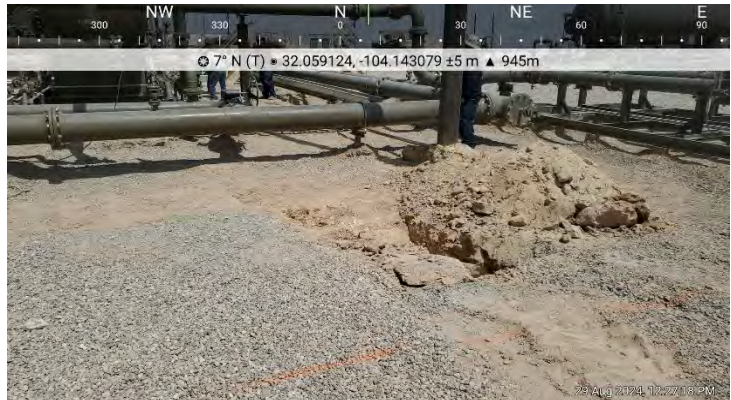
## Photograph No. 1

**Description:**  
Area of Concern.

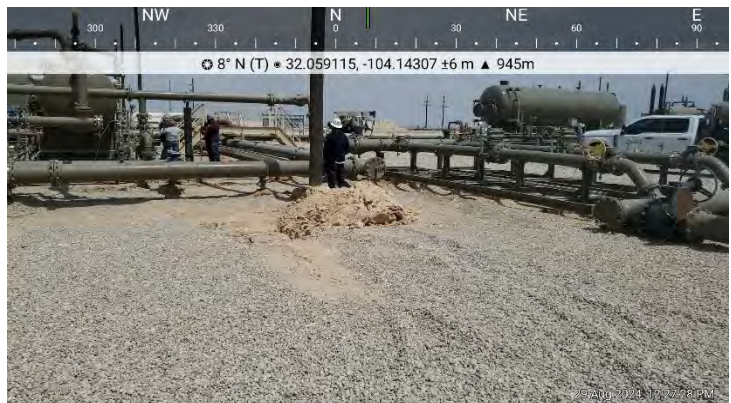
## Photograph No. 2

**Description:**  
Area of Concern.

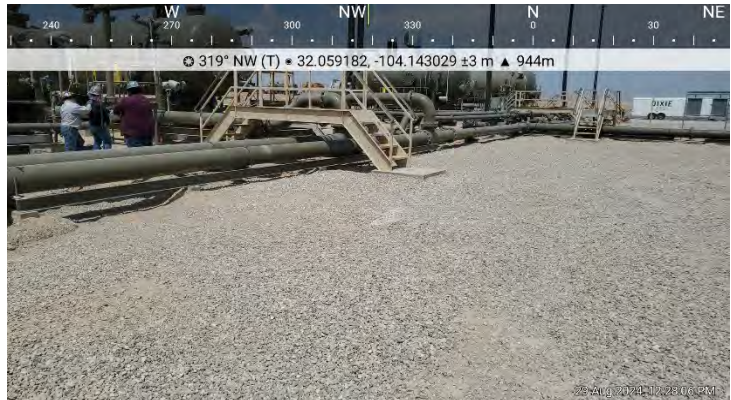
## Photograph No. 4

**Description:**  
Area of Concern.

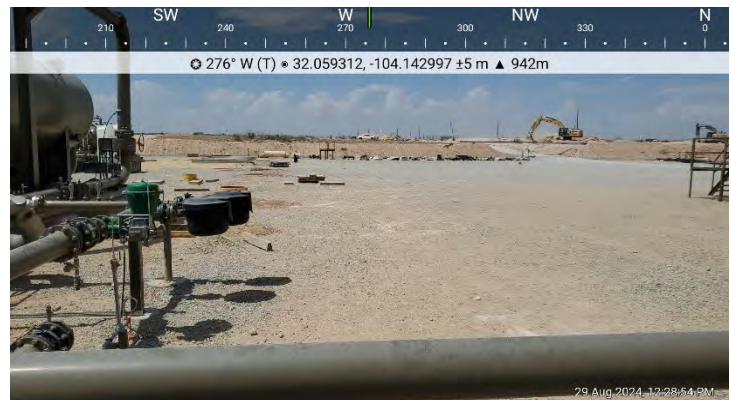
## Photograph No. 6

**Description:**  
Area of Concern.

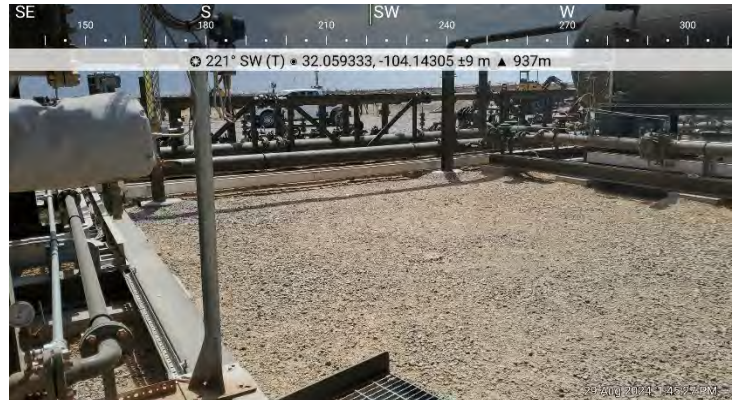
## Photograph No. 7

**Description:**  
Area of Concern.

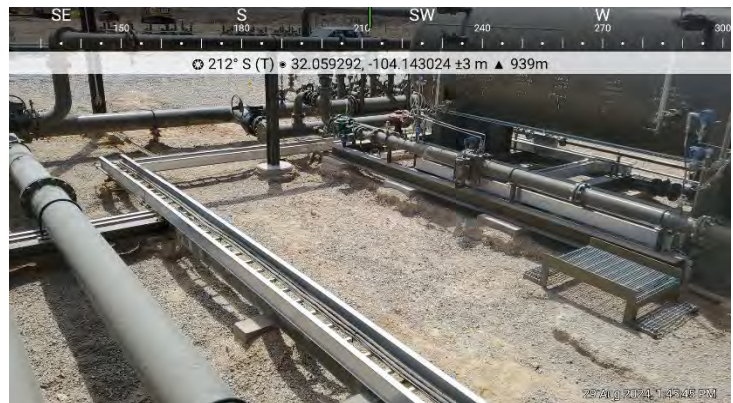
## Photograph No. 8

**Description:**  
Area of Concern.

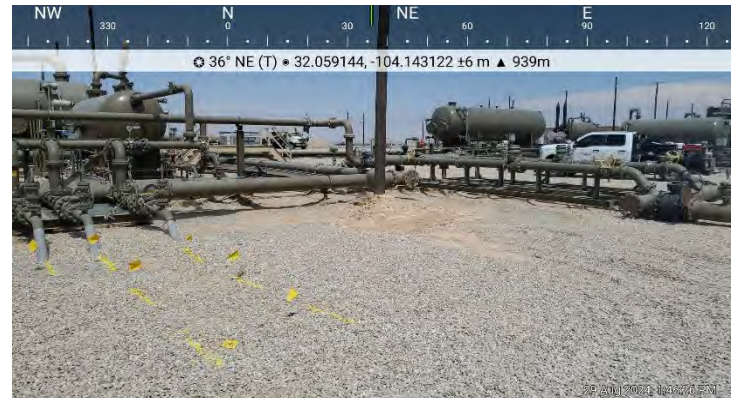
## Photograph No. 9

**Description:**  
Area of Concern.

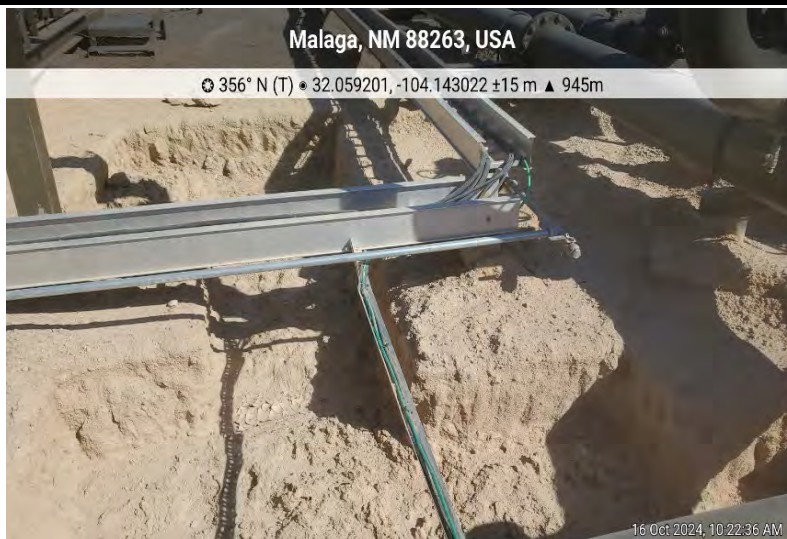
View of excavation and remediation.

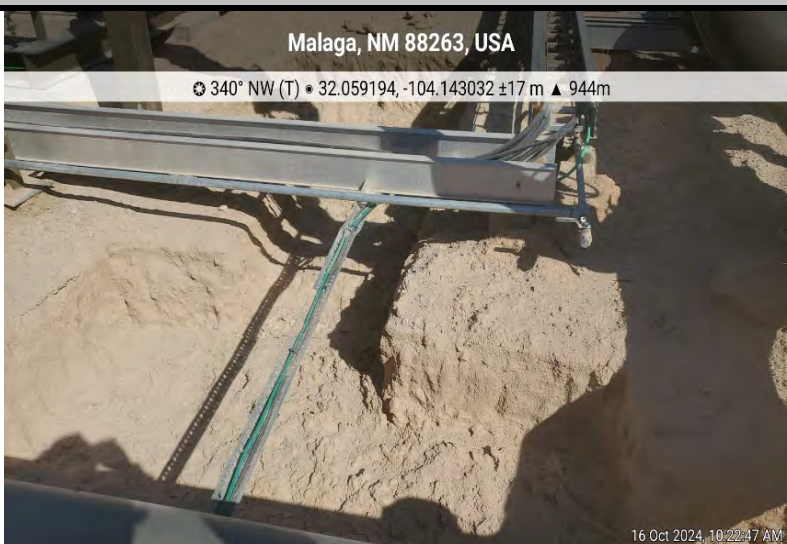
### Photograph No. 11

View of excavation and remediation.

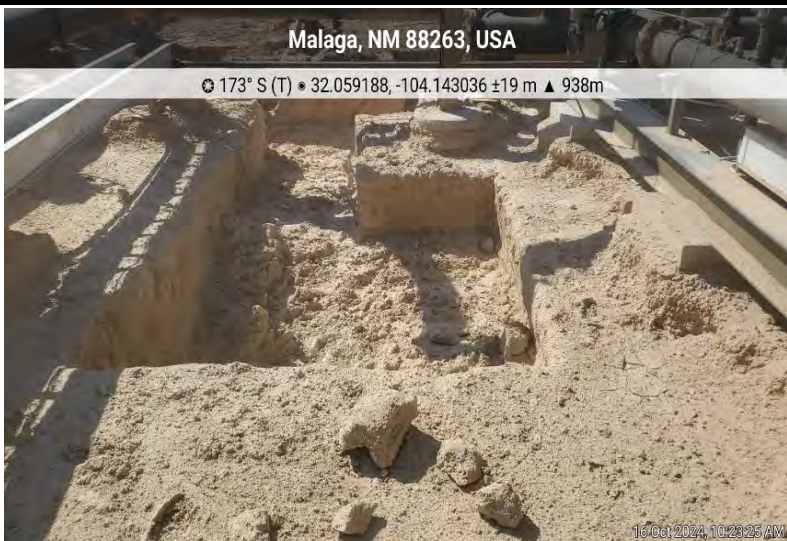
### Photograph No. 12

View of excavation and remediation.
