December 2, 2024

**Re: Site Assessment and Closure Report
BTA Oil Producers, LLC
Mesa B 8115 JV P Com #002H Jet Pump Release
Unit Letter P, Section 07, Township 26 South, Range 33 East
DOR: 9/16/2024
Lea County, New Mexico
Incident ID: nAPP2426245843
API # 30-015-42125**

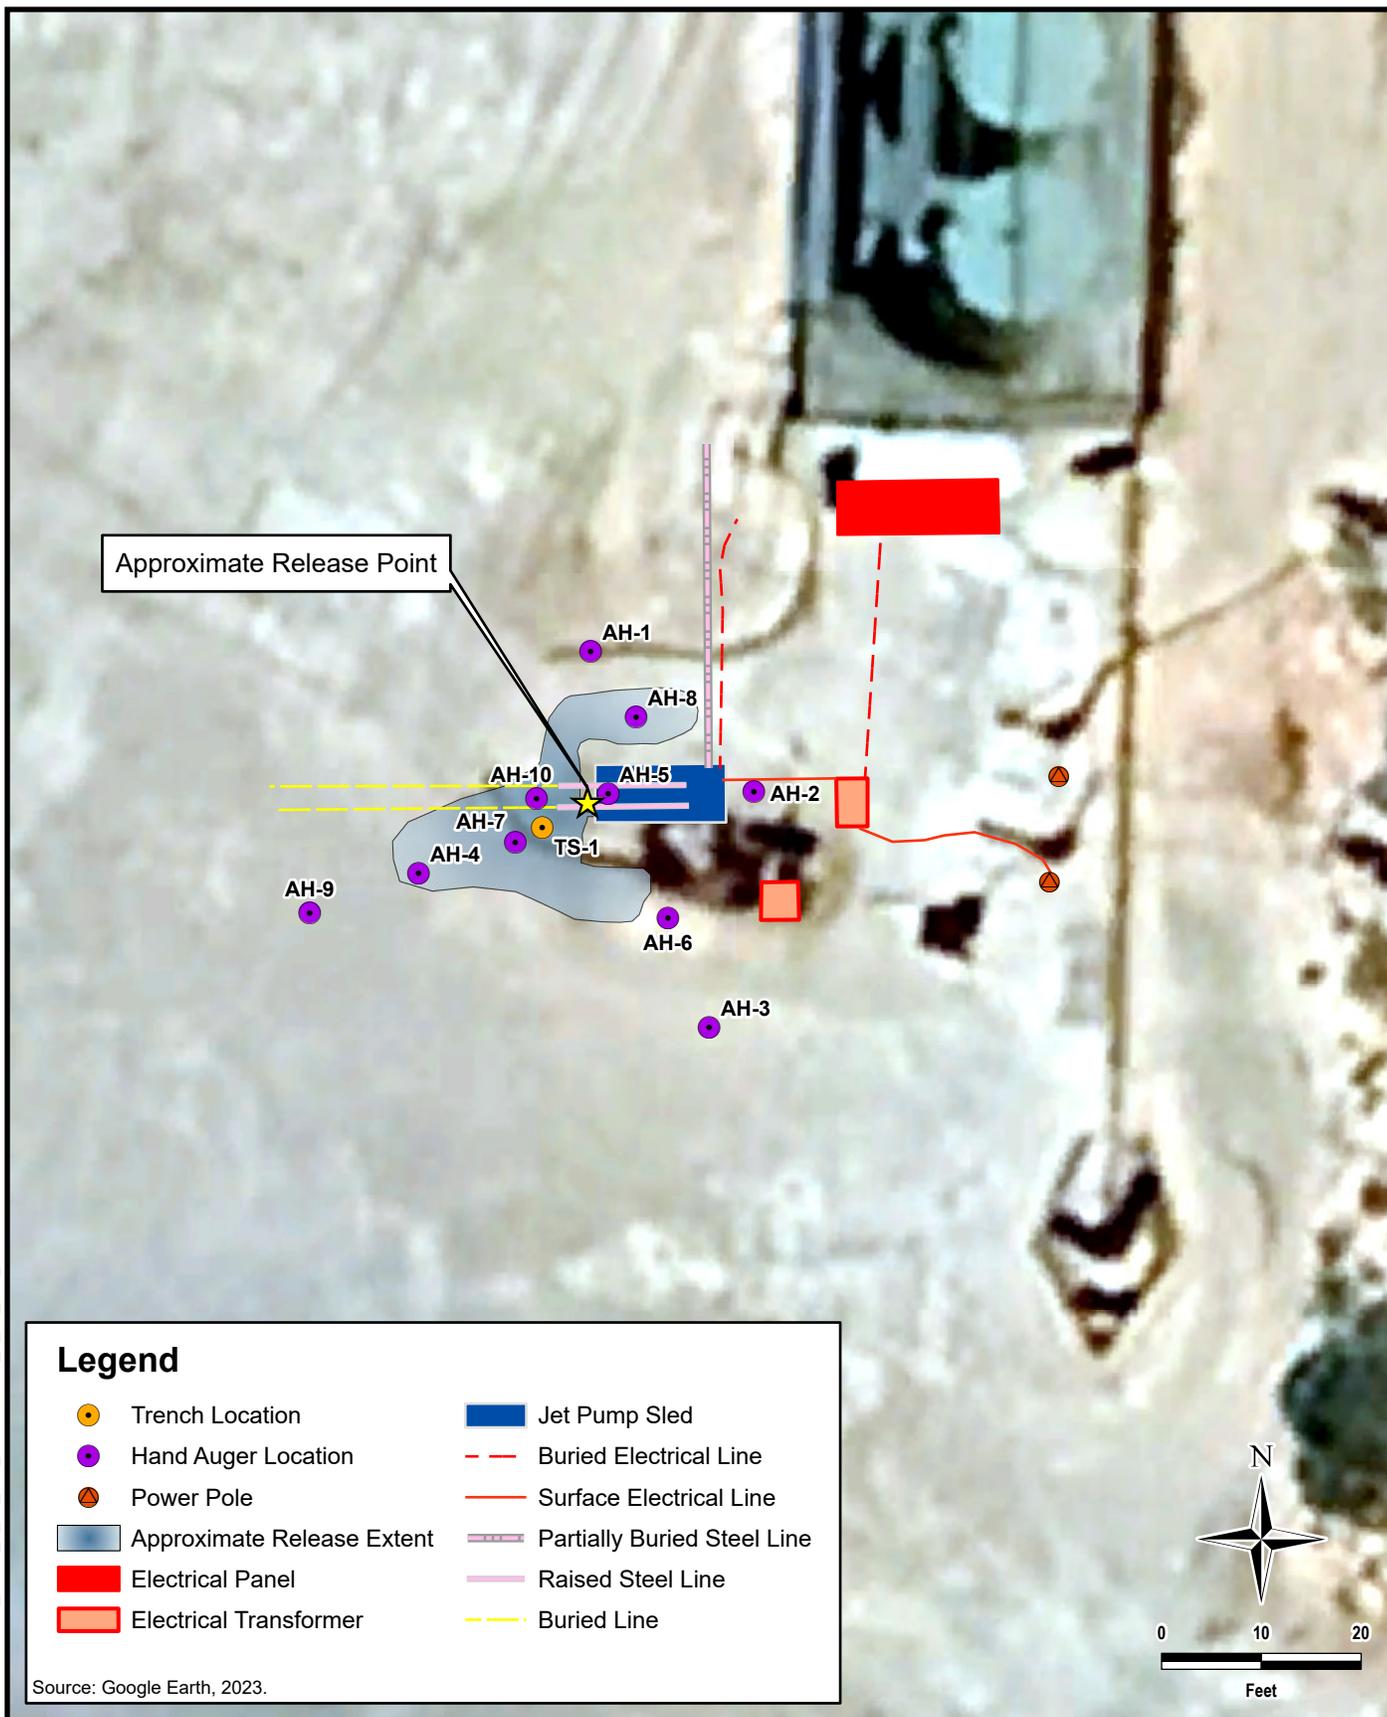
- Trench Location
- Hand Auger Location
- Power Pole
- Approximate Release Extent
- Electrical Panel
- Electrical Transformer
- Jet Pump Sled
- Buried Electrical Line
- Surface Electrical Line
- Partially Buried Steel Line
- Raised Steel Line
- Buried Line

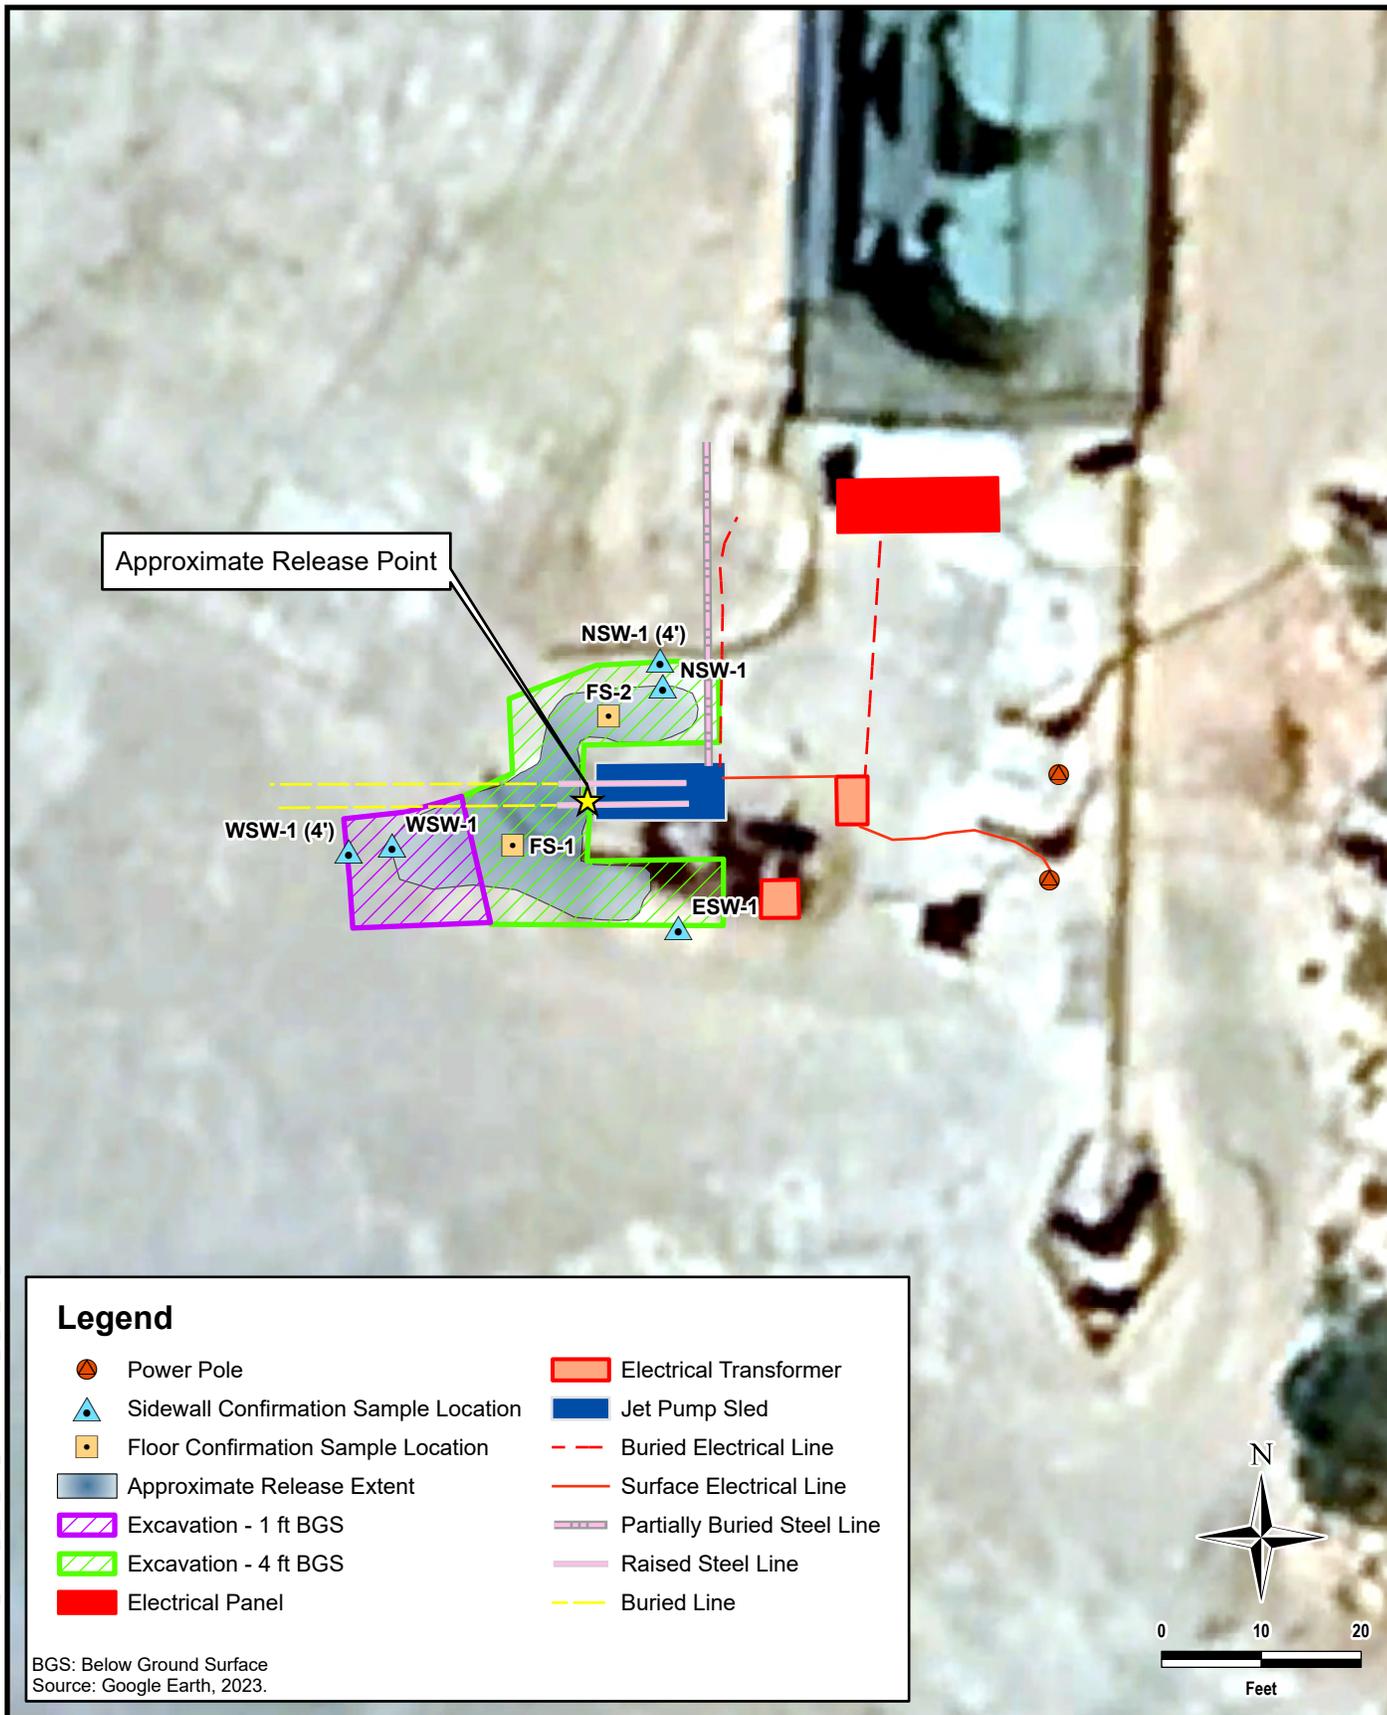
- Power Pole
- Sidewall Confirmation Sample Location
- Floor Confirmation Sample Location
- Approximate Release Extent
- Excavation - 1 ft BGS
- Excavation - 4 ft BGS
- Electrical Panel
- Electrical Transformer
- Jet Pump Sled
- Buried Electrical Line
- Surface Electrical Line
- Partially Buried Steel Line
- Raised Steel Line
- Buried Line

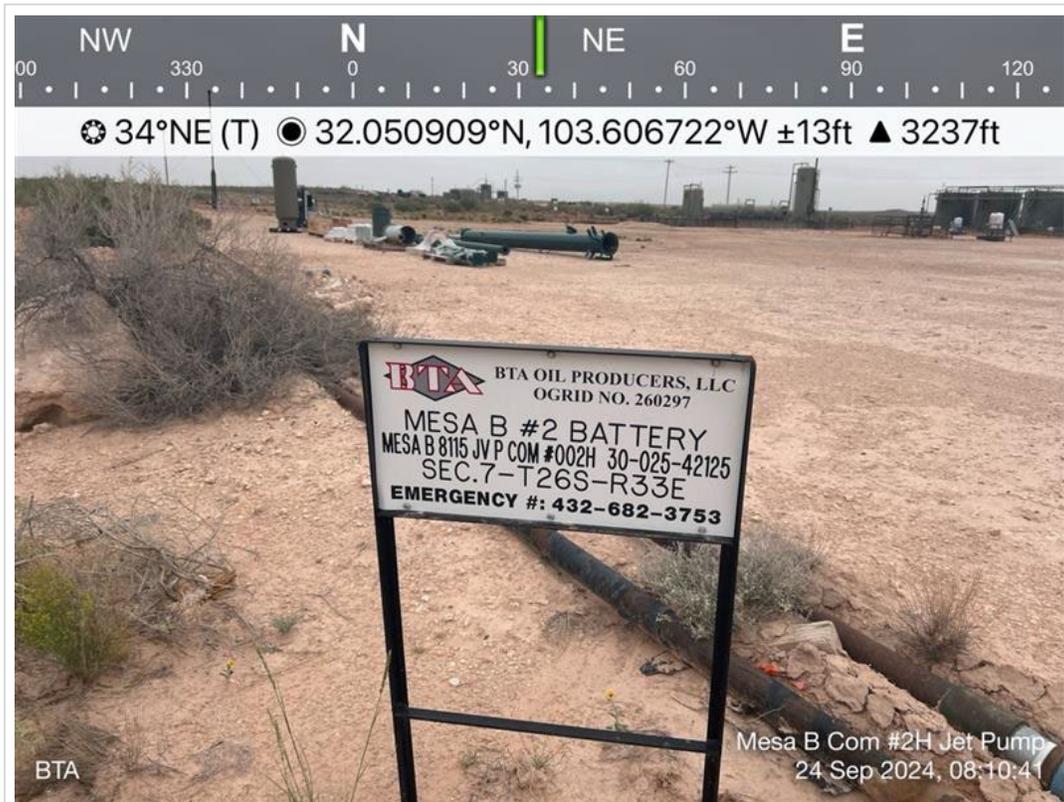
TETRA TECH, INC. PROJECT NO. 212C-MD-03639	DESCRIPTION	View north-northeast of site signage. Mesa B #2 Battery.	1
	SITE NAME	Mesa B 8115 JV P Com #002H Jet Pump Release	9/24/2024

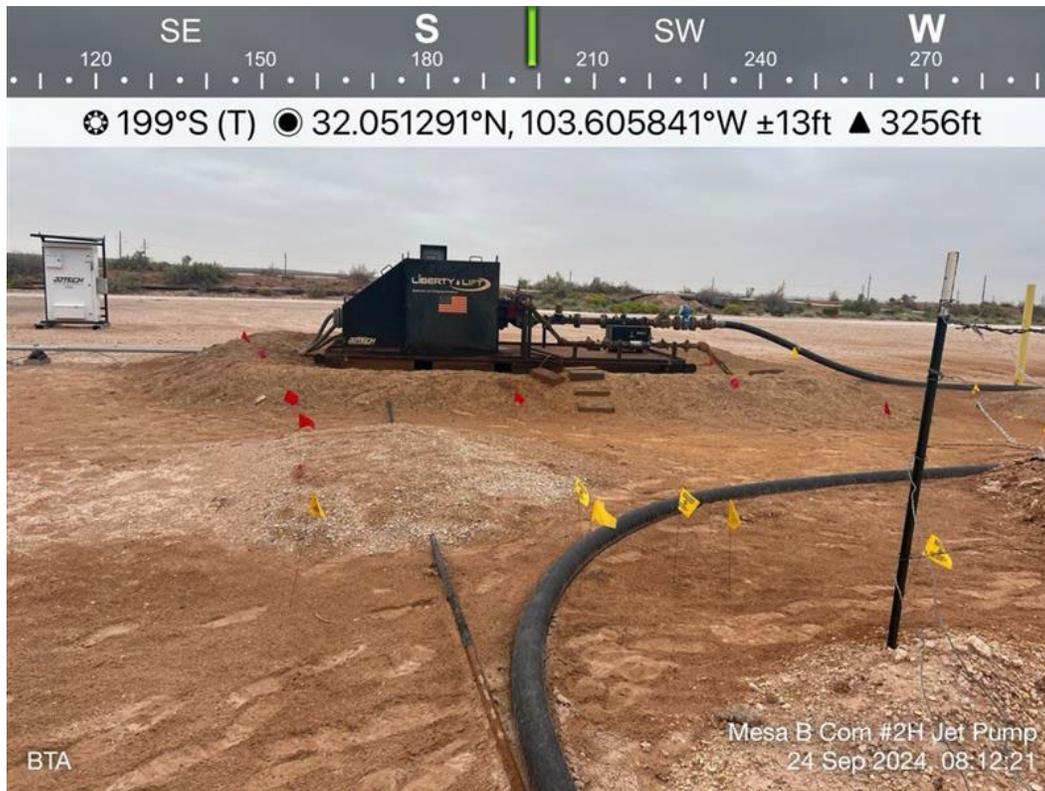
TETRA TECH, INC. PROJECT NO. 212C-MD-03639	DESCRIPTION	View south-southwest of jet pump and associated production equipment. View of marked subsurface utilities.	2
	SITE NAME	Mesa B 8115 JV P Com #002H Jet Pump Release	9/24/2024

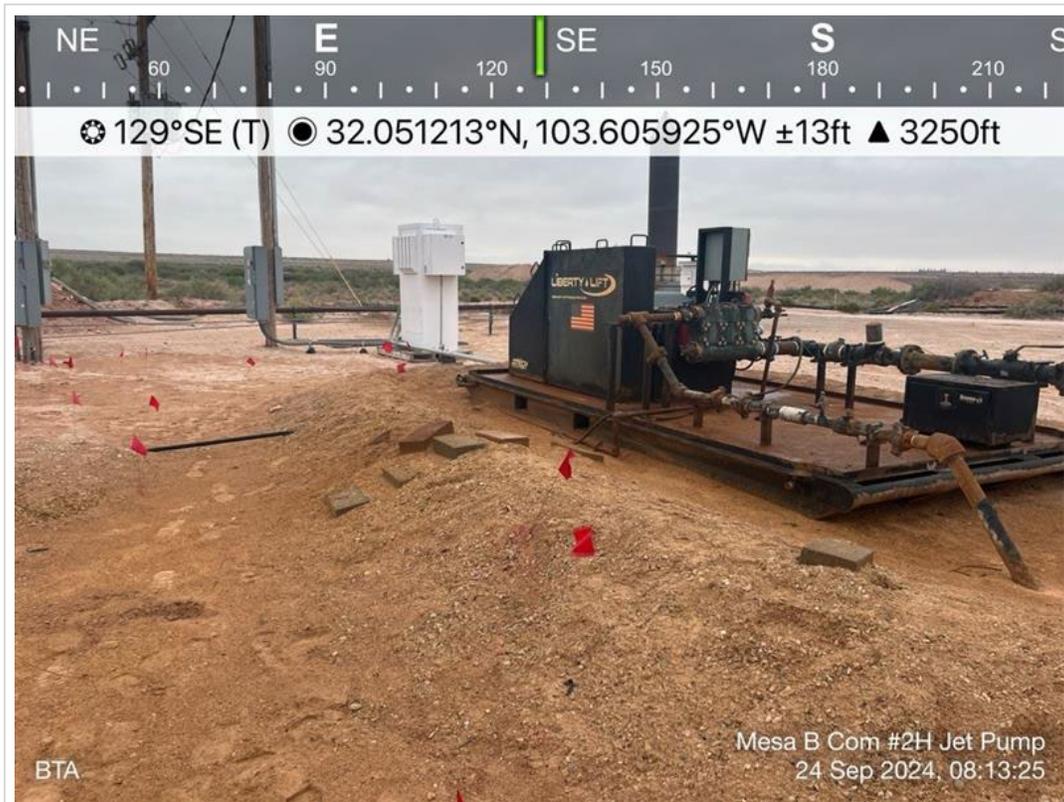
TETRA TECH, INC. PROJECT NO. 212C-MD-03639	DESCRIPTION	View southeast of jet pump and associated production equipment. View of marked subsurface utilities.	3
	SITE NAME	Mesa B 8115 JV P Com #002H Jet Pump Release	9/24/2024

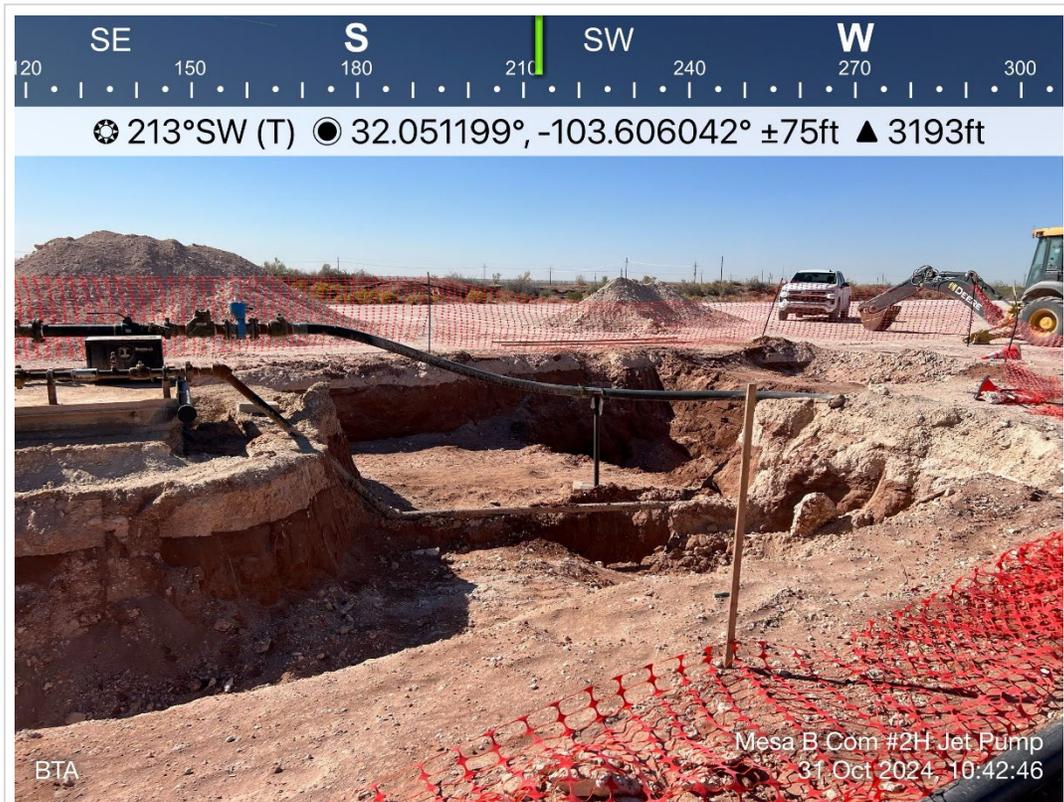
TETRA TECH, INC. PROJECT NO. 212C-MD-03639	DESCRIPTION	View south-southwest of excavation progress in vicinity of jet pump.	5
	SITE NAME	Mesa B 8115 JV P Com #002H Jet Pump Release	10/31/2024

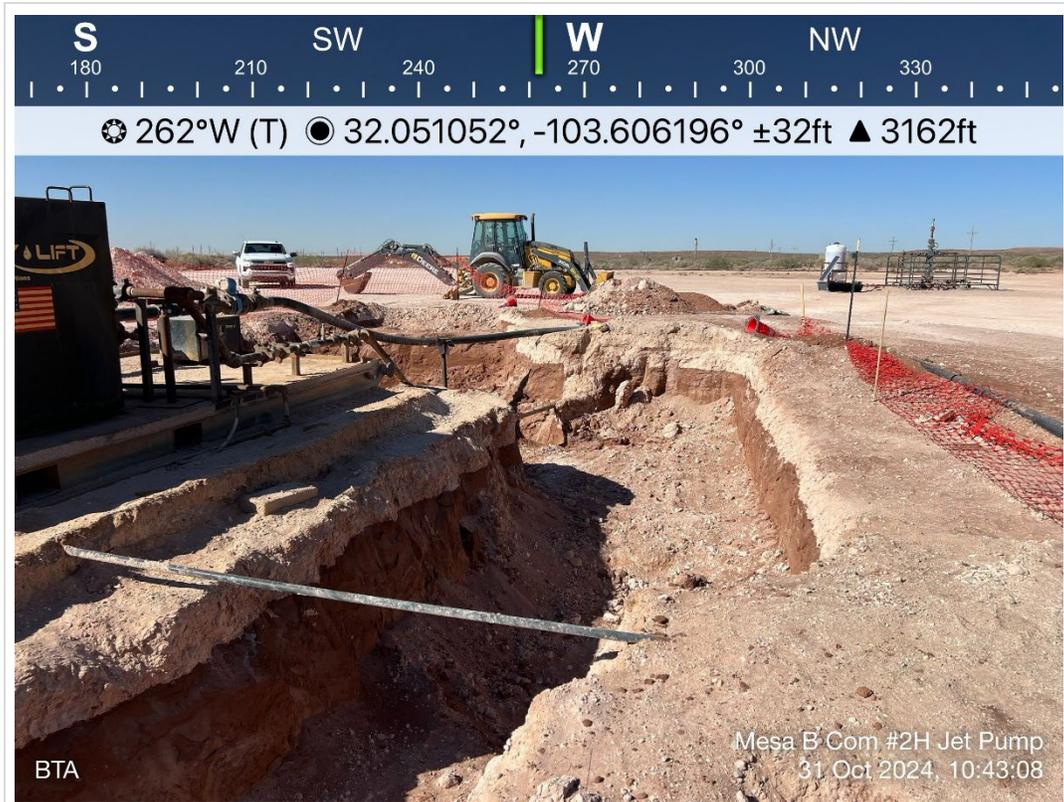
TETRA TECH, INC. PROJECT NO. 212C-MD-03639	DESCRIPTION	View of excavation progress in vicinity of jet pump.	6
	SITE NAME	Mesa B 8115 JV P Com #002H Jet Pump Release	10/31/2024

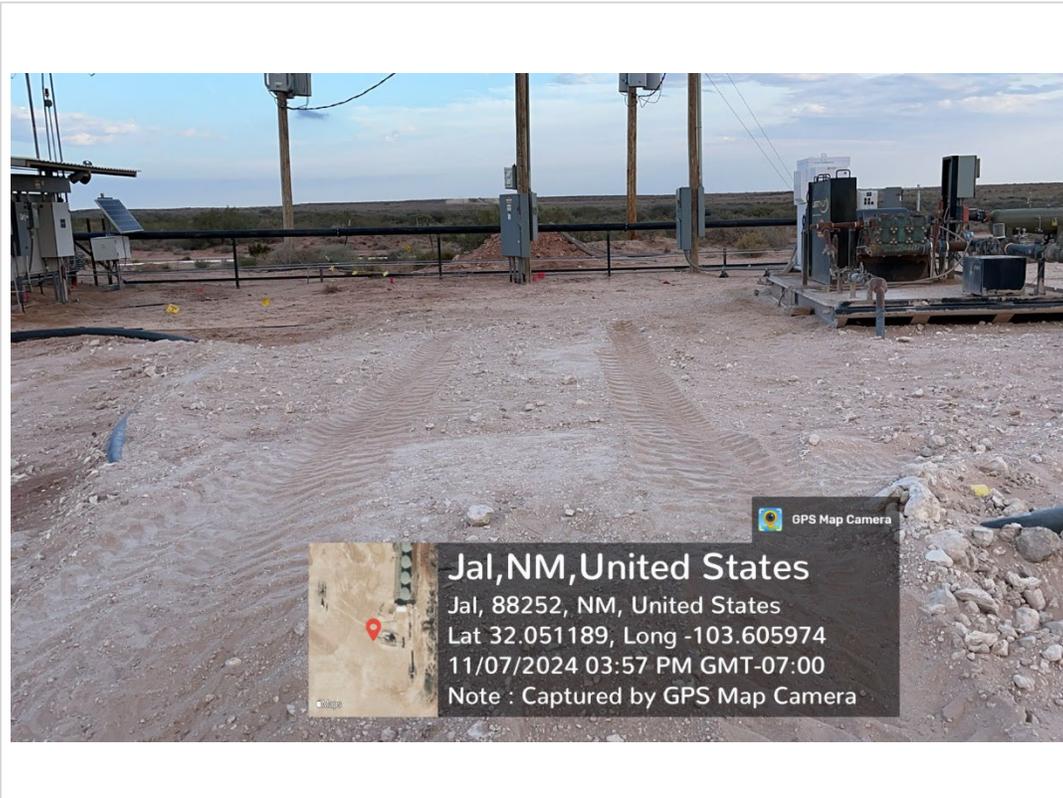
TETRA TECH, INC. PROJECT NO. 212C-MD-003639	DESCRIPTION	View of completed and backfilled excavation.	7
	SITE NAME	Mesa B 8115 JV P Com #002H Jet Pump Release	11/7/2024

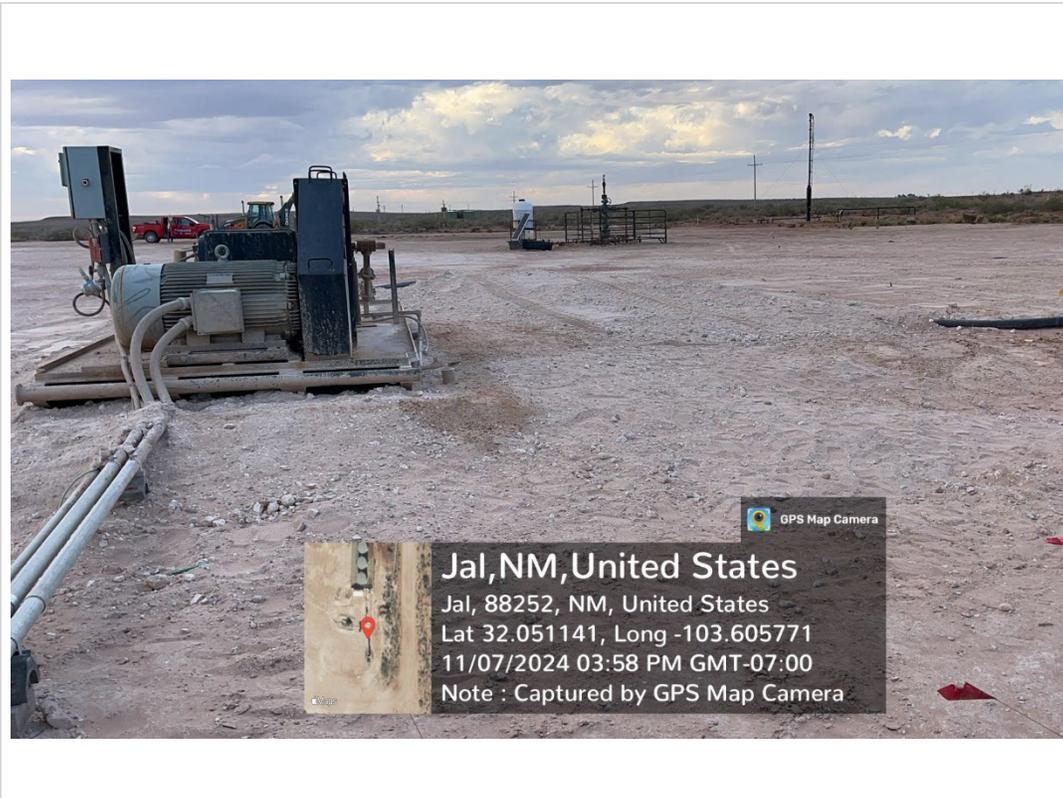
TETRA TECH, INC. PROJECT NO. 212C-MD-03639	DESCRIPTION	View of completed and backfilled excavation.	8
	SITE NAME	Mesa B 8115 JV P Com #002H Jet Pump Release	11/7/2024
