Soil Remediation and Closure Report

Vaca Draw 20-17 Federal #057H
Incident# nAPP2429872874
Lea County, New Mexico

Subject: **Soil Remediation and Closure Report**
Vaca Draw 20-17 Federal #057H
Lea County, NM

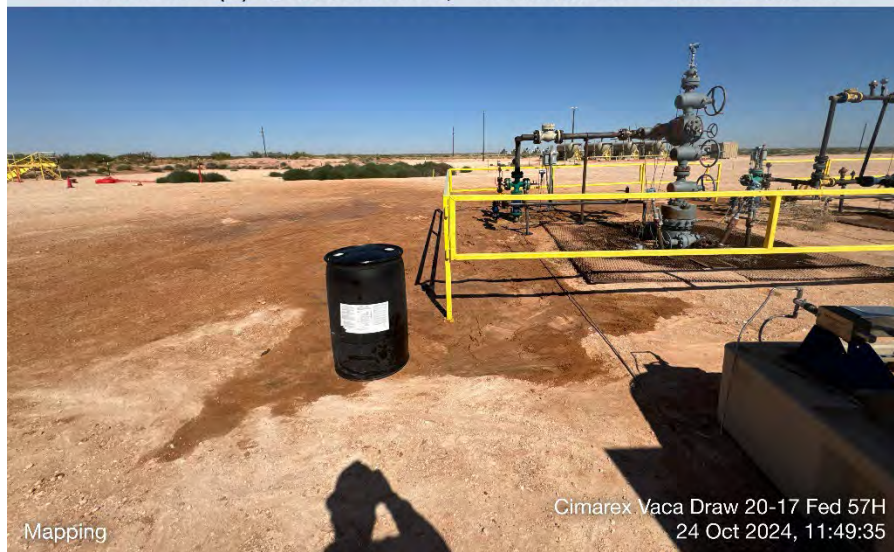
INITIAL RELEASE PHOTOGRAPHS**South East Elevation**

On October 24, 2024, it was discovered that the coupon packing gland had backed out due to the safety chain not being properly secured and tightened. This caused the release of 3 barrels (bbls) of produced water and 2 bbls of crude oil onto the well pad. A total of 2 bbls of crude oil were recovered.
