REMEDIATION CLOSURE REPORT

PREPARED FOR:
DEVON ENERGY PRODUCTION, LP.

PREPARED BY:
PIMA ENVIRONMENTAL SERVICES, LLC.

RE: Remediation Closure Report
LOCATION: Cotton Draw 13 Federal #1H
WELL API #: 30-015-40385
GPS (NAD83): 32.1239395, -103.7380219
INCIDENT LOCATION: M-13-T25S-R31E
COUNTY: Eddy
NMOCD REF. NO. nAPP2110326244

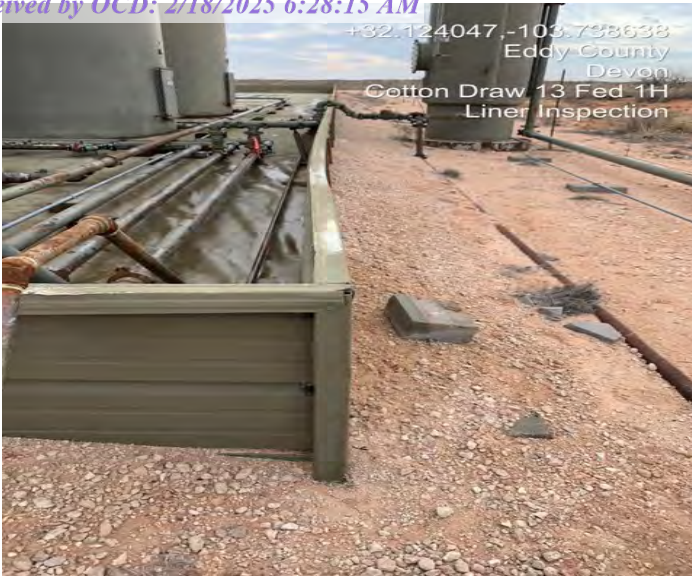
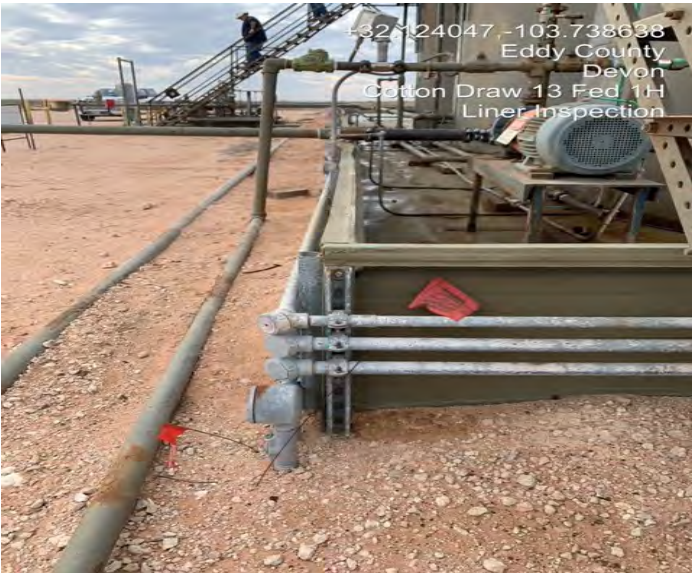
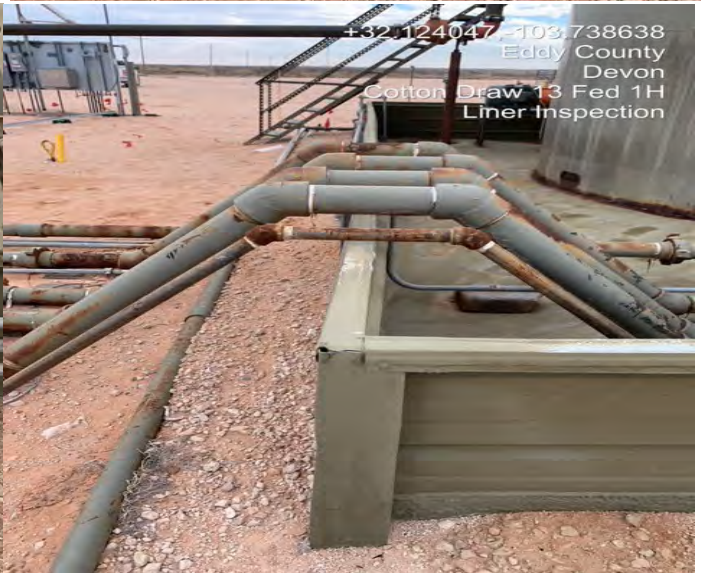
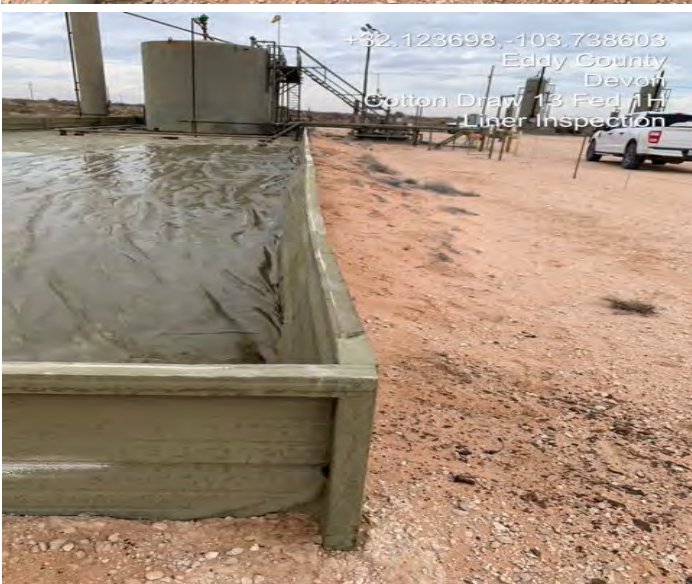
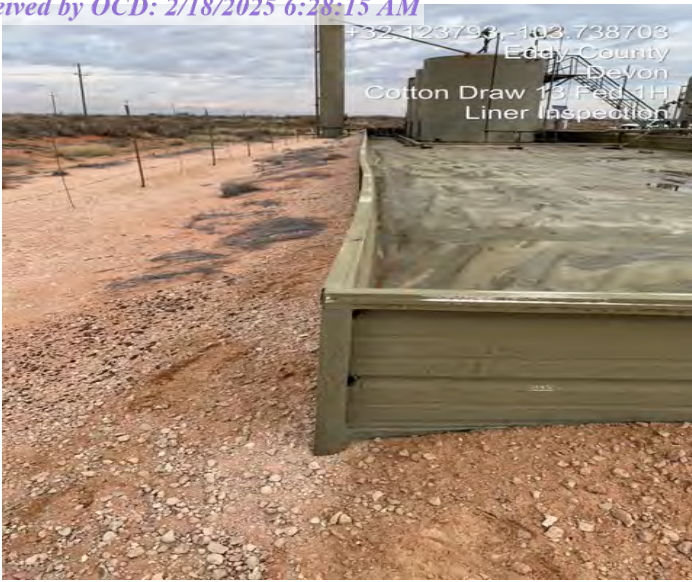
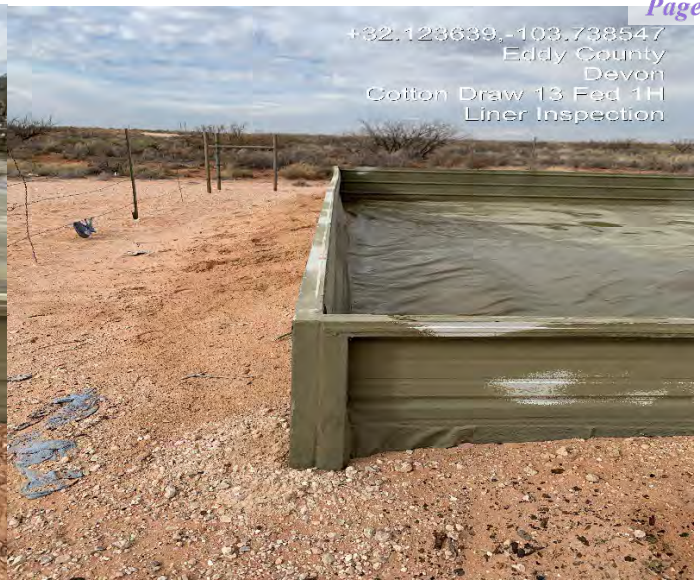
+32.124047, -103.738638
Eddy County
Devon
Cotton Draw 13 Fed 1H
Liner Inspection

+32.123698, -103.738603
Eddy County
Devon
Cotton Draw 13 Fed 1H
Liner Inspection

+32.123686, -103.738651
Eddy County
Devon
Cotton Draw 13 Fed 1H
Liner Inspection

+32.123793.-103.738703
Eddy County
Devon
Cotton Draw 13 Fed 1H
Liner Inspection

+32.123639.-103.738547
Eddy County
Devon
Cotton Draw 13 Fed 1H
Liner Inspection

On May 14, 2023, after a 48-hour notification of a liner inspection was submitted via email, Pima personnel mobilized to the site to perform the inspection. It was found that the deficiencies mentioned in the initial C141, in the containment wall at the southeast corner of the secondary containment, were still not properly repaired.

On January 5, 2024, after Devon submitted a 48-hour notification for a liner inspection, Pima personnel mobilized to the site to perform the final inspection. The deficiencies in the containment wall had been patched, the containment had been power washed, and the rest of the liner was inspected for tears, holes, and damage. None were found. It was concluded that this secondary containment liner now had the integrity to maintain a release. Photographic Documentation along with the Liner Inspection Form can be found in Appendix D.

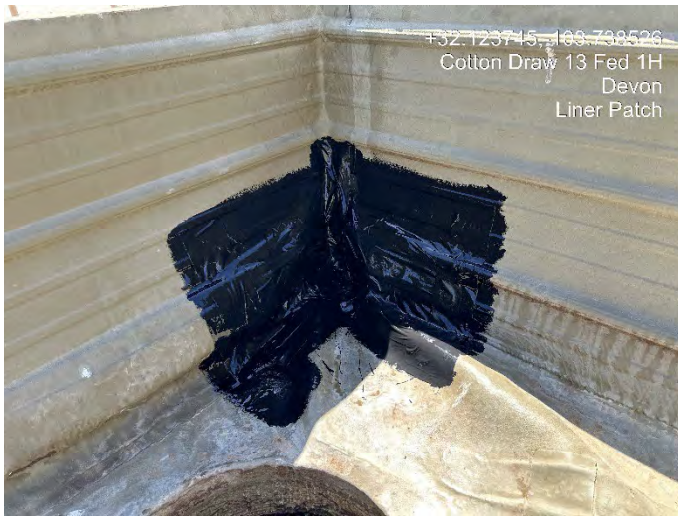
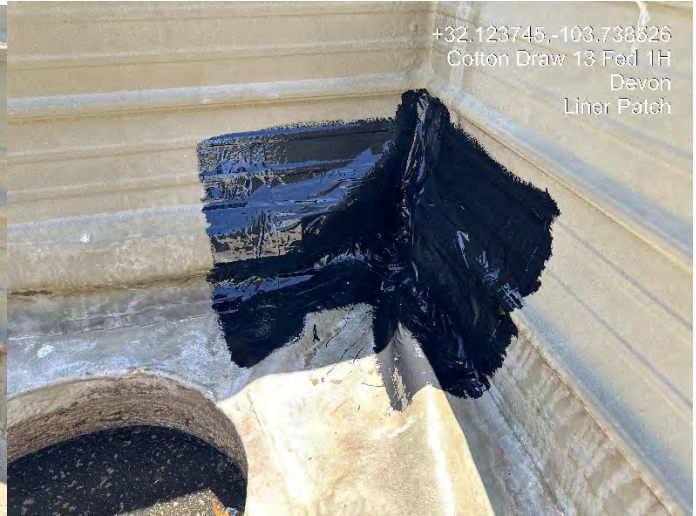
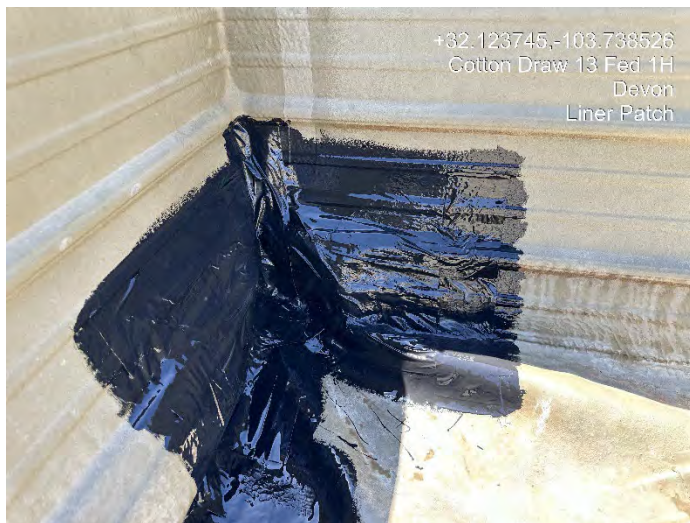
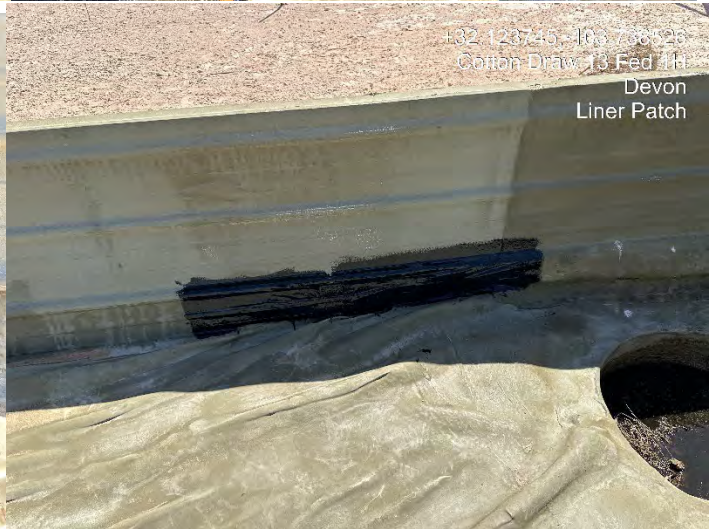
+32.123745.-103.738526
Cotton Draw 13 Fed 1H
Devon
Liner Patch
