Remediation Summary and Closure Report

**West Eumont Unit #410
API No. 30-025-04387
Incident No. nAPP2404472013
Lea County, New Mexico**

Forty Acres Energy, LLC
11757 Katy Freeway, Suite 725
Houston, Texas 77079

Crain Environmental
2925 East 17th Street
Odessa, Texas 79761

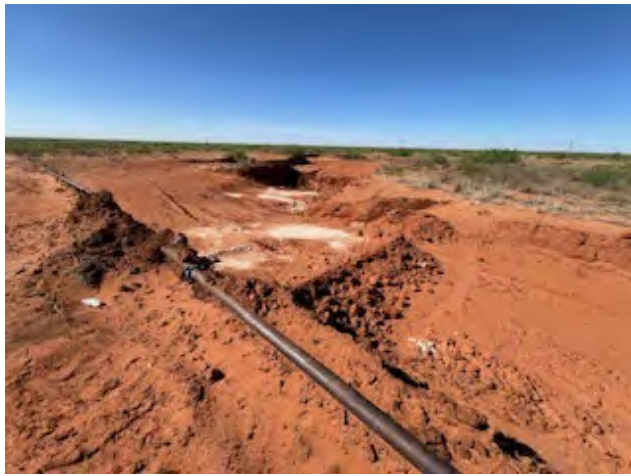
View to SE of release point and excavation (5/2/24).

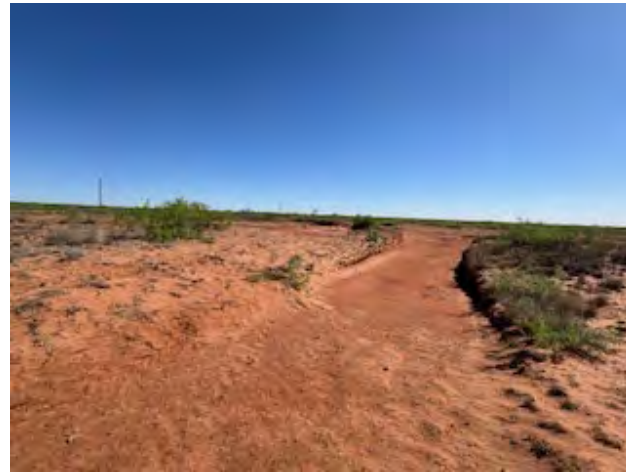
View to S of excavation (5/2/24).

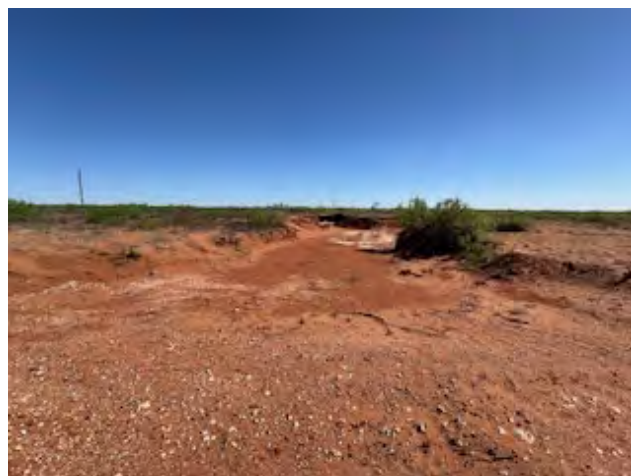
View to E of excavation (5/2/24).

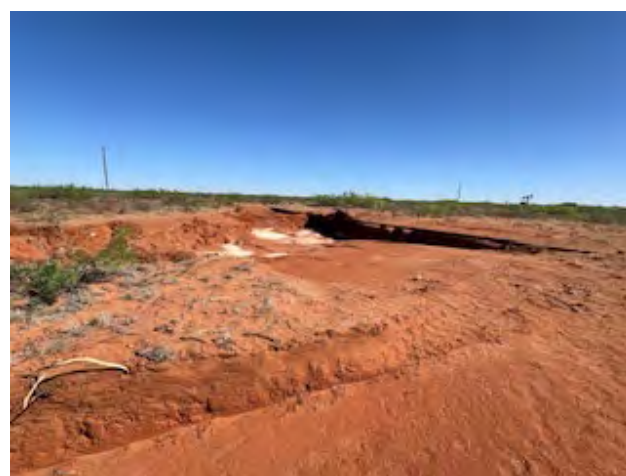
View to NW of excavation (5/2/24).

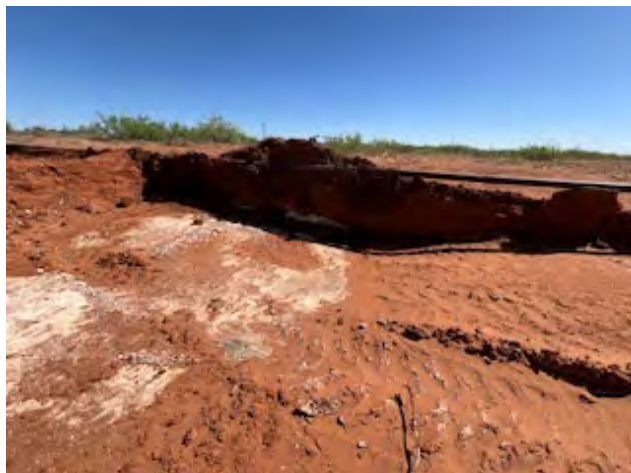
View to N of excavation at release point (5/2/24).

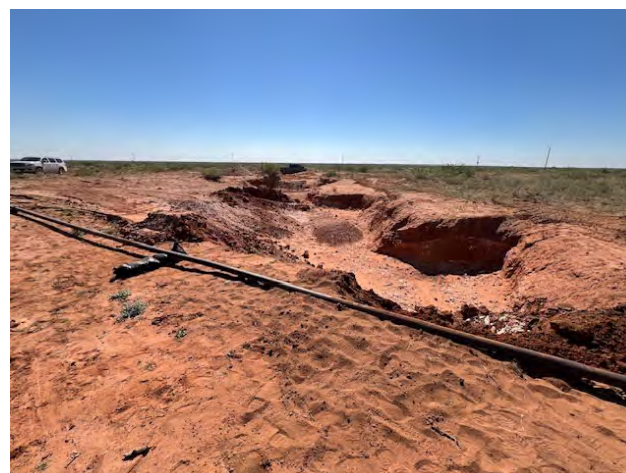
View to S of excavation (10/15/24).

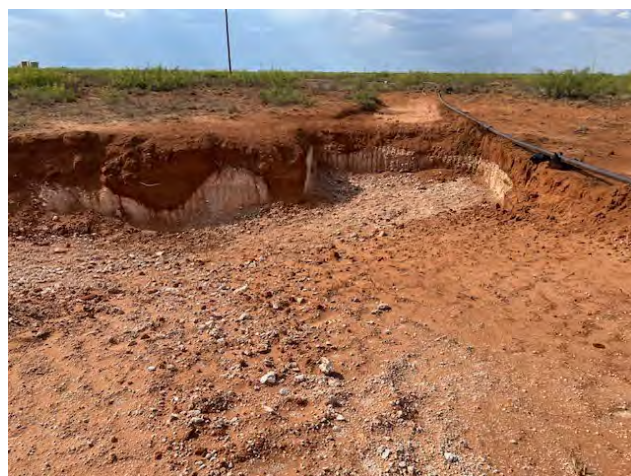
View to W of excavation (10/15/24).

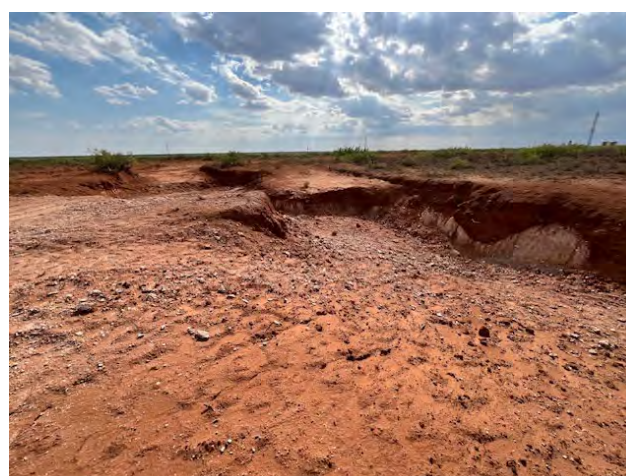
View to SW of excavation (10/15/24).

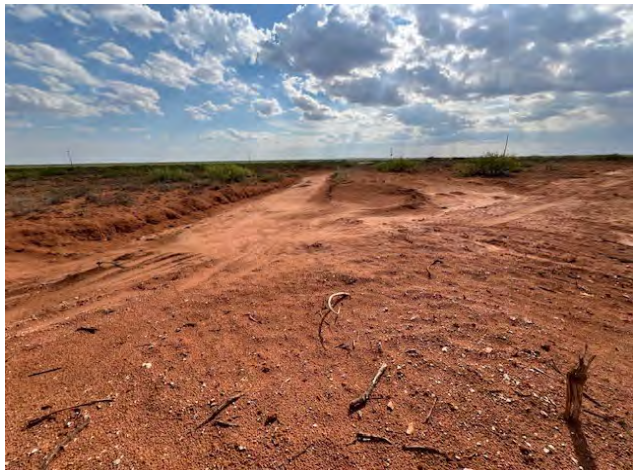
View to N of excavation (10/15/24).

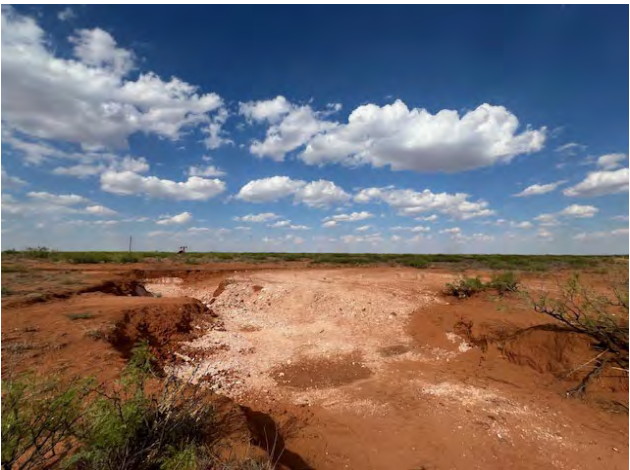
View to S of excavation (10/15/24).

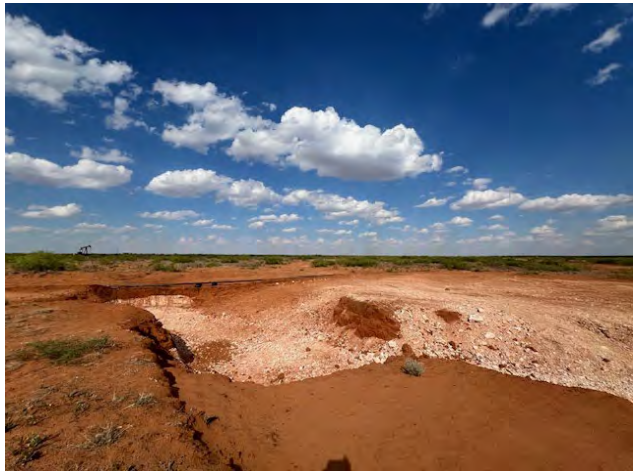
View to N of excavation (10/15/24).

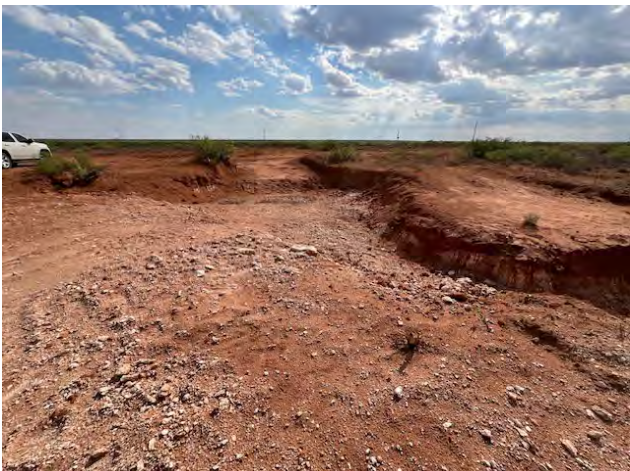
View to S of excavation (10/15/24).
