Pima Environmental Services, LLC  
5614 N. Lovington Hwy.  
Hobbs, NM 88240  
575-964-7740

December 4, 2024

**Re: Site Assessment, Remediation, and Closure Report**  
**Big N Tasty State Com #051H**  
**API No. 30-015-47696**  
**GPS: Latitude 32.86266 Longitude -103.84873**  
**UL "L", Sec. 2, T17S, R31E**  
**Eddy County, NM**  
**NMOCD Ref. No. NAPP2419132456**

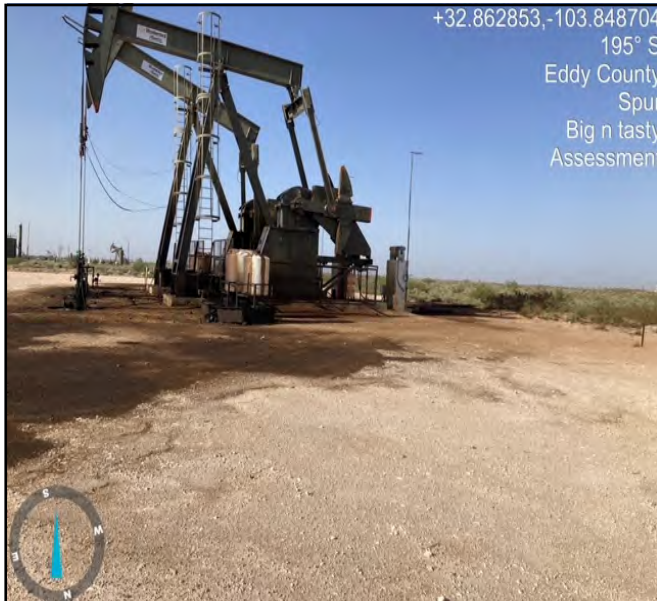
Photo showing the release that occurred on pad facing South.

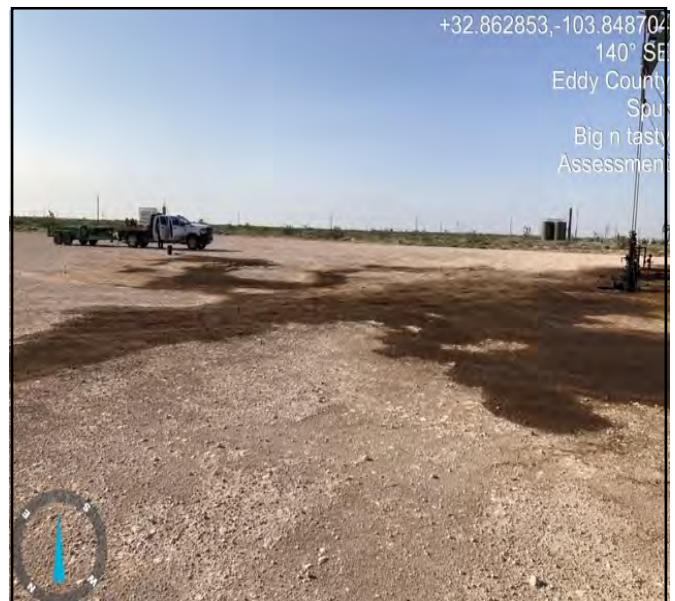
Photo showing the release that occurred on pad facing South.

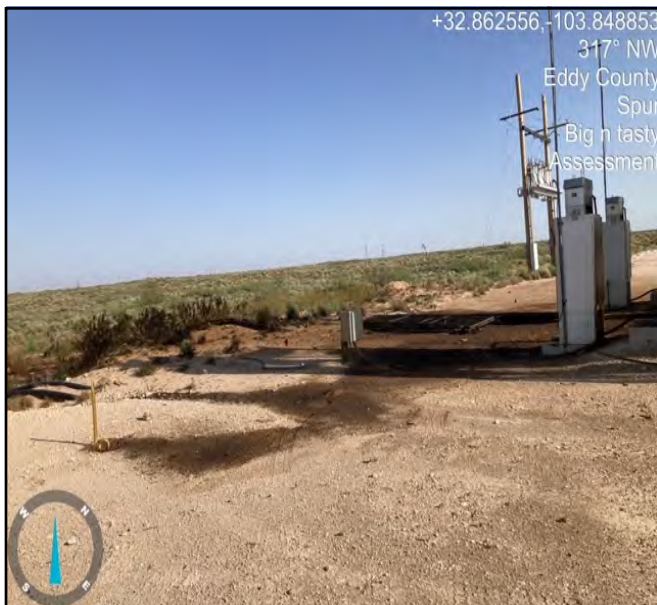
Photo showing the release that occurred on pad facing South.

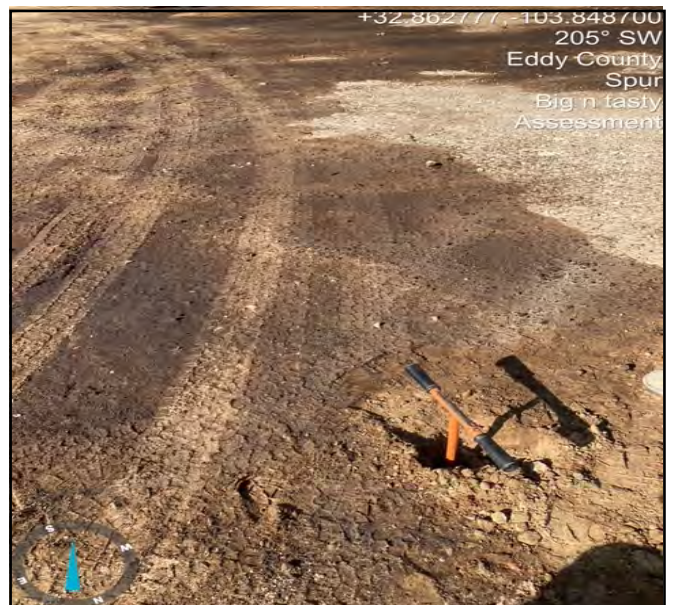
Photo of hand auger in ground to gather samples facing Southwest.

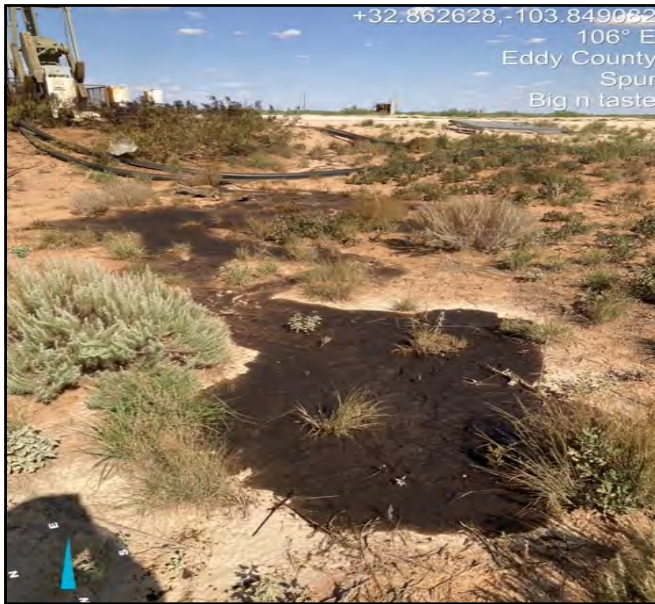
Photo showing the release that occurred on pad and leaked onto the pasture facing East.

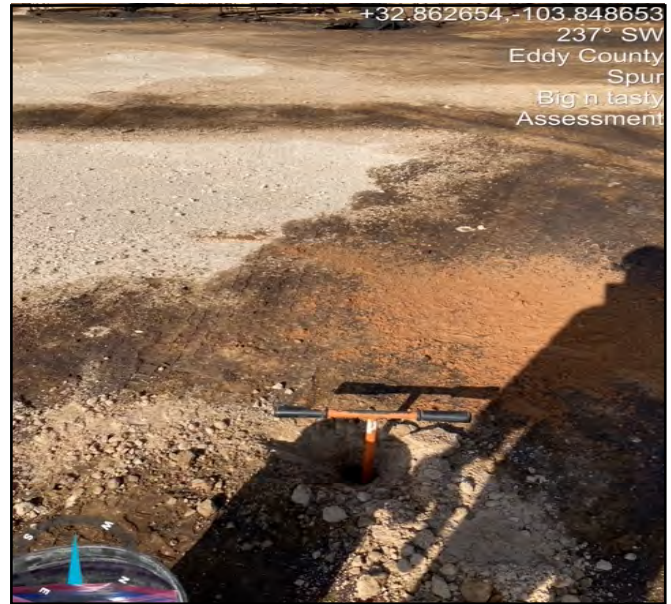
Photo of hand auger in ground to gather samples facing Southwest.

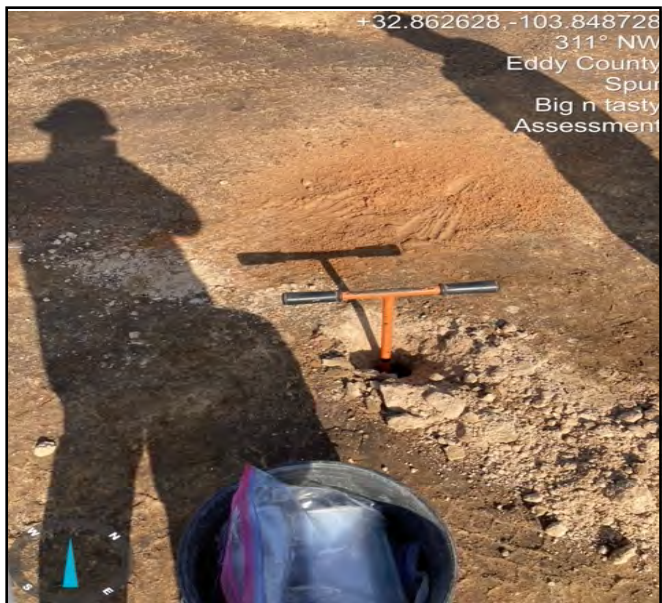
Photo of hand auger in ground to gather samples facing Northwest.

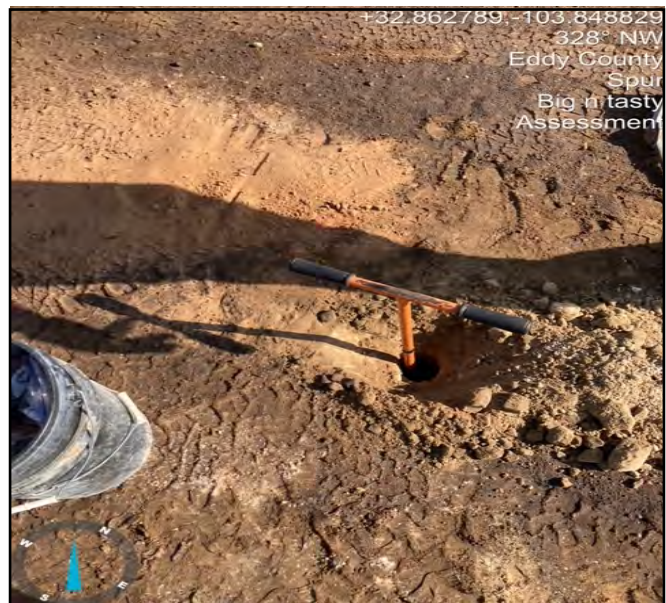
Photo of hand auger in ground to gather samples facing Northwest.

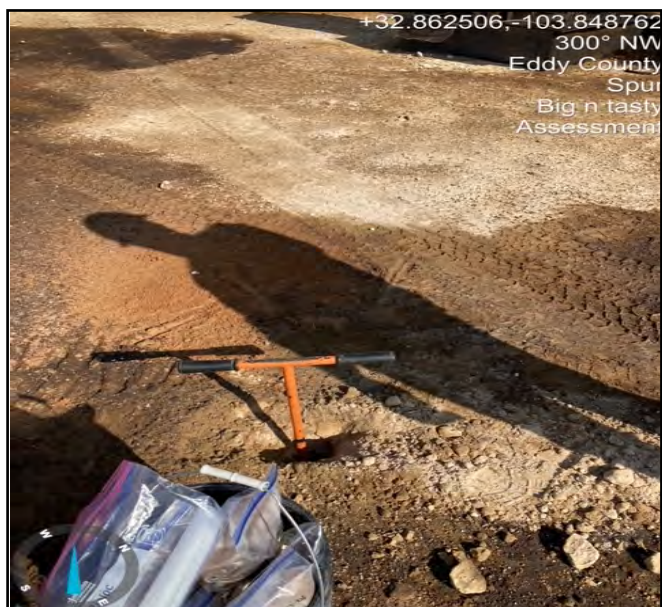
Photo of hand auger in ground to gather samples facing Northwest.

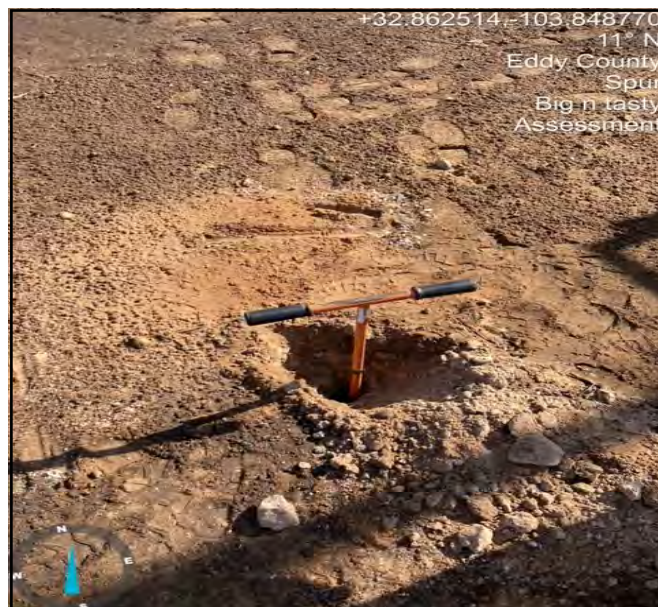
Photo of hand auger in ground to gather samples facing North.

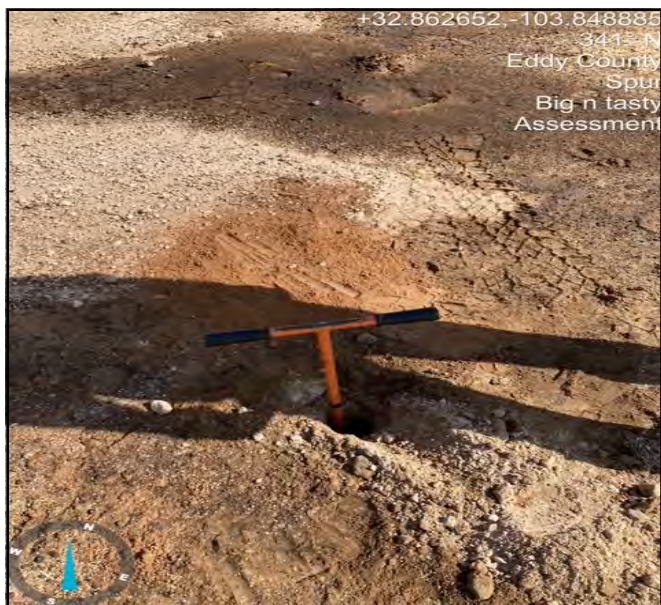
Photo of hand auger in ground to gather samples facing North.

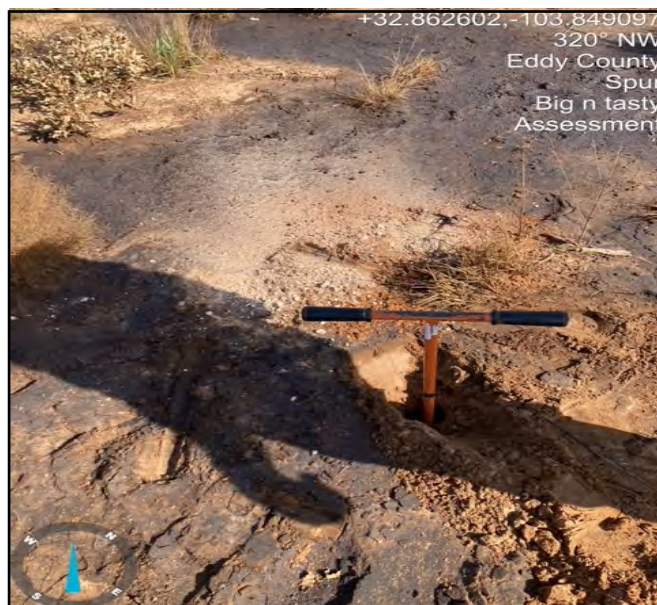
Photo of hand auger in ground to gather samples facing Northwest.

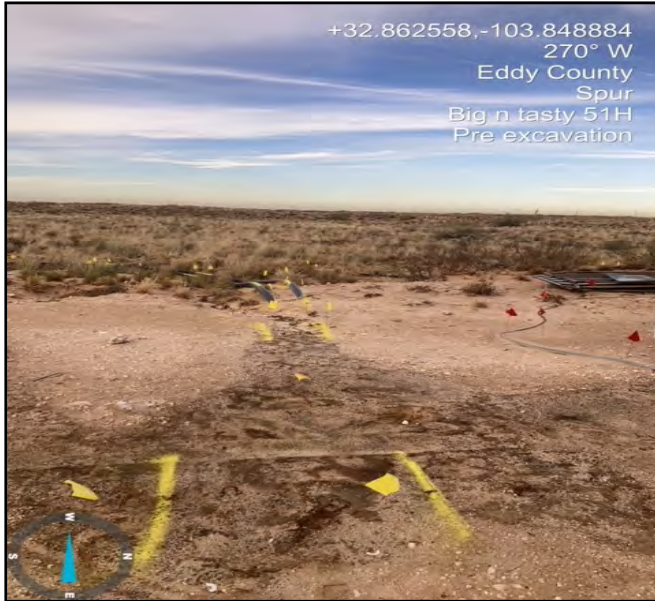
Photo showing the site being flagged to show the excavation area facing West.

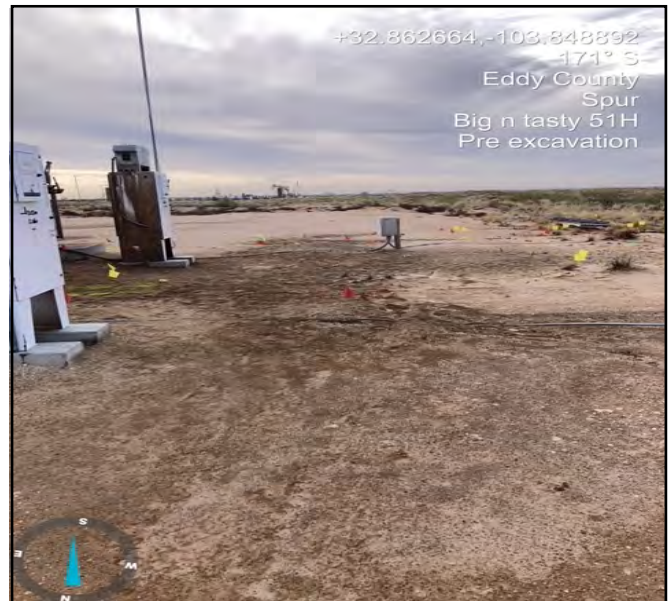
Photo showing the site being flagged to show the excavation area facing West.

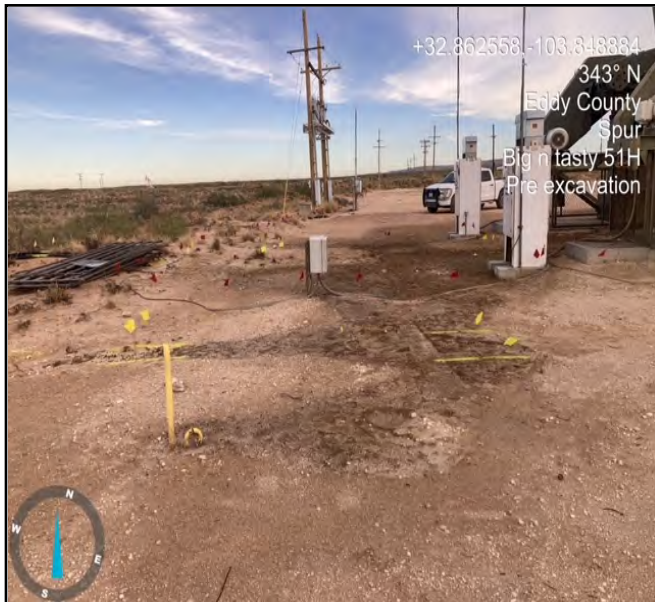
Photo showing the site being flagged to show the excavation area facing North.

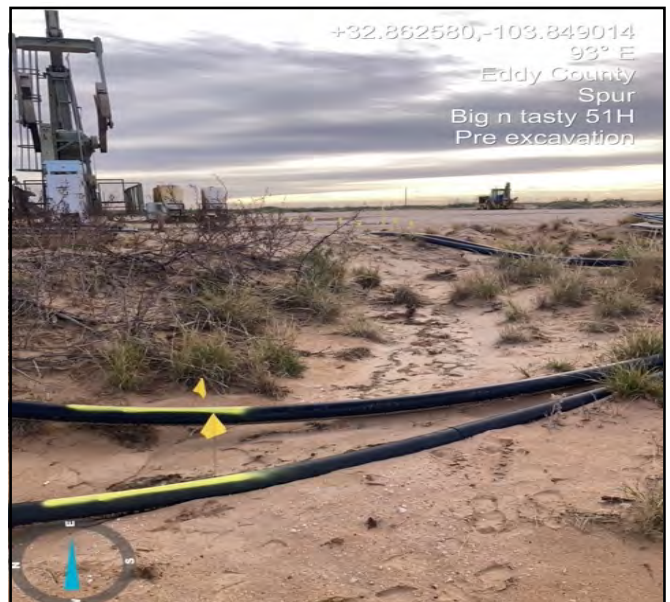
Photo showing the site being flagged to show the excavation area facing East.

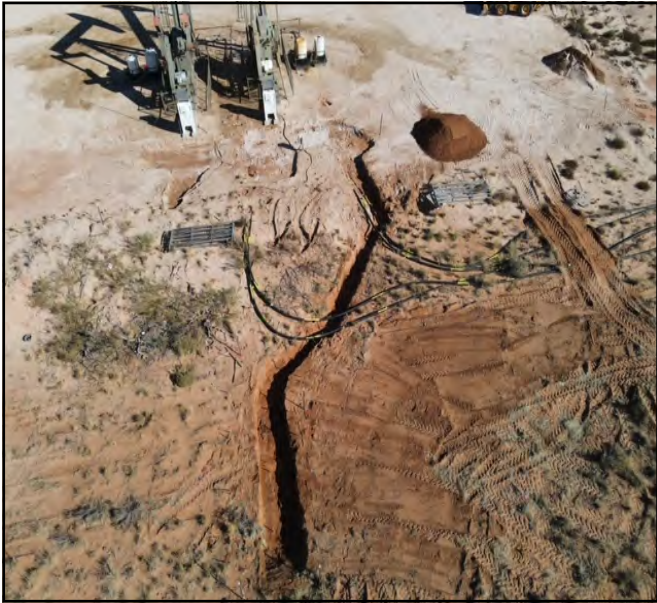
Photo of the release area being completely excavated.

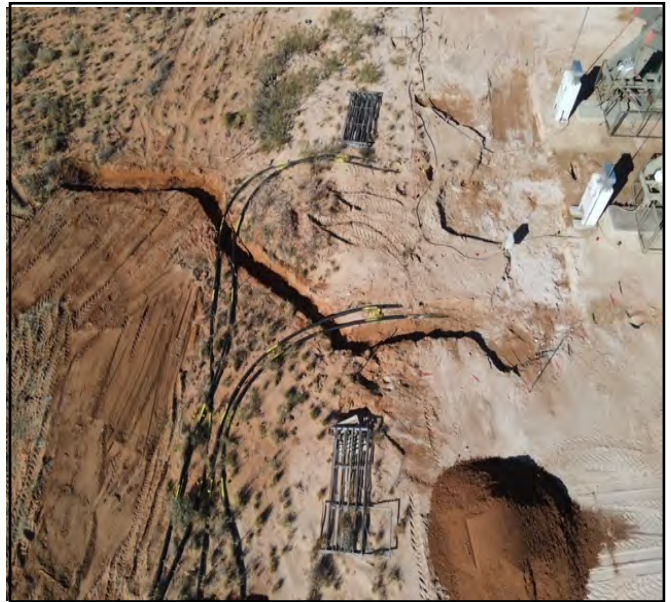
Photo of the release area being completely excavated.

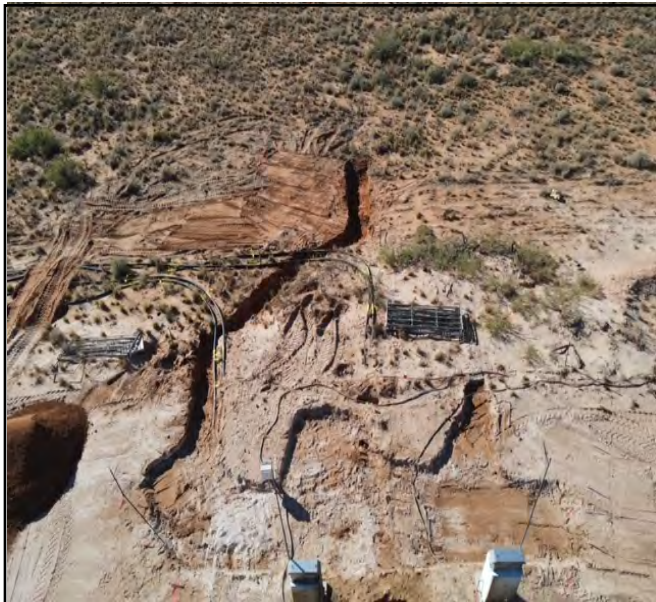
Photo of the release area being completely excavated.

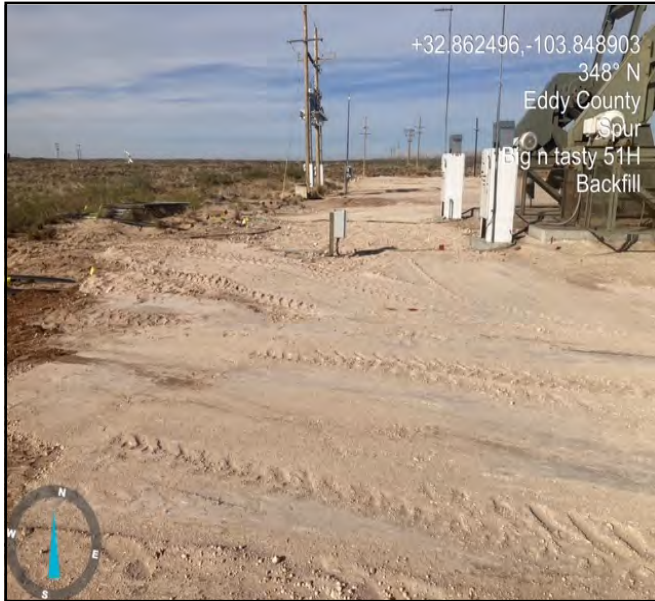
Photo showing the site being backfilled with clean material facing North.

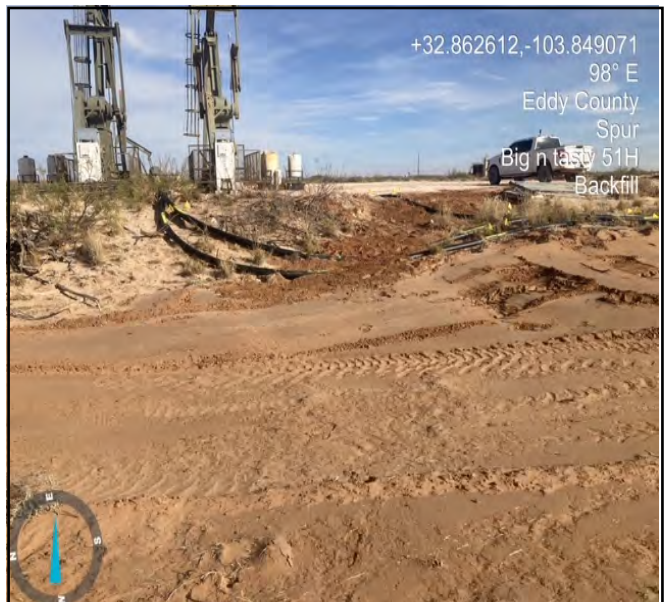
Photo showing the site being backfilled with clean material facing East.

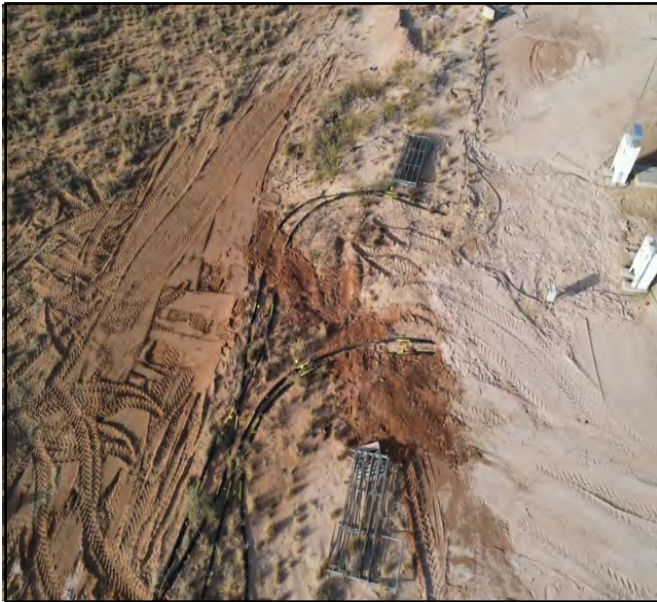
Photo showing the excavated area backfilled with clean material.

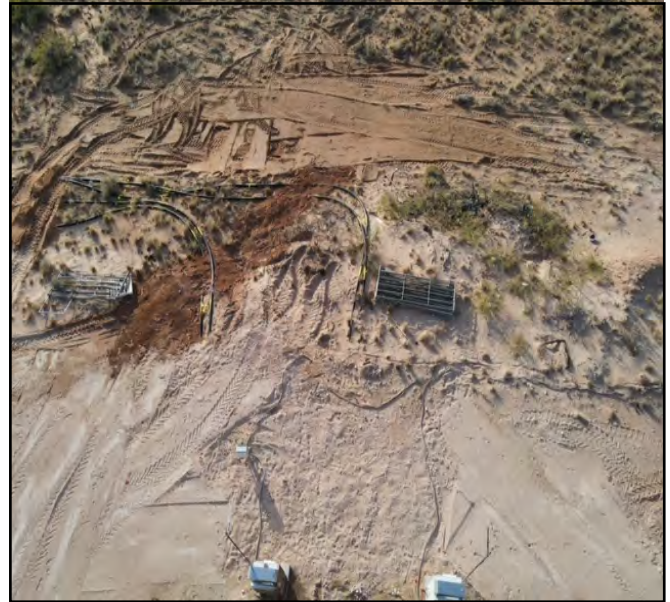
Photo showing the excavated area backfilled with clean material.

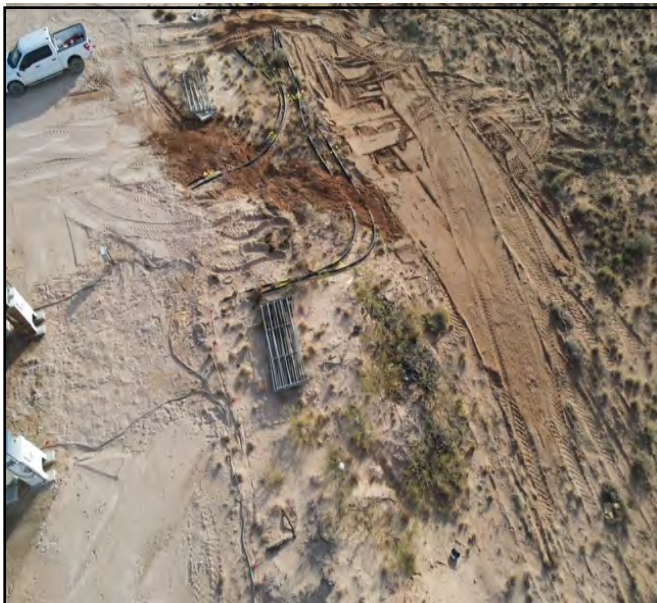
Photo showing the excavated area backfilled with clean material.

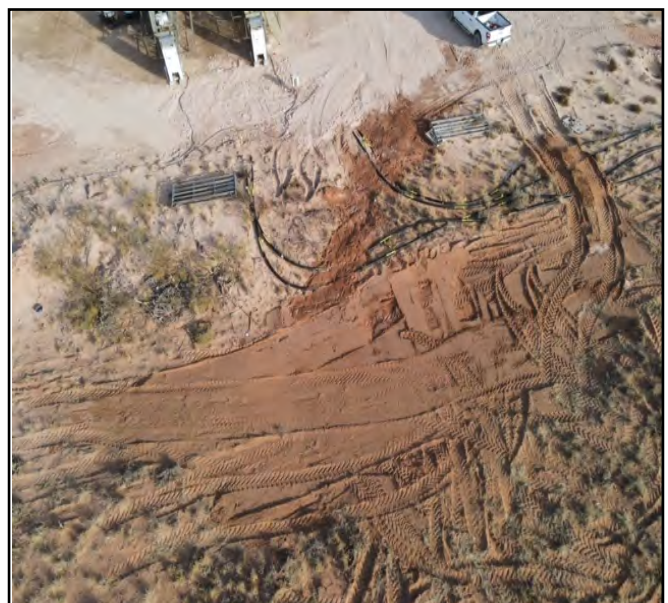
Photo showing the excavated area backfilled with clean material.
