**Re: Closure Request
PLU 42 Battery
Incident Number nAPP2426427757
Eddy County, New Mexico**

XTO Energy, Inc.
Closure Request
PLU 42 Battery

XTO Energy Inc.
PLU 42 Battery
Incident Number: NAPP2426427757
Unit G, Sec 10, T25S, R30E
Eddy County, New Mexico

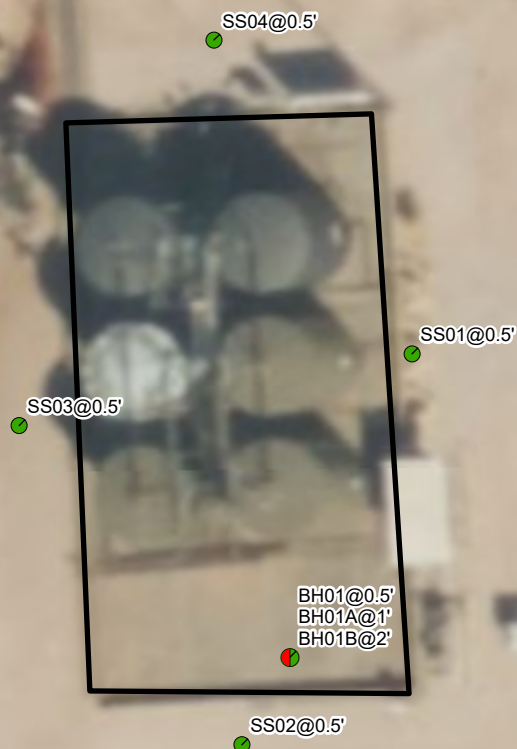
FIGURE
2

On October 31, 2024, Ensolum personnel were at the Site to oversee delineation activities. Four delineation soil samples (SS01 through SS04) were collected around the lined containment from a depth of approximately 0.5 feet bgs to assess the lateral extent of the release. Borehole, BH01, was advanced via hand auger to a terminal depth of 2-foot bgs in the location of the tear in the liner. The delineation soil samples were field screened for volatile organic compounds (VOCs) utilizing a calibrated photoionization detector (PID) and chloride utilizing Hach® chloride QuanTab® test strips. Field screening results and observations of the soil samples from the borehole were logged on a lithologic/soil sampling log, which is included in Appendix C. The delineation soil sample locations were mapped utilizing a handheld Global Positioning System (GPS) unit and are depicted on Figure 2. Photographic documentation is included in Appendix B.

Delineation Soil Sample Locations

Laboratory analytical results for delineation soil samples SS01 through SS04 indicated all COCs were in compliance with Site Closure Criteria, confirming the release remained within the lined containment. Delineation soil samples from borehole BH01 indicated all COCs were in compliance with Site Closure Criteria. Laboratory analytical results are summarized in Table 1 and the laboratory analytical reports are included in Appendix D.

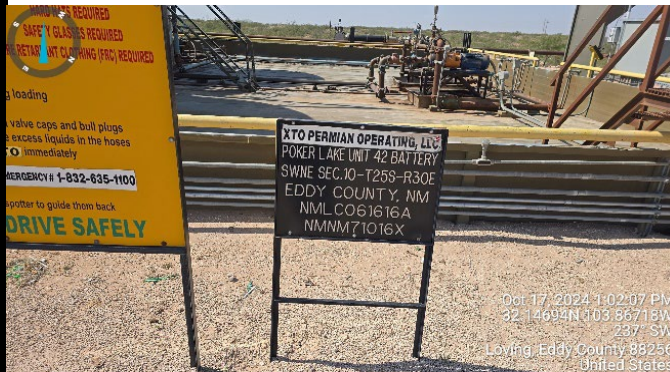
Photograph: 1 Date: 10/17/2024
Description: Liner inspection activities
View: West

After a review of the C-141, internal documents, and initial release photographs, it was confirmed the release occurred within the lined containment. The lined containment was cleaned of all debris, power washed and a 48-hour advance notice of the liner inspection was submitted to the NMOCD on October 9, 2024. On October 17, 2024, the lined containment was inspected by Ensolum personnel and was determined to contain a small tear. Delineation to determine the extent of the release was warranted. A site map of the lined containment is included in Figure 2. Photographic documentation of the inspection is included in Appendix B.

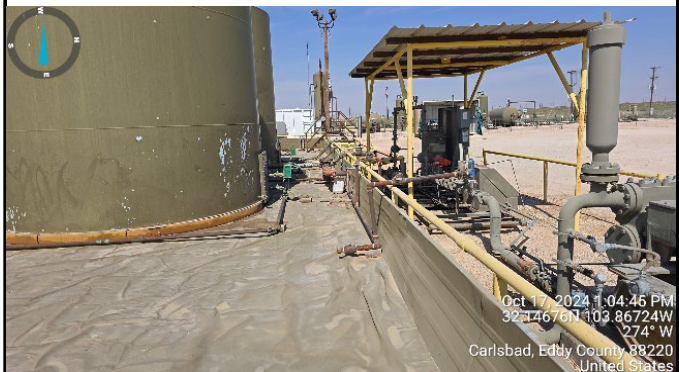
Photograph: 2 Date: 10/17/2024
Description: Liner inspection activities
View: West

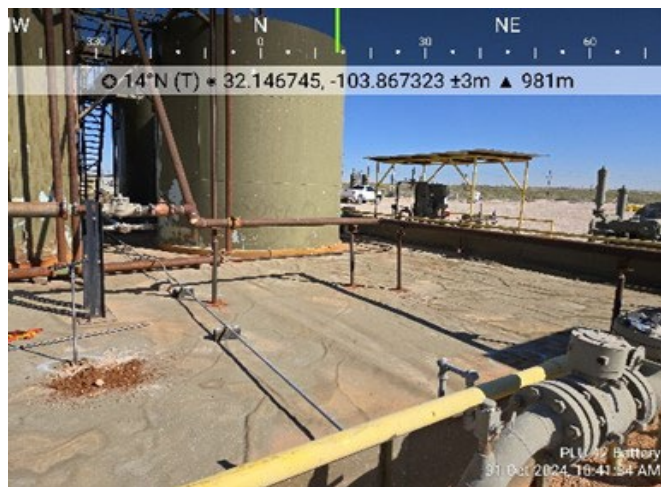
Photograph: 3 Date: 10/31/2024
Description: Delineation activities
View: North

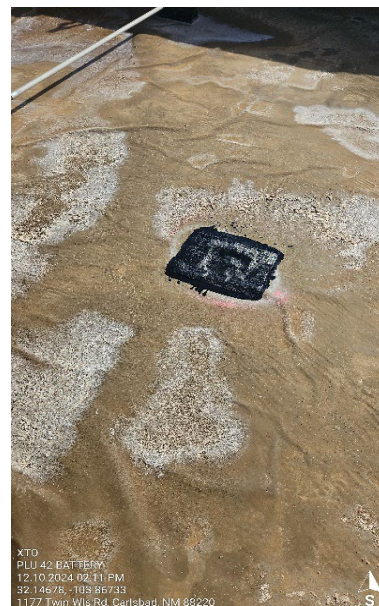
Photograph: 4 Date: 12/10/2024
Description: Patched liner tear
View: South

Liner integrity inspection and delineation activities were conducted at the Site to address the September 29, 2024, release of produced water. Laboratory analytical results for the delineation soil samples, collected in the liner tear, indicated that all COC concentrations were compliant with the Site Closure Criteria. Based on the soil sample analytical results, no impacted soil was identified, and no further remediation was required. XTO has patched the tear in the liner following completion of delineation activities.
