**Re: Closure Request
PLU 28 Big Sinks West BTY
Incident Number nAPP2421839212
Eddy County, New Mexico**

Ensolum, LLC (Ensolum) on behalf of XTO Energy, Inc. (XTO), has prepared this *Closure Request* to document site assessment and soil sampling activities at the PLU 28 Big Sinks West BTY (Site). The purpose of the site assessment and soil sampling activities was to assess the presence or absence of impacts to soil following a release of produced water. Based on field observations, field screening activities, and soil sample laboratory analytical results, XTO is submitting this *Closure Request*, describing liner inspection and delineation activities that have occurred and requesting no further action for Incident Number nAPP2421839212.

XTO Energy, Inc
Closure Request
PLU 28 Big Sinks West BTY

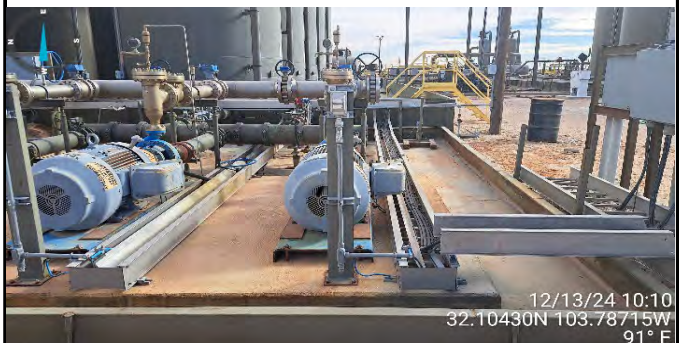
Photograph: 2
 Description: Liner inspection activities
 View: East

After a review of the C-141, internal documents, and initial release photographs, it was confirmed the release occurred within the lined containment. The lined containment was cleaned of all debris, power washed and a 48-hour advance notice of the liner inspection was submitted on December 5, 2024. On December 13, 2024, the lined containment was inspected by Ensolum personnel and was determined to be operating as designed. Upon inspection, no rips, tears, holes, or damage were observed. The liner was determined to be sufficient, and all released fluid had been recovered. The release extent was mapped utilizing a handheld Global Positioning System (GPS) unit. Photographic documentation of the inspection is included in Appendix B.

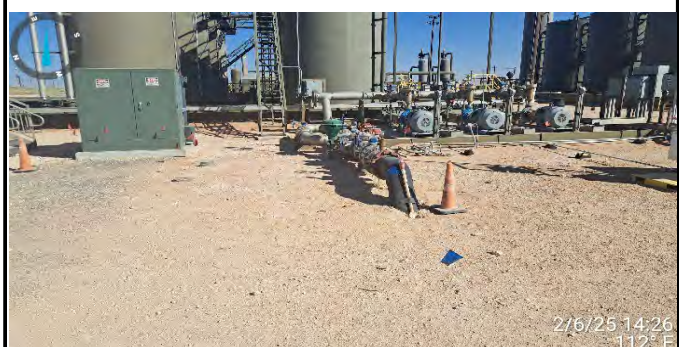
Photograph: 4
 Description: Delineation activities
 View: East

On February 6, 2025, Ensolum personnel returned to the Site to conduct delineation activities. Three delineation soil samples, SS01 through SS03, were collected from a depth of approximately 1-foot bgs around the release to assess the lateral extent. Due to production equipment and lined containment areas directly adjacent, no lateral surface samples were collected to the east. Additionally, two boreholes, BH01 and BH02, were advanced via hand auger within the release extent to a terminal depth of 1-foot bgs. Two 5-point confirmation soil samples, CS01 and CS02, were collected from a depth of 0.5 feet bgs within the release extent representing no more than 200 square feet. The 5-point composite soil samples were collected by placing five equivalent aliquots of soil into a 1-gallon, resealable plastic bag and homogenizing the samples by thoroughly mixing. The soil samples were field screened for volatile organic compounds (VOCs) utilizing a calibrated photoionization detector (PID) and chloride
