RE: Remediation Closure Request – Northeast Blanco Unit #441A
API #30-045-31893; Incident ID nAPP2412451900
Simcoe LLC
Latitude/Longitude: 36.794517/-107.62274
San Juan County, New Mexico

Cottonwood Consulting, LLC (Cottonwood), on behalf of Simcoe LLC (Simcoe), is pleased to provide you with a closure summary for the release at Simcoe's Northeast Blanco Unit (NEBU) #441A (API #30-045-31893; Incident ID nAPP2412451900) well site. Details regarding the release, sampling results, and remediation are summarized below.

NEBU #441A
Photographic Log
Simcoe LLC

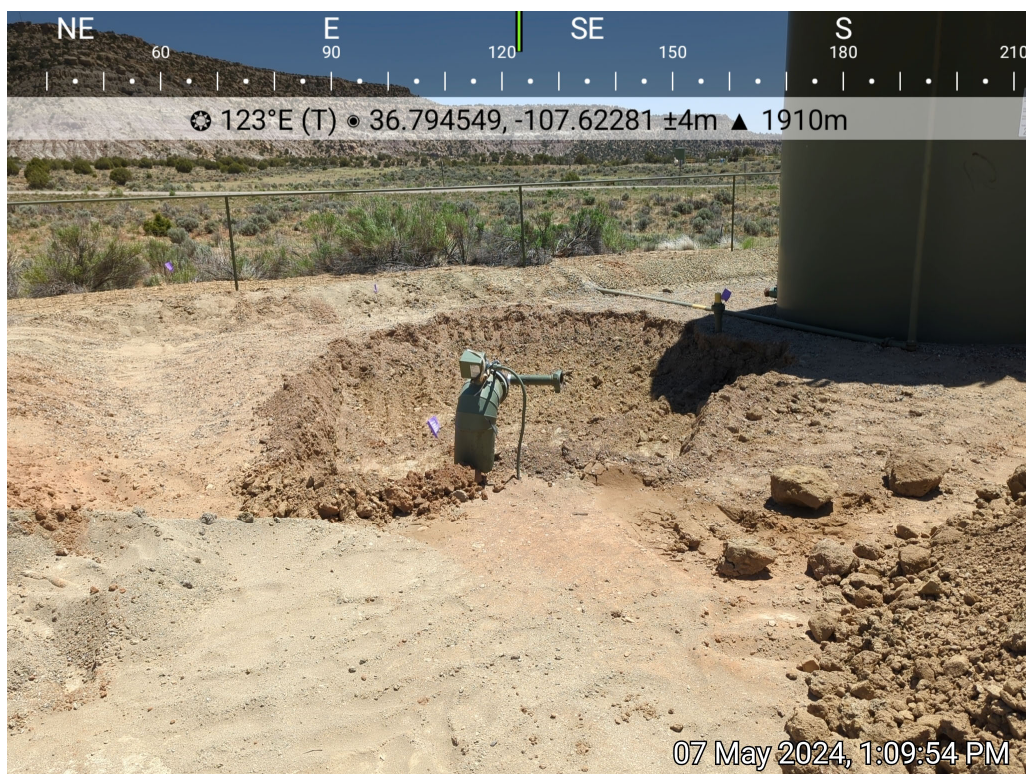
Photo 3: Excavation area.

Approximately 20 yards of impacted material were excavated and hauled to Envirotech's Landfarm. Bills of lading are included as Attachment 5. The excavated area was backfilled with clean soil. Because the release and excavation area were located on the working surface of the NEBU #441A well pad, no reseeding or other reclamation activities have occurred. The release area will be reclaimed during final reclamation of the well pad.

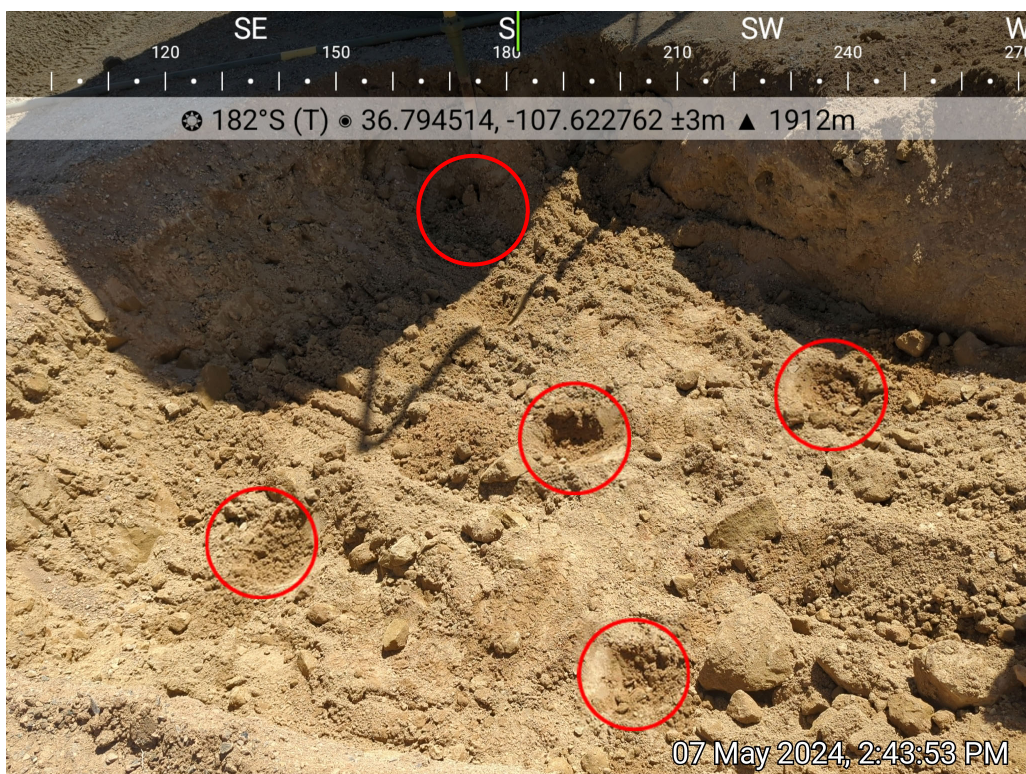
Photo 4: SS01 collected as a 5-point composite sample from the excavation area.

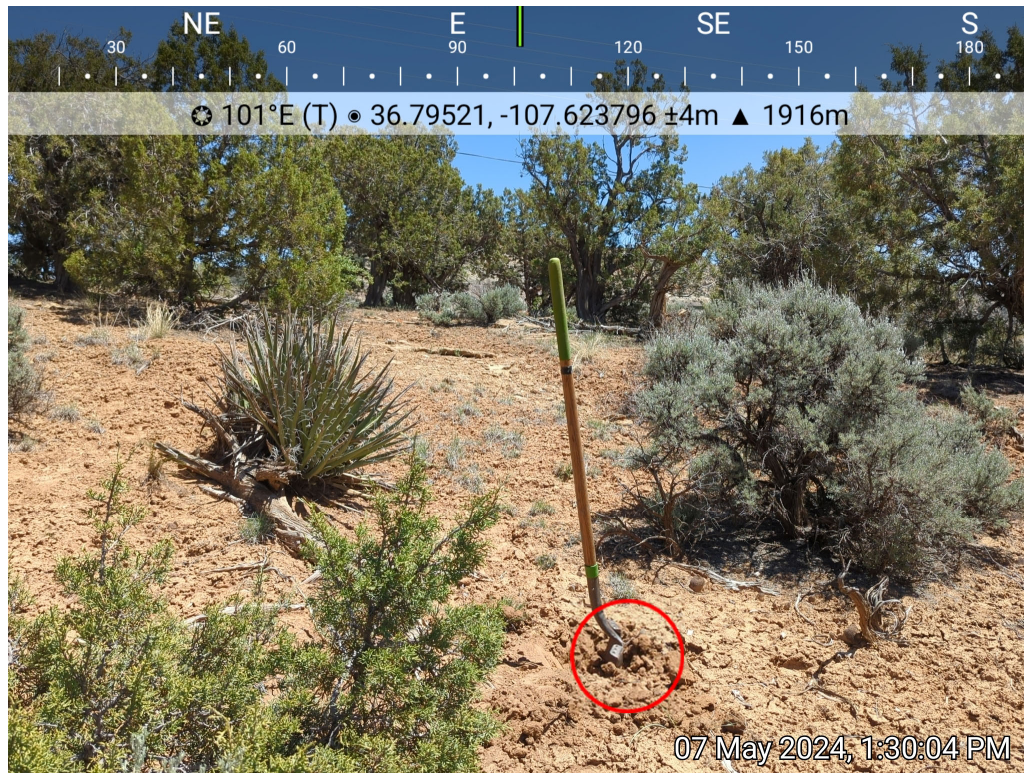
Photo 5: BG01 collected as a background sample upgradient of the release.

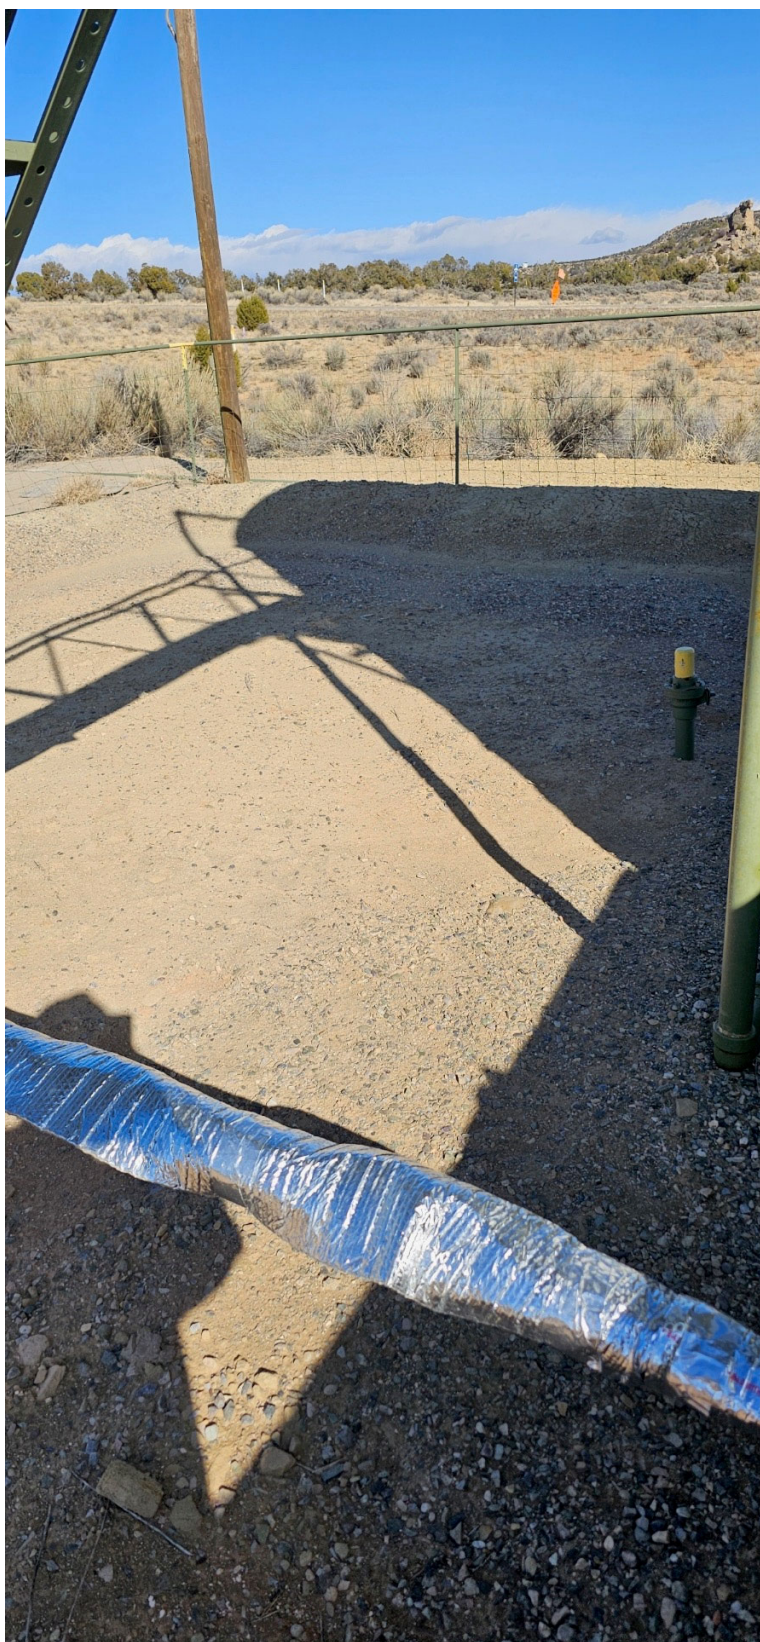
Photo 6: The backfilled area following tank removal and remediation. Photo from Simcoe.

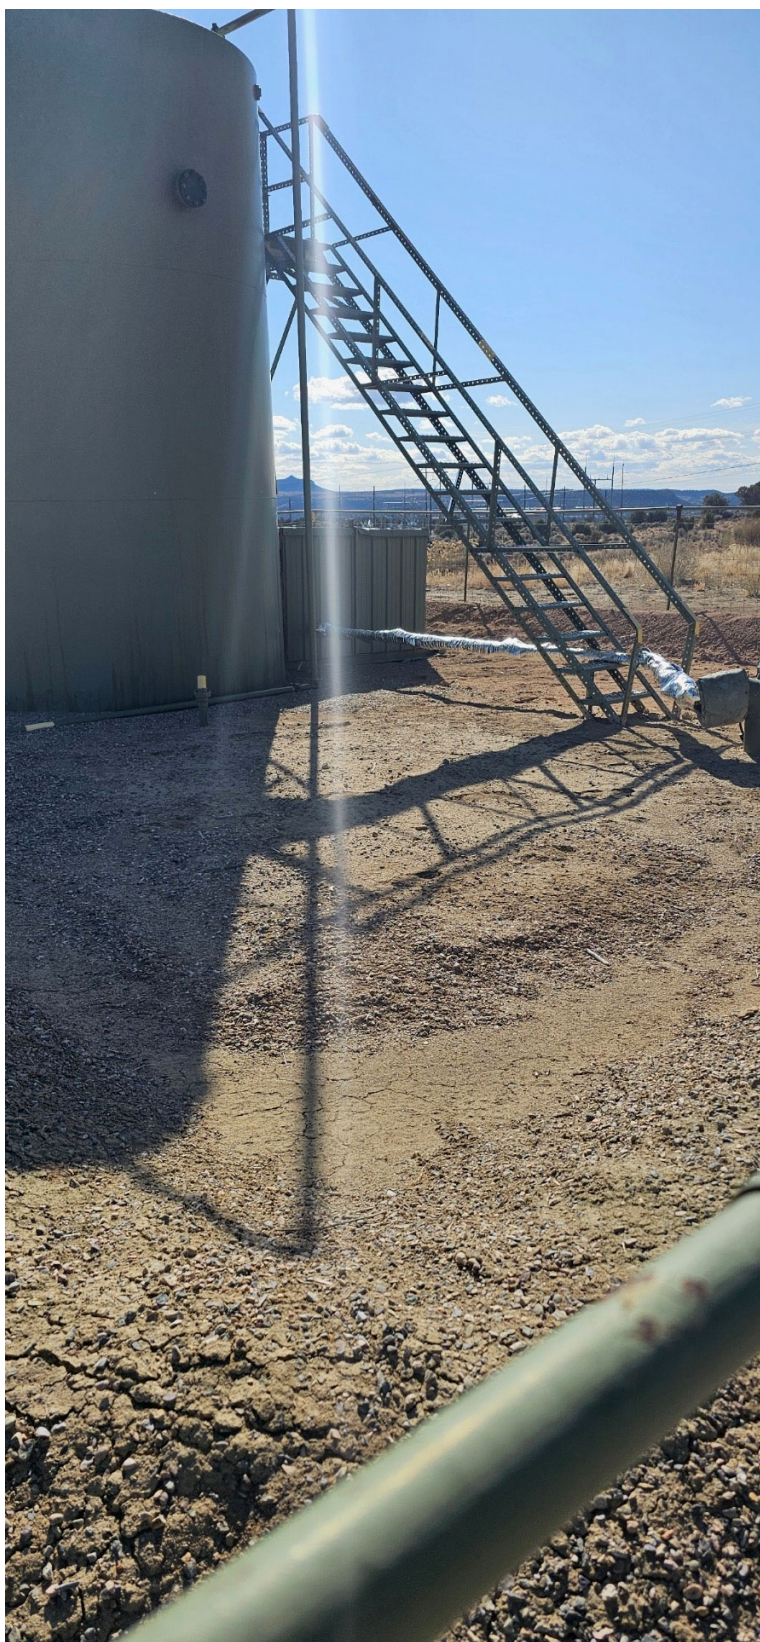
Photo 7: The backfilled area following tank removal and remediation. Photo from Simcoe.
