RECLAMATION REPORT

PREPARED FOR:
DEVON ENERGY PRODUCTION, LP.

PREPARED BY:
PIMA ENVIRONMENTAL SERVICES, LLC.

RE: Reclamation Report
LOCATION: Galapagos 14 CTB 2
FACILITY ID: fAPP2123647067
GPS (NAD83): 32.310878472, -103.7485736
INCIDENT LOCATION: D-14-T23S-R31E
COUNTY: Eddy
NMOCD REF. NO. nAPP2207536482

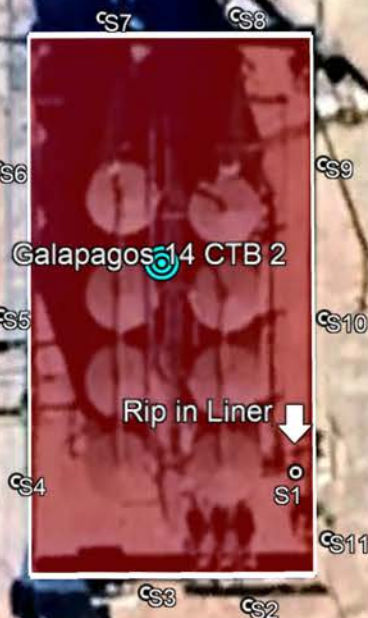
Devon Energy
Facility ID fAPP2123647067
Eddy County, NM
nAPP2207536482
Delineation Map

On November 17, 2023, Pima personnel arrived on site to complete the delineation sampling event. Discreet samples were collected from the area in the liner where a tear was found, and around the outside of the metal wall containment. A total of 11 sample points were collected from depth intervals of 0 to 4 feet below grade surface (bgs). A background sample was also collected from just off the pad site to the south. A total of 46 samples were put on ice, jarred, and delivered to Envirotech Laboratories for official testing. All samples were tested for all constituents. A sampling notification was not submitted for this sampling event, due to it was not required for delineation samples at the time these were collected. The results of the lab testing for this sampling event can be found in Figure 1. A corresponding Delineation Map can be found in Figure 2.

- Background sample
- Delineation samples
- ↓ Rip in Liner
- Secondary Containment - 7,169 sqft

Rip in Liner

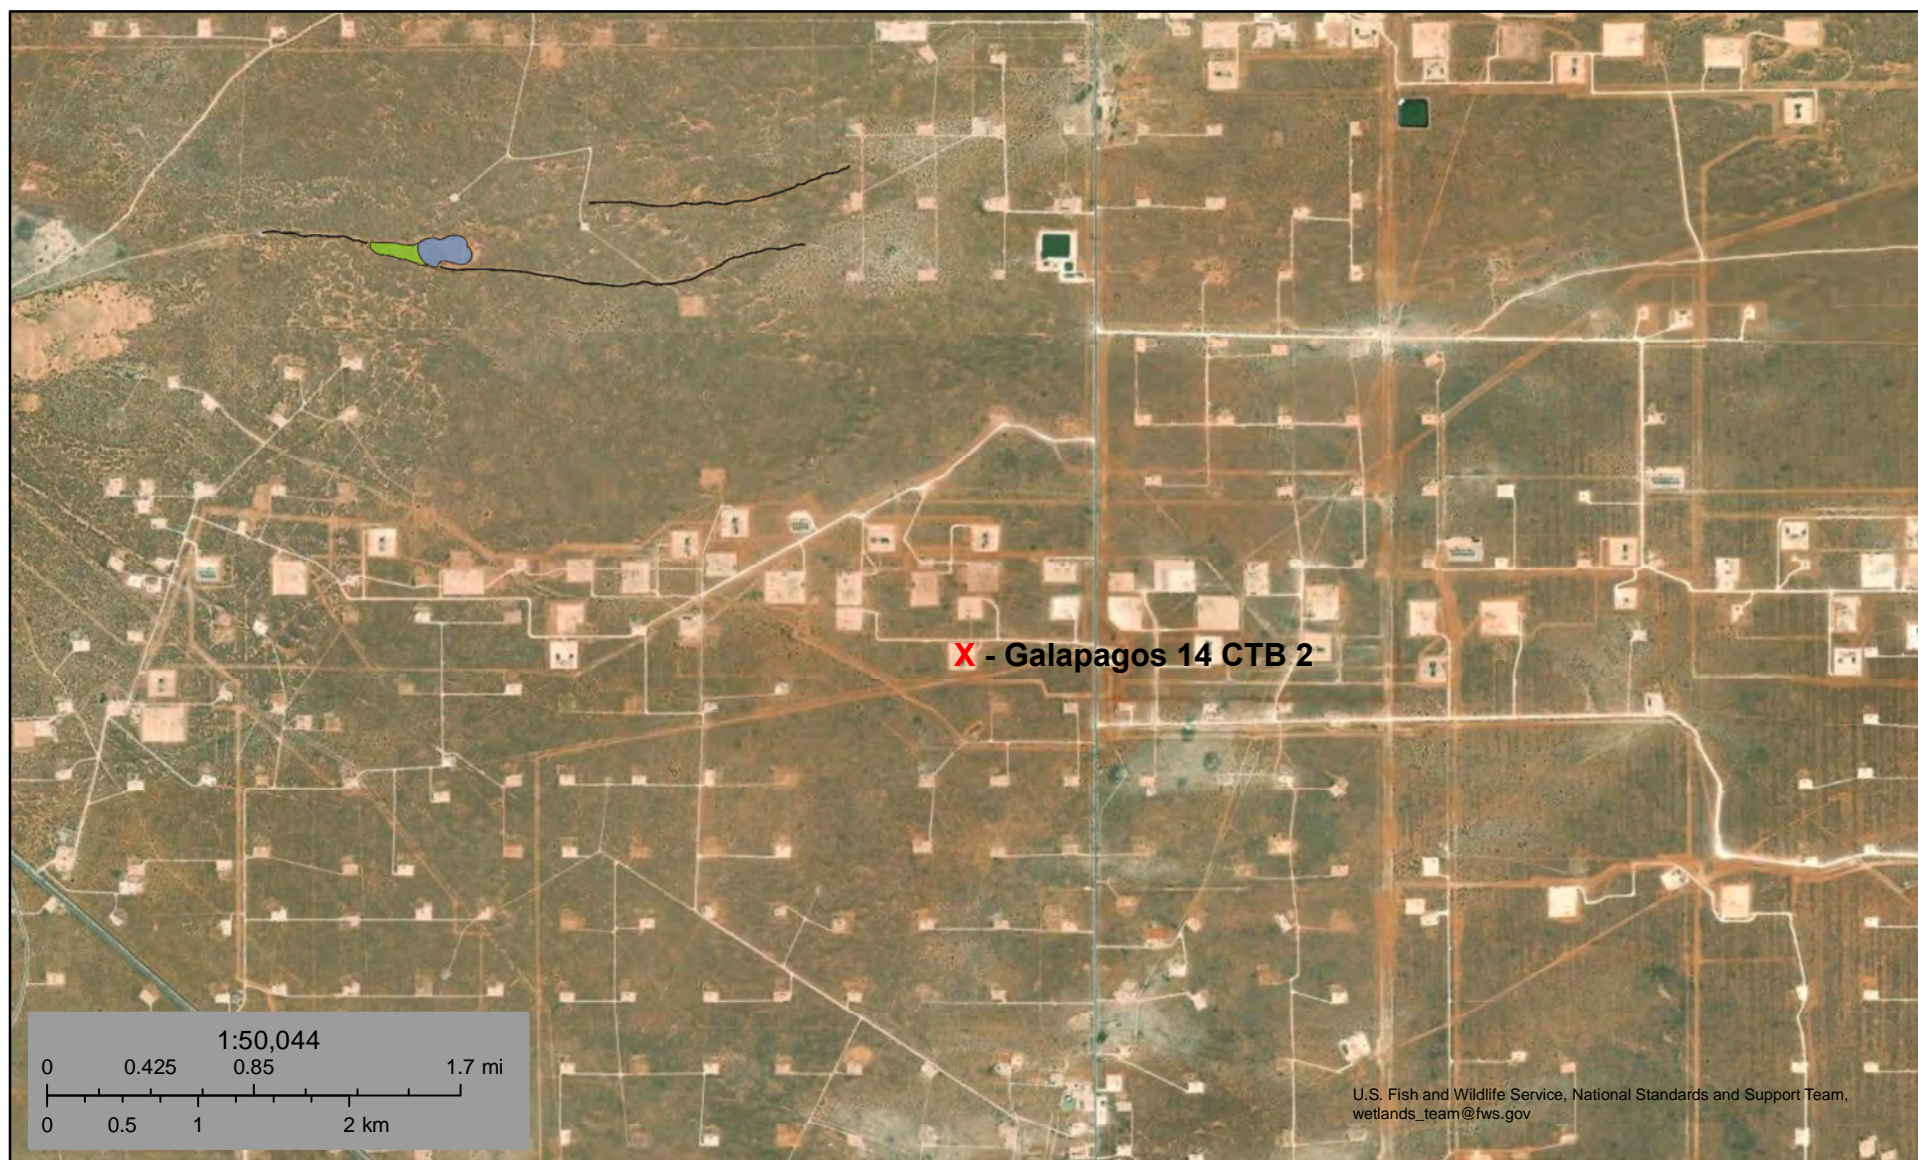
Wetlands Map

According to the U.S. Fish and Wildlife Service National Wetlands Inventory, a Freshwater Pond lies approximately 2.2 miles to the northwest of the release area. According to a FEMA search for flood hazard information, the Galapagos is in Zone X – Area of Minimal Flood Hazard.
