EVGSAU 2155-001

nKJ1516743465

## **Proposed Sampling and Remediation Work Plan**

Re: Proposed Sampling and Remediation Work Plan  
 NMOCD Incident Number: **nKJ1516743465**  
 EVGSAU 2155-001 API No. 30-025-27315  
 Unit O, Section 21, Township 17S, Range 35E 1175 FSL 2500 FEL Lea County, NM  
 GPS Coordinates: Latitude 32.8164673 Longitude -103.4622421 NAD83

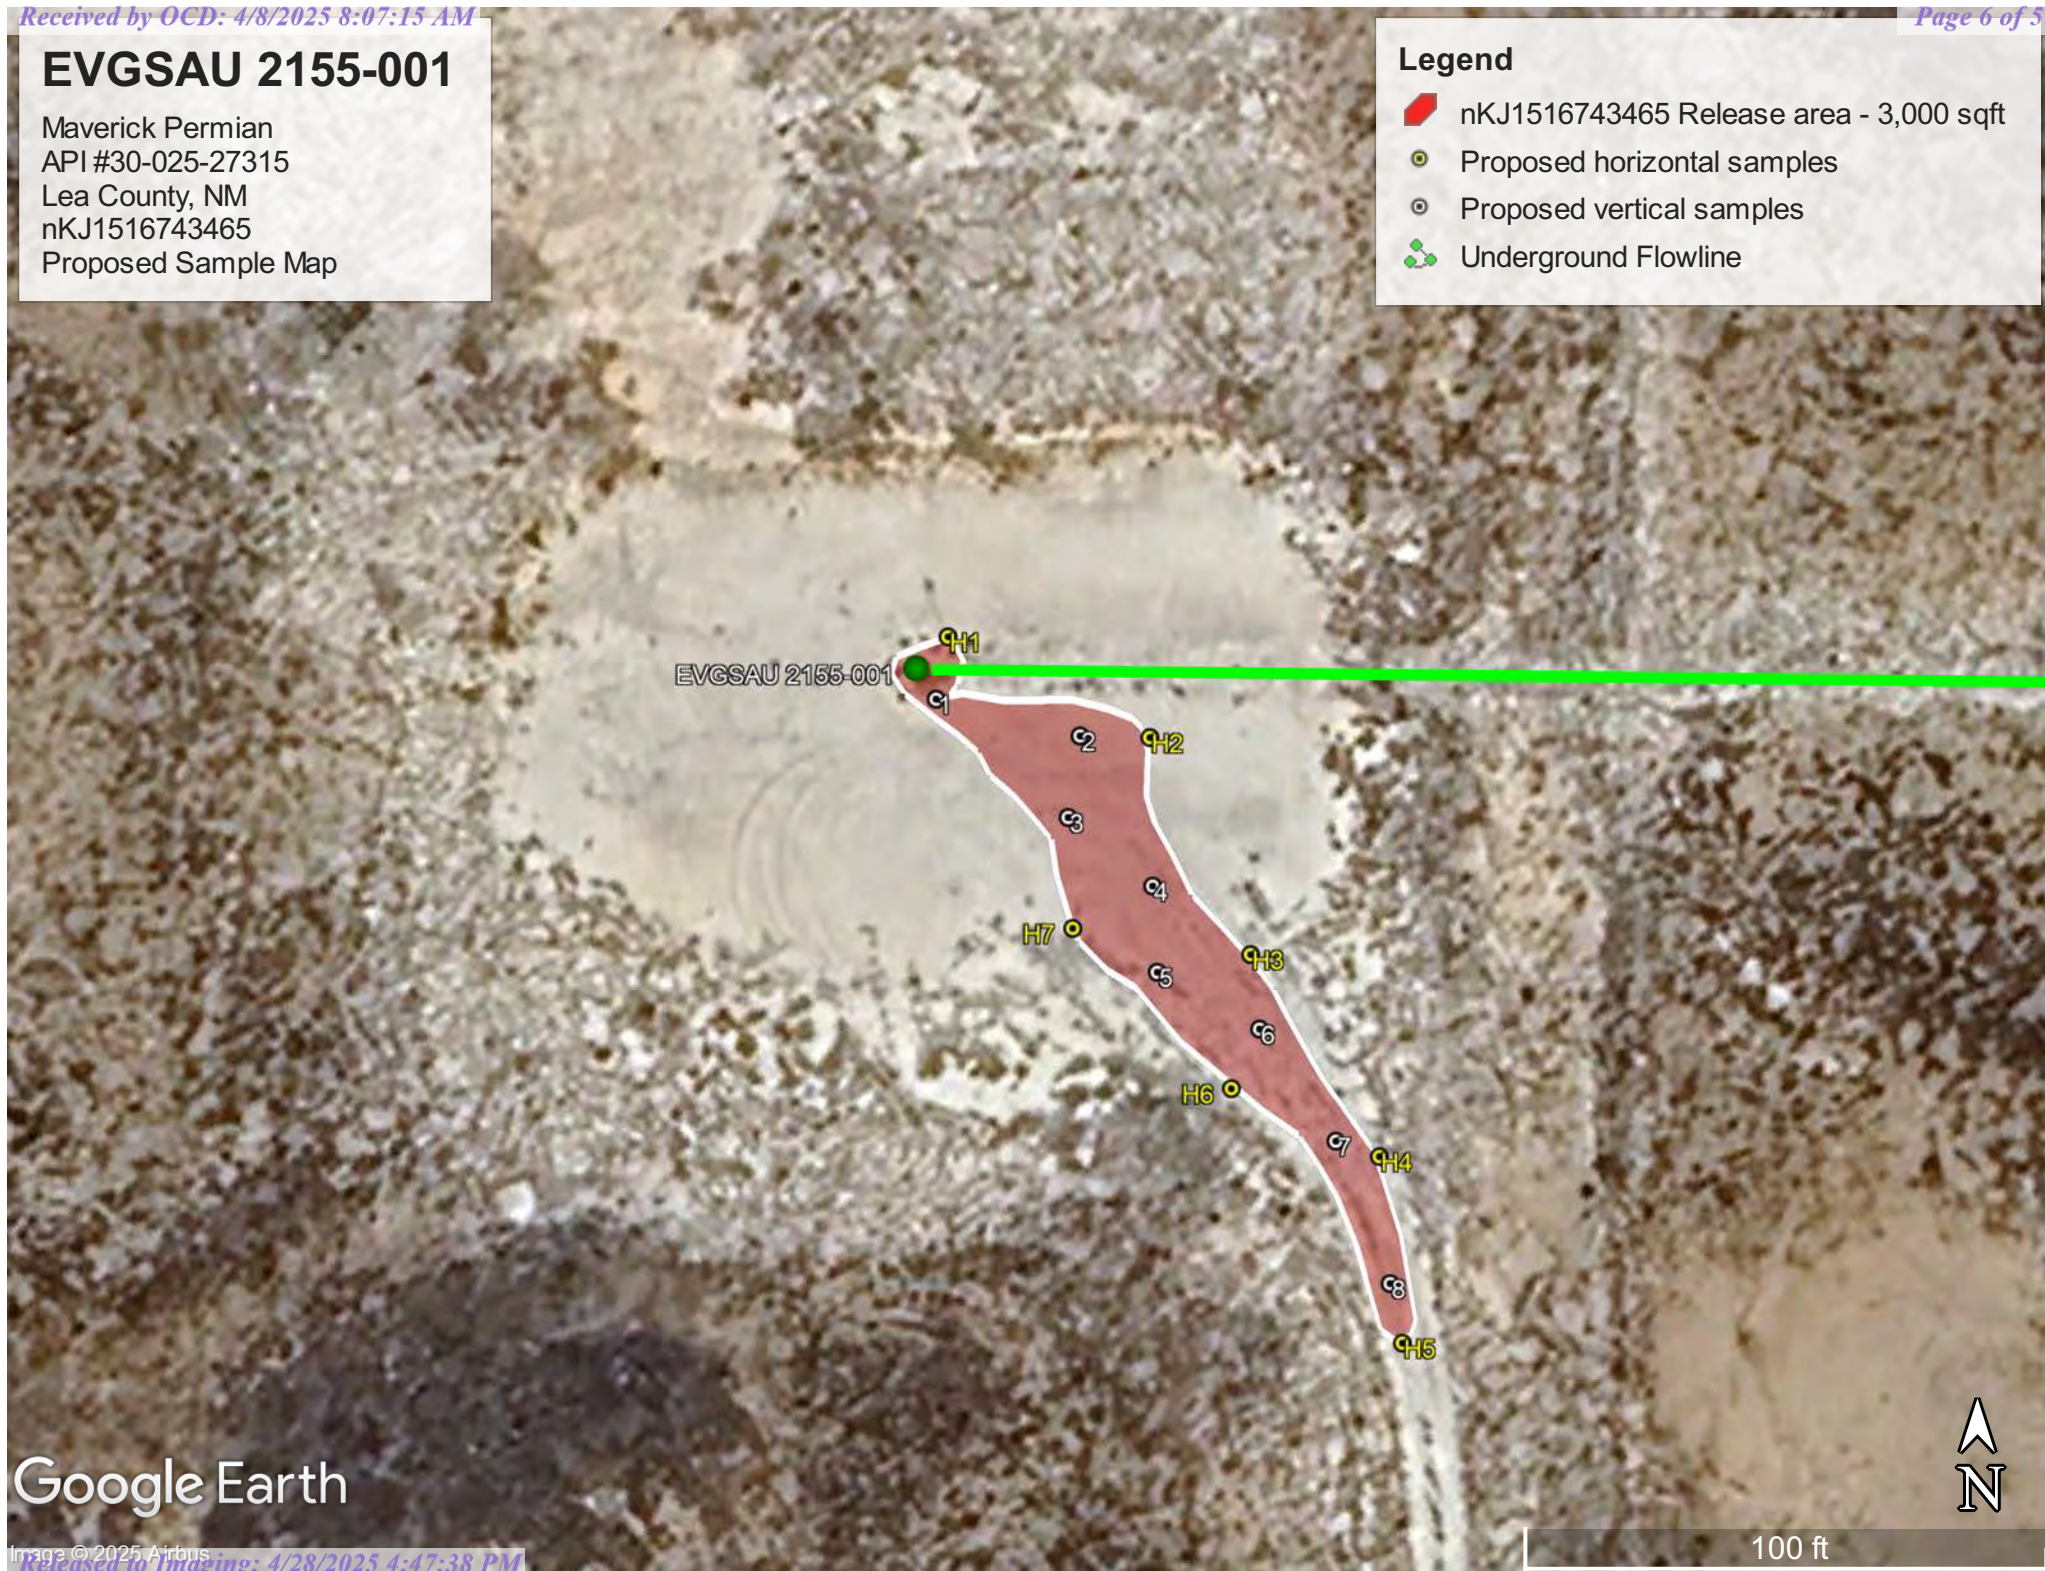
Maverick Permian  
API #30-025-27315  
Lea County, NM  
nKJ1516743465  
Proposed Sample Map

nKJ1516743465 Release area - 3,000 sqft
-

Proposed horizontal samples
-

Proposed vertical samples
-

Underground Flowline

- The area of concern measures approximately 3,000 square feet with the primary portion on the pad surface and a smaller portion extending to the lease road surface.

- Collect discrete samples from within and around the edges of the release area to evaluate the presence of contaminants. Forty (40) samples will be collected from 8 different sample points within the release area from depths of surface, 1', 2', 3', and 4' bgs. Thirty-five (35) samples will be collected from 7 different sample points around the edges of the release area from depths of surface, 1', 2', 3', and 4' bgs.

- A 48-hour sampling notification will be issued to the NMOCD for these sampling events. A variance request is included below for permission to use the delineation samples as confirmation samples depending on the sample results of the soil. A Proposed Sample Map can be found in Figure 1.

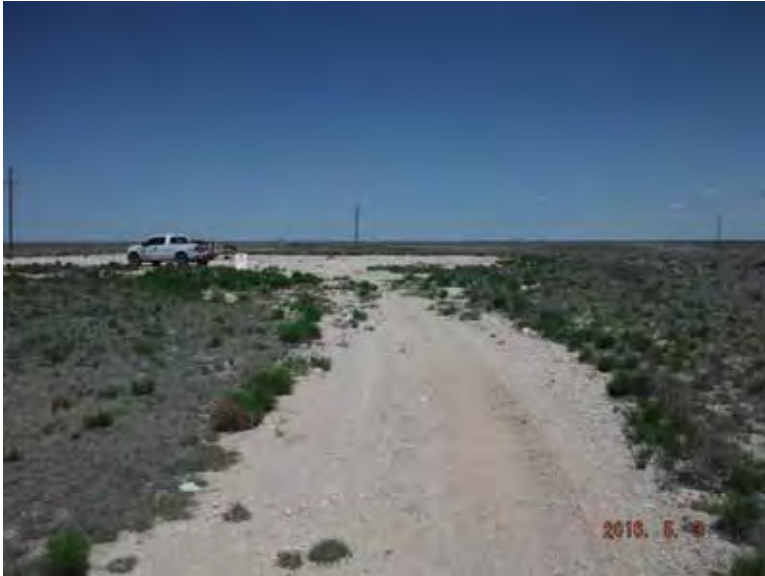
Initial release, facing north west

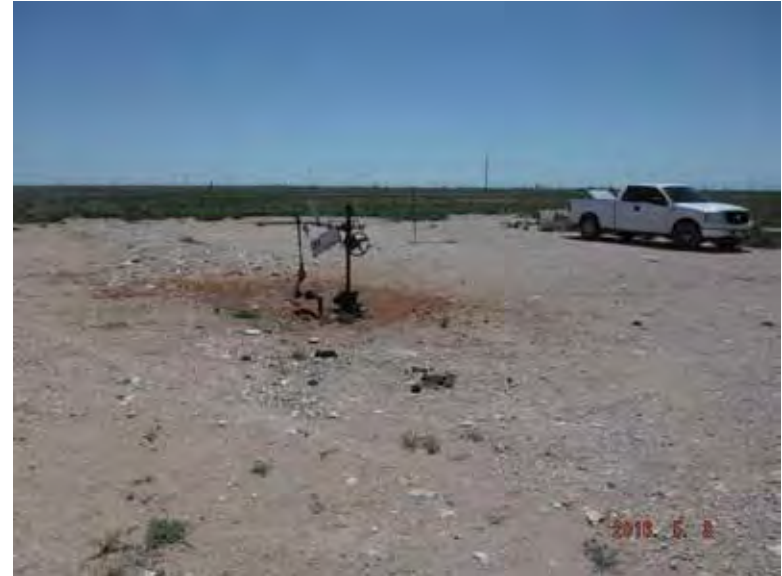
Initial release, facing south east

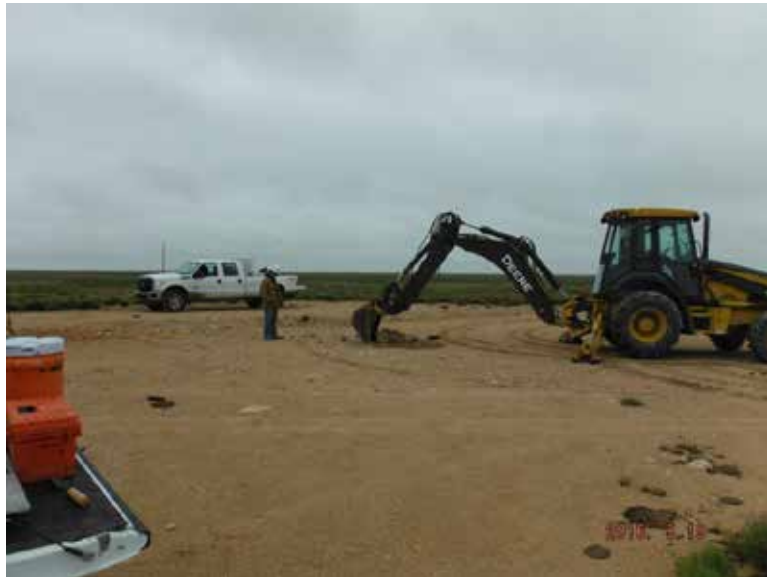
Excavating vertical 1, facing north east

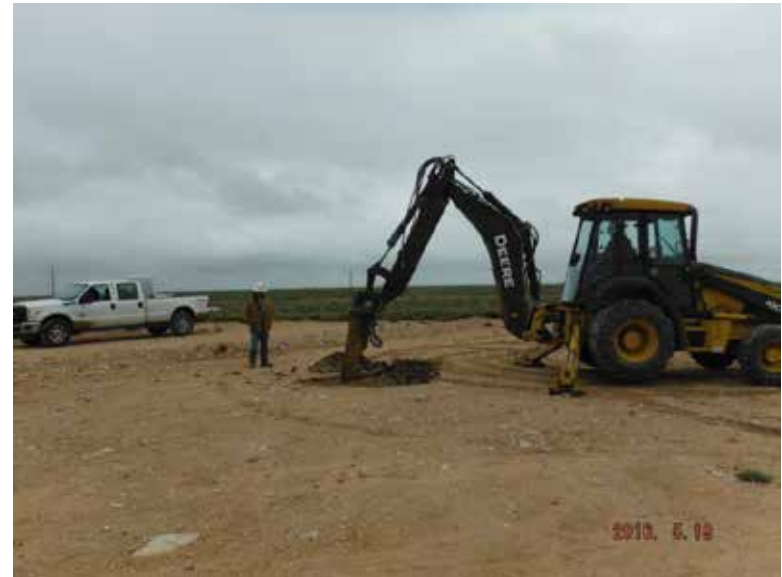
Hammer hoe vertical 1, facing north east
