RECLAMATION REPORT

PREPARED FOR:
DEVON ENERGY PRODUCTION, LP.

PREPARED BY:
PIMA ENVIRONMENTAL SERVICES, LLC.

RE: Reclamation Report
LOCATION: Fighting Okra 18 CTB 3
FACILITY ID: fAPP2123646509
GPS (NAD83): 32.049378, -103.516575
INCIDENT LOCATION: D-18-T26S-R34E
COUNTY: Lea
NMOCD REF. NO. nAPP2317925175

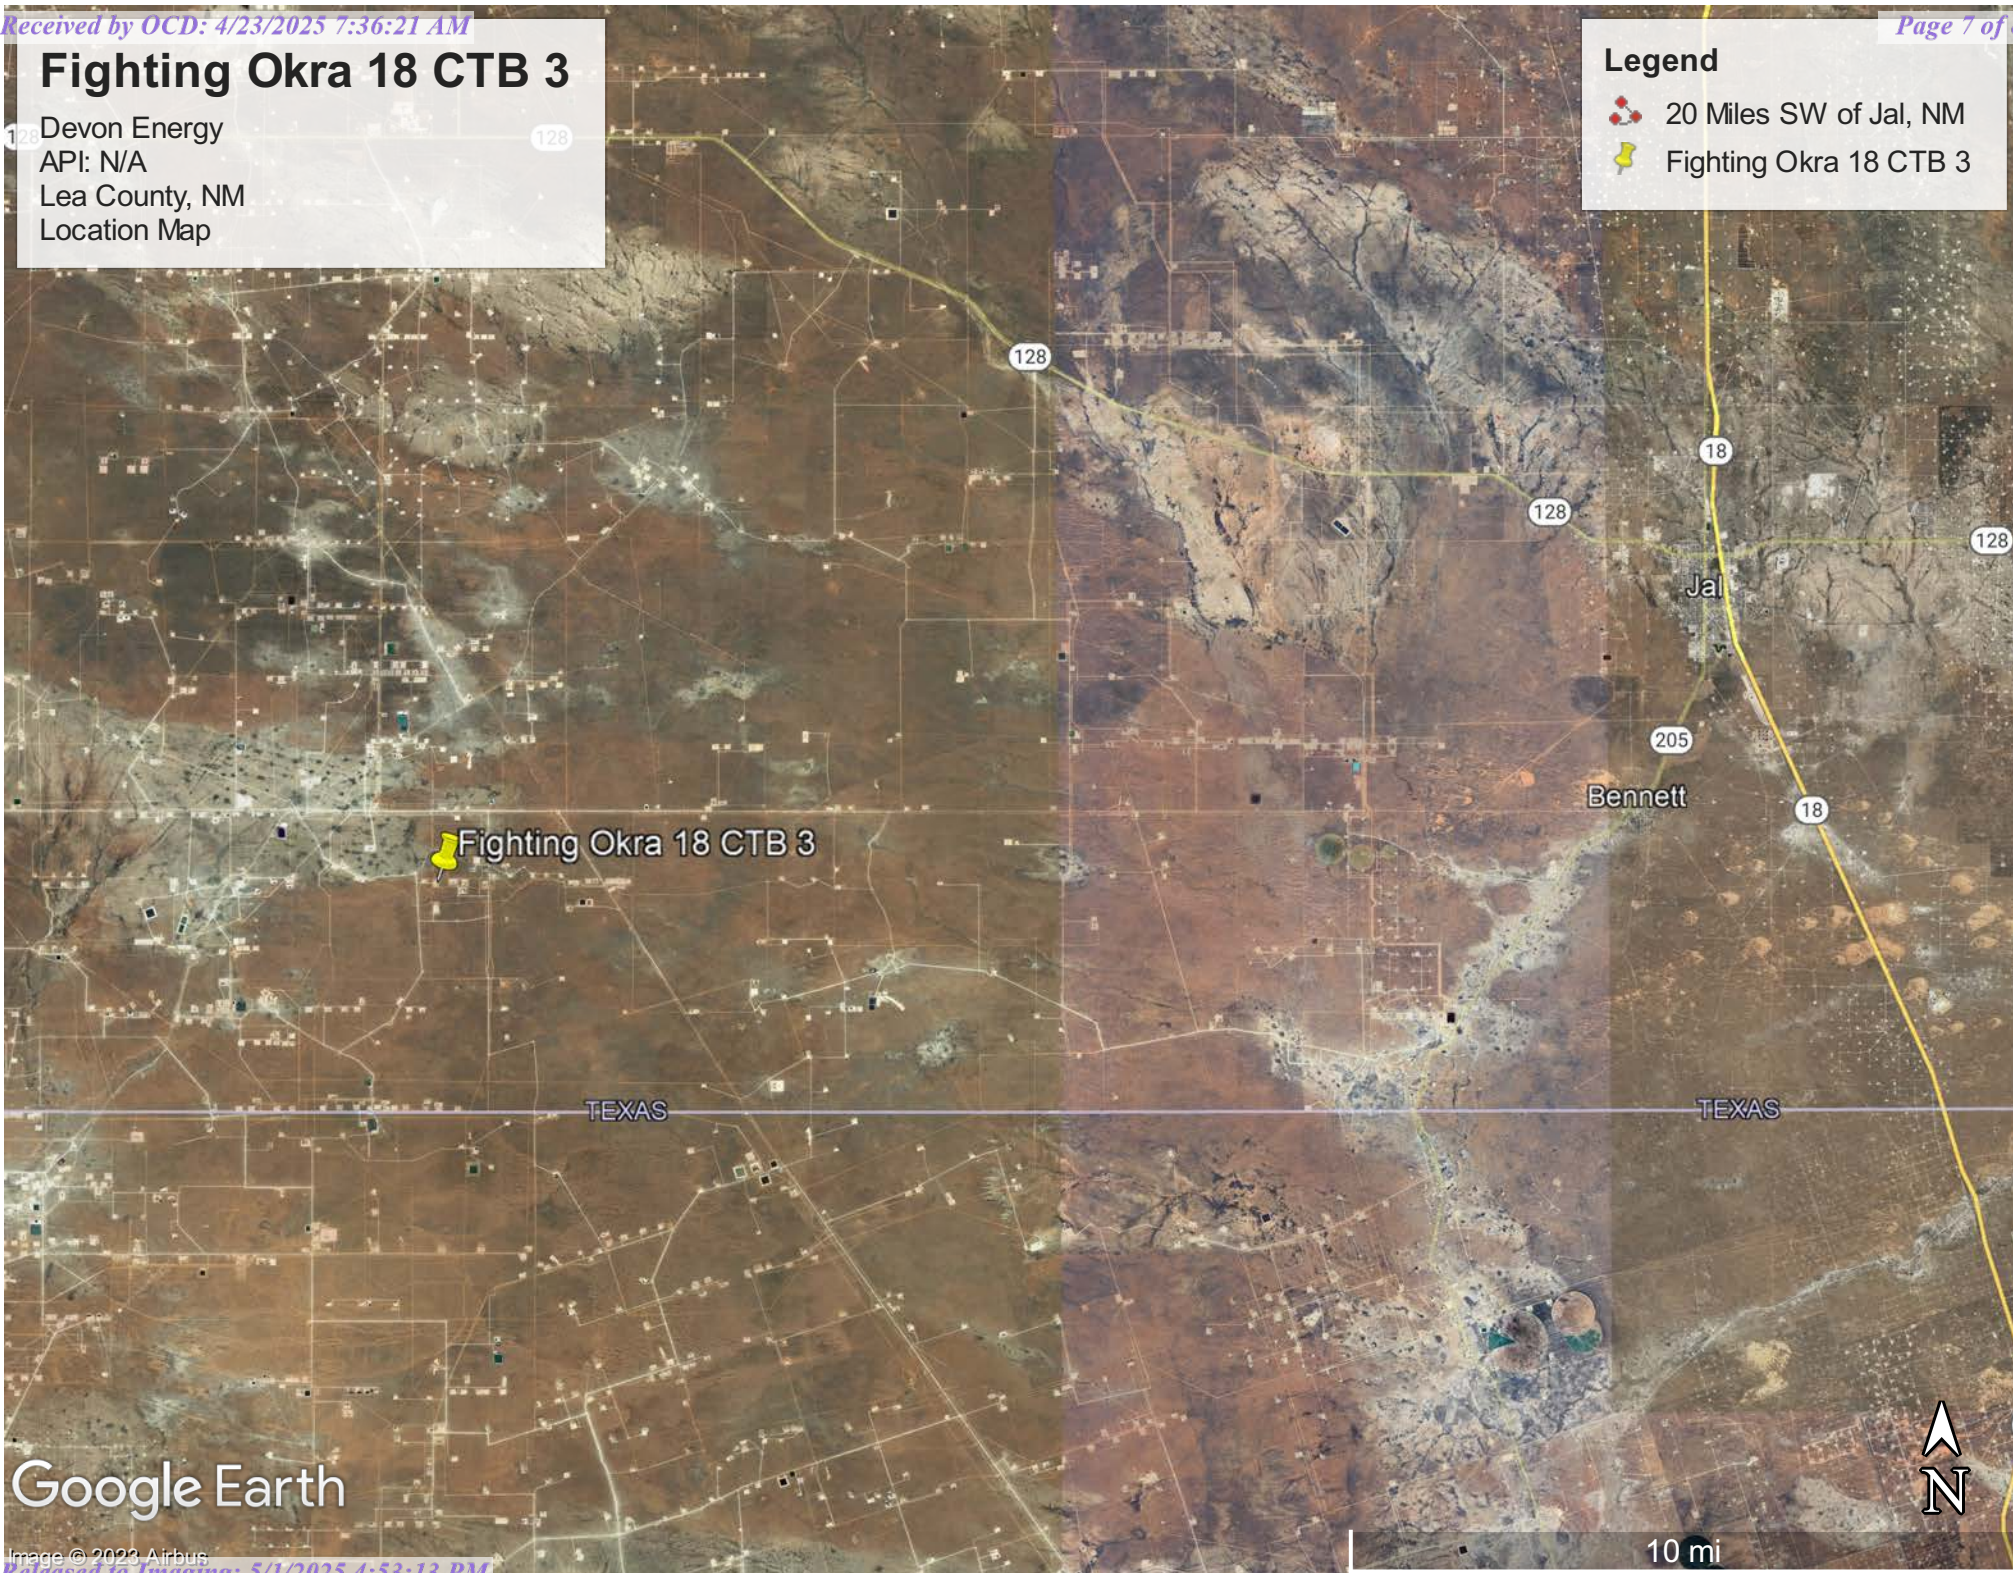
Devon Energy
API: N/A
Lea County, NM
Location Map

The Fighting Okra is located approximately twenty (20) miles southwest of Jal, NM. This spill site is in Unit D, Section 18, Township 26S, Range 34E, Latitude 32.049378 Longitude -103.516575, Lea County, NM. Figure 1 references a Location Map.

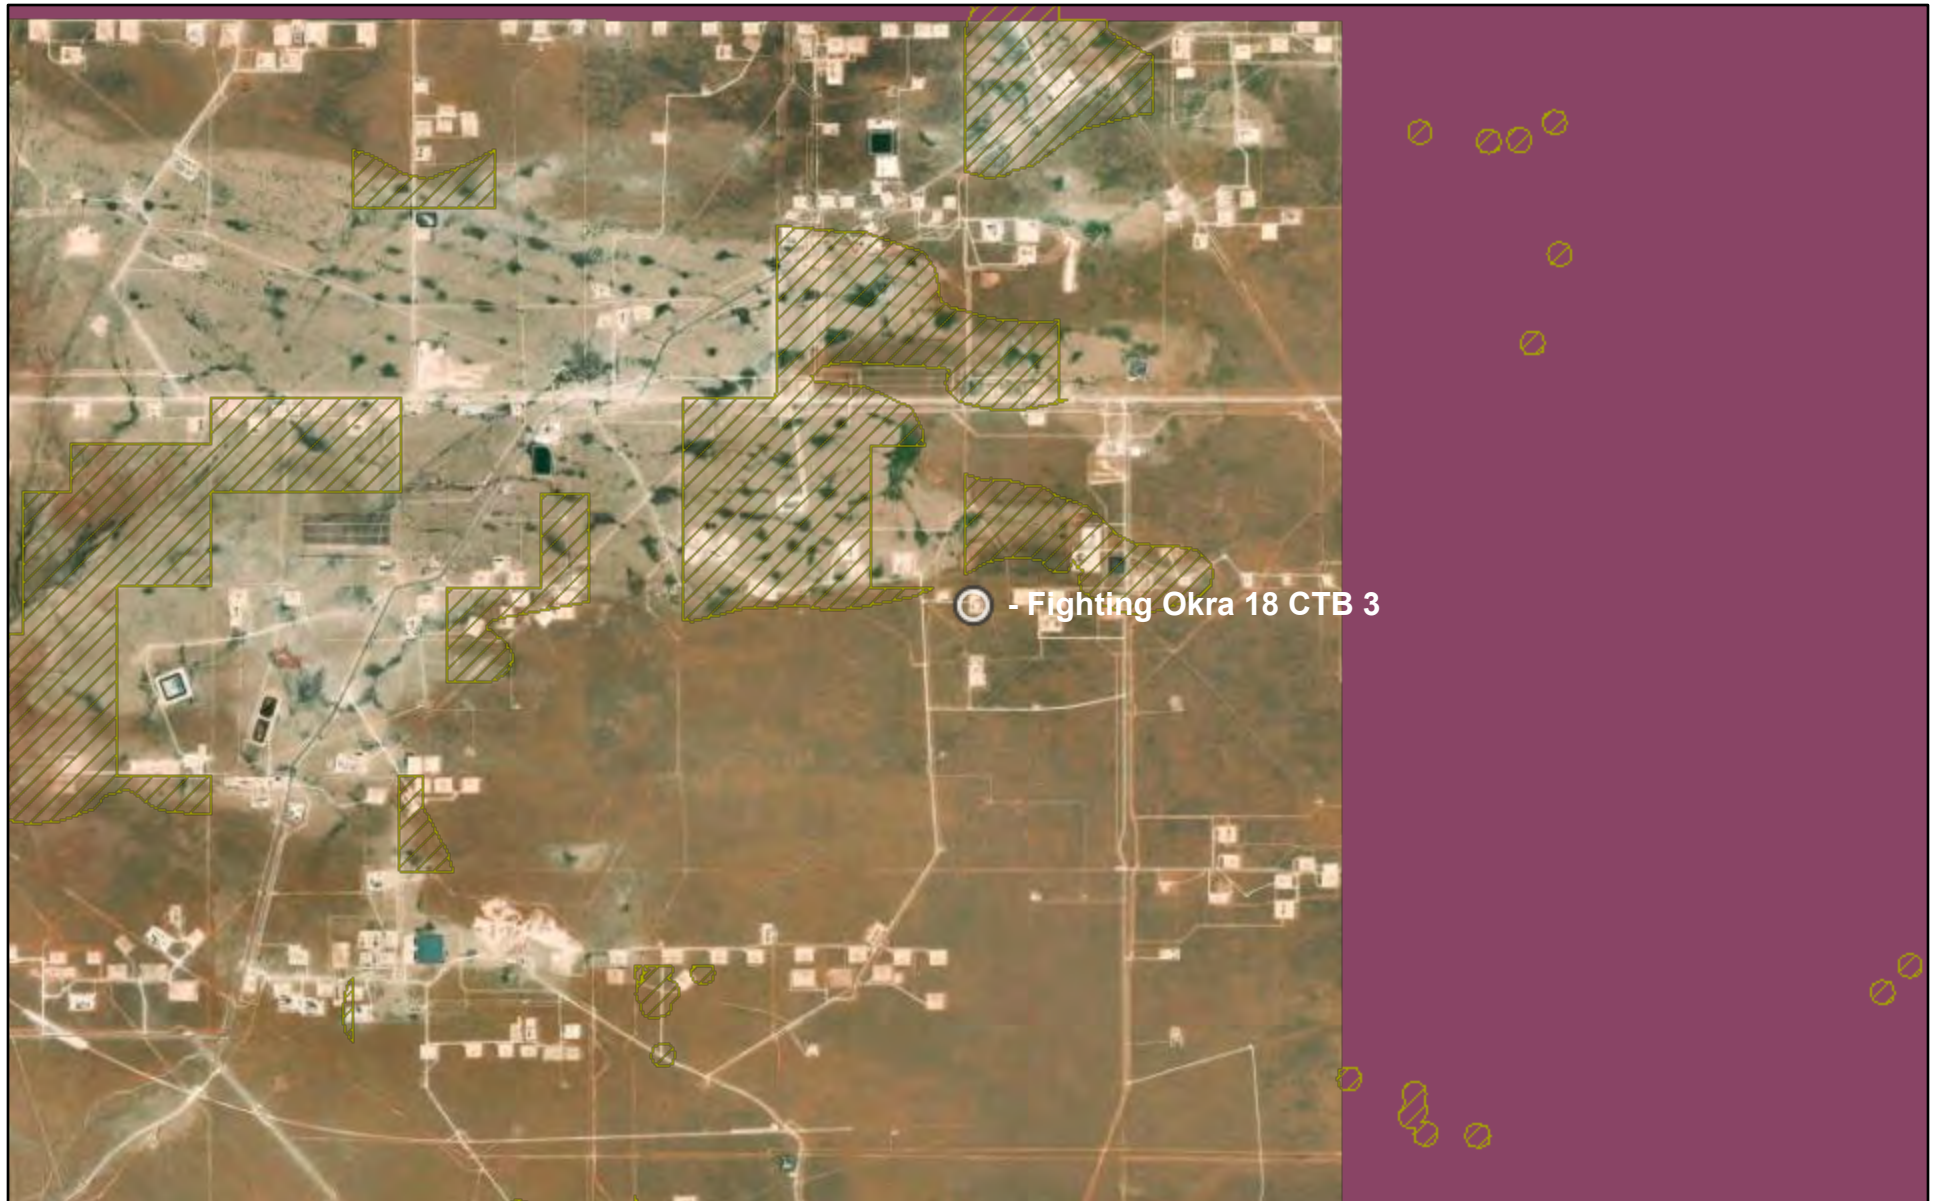
A desktop review of the Fighting Okra was performed and found to not be in range of any Special Status Plant or Wildlife Species. A Special Status Plant/Wildlife Map can be referenced in Figure 5.

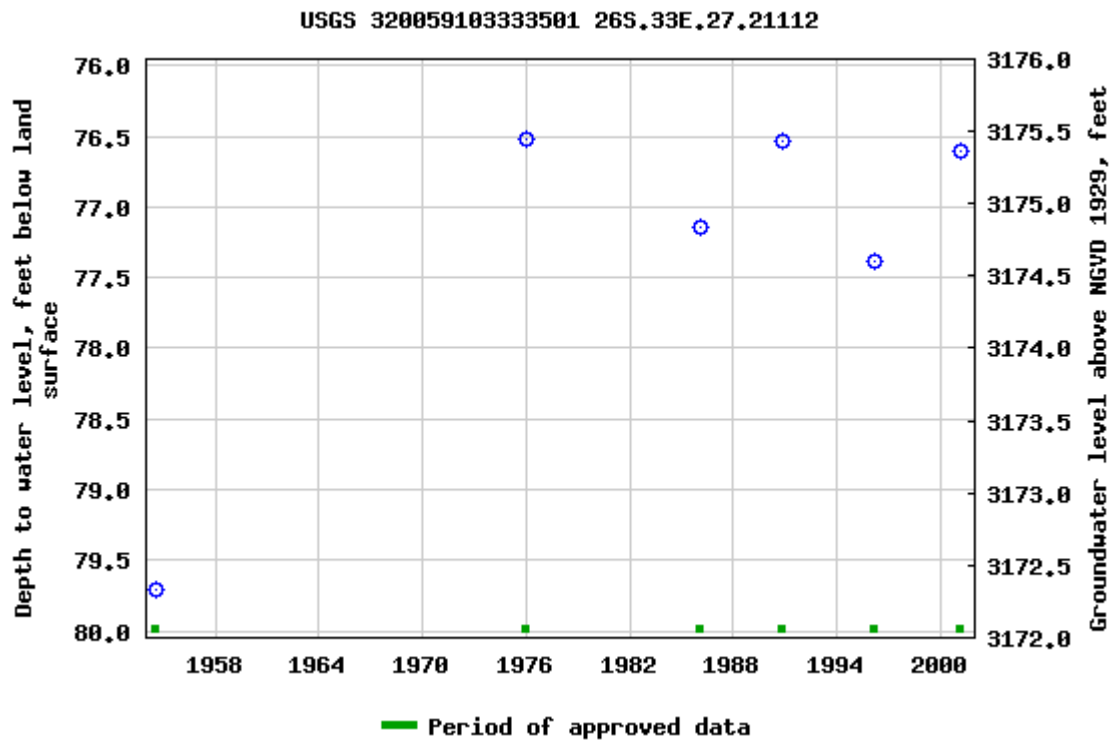
The depth of the well is 200 feet below land surface.

Breaks in the plot represent a gap of at least one year between field measurements.

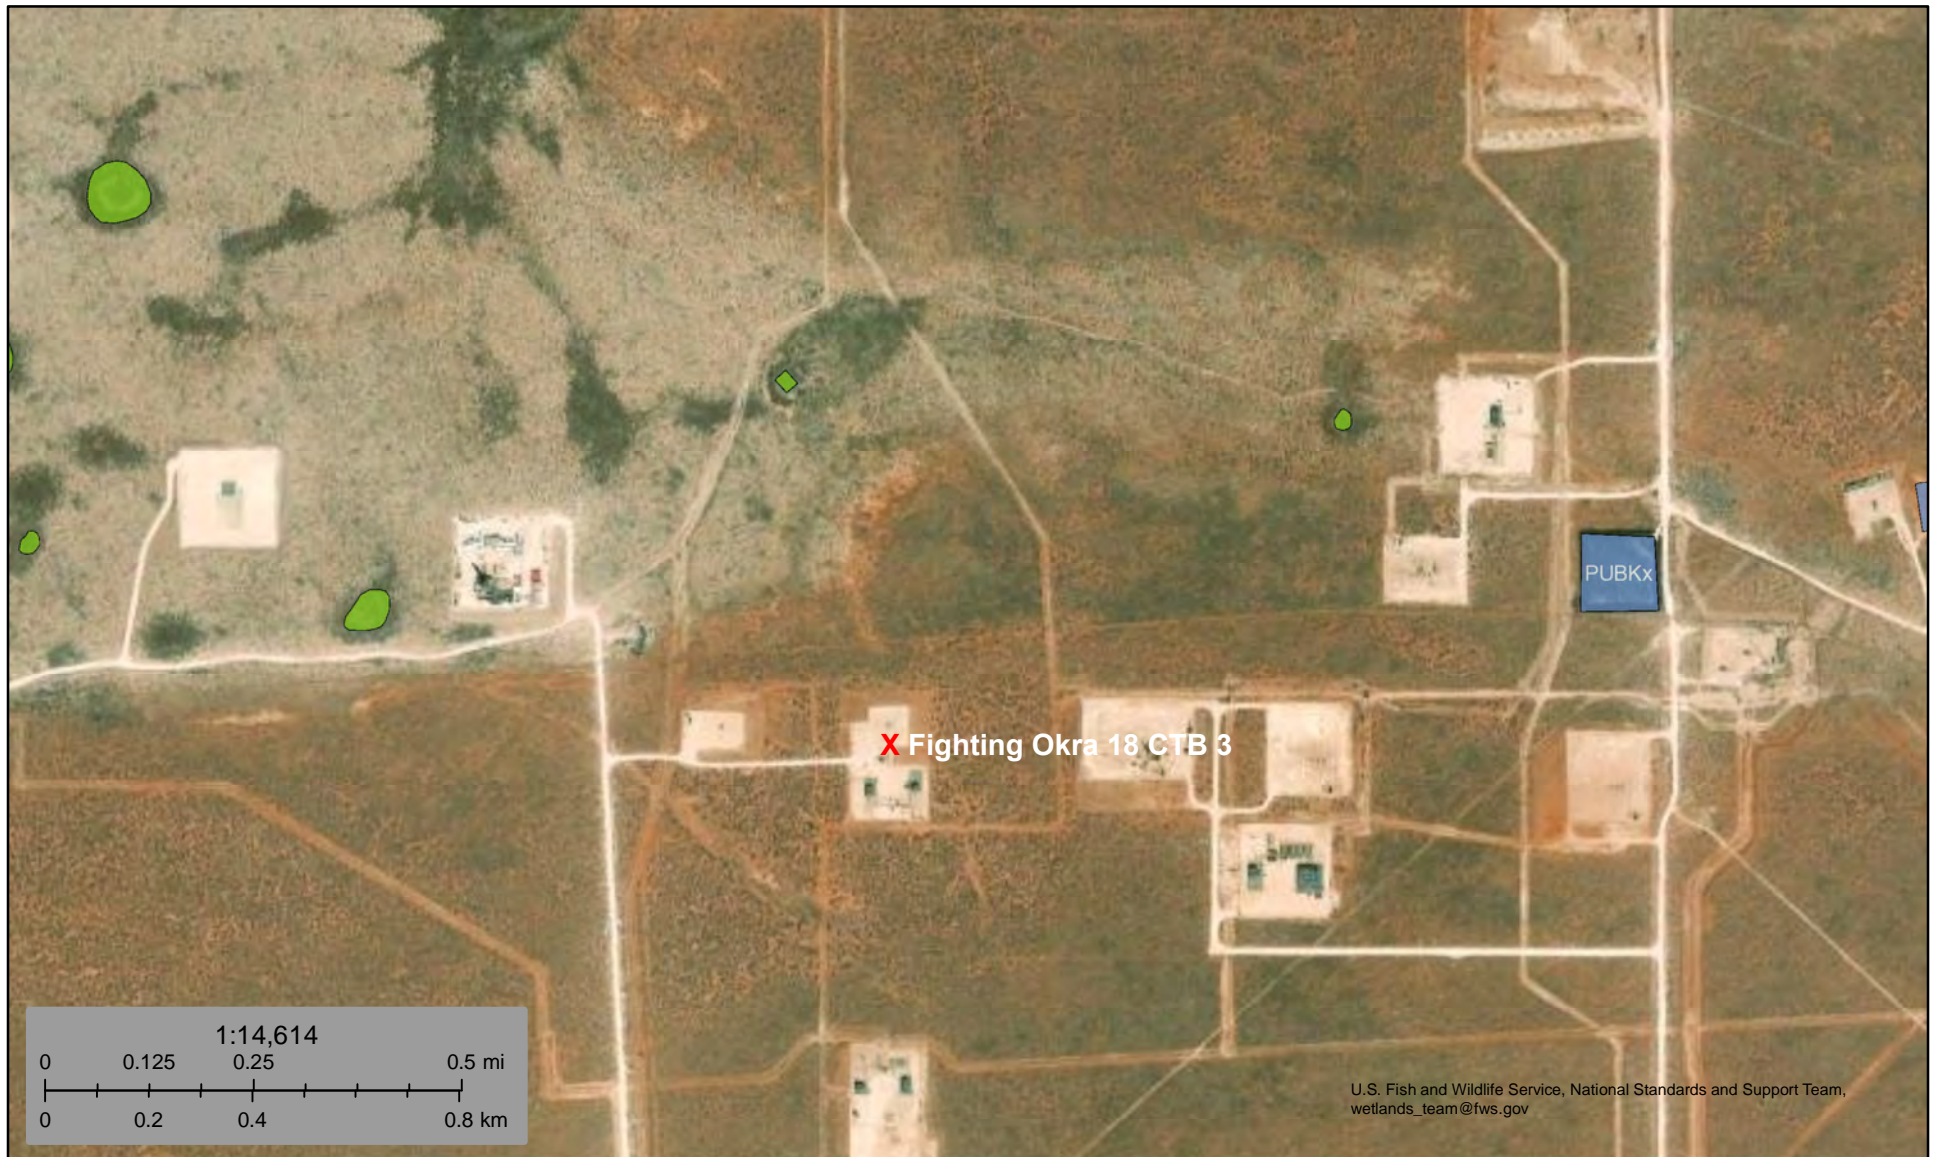
Wetlands Map

According to the U.S. Fish and Wildlife Service National Wetlands Inventory, a Freshwater Emergent Wetland lies approximately 0.42 miles to the north of the release area. According to a FEMA search for flood hazard information, the Fighting Okra is in Zone D – Area of Undetermined Flood Hazard.

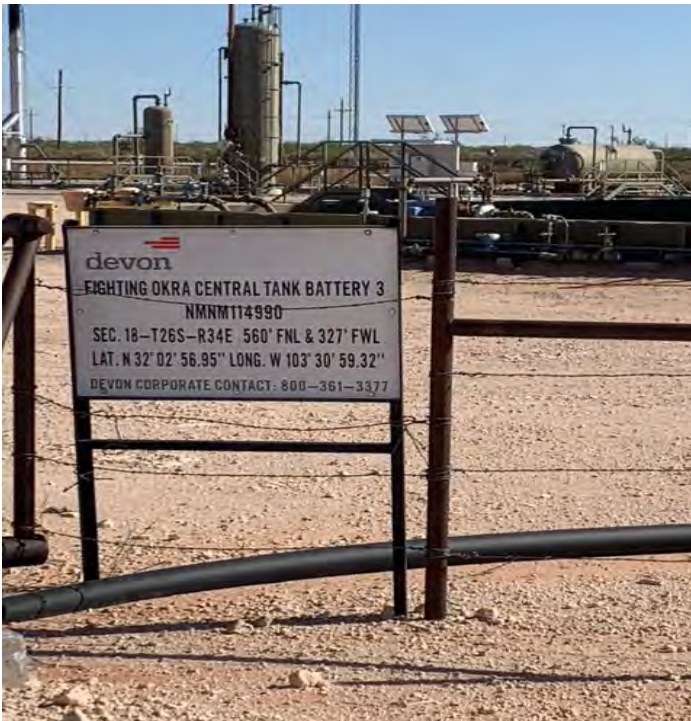
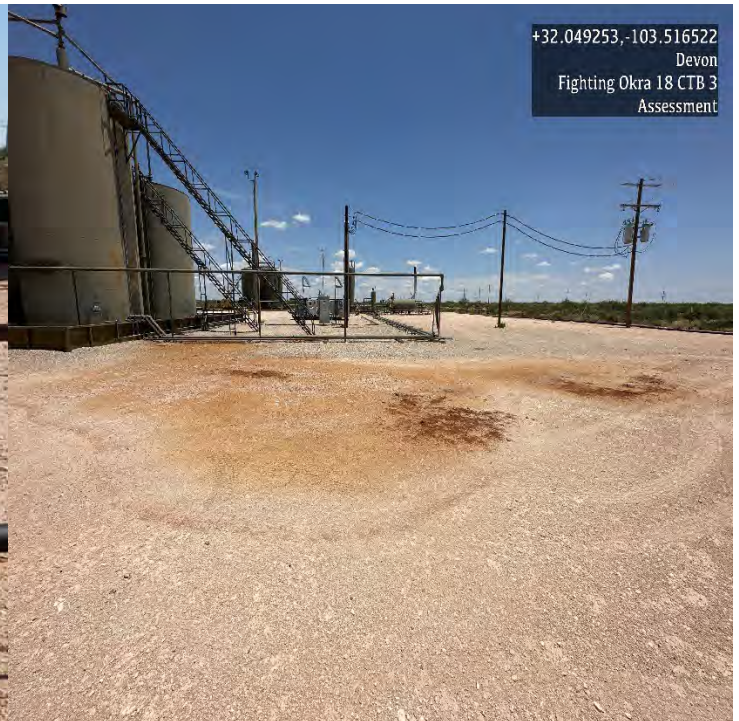
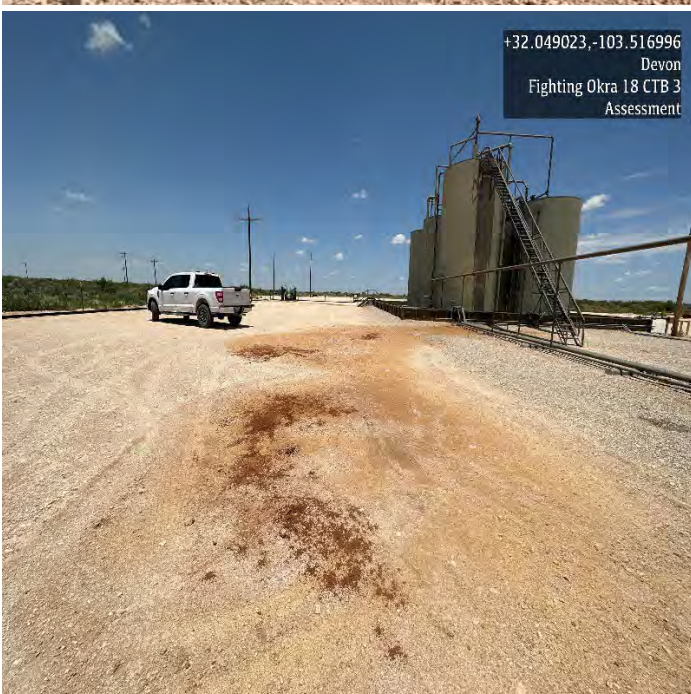
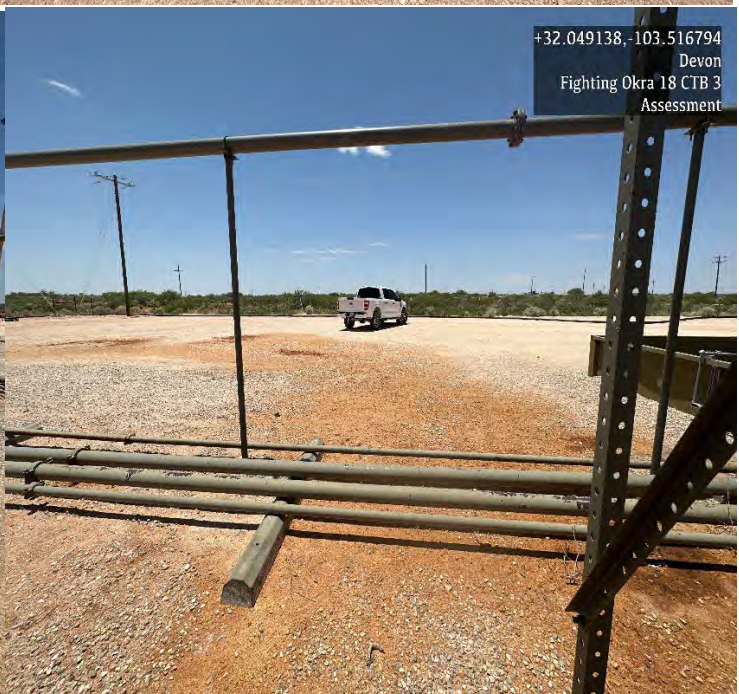
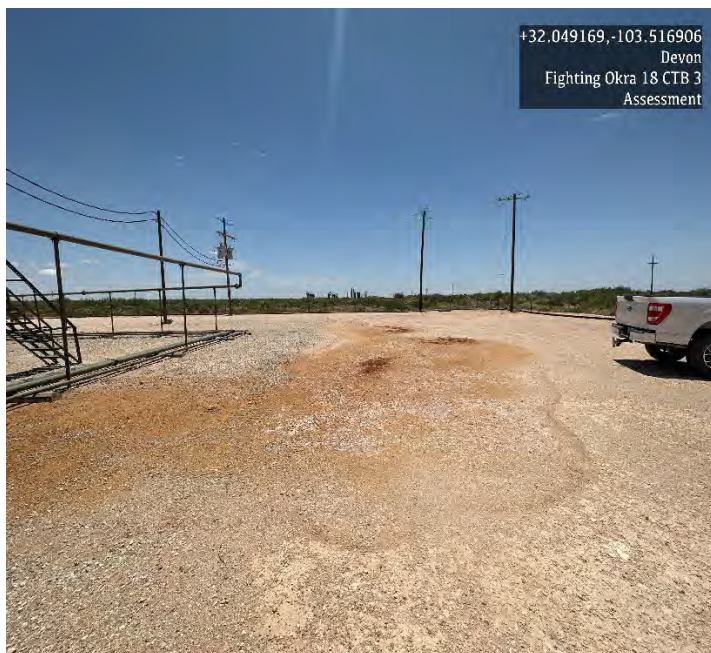
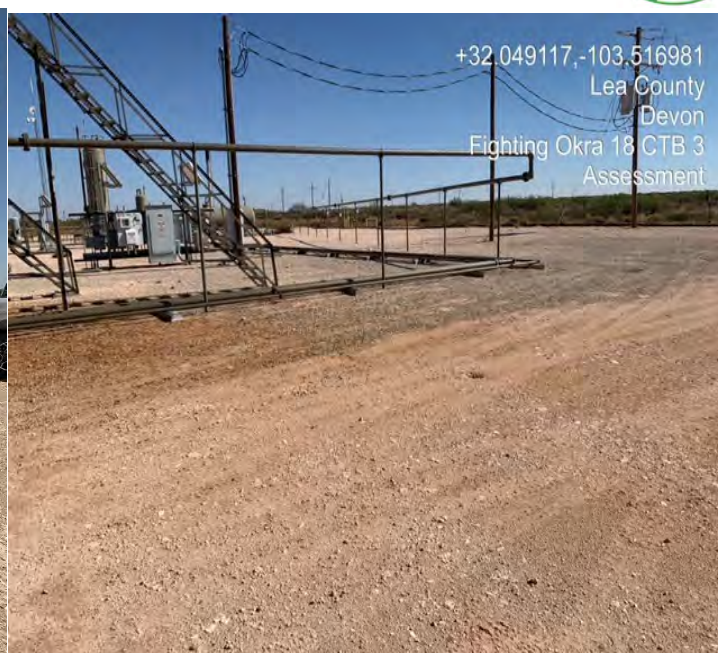
Site Assessment

Based on the sample results, the bottoms and sidewalls were below NMOCD Closure Criteria 19.15.29 NMAC. See Appendix D for Photographic Documentation.
