**Re: Closure Request
Poker Lake Unit #41
API Number 30-015-20933
Incident Number NAB1832354684
Eddy County, New Mexico**

Ensolum, LLC (Ensolum), on behalf of XTO Energy, Inc. (XTO), has prepared the following *Closure Request* as a follow-up to the *Deferral Request* dated January 17, 2019. The *Deferral Request* was approved by the New Mexico Oil Conservation Division (NMOCD) on January 22, 2019. This *Closure Request* documents the excavation and soil sampling activities completed at the Poker Lake Unit #41 (Site) following final plugging and abandonment of the well and removal of the surface production equipment from the deferred area. Based on the additional remediation activities described below, XTO is submitting this *Closure Request* and requesting no further action and closure for Incident Number NAB1832354684.

Photographic Log
XTO Energy, Inc.
Poker Lake Unit #41

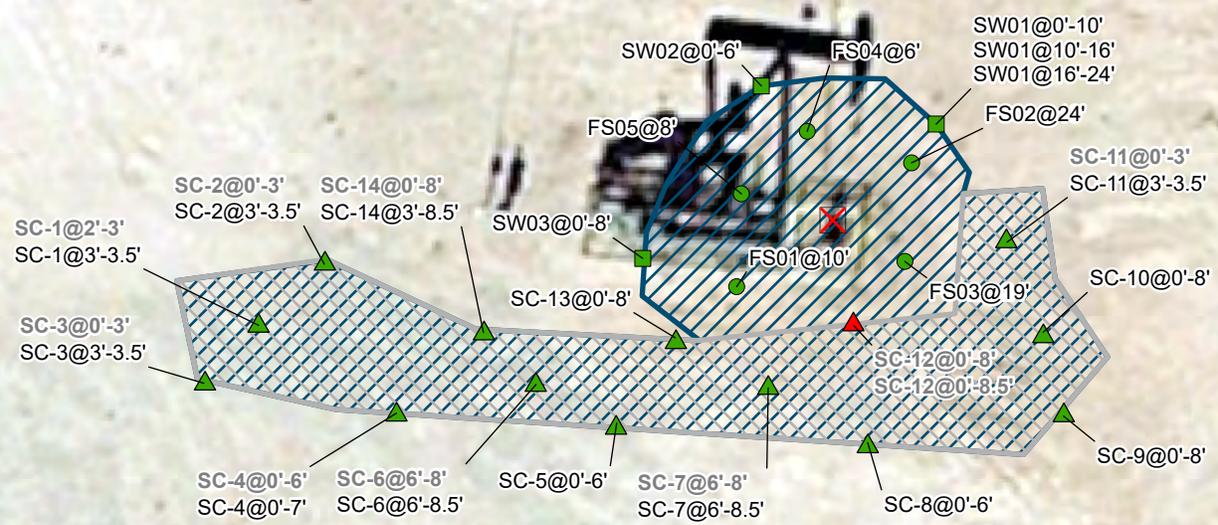
2024 Excavation Extent

Notes:
 Sample ID @ Depth Below Ground Surface
 Concentrations in **bold** exceed the NMOCD Table I Closure Criteria or reclamation requirement where applicable.
 Grey text indicates soil sample removed during excavation activities.

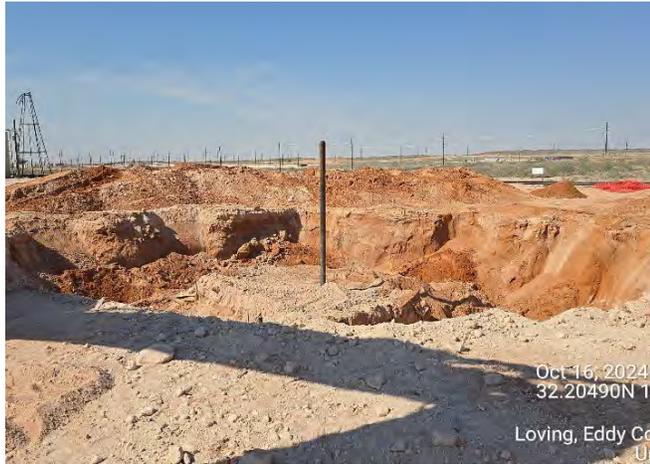
Photograph: 1 Date: 10/16/2024
Description: Excavation activities
View: North

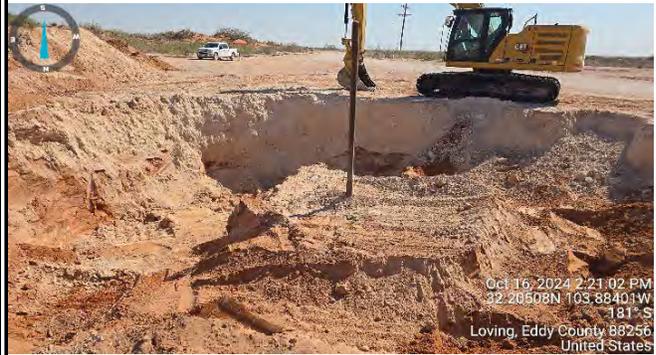
Photograph: 2 Date: 10/16/2024
Description: Excavation activities
View: South

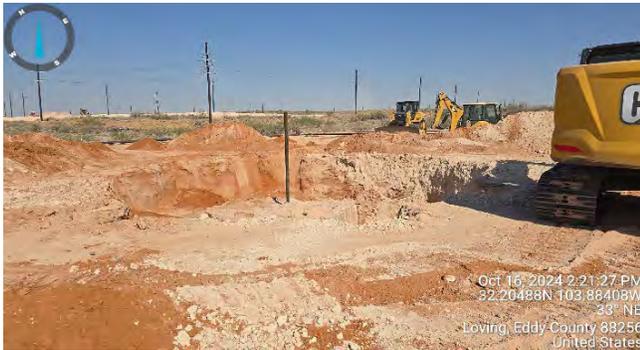
Photograph: 3 Date: 10/16/2024
Description: Excavation activities
View: Northeast

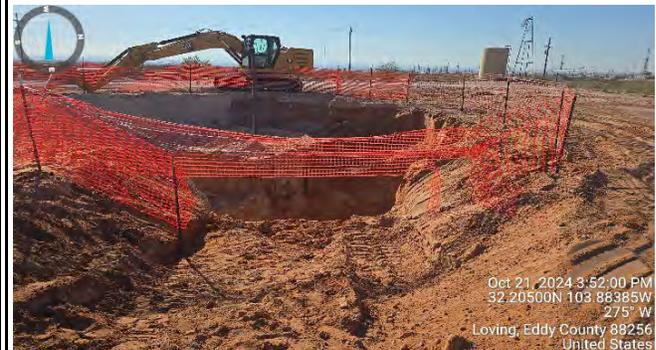
Photograph: 4 Date: 10/21/2024
Description: Excavation activities
View: West

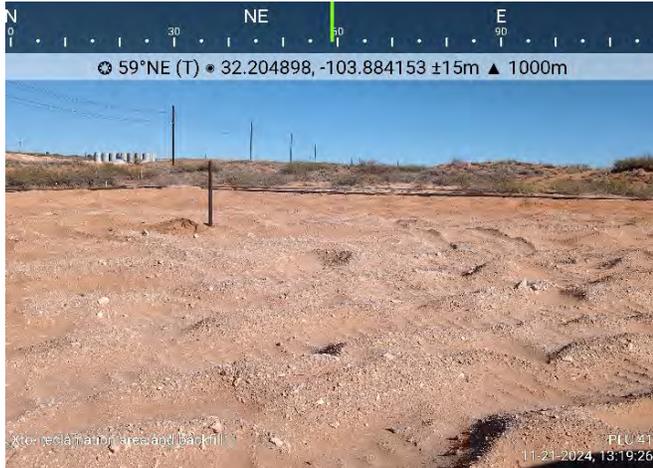
Photograph: 5 Date: 11/21/2024
Description: Well marker and backfilled excavation
View: Northeast

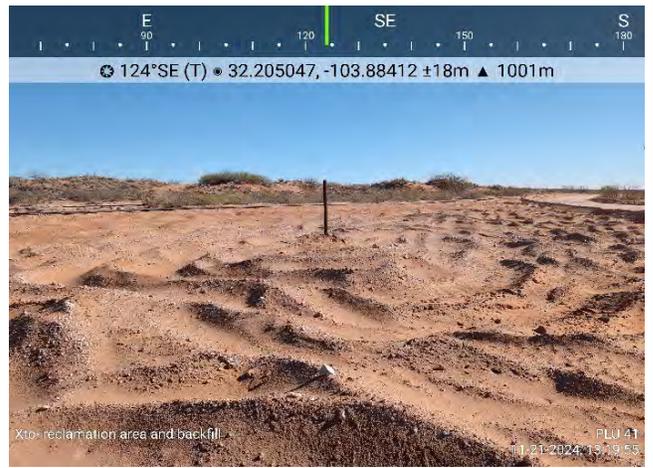
Photograph: 6 Date: 11/21/2024
Description: Reclaimed pad and excavation area
View: Southeast

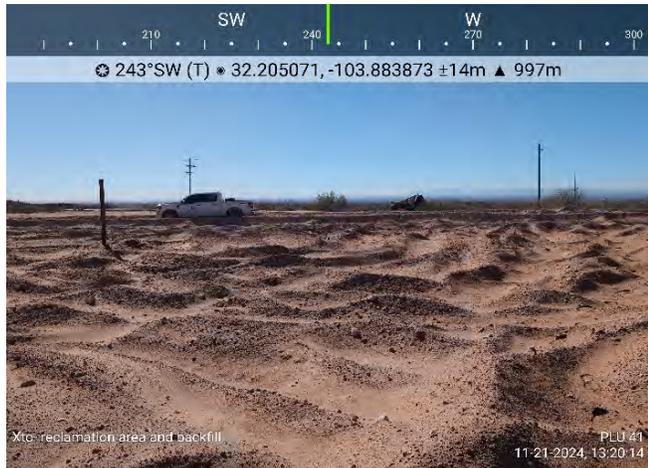
Photograph: 7 Date: 11/21/2024
Description: Reclaimed pad and excavation area
View: Southwest

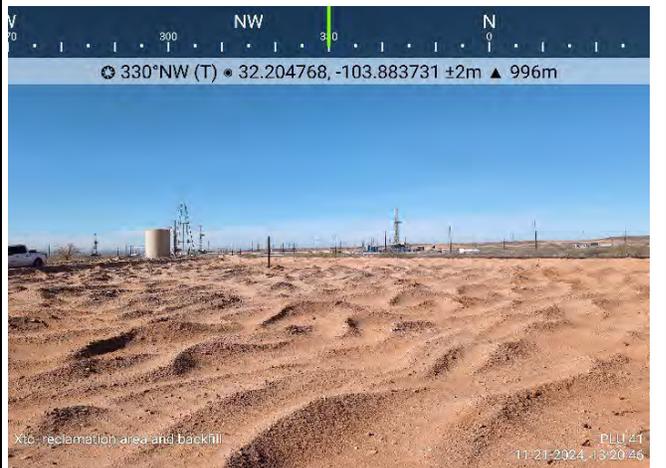
Photograph: 8 Date: 11/21/2024
Description: Reclaimed pad and excavation area
View: Northwest

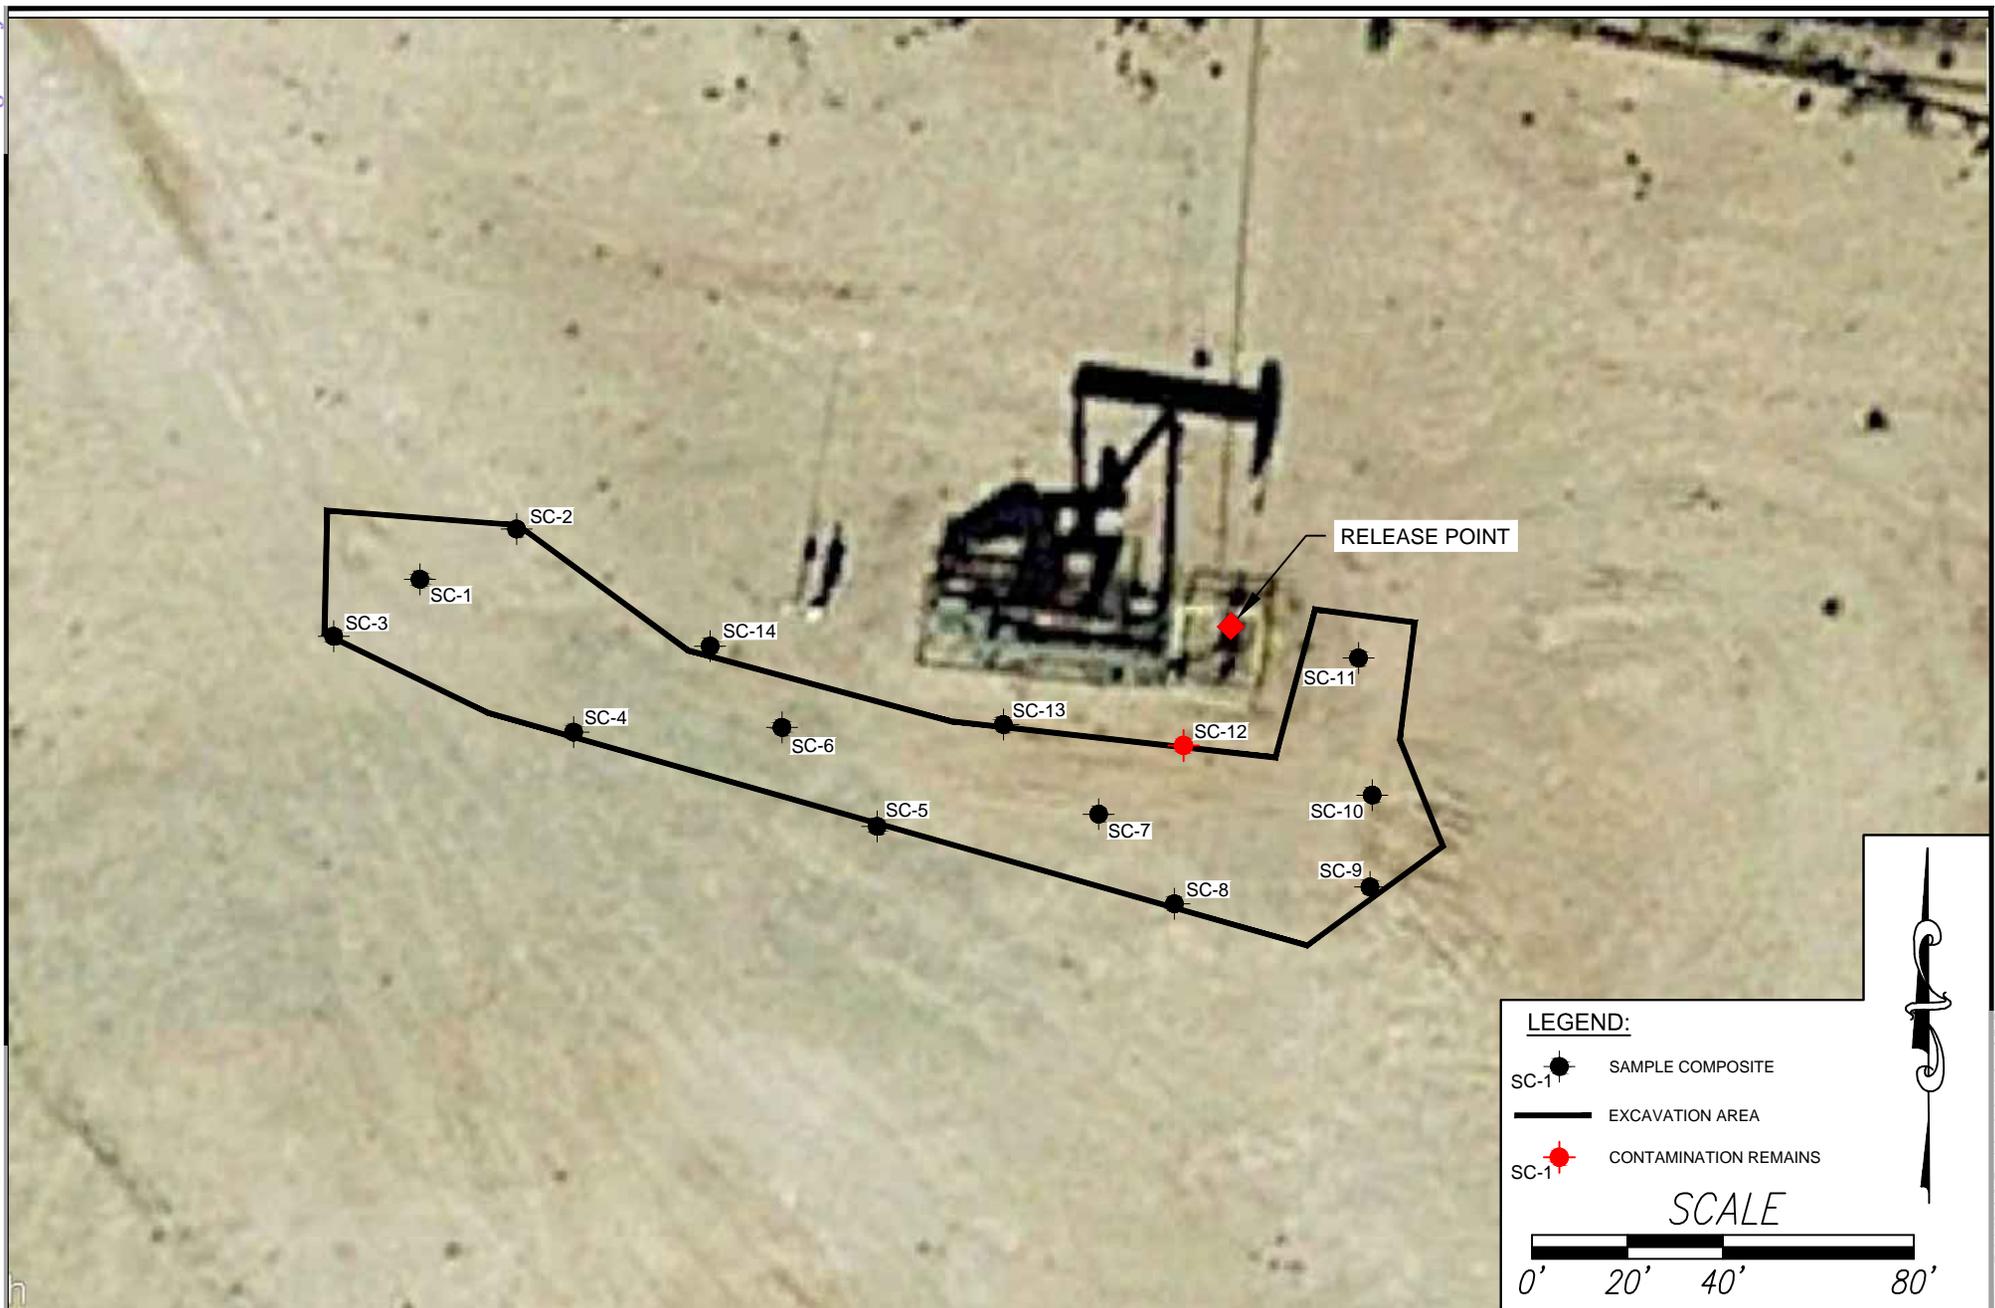
SAMPLE LOCATION MAP

Laboratory results confirm that contamination was removed from all locations, with the exception of SC-12, which remains above the closure level for chlorides at 1,100 mg/Kg. However, further excavation could not be completed at SC-12 due to its proximity to the pumpjack unit. SMA recommends deferring the area of SC-12 until site plugging and abandonment.

- SC-1 SAMPLE COMPOSITE
- EXCAVATION AREA
- ◆ SC-1 CONTAMINATION REMAINS

- Contamination must be in areas immediately under or around production equipment where remediation could cause a major facility deconstruction.
 - Extents of contamination must be fully delineated.
 - Contamination does not cause an imminent risk to human health, the environment, or groundwater.
- Deferral for sample area SC-12 (Figure 3 of Closure Report).

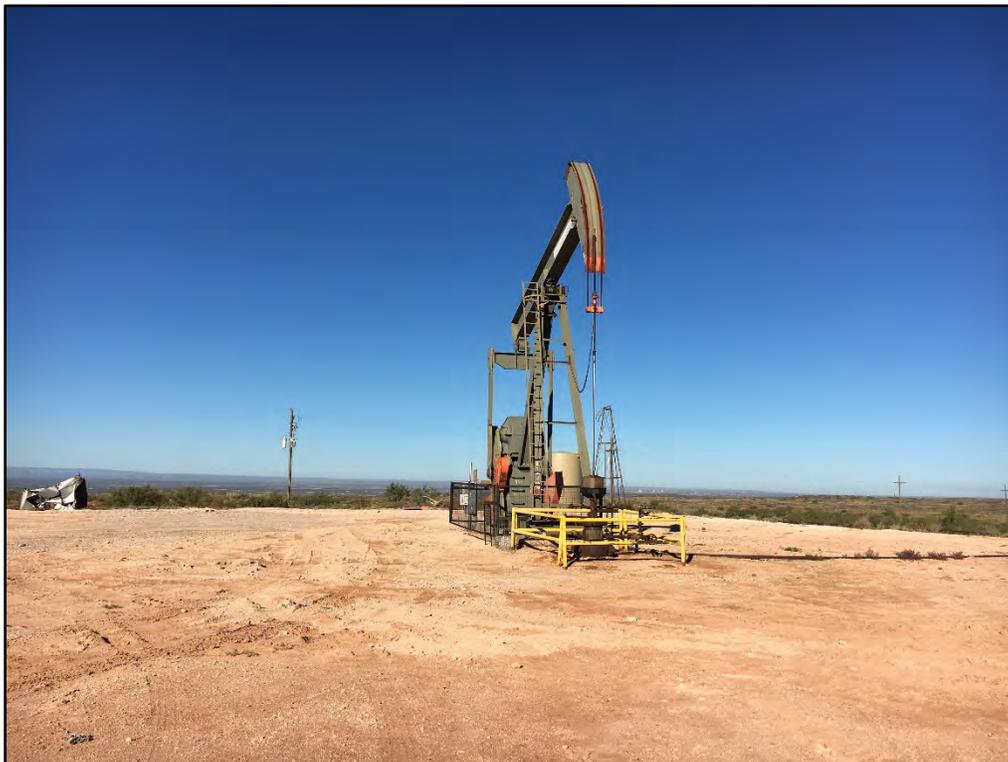
Photo 1. Pumpjack unit. Impacted soils located left of pumpjack and extending in direction of powerline.

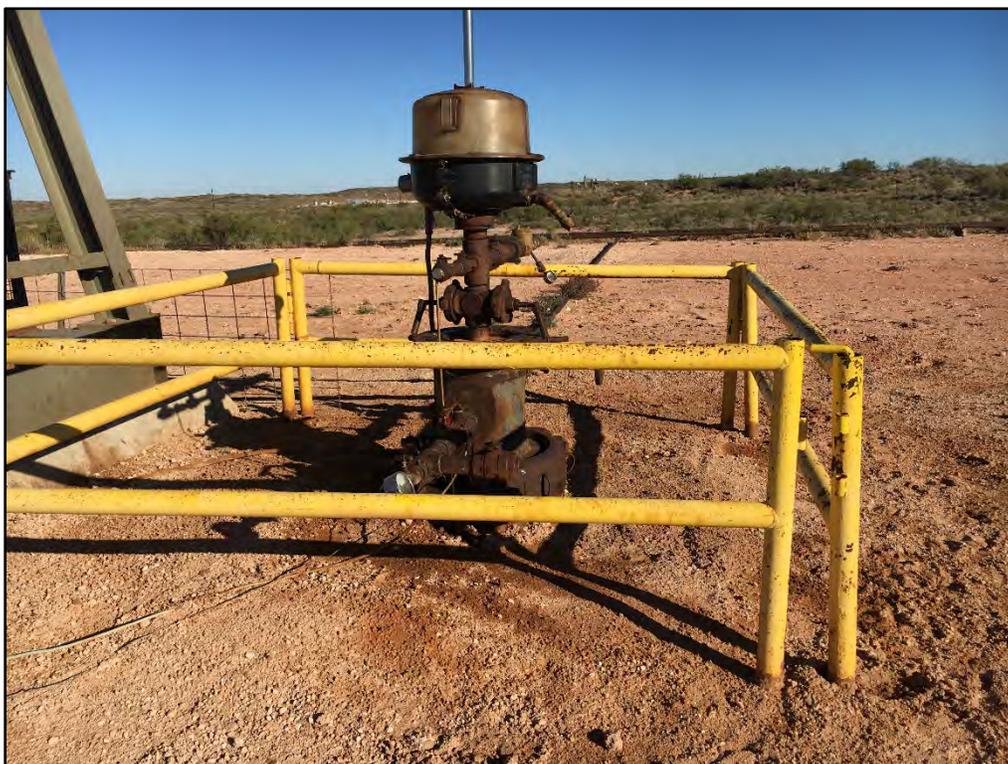
Cause of Release
Fluids were released from the well head due to a stuffing box packing failure. A vacuum truck recovered free standing fluids. The packing was replaced and the well was returned to production.

Photo 2. Source of release.

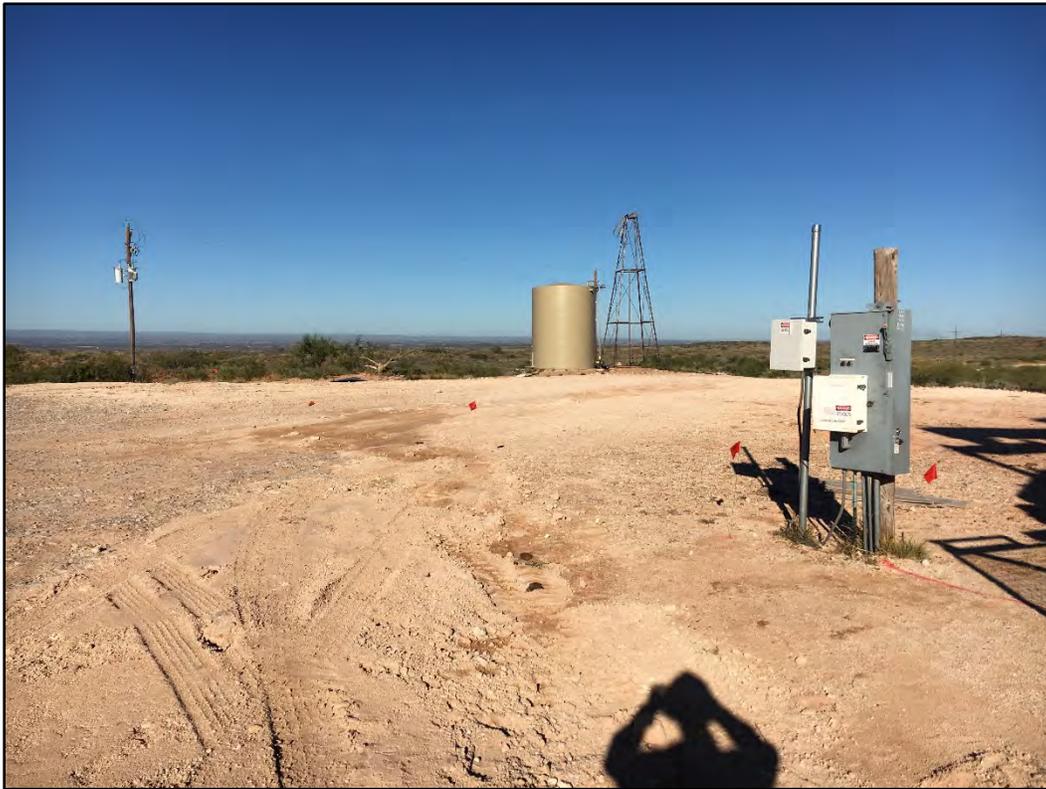
Photo 3. Impacted soils extending northwest from pumpjack.

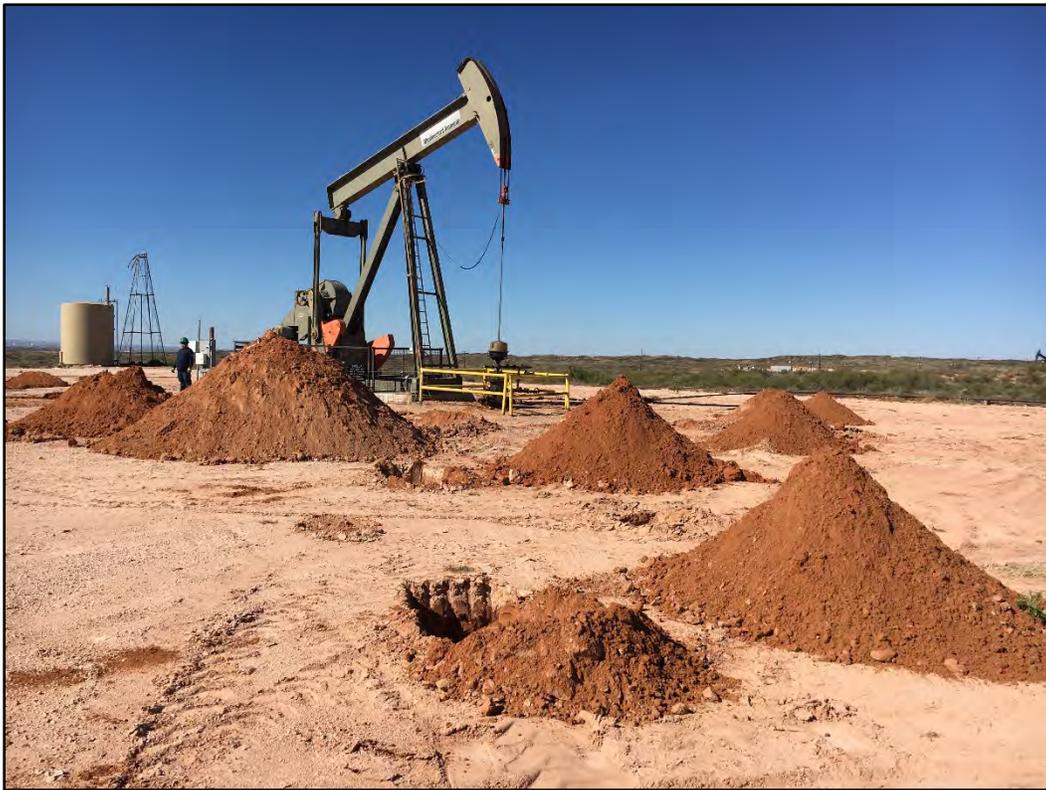
Photo 4. Delineation activities showing pothole locations.

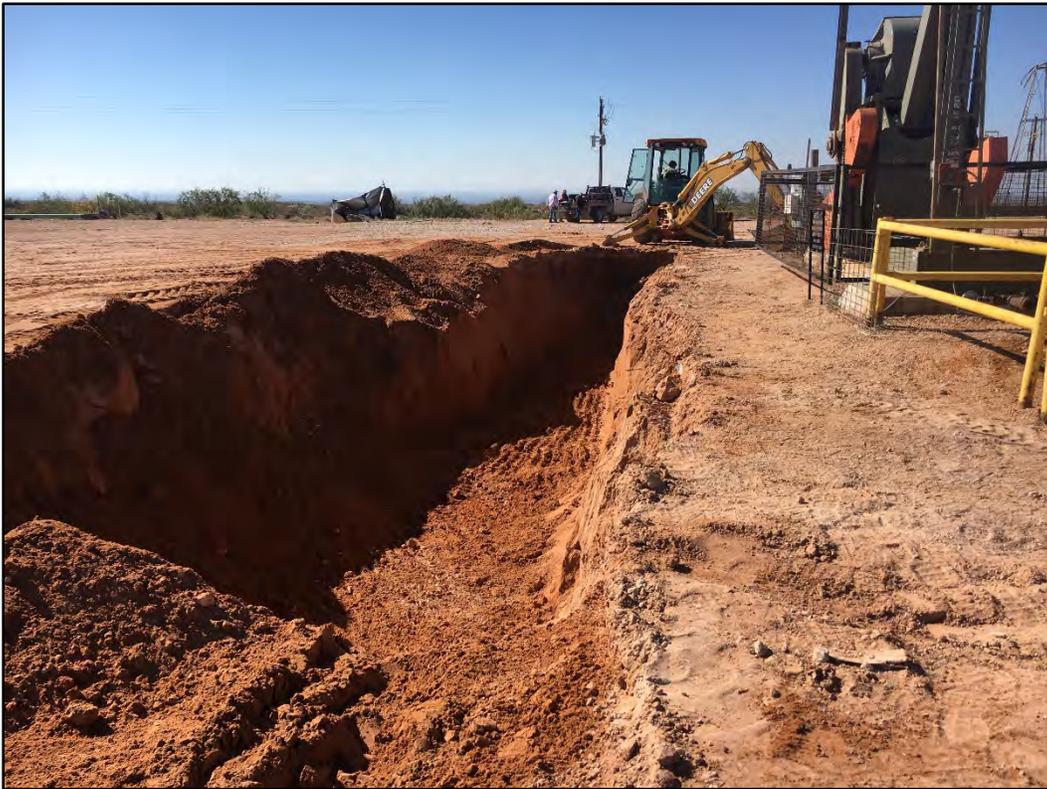
Photo 5. Beginning excavation adjacent to pumpjack.

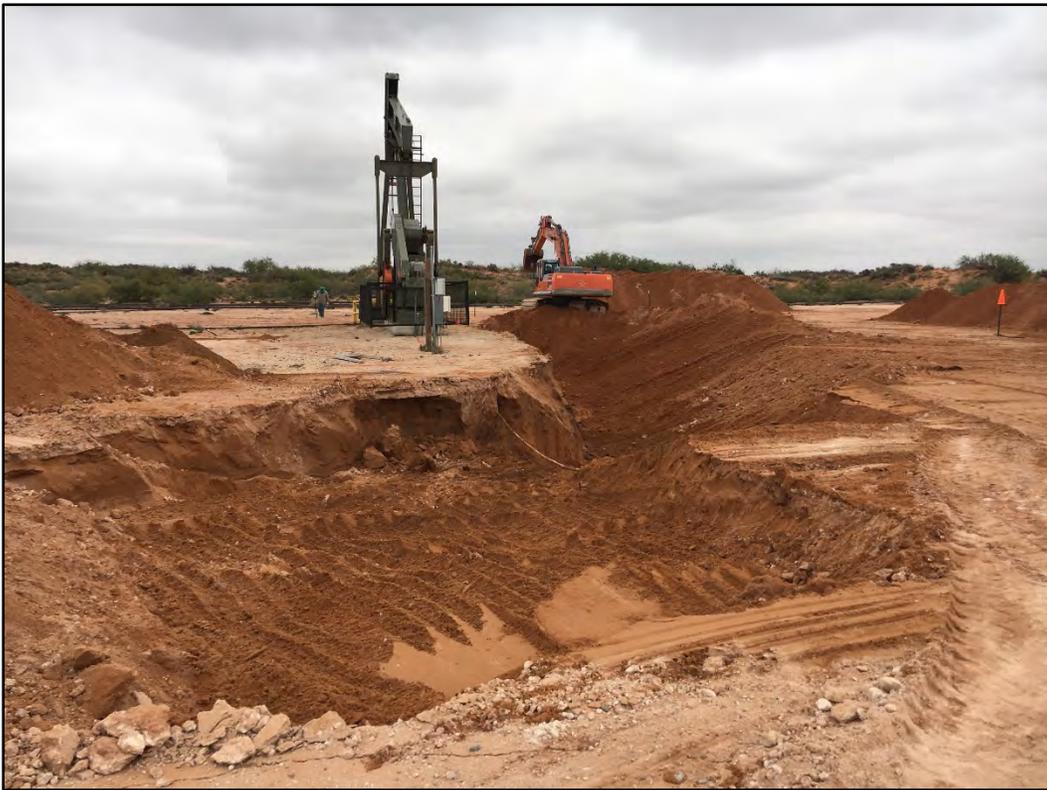
Photo 6. Excavation activities. Note exposed electrical line in center of photo.

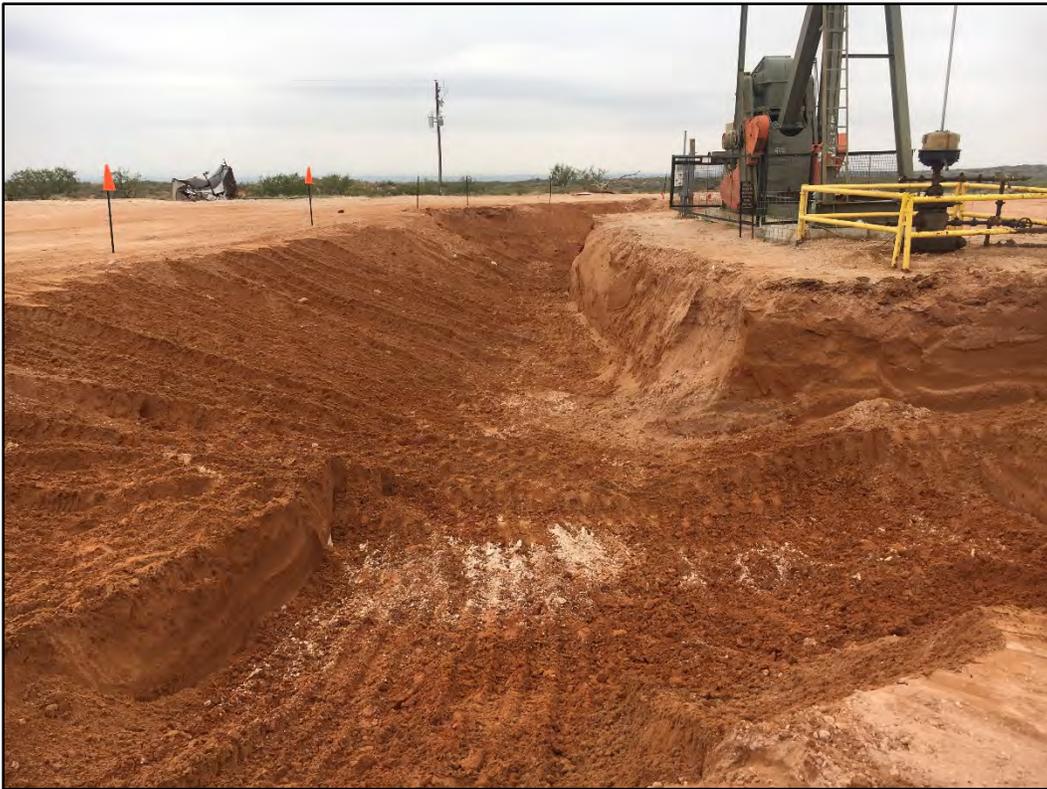
Photo 7. Excavation area.

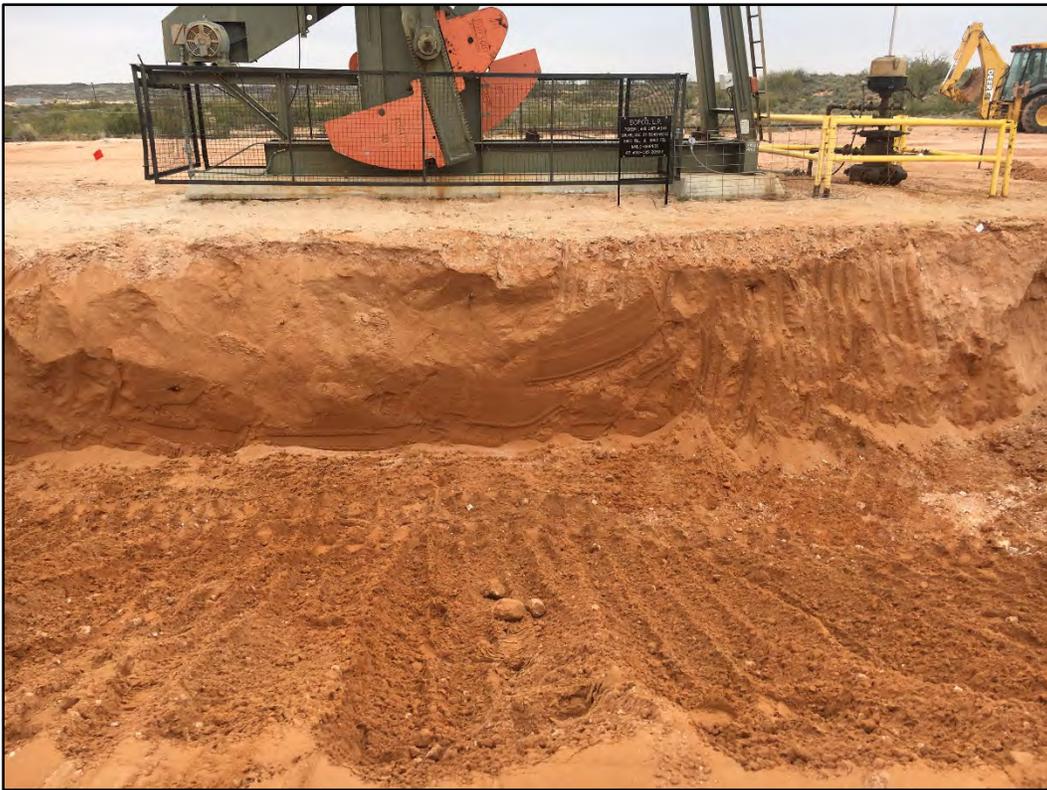
Photo 8. Scraping the walls for samples SC-12 and SC-13.

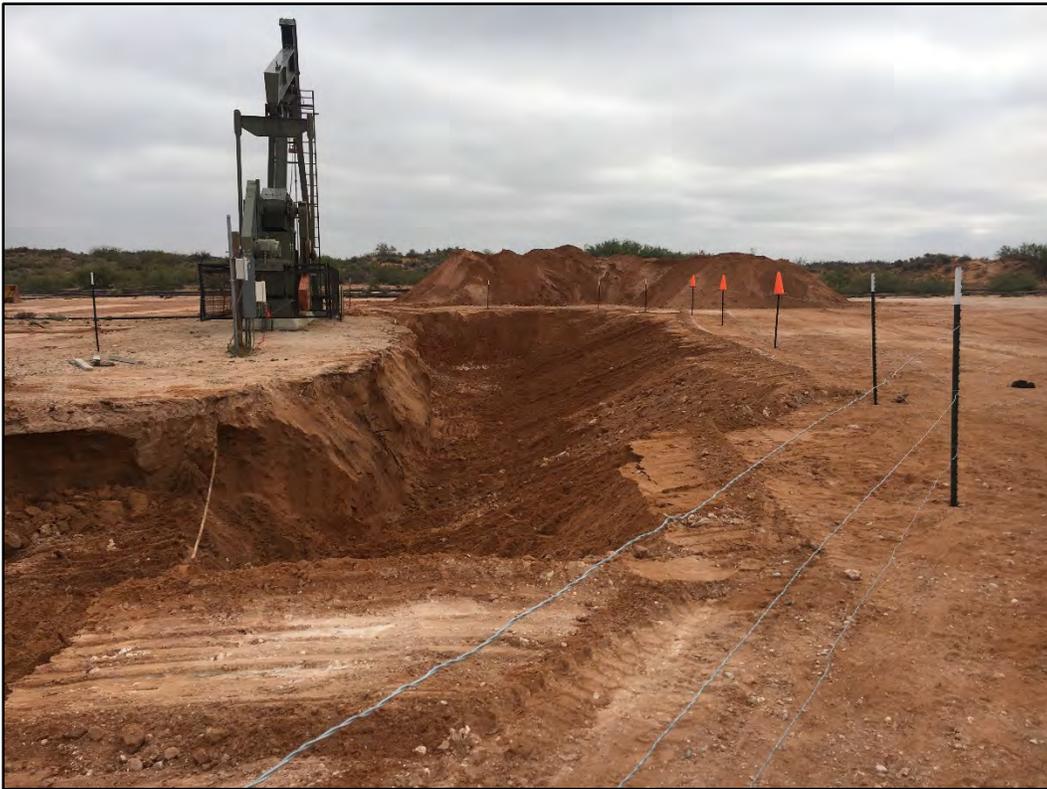
Photo 9. Excavation secured using 3-wire fencing.
