RECLAMATION REPORT

PREPARED FOR:
DEVON ENERGY PRODUCTION, LP.

LOCATION: White Dove 17 Federal Com #022H

NMOCD REF. NO. NAPP2204560256

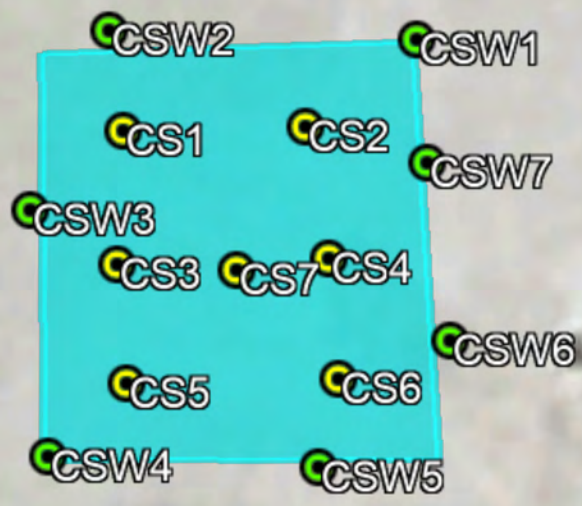
On August 13, 2024, after sending a 48-hour notification (application ID: 371943, Appendix C), Pima returned to the site to collect 5-point confirmation sample from the excavation. The 5-point composite sample was taken from the exposed excavation sidewalls and bottom samples were collected at 2' feet deep. All samples were put on ice, jarred, and delivered to Envirotech Analytical Laboratories, an NMOCD-approved laboratory for official analysis for all constituents listed in Table 1 19.15.29.12 NMAC. The laboratory results of this sampling event can be found in Figure 5 as well as the analytical laboratory reports available in Appendix E. A corresponding Confirmation Sample Map can be found in Figure 7.

- 2' Deep Bottom Composite Confirmation Samples
- Sidewalls 0 to 2' feet Composite Confirmation samples
- White Dove 17 Federal 22H

Based on the sample results, the bottoms and sidewalls were below NMOCD Closure Criteria 19.15.29 NMAC. The contaminated material was sufficiently removed and then transported to Northern Delaware Basin Landfill, an NMOCD approved disposal site. See Appendix D for Photographic Documentation.

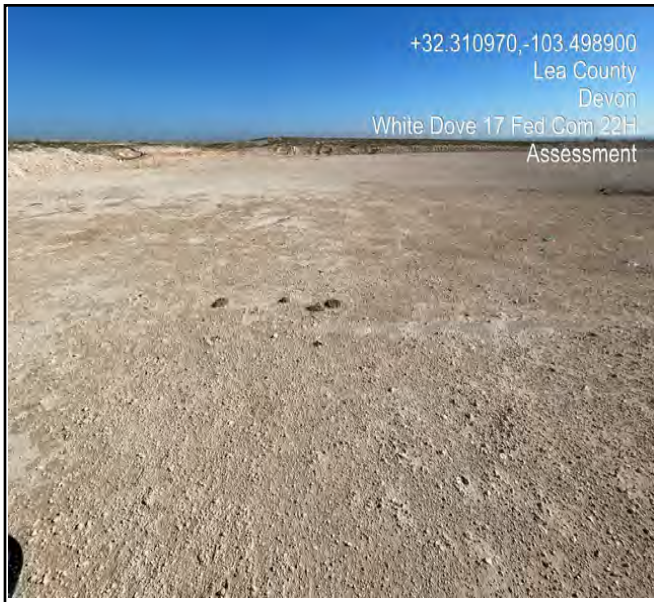
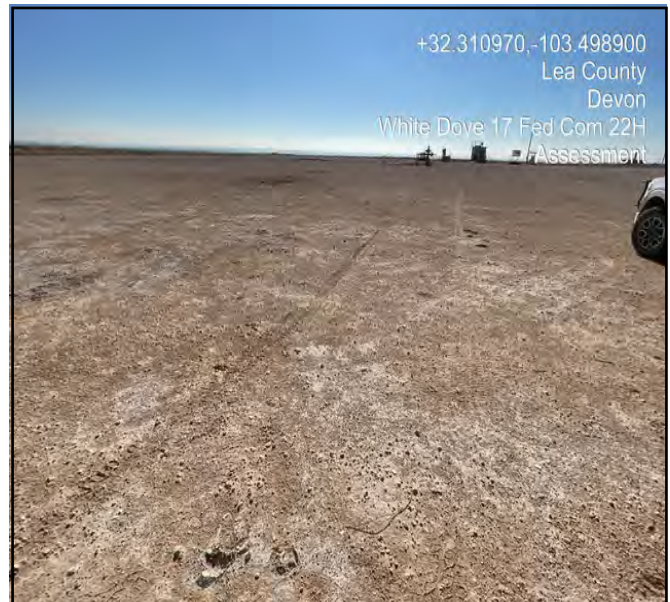
Photo taken during assessment, prior to excavation.

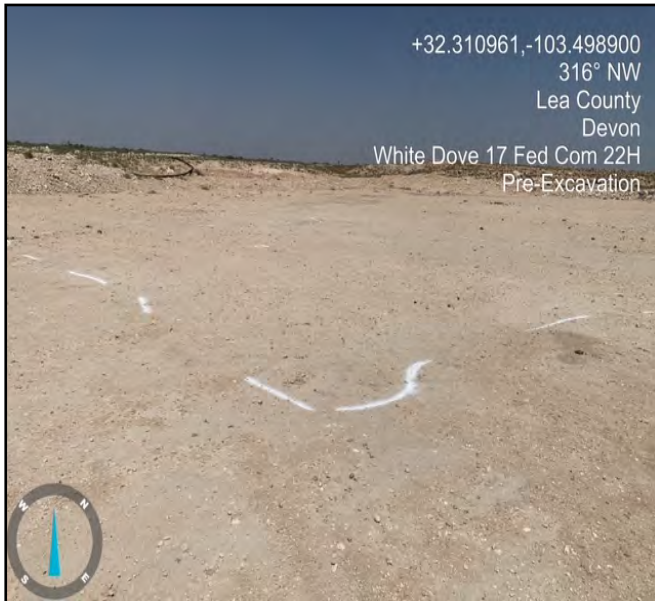
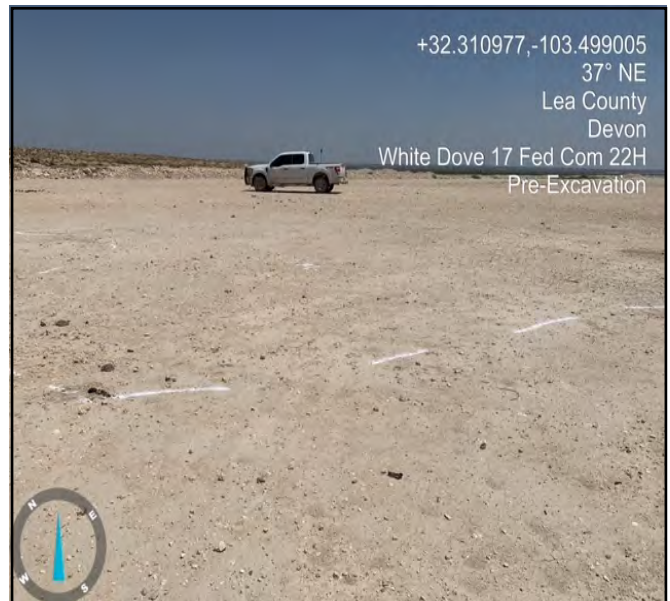
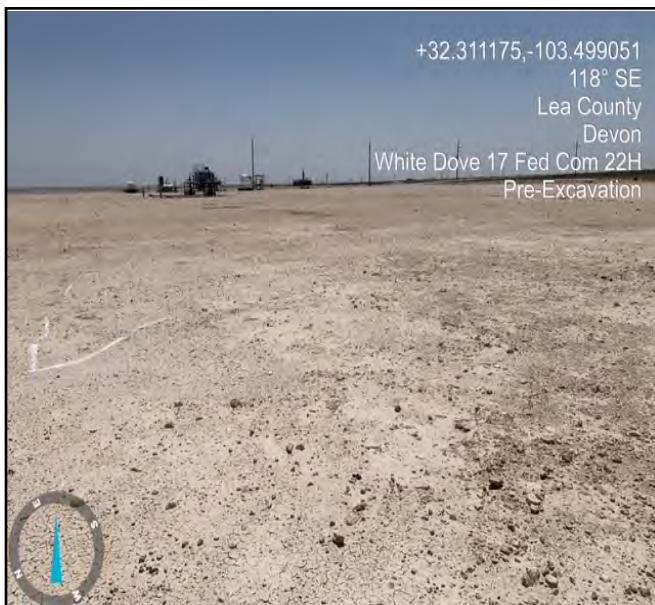
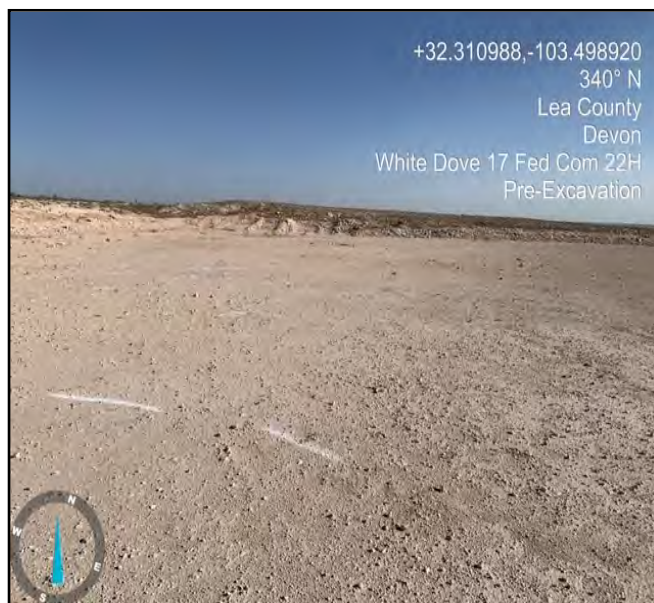
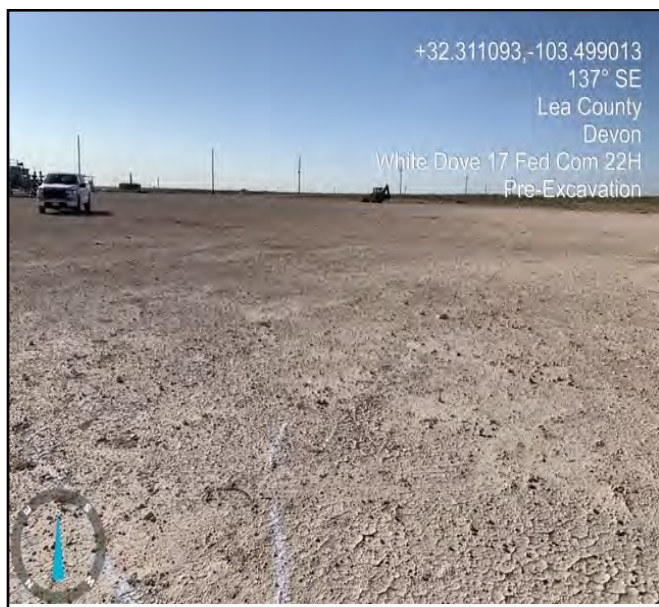
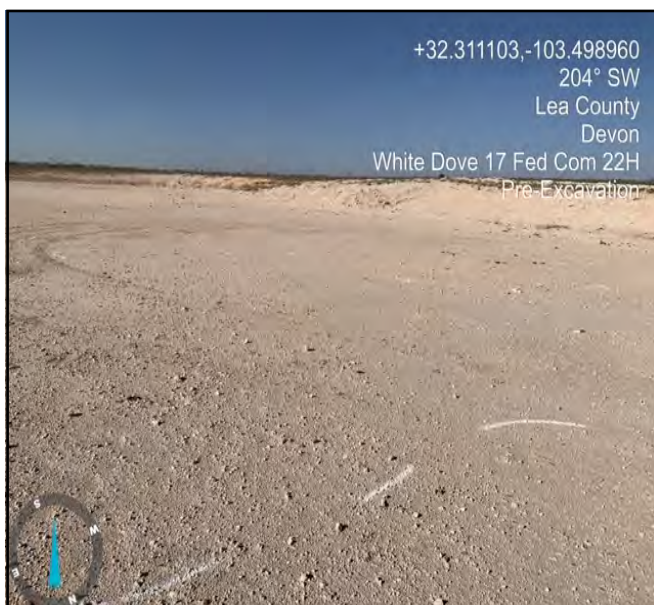
Photo of outline of the excavation area facing Northwest.

Photo of outline of the excavation area facing Northeast.

Photo of outline of the excavation area facing Southeast.

Photo of outline of the excavation area facing Southwest.

Photo of outline of the excavation area facing West.

Photo of outline of the excavation area facing North.

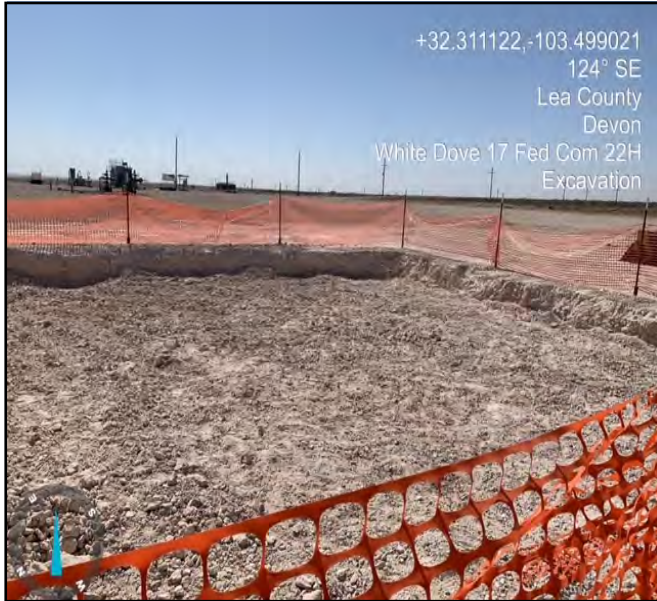
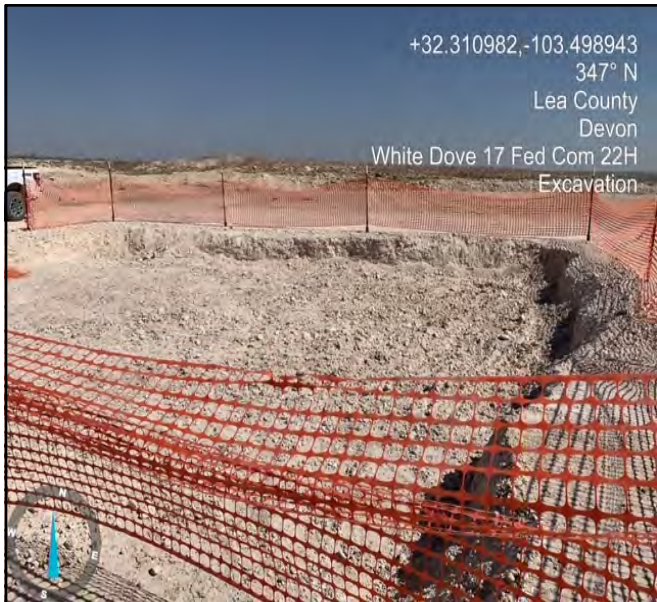
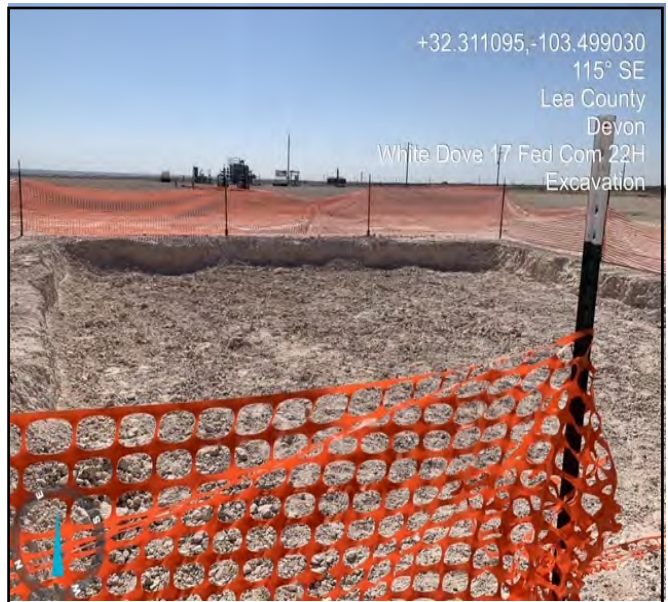
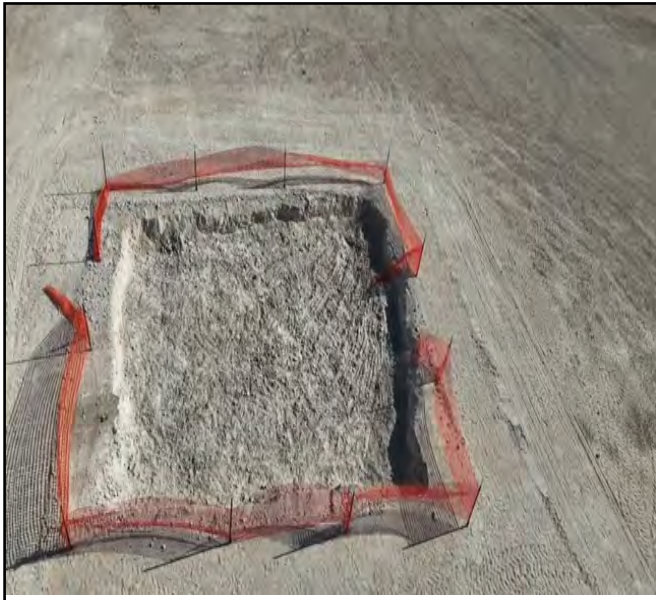
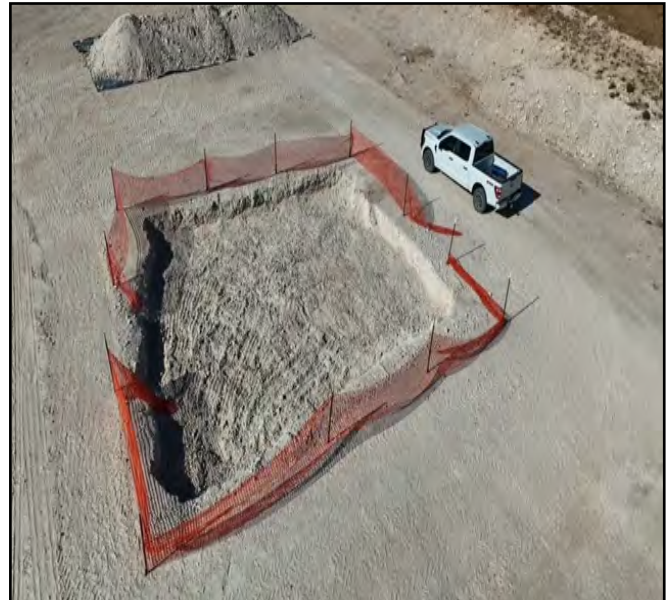
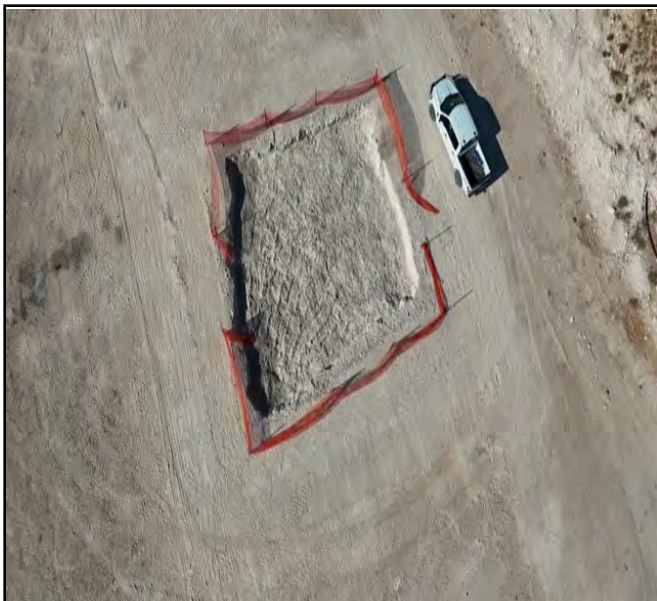
Photo during excavation facing Southeast.

Photo during excavation facing Southwest.

Photo during excavation facing North.

Aerial photo taken during excavation.

On August 7, 2024, the Devon Construction Department mobilized personnel and equipment to initiate immediate remediation activities. They began excavating the area to a depth of 2' foot below ground surface (BGS). A total of 95 cubic yards of contaminated soil was hauled to Northern Delaware Basin Landfill, an approved, lined disposal facility and clean backfill material was brought in.

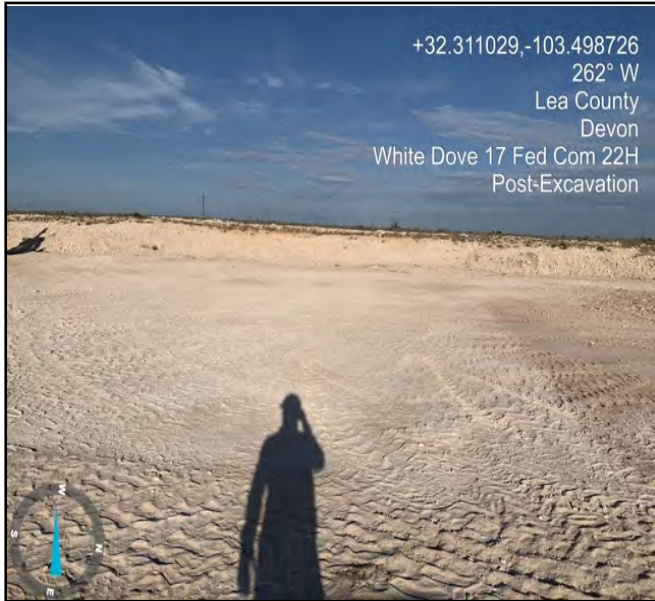
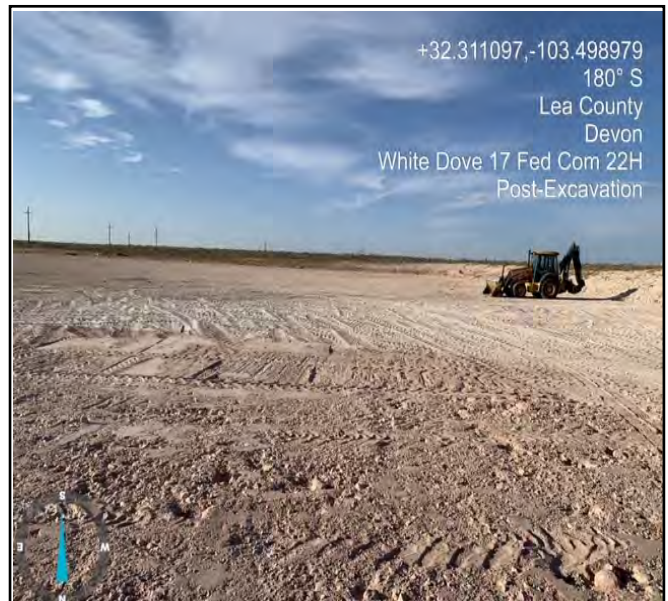
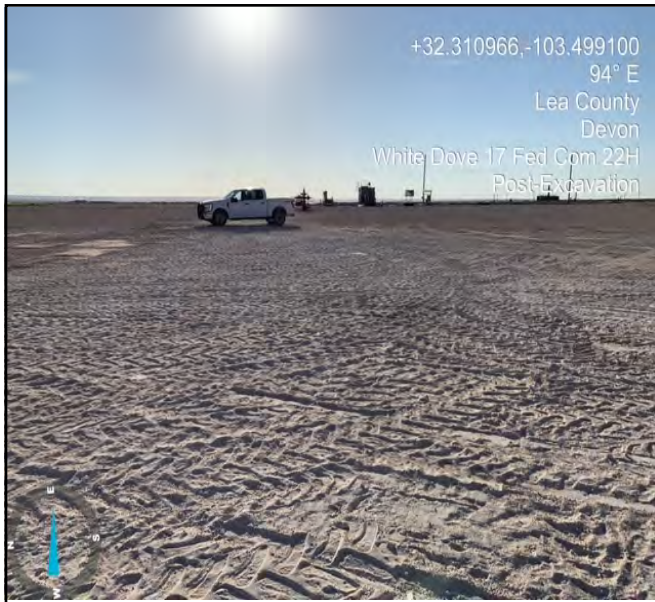
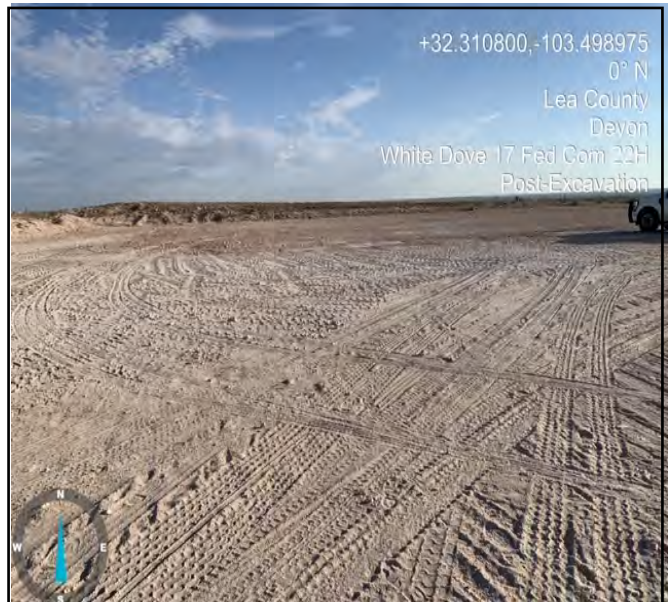
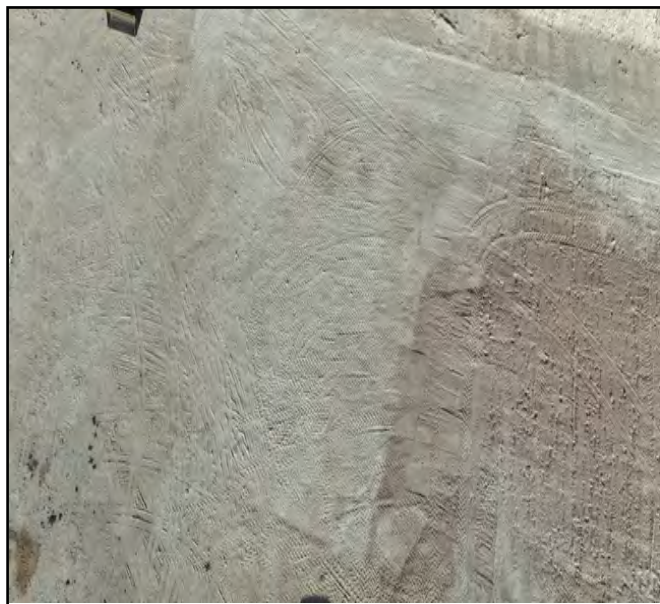
Photo taken pursuant to excavation, taken facing West.

Photo taken pursuant to excavation, taken facing South.

Photo taken pursuant to excavation, taken facing East.

Photo taken pursuant to excavation, taken facing North.

Aerial photo taken pursuant excavation.
