LEAK #35

Remediation Action Plan

NMOCD Incident No. nAPP2413952028
UL "H," Sec. 21, T16S, R37E
32.908050 -103.248165
Lea County, New Mexico

April 8, 2025

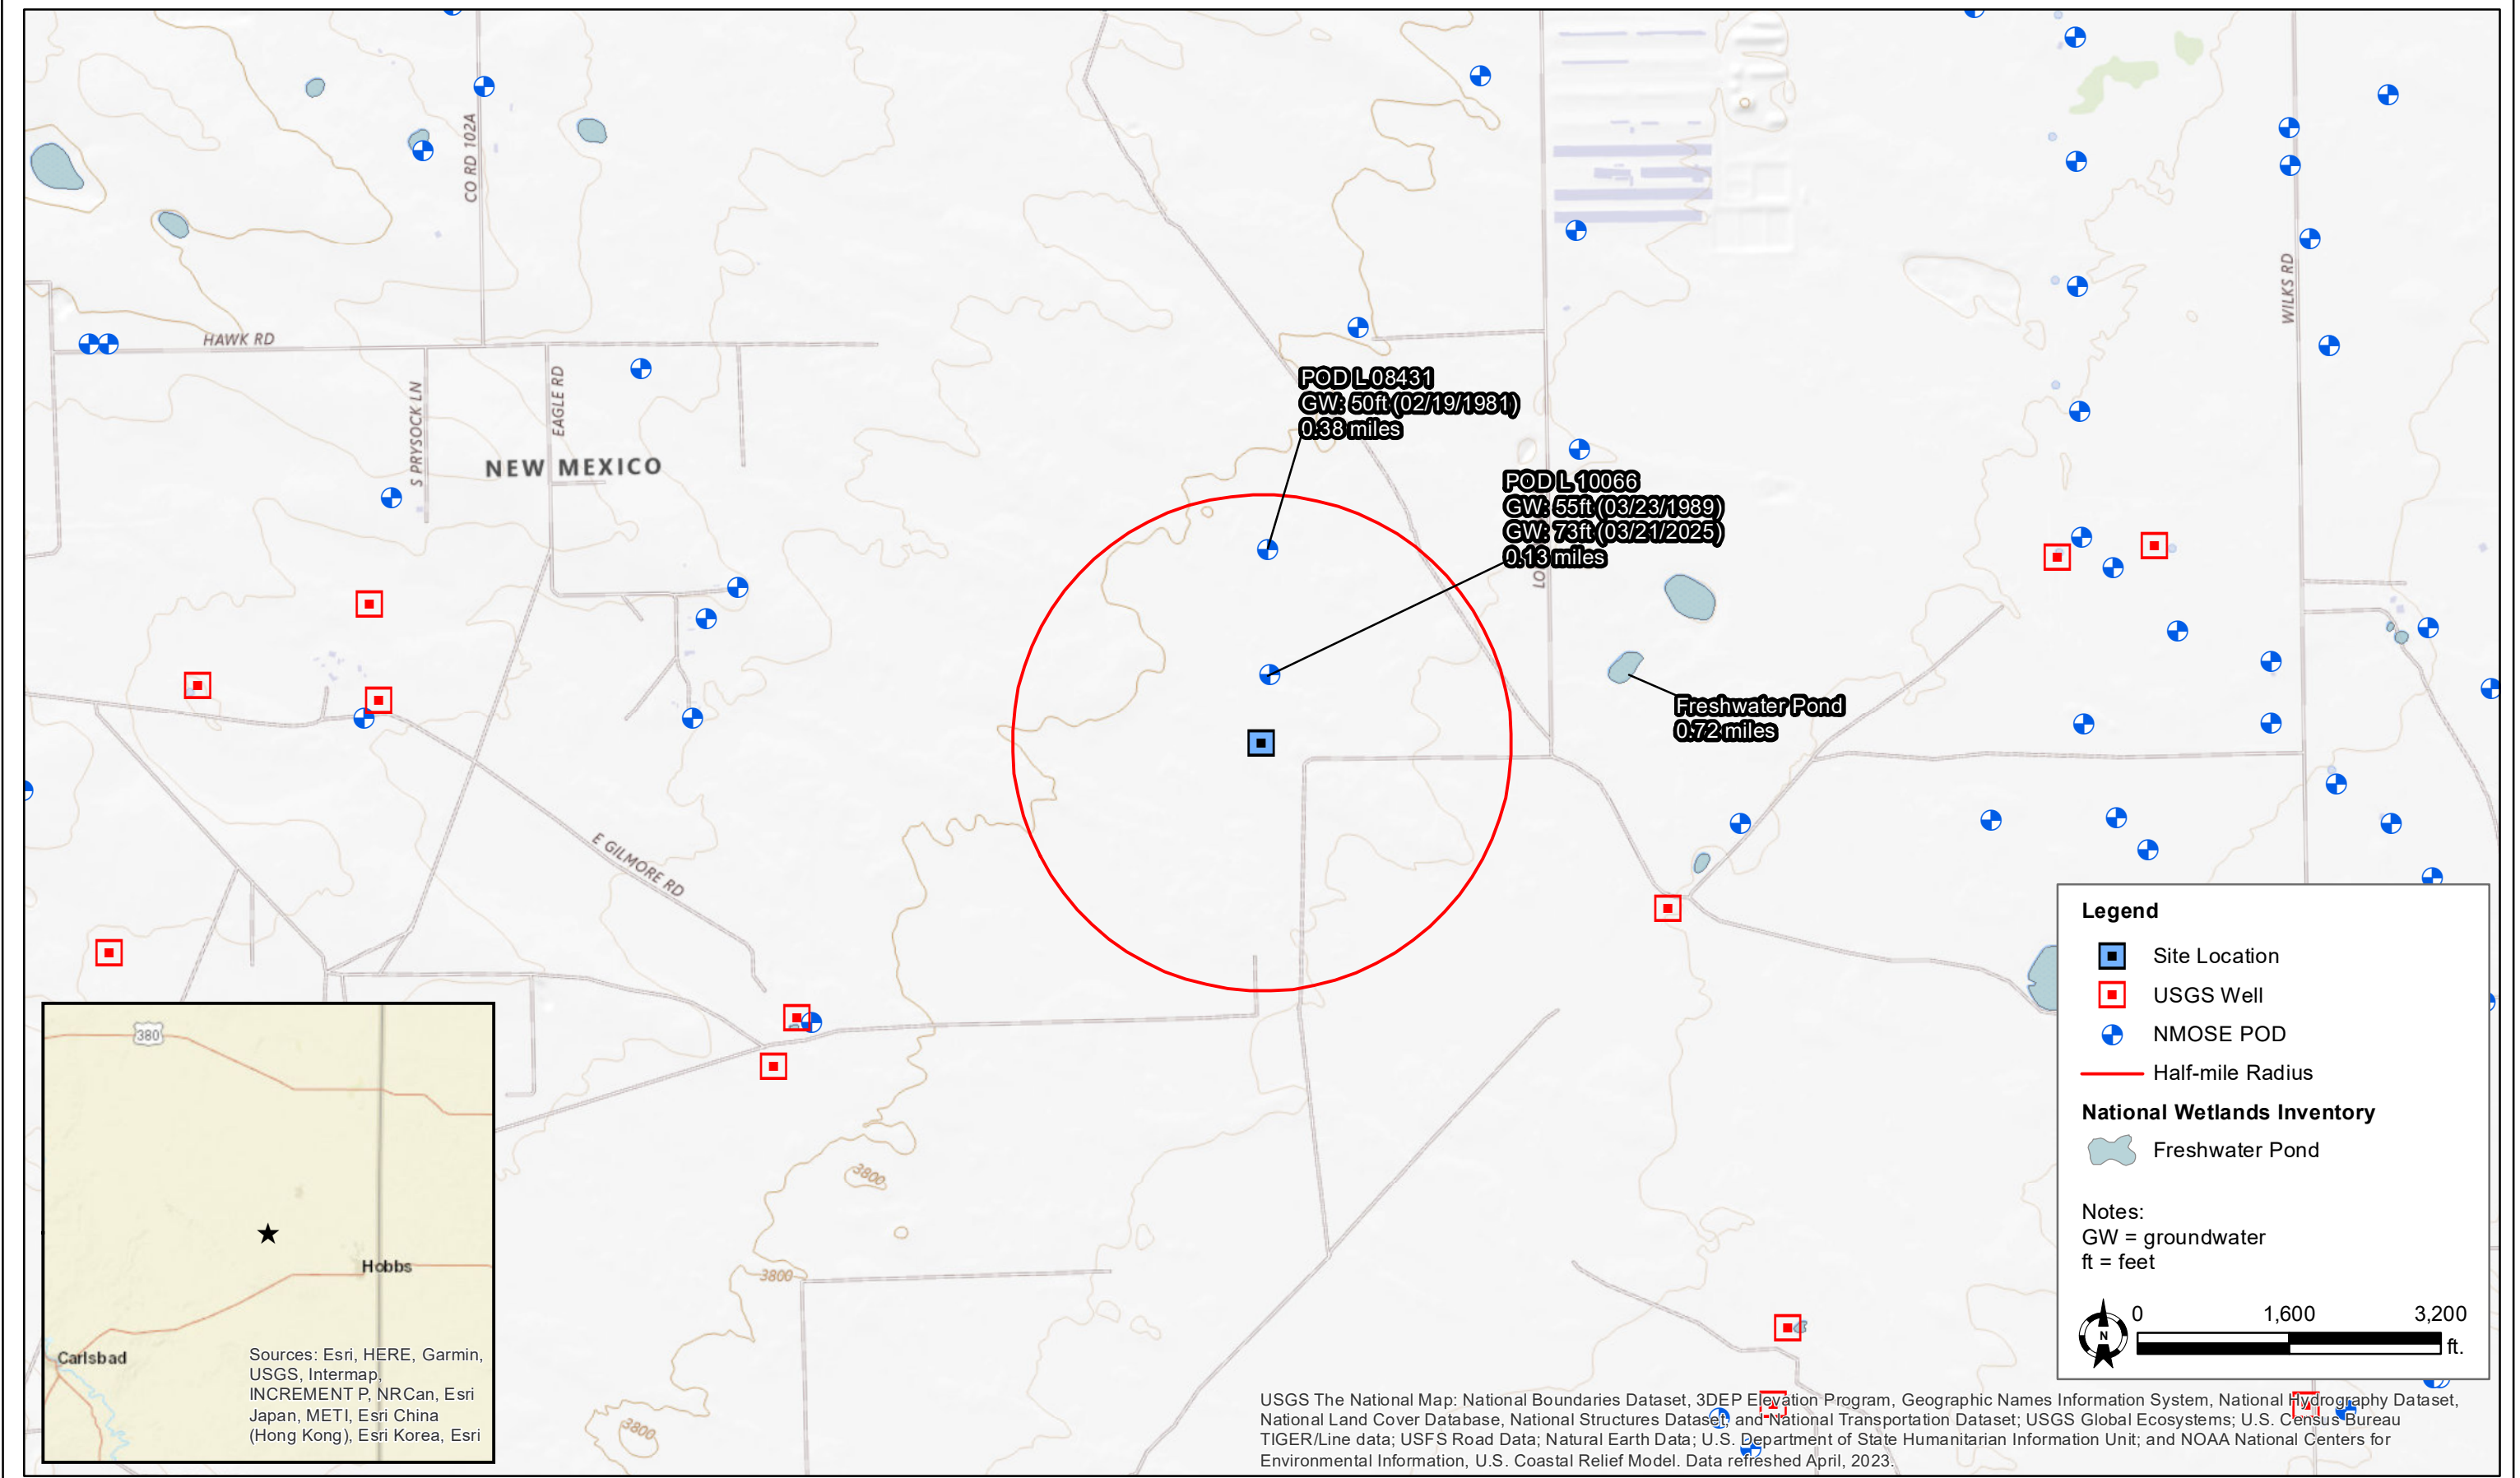
DATE: March 2025	  Tasman, Inc. 6855 W. 119th Ave Broomfield, CO 80020	Targa Resources Leak #35 - nAPP2413952028 UL "A", Sec. 21, T16S, R37E Lea County, New Mexico	Site Location & Groundwater Map	Figure 1
DESIGNED BY: C. Flores				
DRAWN BY: C. Flores

The Site Location & Groundwater Map included as Figure 1 illustrates the location of the registered water well closest to the site, a summary of depth to groundwater information, and a photo of the new measurement is provided as Appendix C.

The site is located in Unit Letter “H” of Section 21, Township 16 South, Range 37 East in Lea County, New Mexico. The release occurred due to gathering system pipeline failure. The release occurred on New Mexico State Trust Land (NMSLO) property. A site location map can be found attached as Figure 1.

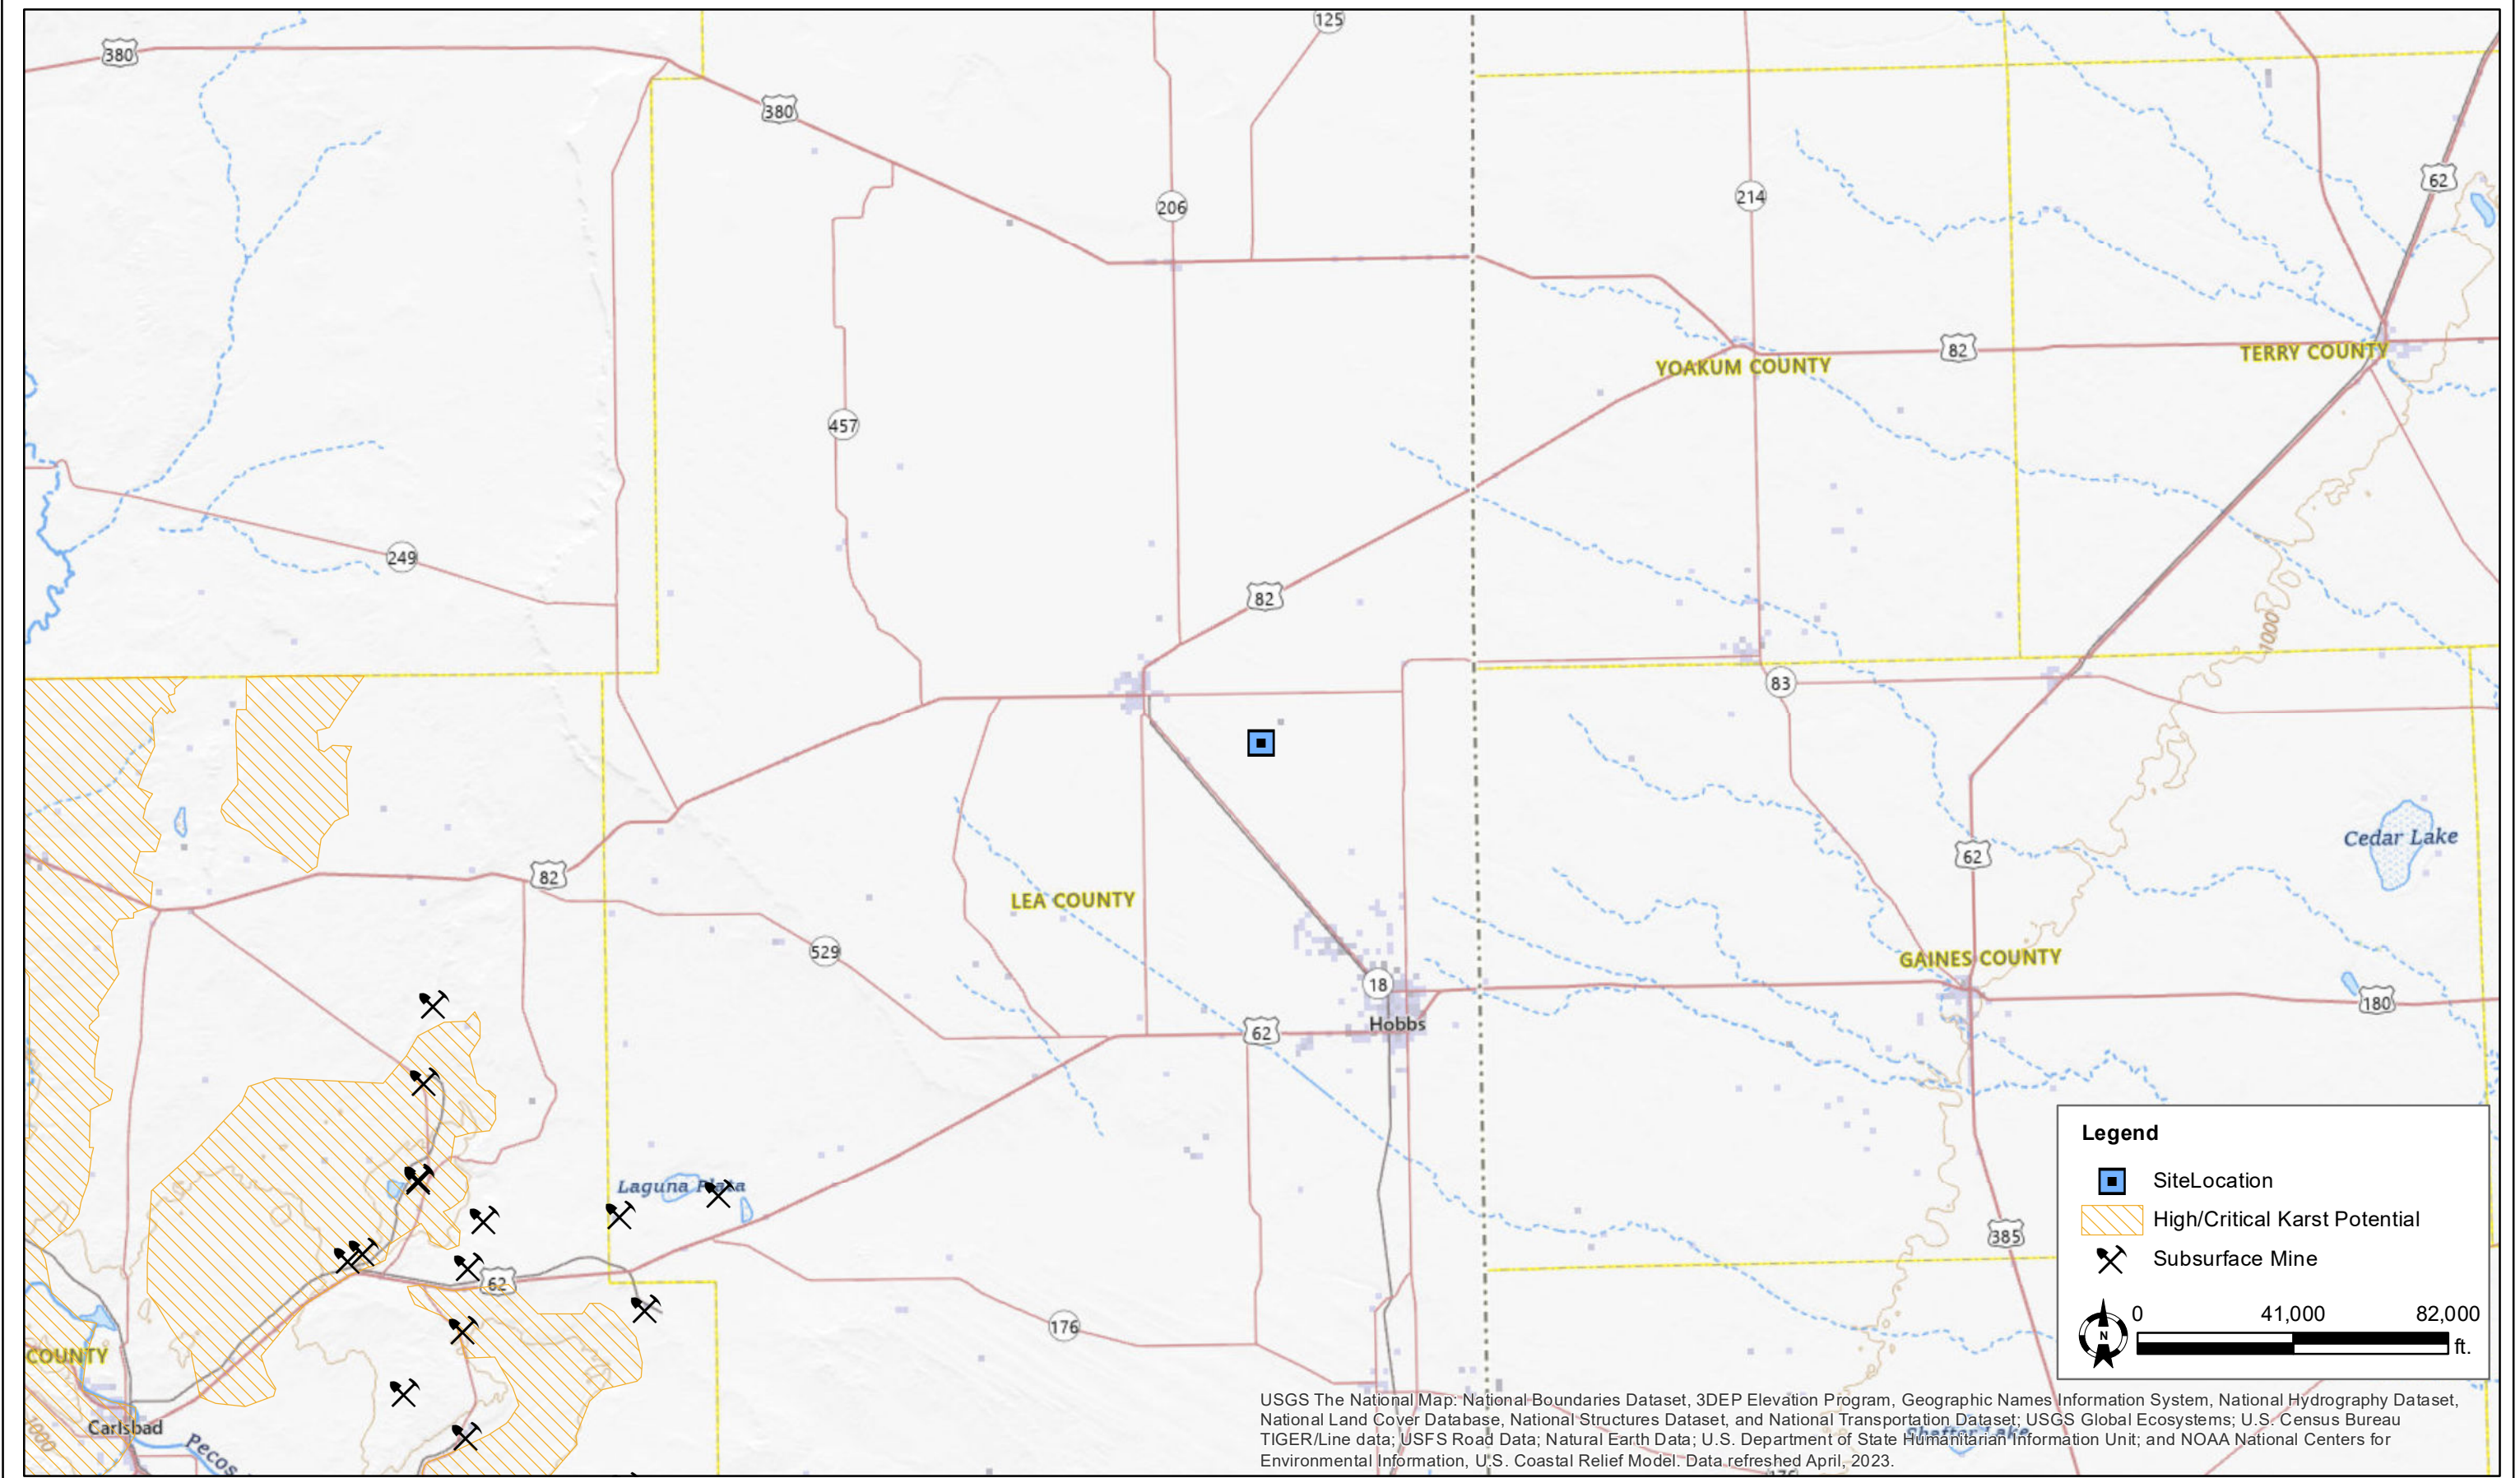
Figure
2

Karst Potential & Subsurface
Mine Map

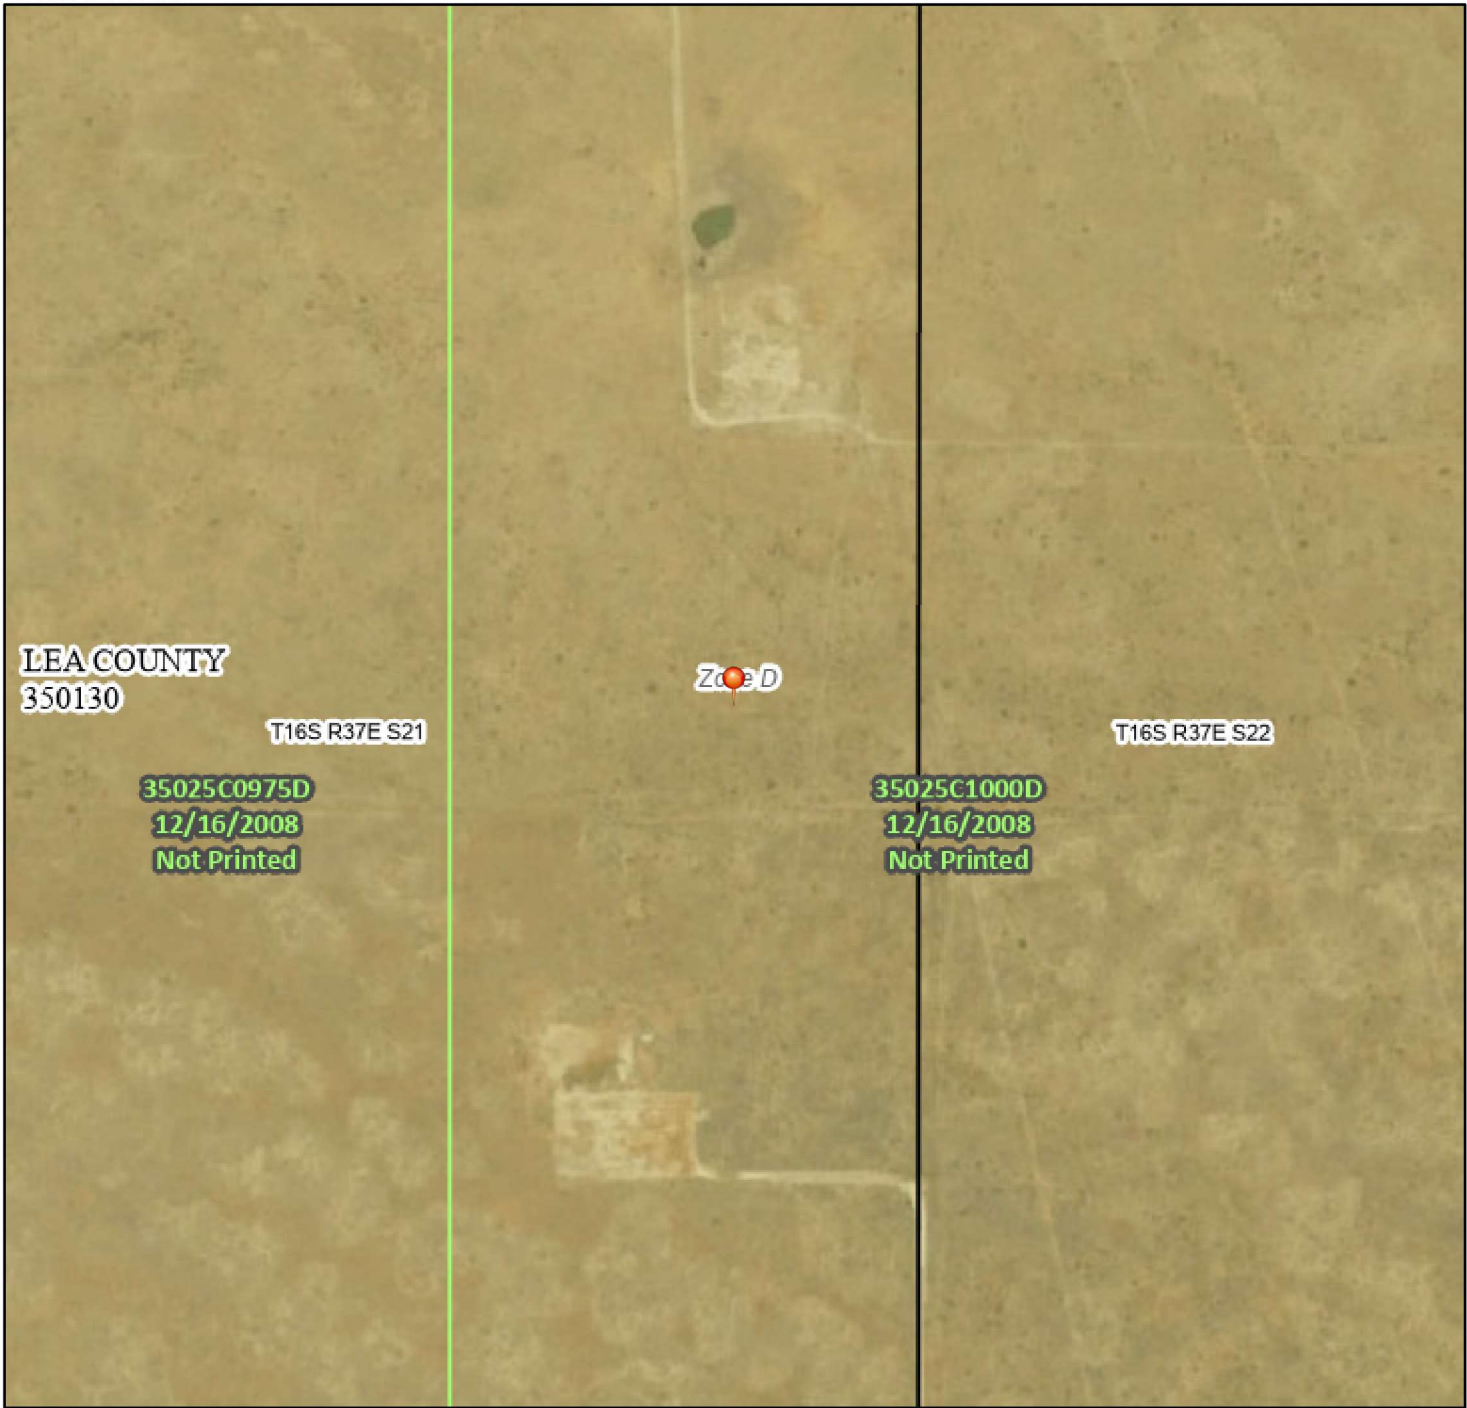
National Flood Hazard Layer FIRMMette

Review of flood map data published by the Federal Emergency Management Agency (FEMA) indicates the site is not located within a 100-year floodplain. A copy of the FEMA FIRMet Map can be found attached as Figure 4.

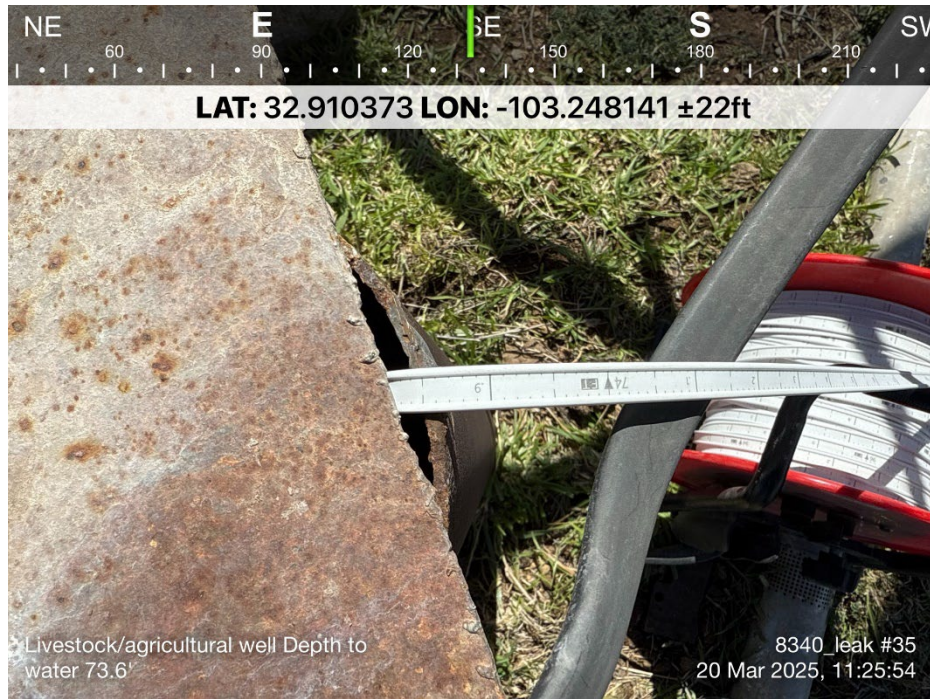
DTW Measurement of L 10066

Depth to Groundwater (DTW) measurement was collected March 10, 1989, at a 55 ft below ground surface (bgs). On March 20, 2025, Tasman personnel, using a water level meter, collected a direct measurement of DTW from L10066 at 73.6 ft bgs.

Measurement 73.6' bgs

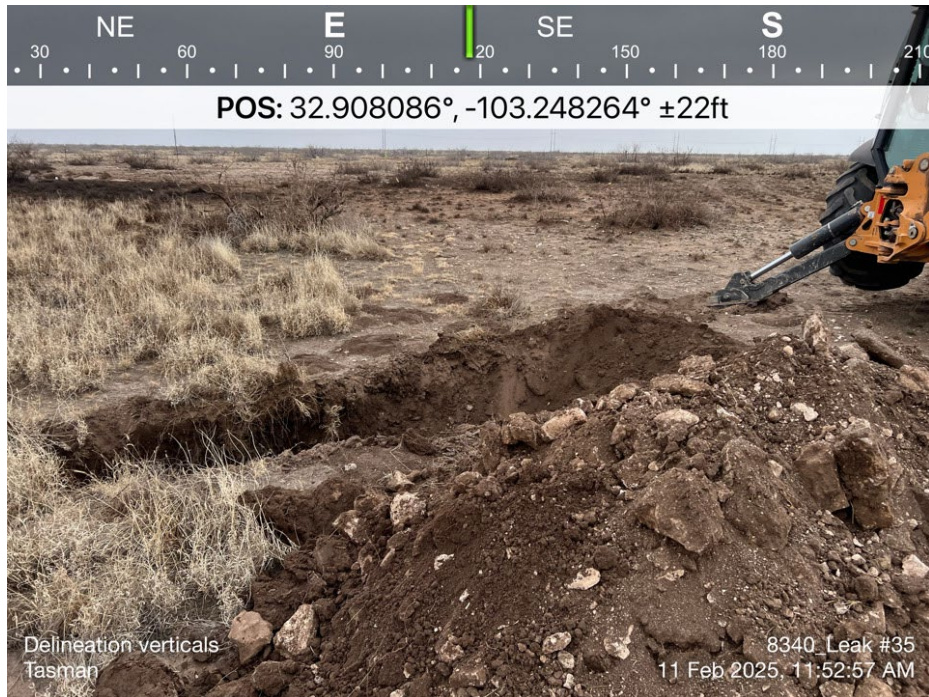
Delineation Vertical

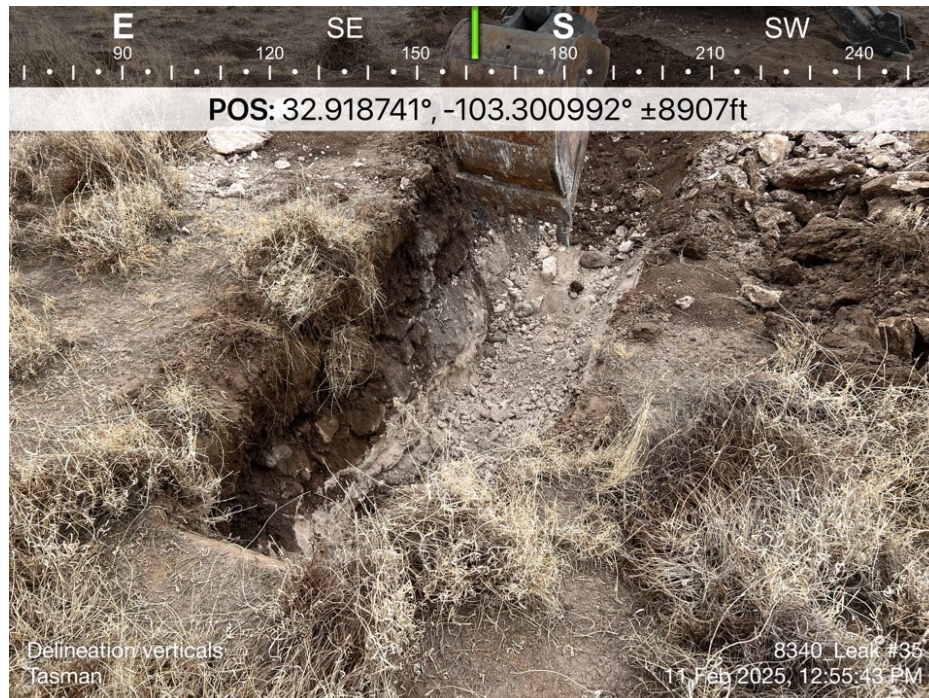
Delineation Vertical

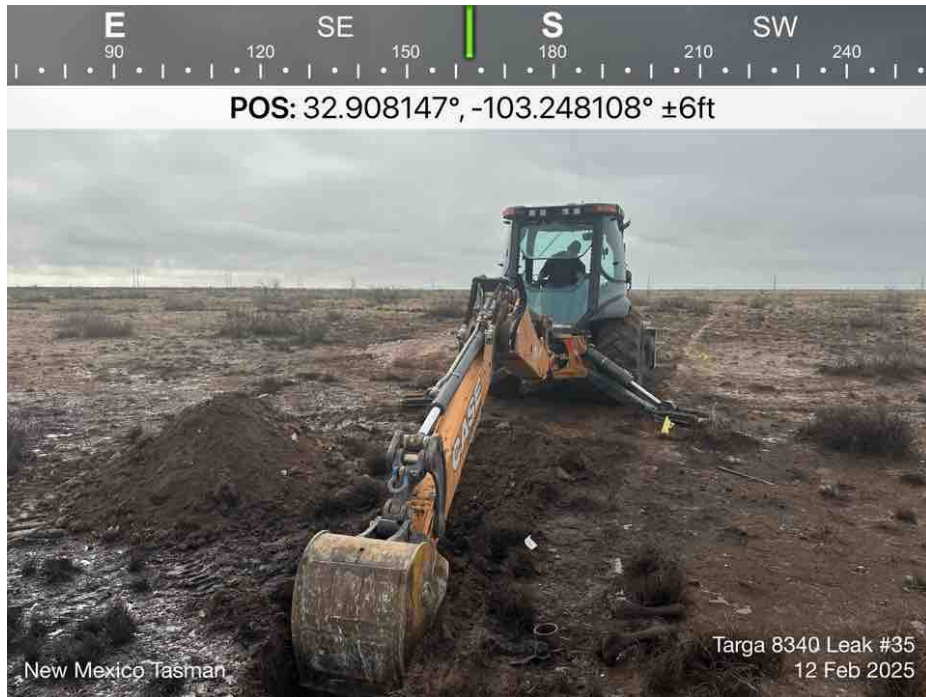
Delineation Vertical

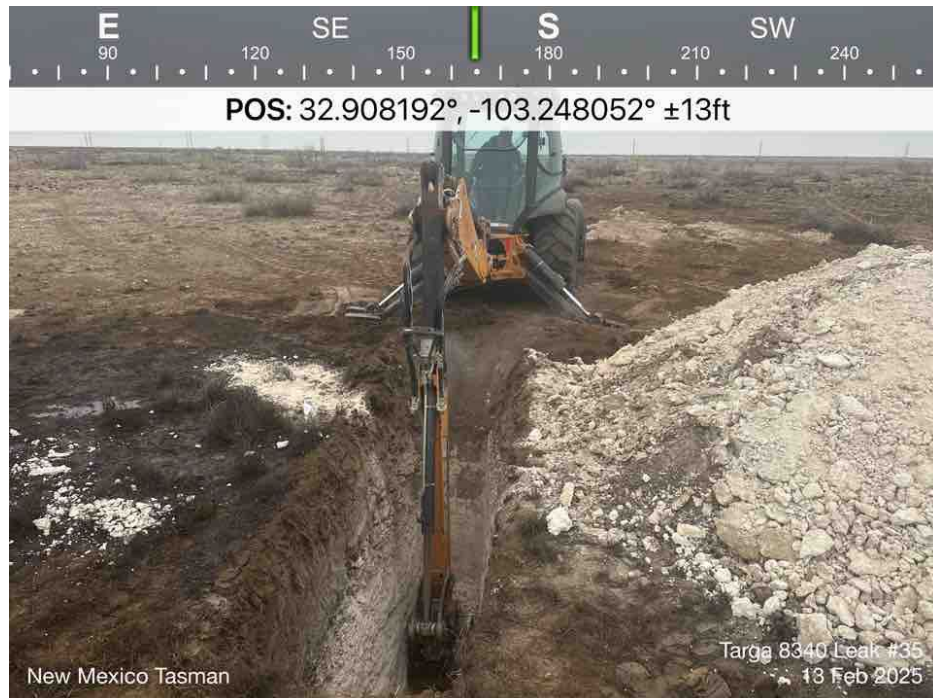
Delineation Vertical

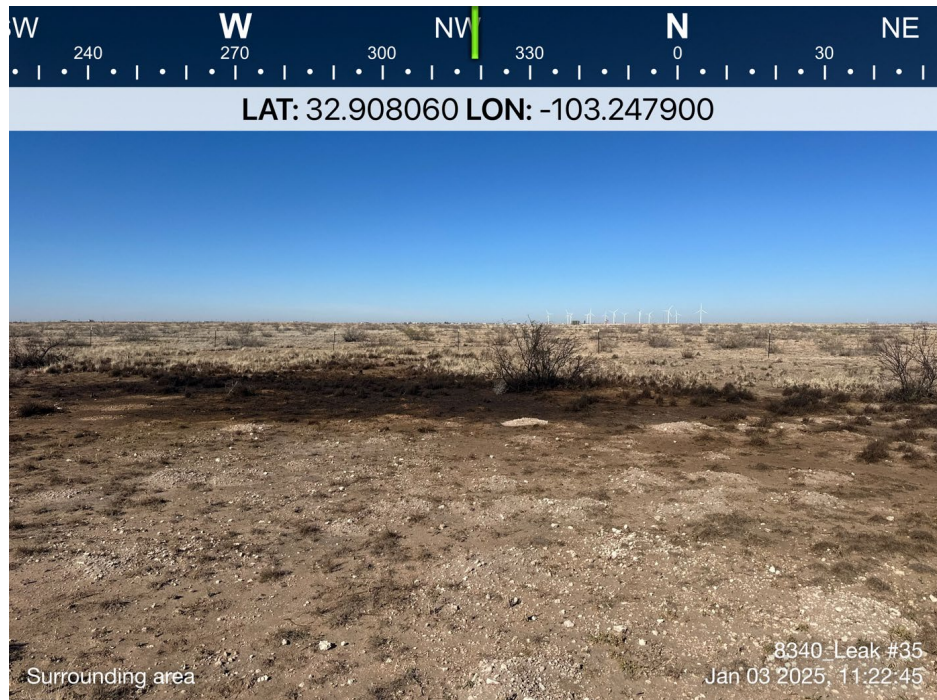
Release Area
