Trinity Oilfield Services & Rentals, LLC

May 9th, 2025

Site Location Map
Cross Timbers Energy, LLC
North Vacuum Abo 120 Battery - Area 3
Lea County, New Mexico
32.83819002, -103.52467326

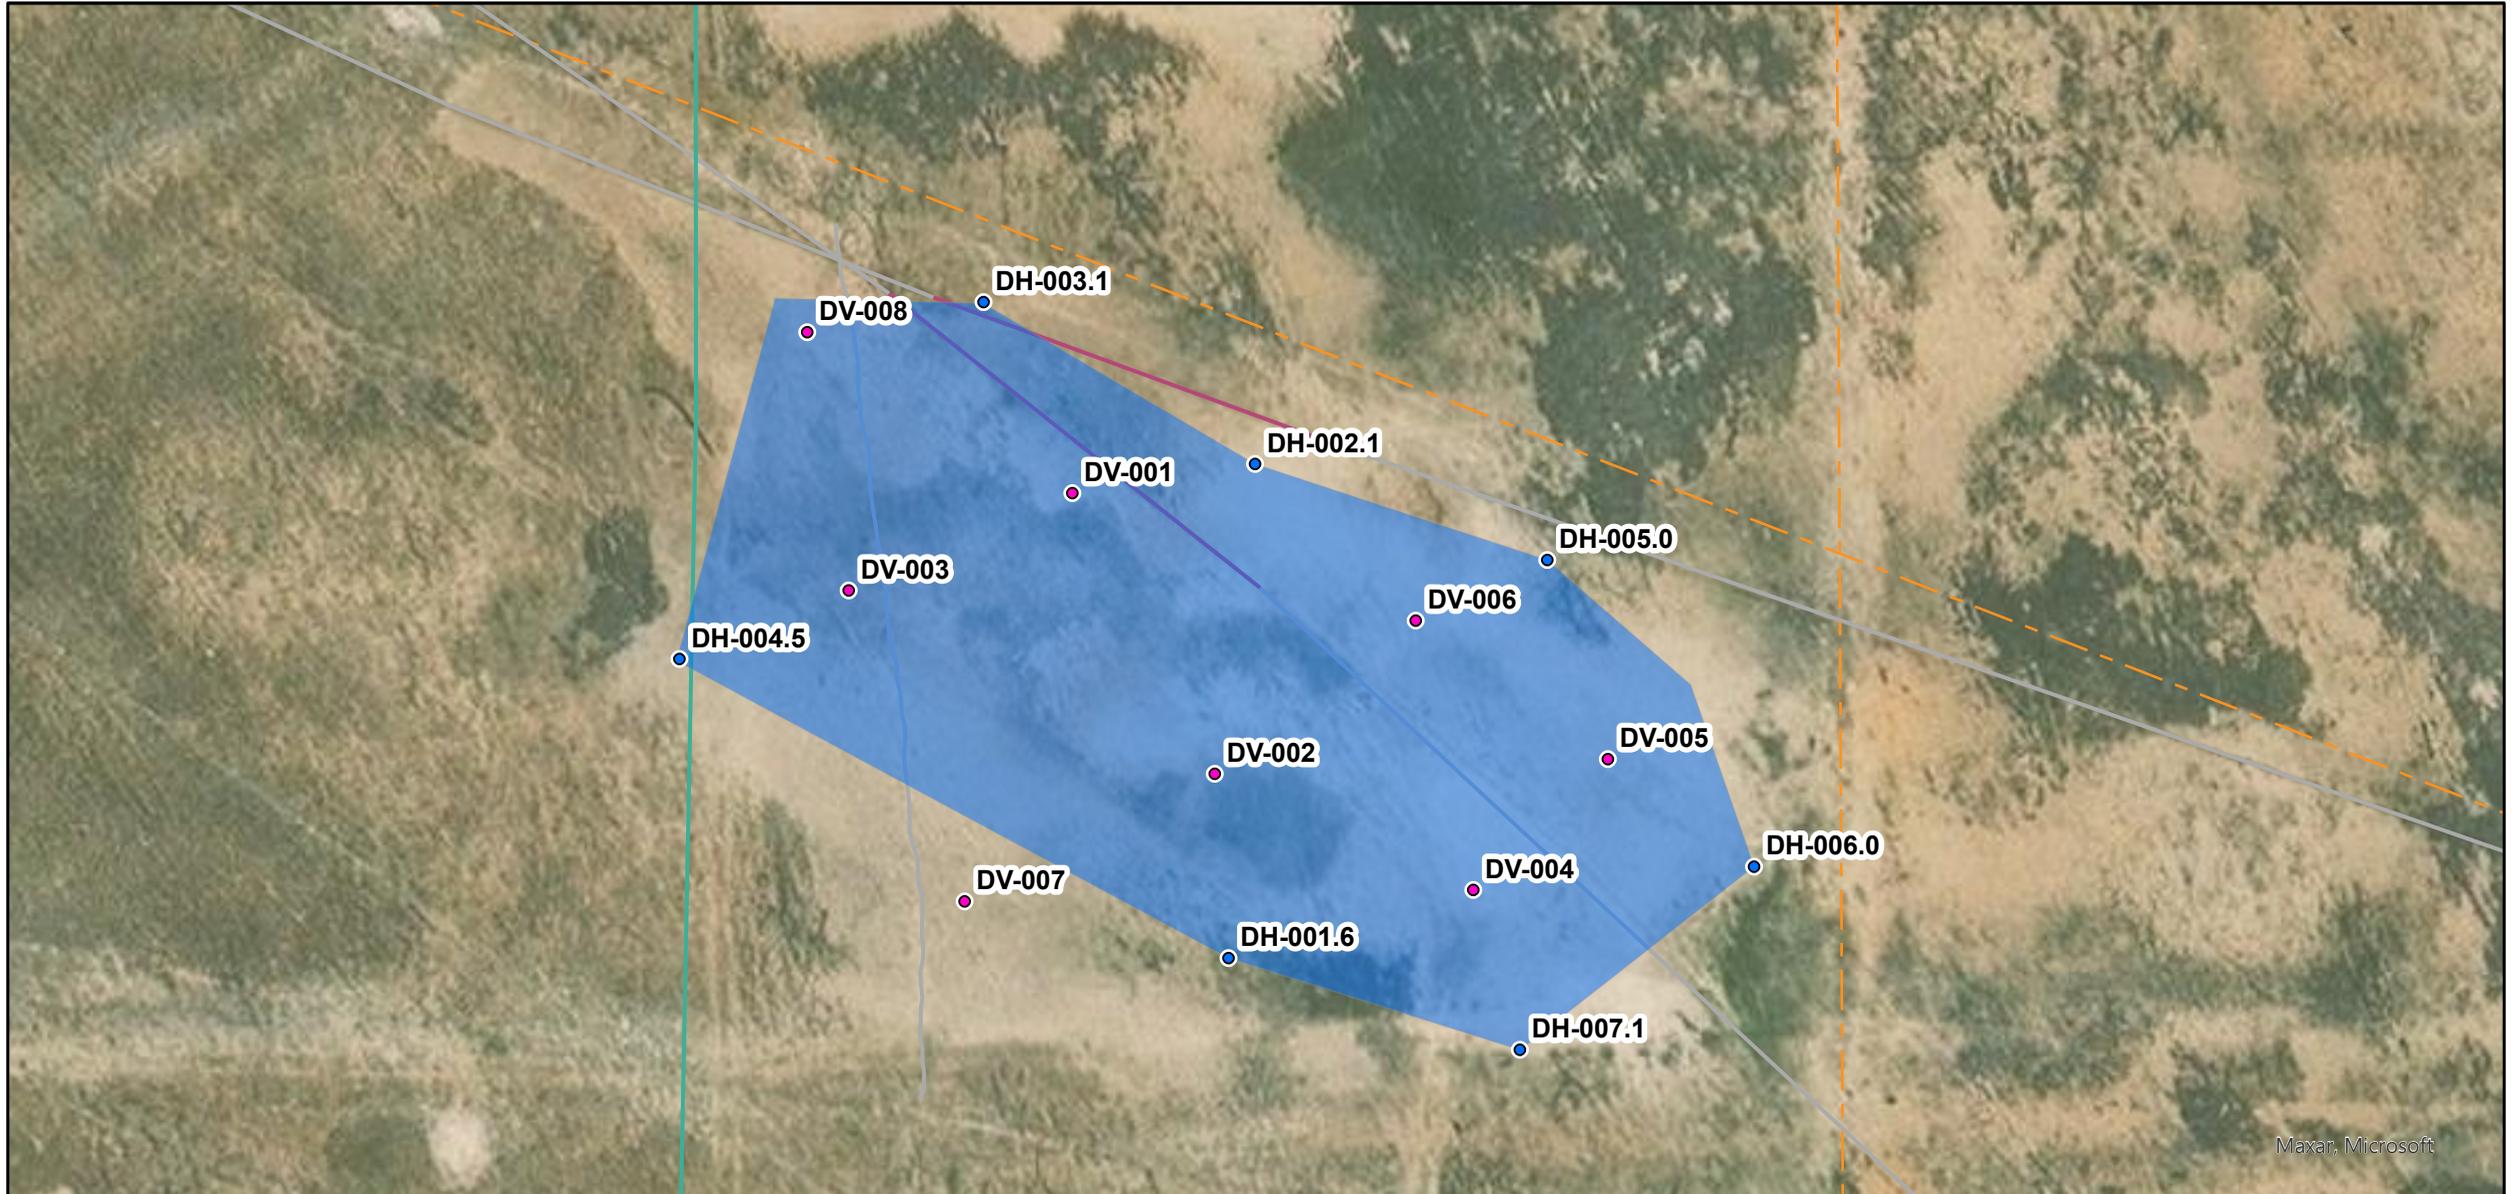
Initial Release Area
Cross Timbers Energy, LLC
North Vacuum Abo 120 Battery - Area 3
32.83819002, -103.52467326
Lea County, New Mexico

On 03/05/2021, Cross Timbers Energy, LLC reported a release at the North Vacuum Abo Unit 255. The release was caused when a flowline froze and busted. Approximately 44,442 sqft. of the Pasture was found to be affected by the release.

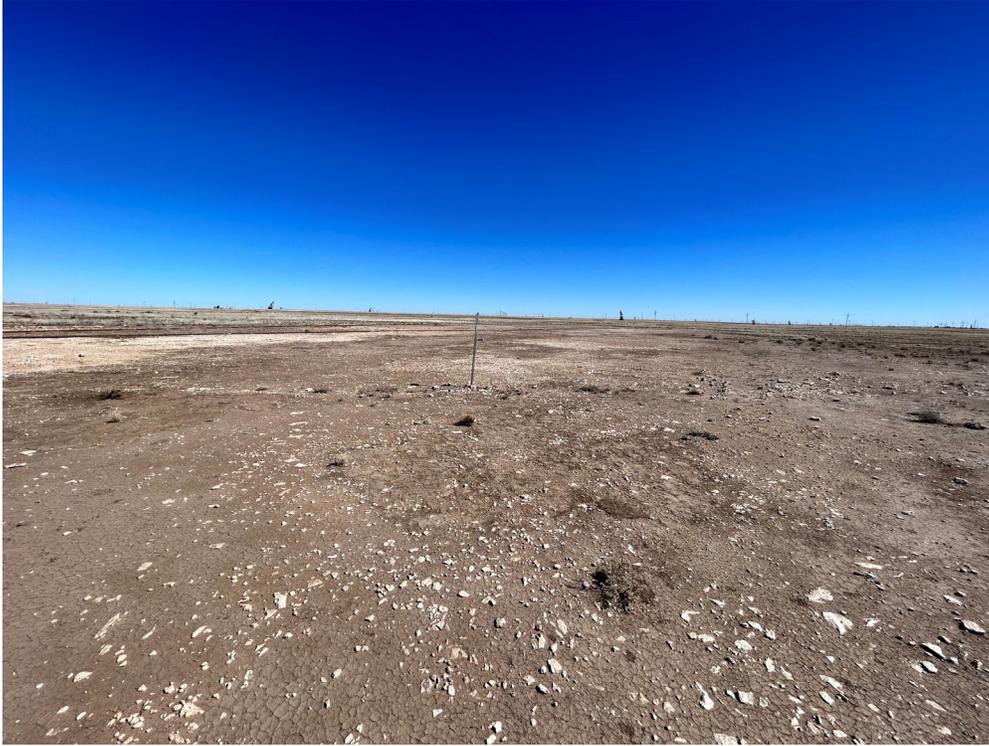
Initial Observation

Pasture:

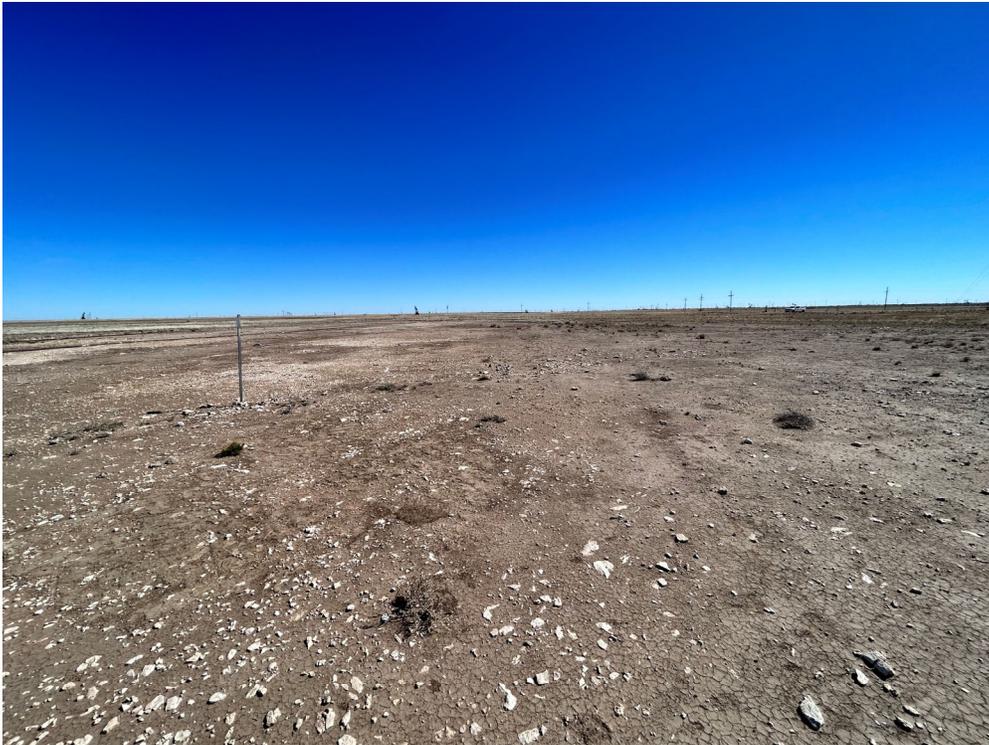
Pasture:

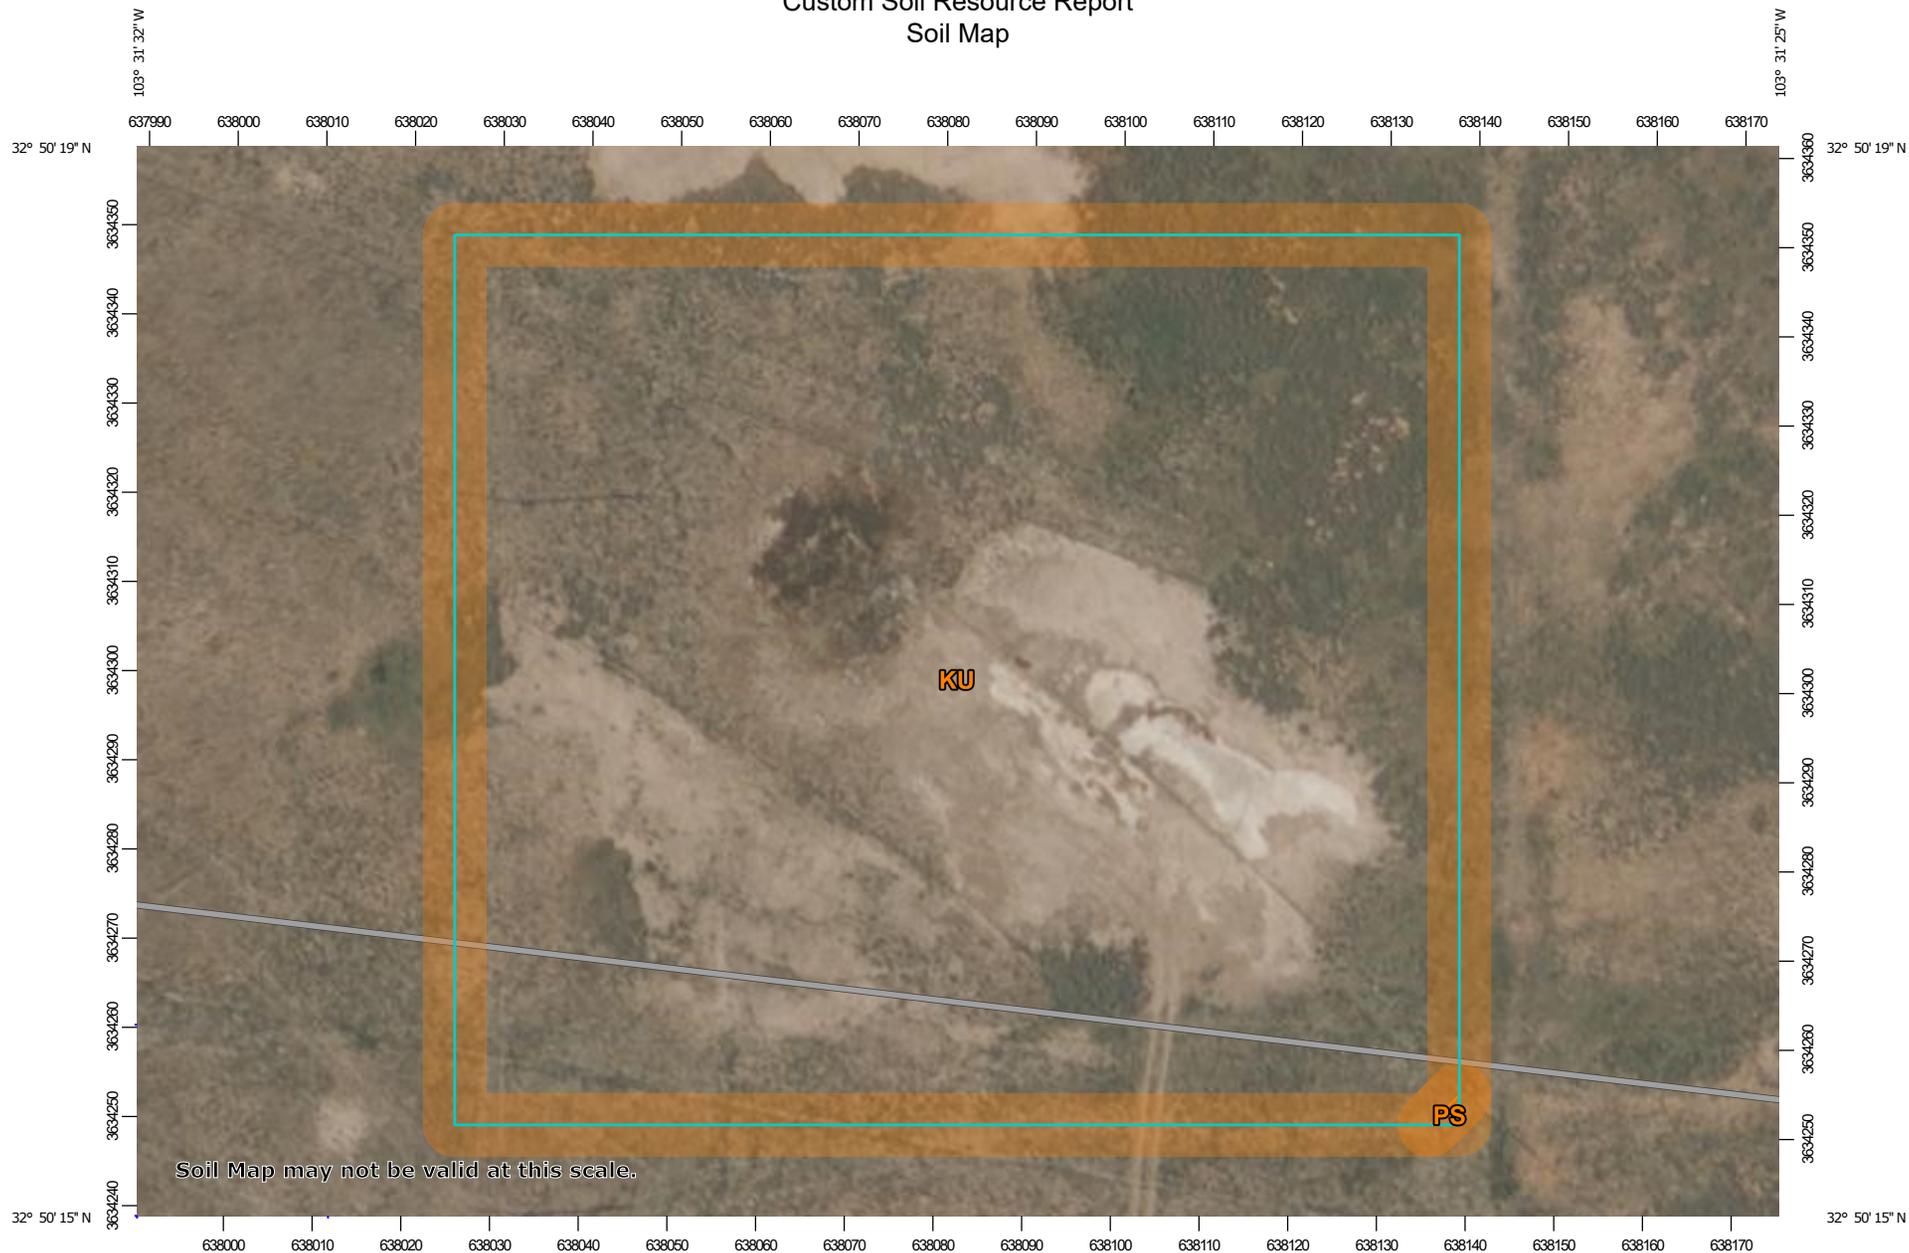
Custom Soil Resource Report Soil Map

The soil map section includes the soil map for the defined area of interest, a list of soil map units on the map and extent of each map unit, and cartographic symbols displayed on the map. Also presented are various metadata about data used to produce the map, and a description of each soil map unit.
