Re: **Closure Request**  
**Tour Bus 23 State 503H & 504H**  
**Tracking #: NAPP2205354026**

Site Information	
Incident ID	NAPP2205354026
Site Name	Tour Bus 23 State 503H & 504H
Company	Centennial Resource Production, LLC
County	Lea
ULSTR	C-23-22S-34E
GPS Coordinates (NAD 83)	32.38382, -103.44304
Landowner	Private

On 2/22/2022, Centennial Resource Production, LLC reported a release at the Tour Bus 23 State 503H & 504H. The release was caused when a the hammer union failed. Approximately 2,973 sqft. of the Pad and Pasture was found to be damp upon initial inspection.

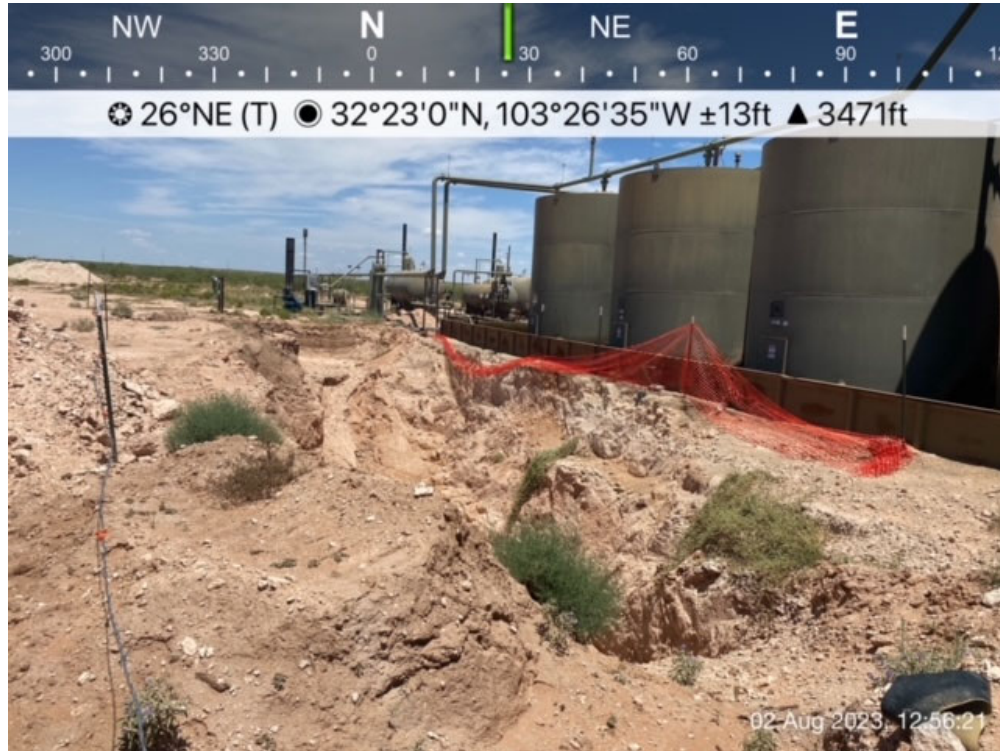
Pasture:

## Excavation

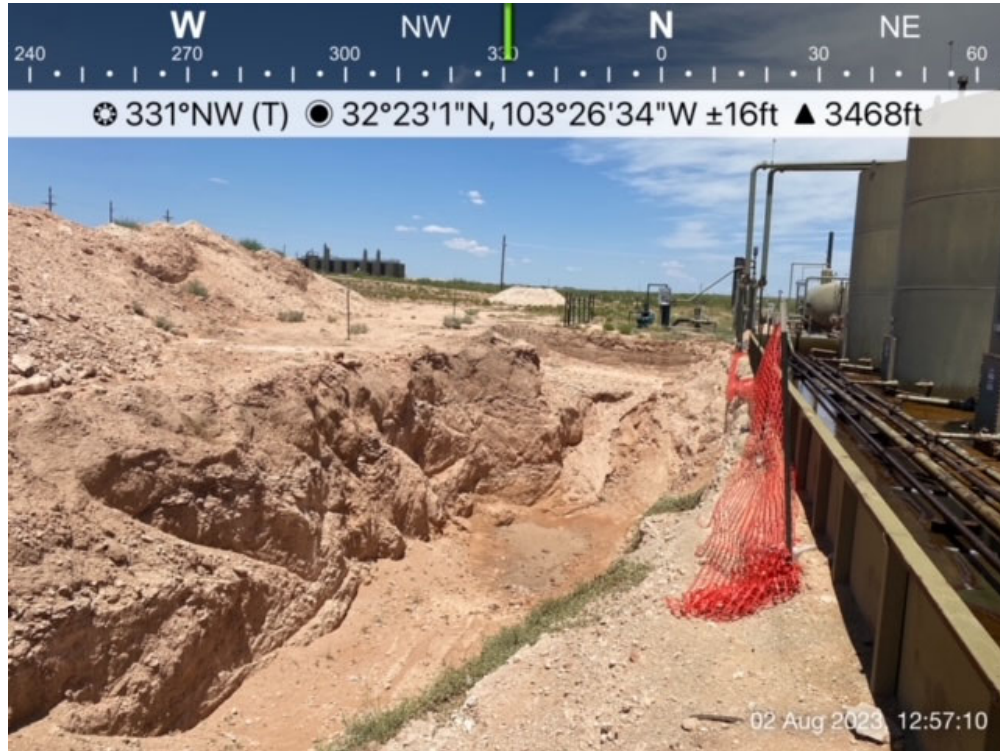
Pasture:

## Excavation

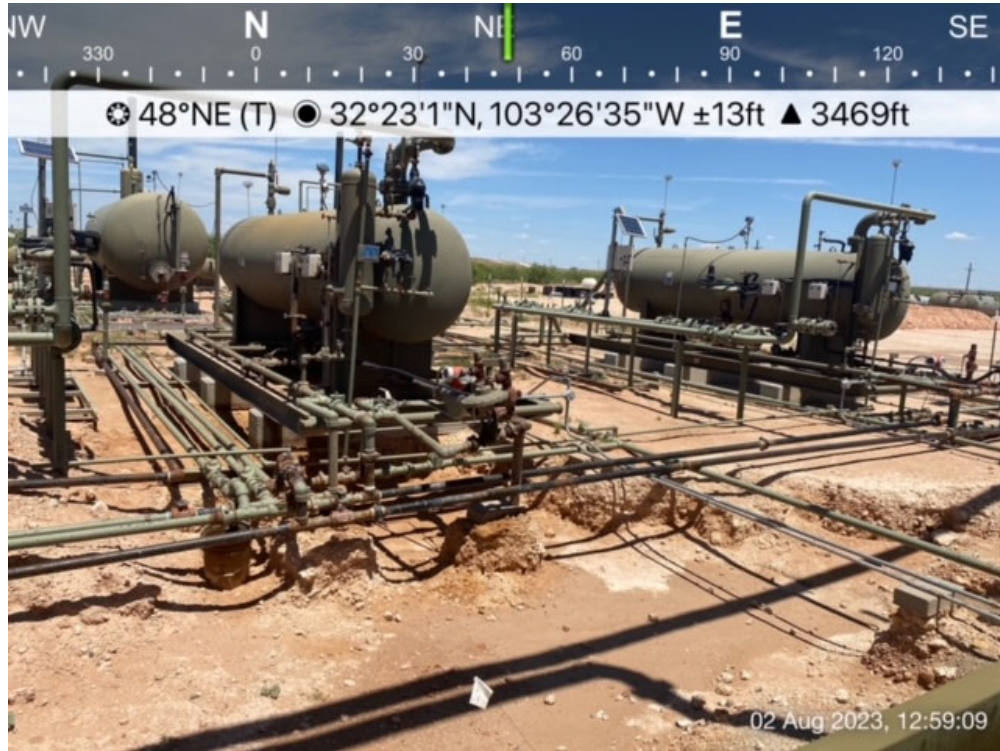
Pad:

## Excavation

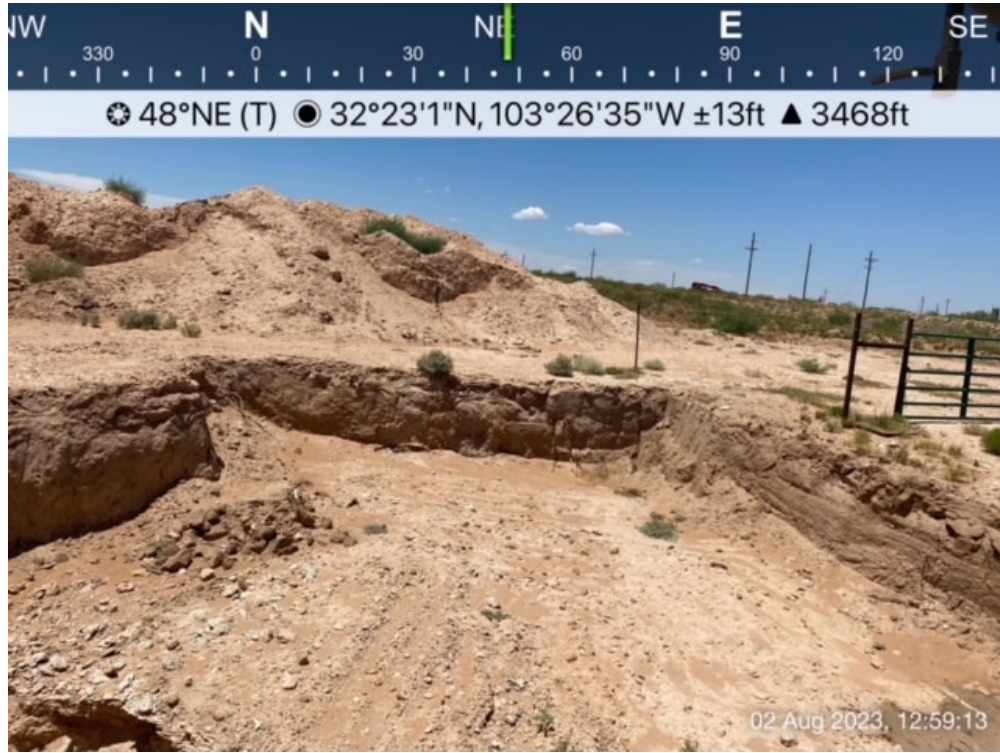
Pad:

## Excavation

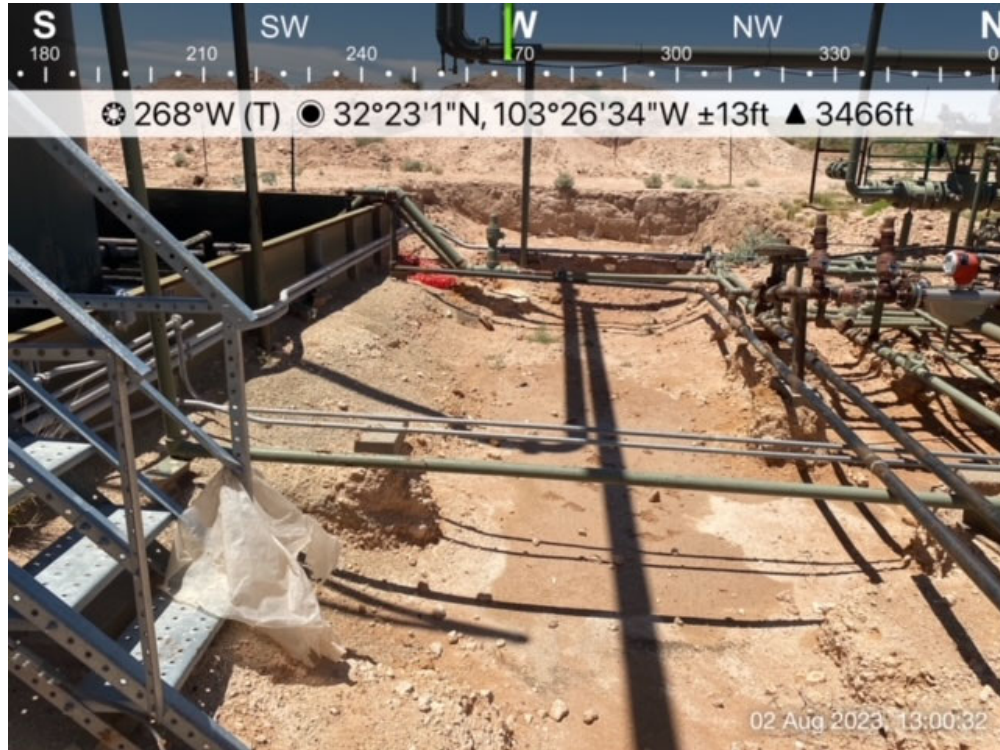
Pad:

## Excavation

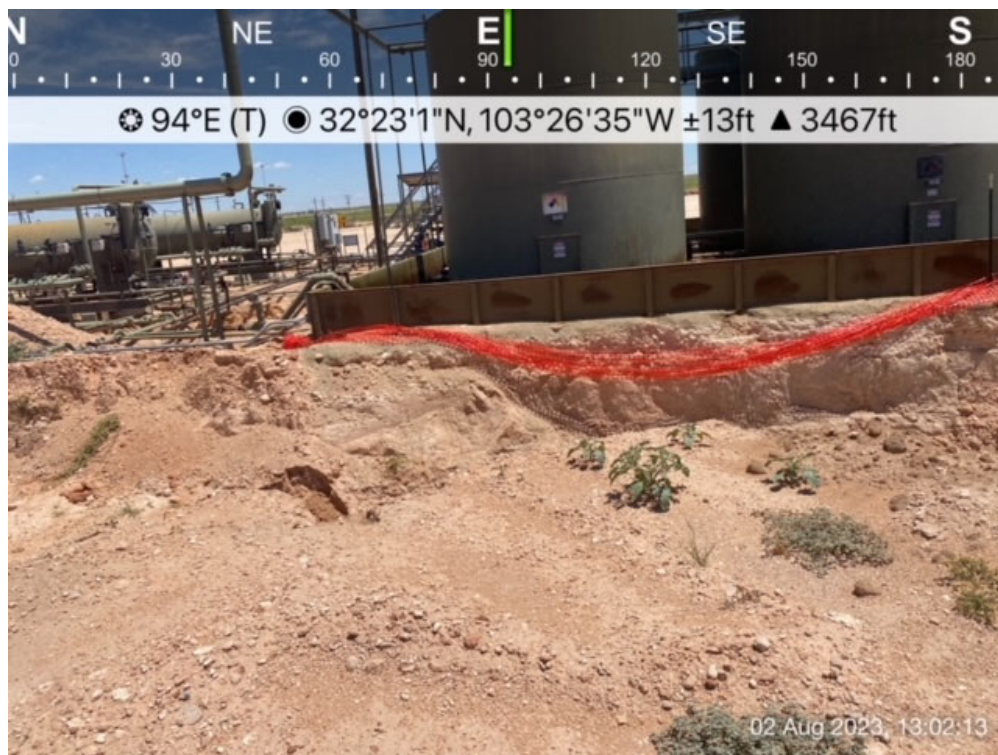
Pasture:

## Excavation
