## RECLAMATION CLOSURE REPORT

**LOCATION:** Alley Cat 17 CTB 3

**FACILITY ID:** fAPP2123635487

**NMOCD REF. NO.** NAPP2327225644

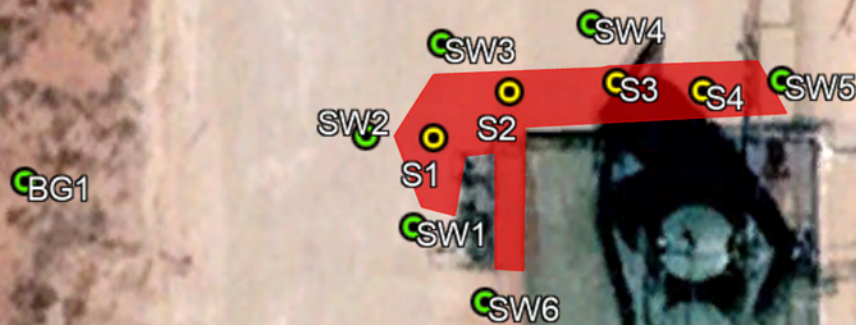
Devon Energy  
API: N/A  
Eddy County, NM  
Site Map

On October 30, and November 8 of 2023, Pima Environmental conducted a site assessment and obtained soil samples. The laboratory results of this sampling event can be found in Figure 4. Analytical Laboratory Reports can be found in Appendix D. Photographic Documentation can be found in Appendix C.

Spill Area 1,195 sqft

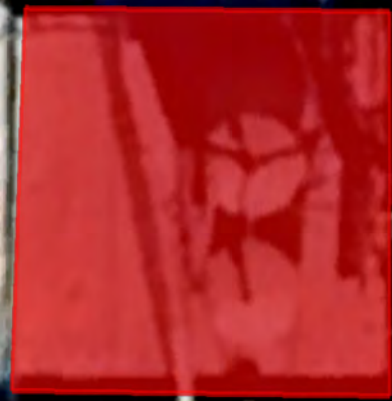
Devon Energy  
API: N/A  
Eddy County, NM  
Site Map Liner

On December 15, 2023, after submitting a 48-hour notification application ID: 294179 to the OCD, Pima Environmental conducted a liner inspection at this location. Pima concluded that this liner and containment maintained its integrity and was able to retain fluids. The liner inspection form and photographic documentation can be found in Appendix D.

Liner 3,274 Sqft

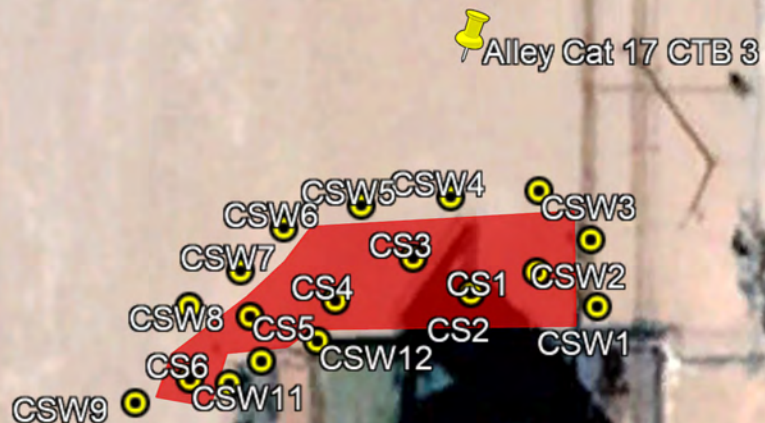
Devon Energy  
API:N/A  
Eddy County, NM  
Confirmation Sample Map

On December 15, 2023, after sending a 48-hour notification, application ID: 294188, Pima returned to the site to collect confirmation samples of the excavation. The results of this sampling event can be found in Figure 4. Analytical Laboratory Reports can be found in Appendix D. Photographic Documentation can be found in Appendix C.

The sample results were below NMOCD Closure Criteria 19.15.29 NMAC. Based on these findings, no additional remediation activities were required at this location.

Excavation
-

Confirmation Samples

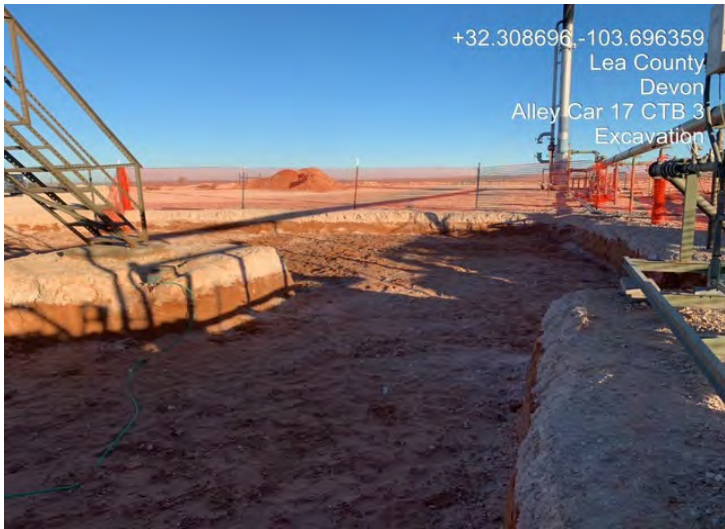
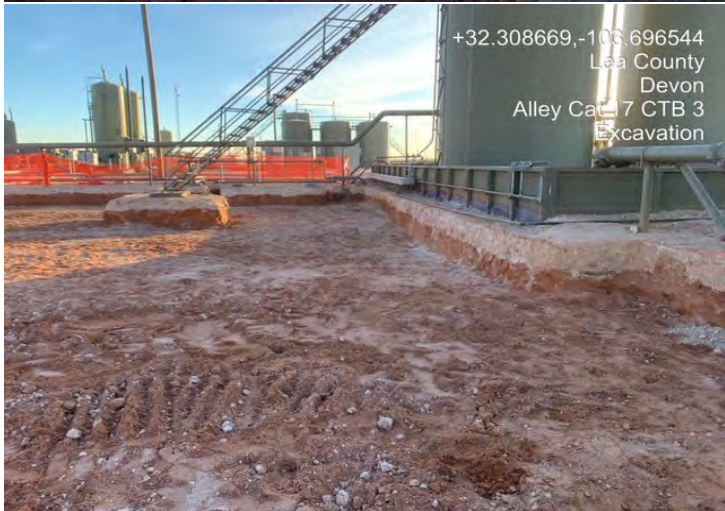
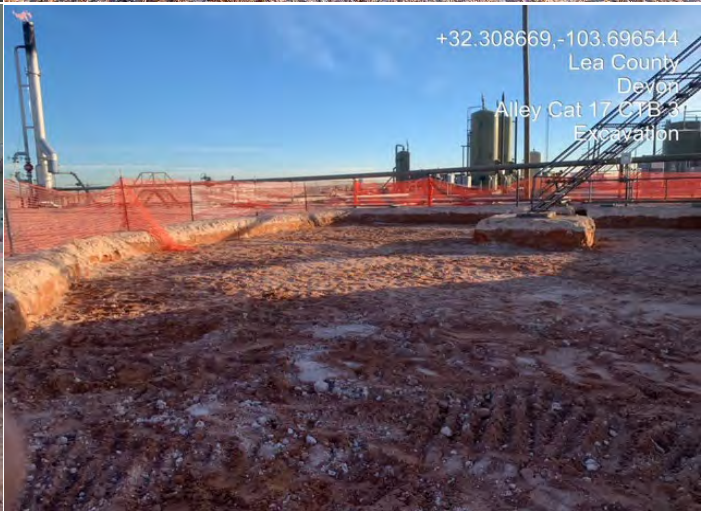
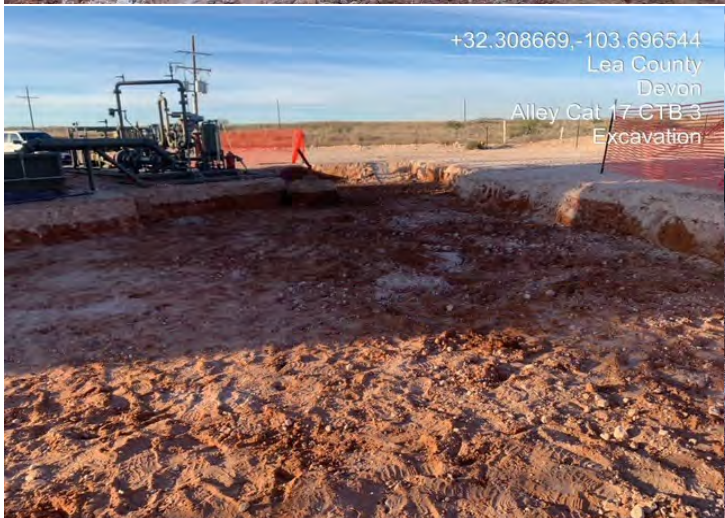
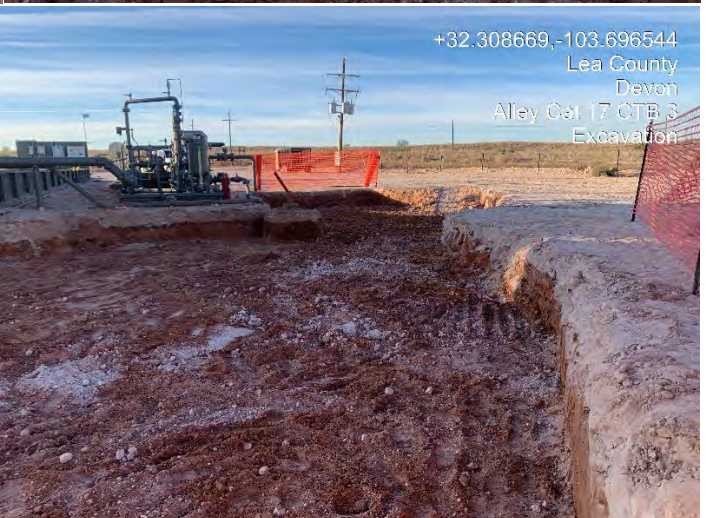
Excavation

On December 1, 2023, the Devon Construction Department mobilized personnel and equipment to begin immediate remediation activities. They began by excavating the area to a depth of 3' BGS. The contaminated soil (133 cubic yards) was hauled to an approved, lined disposal facility and clean backfill material was brought in.

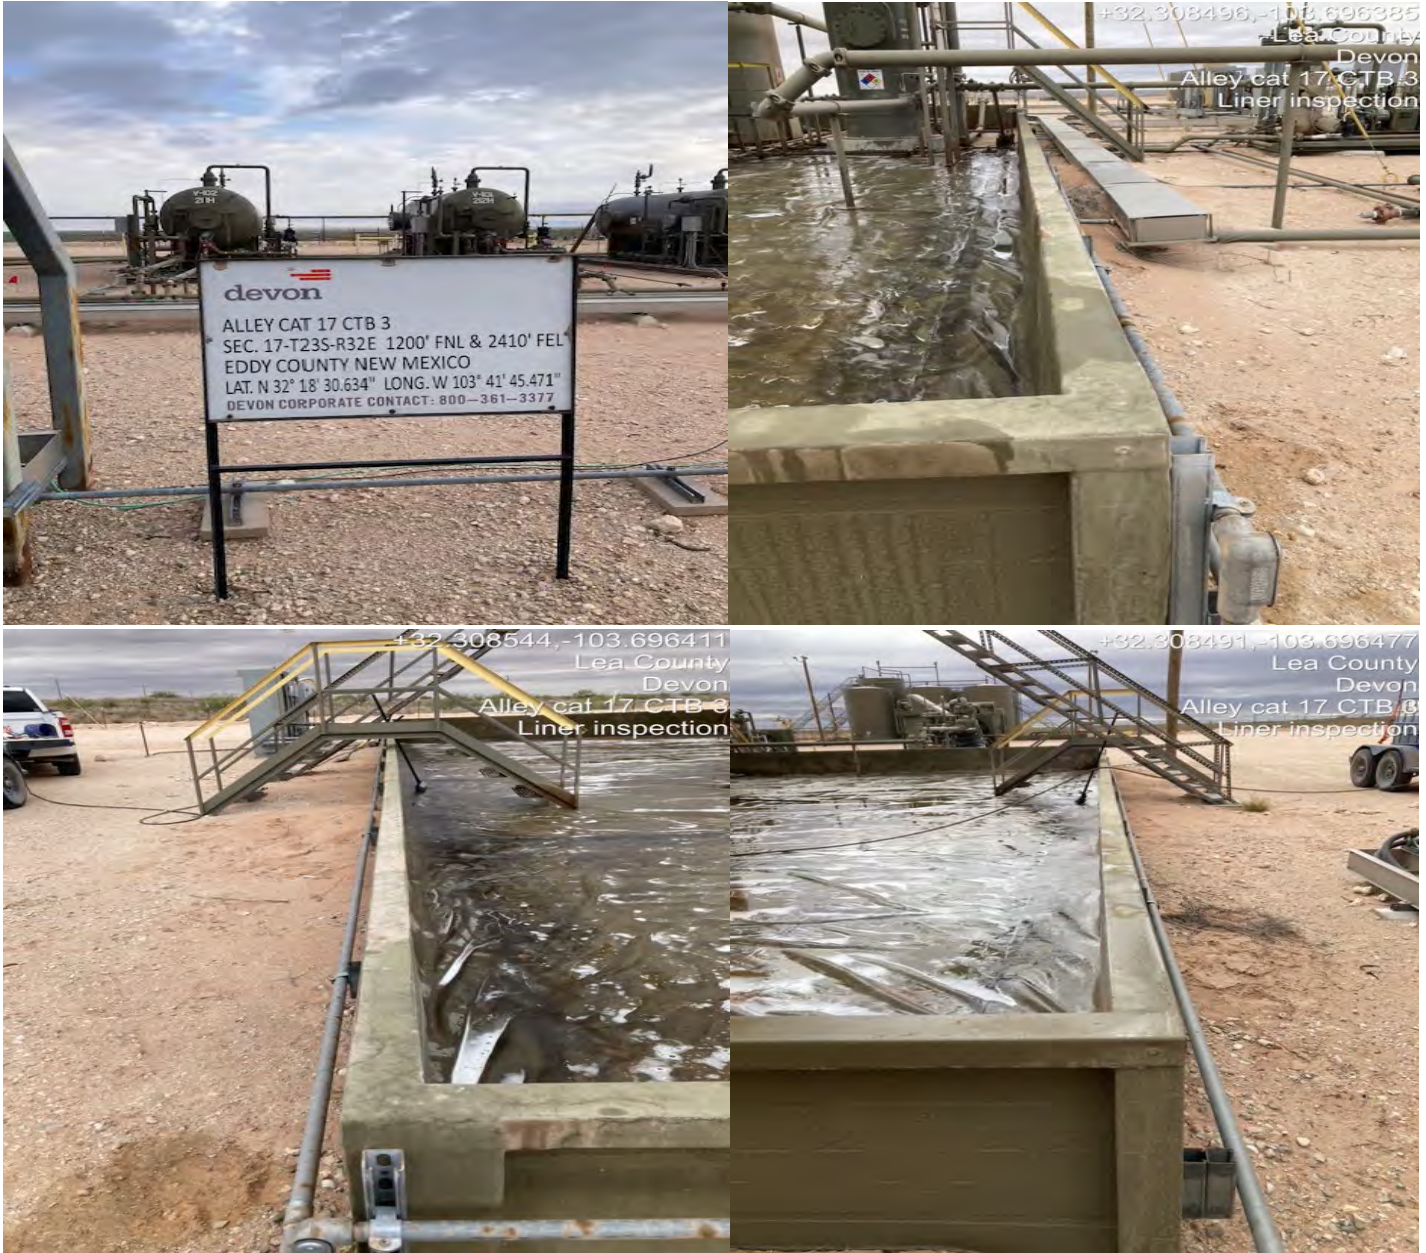
**Liner Inspection**

Visualization	Yes	No	Comments
Is there a tear in the liner?		X	
Are there holes in the liner?		X	
Is the liner retaining any fluids?	X		Fluids from power washing.
Does the liner have integrity to contain a leak?	X
