Re: Reclamation Report

Rustler Breaks East Loop Water Line Incident Number nAPP2418024950 Eddy County, New Mexico

San Mateo RB Pipeline, LLC Reclamation Report Rustler Breaks East Loop Water Line

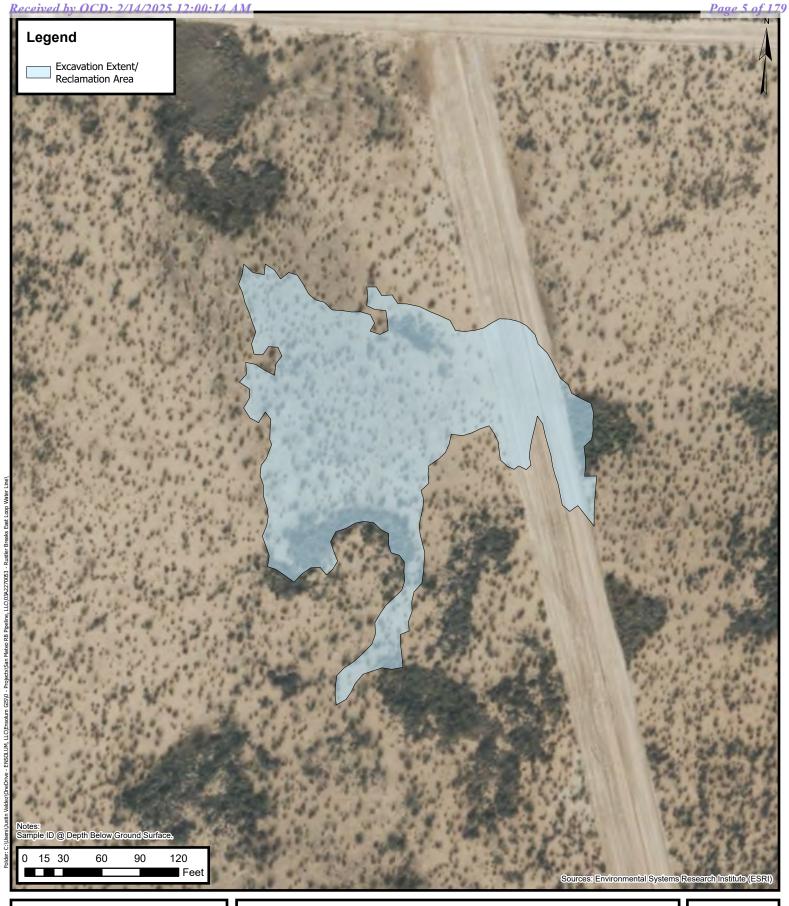
Excavation Extent/Reclamation Area

for ground surface to 1-foot bgs, consistent with the surrounding native soil type. The excavation extent and reclamation area are depicted on the attached Figure 1. Photographic documentation is included in Appendix B.

The excavation area measured approximately 39,600 square feet. A total of approximately 8,000 cubic yards of impacted soil were removed during the excavation activities. Upon completion of excavation activities and receipt of final laboratory analytical results, the excavation was backfilled, and the area was graded and contoured to match the surrounding topography. The excavation area was backfilled with locally procured caliche to 1-foot below ground surface (bgs) and locally sourced topsoil was used

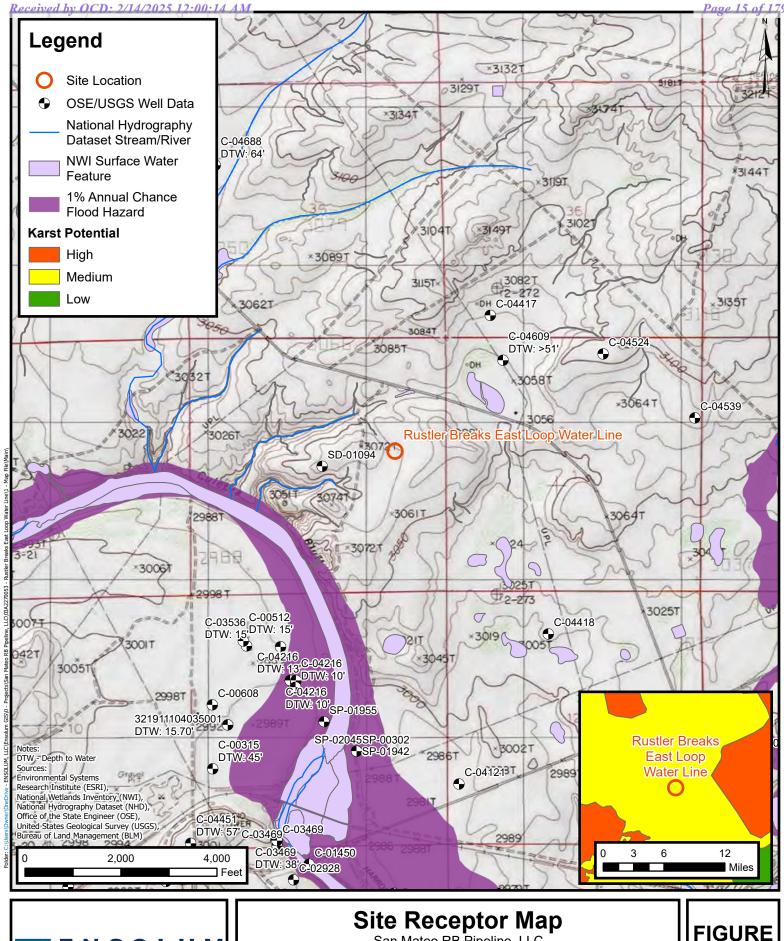
IGURE 1

The closest permitted groundwater well with depth to groundwater data is New Mexico Office of the State Engineer (NMOSE) well, C 04609 POD 1, located approximately 0.5 miles northeast of the Site. The well had a reported depth to groundwater greater than 51 feet below ground surface (bgs) and a total depth of 51 feet bgs. There are no regional or Site-specific hydrogeological conditions, such as shallow surface water, karst features, wetlands, or vegetation that suggest the Site is conducive to shallower groundwater. All wells used for depth to groundwater determination are presented on Figure 1. The referenced well record is included in Appendix A.

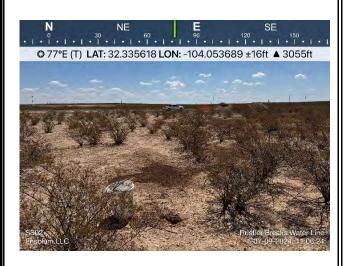
Photograph 5 Date: 07/09/2024

Description: Lateral Delineation Sampling

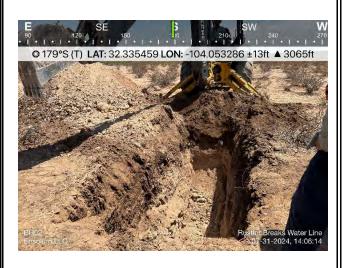
Date: 08/01/2024

Description: Potholing (BH05)

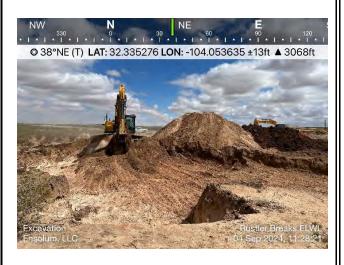
Photograph 13 Date: 09/04/2024

Description: Excavation Activities

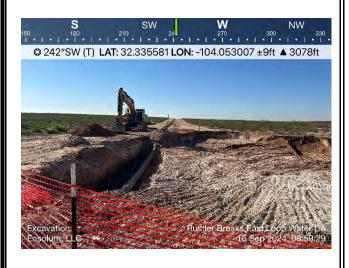
Photograph 17 Date: 09/16/2024

Description: Excavation Activities

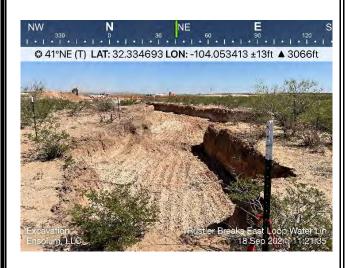
Photograph 21 Date: 09/18/2024

Description: Excavation Activities

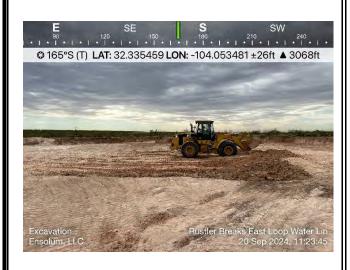
Photograph 25 Date: 09/20/2024

Description: Excavation Activities

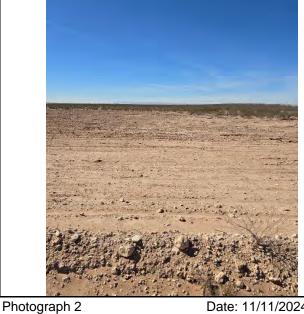
Description: Reseeding View: West
