SITE CHARACTERIZATION AND PROPOSED REMEDIATION PLAN

**LANGLIE MATTIX PENROSE SAND UNIT #604 FLOWLINE
32.36225, -103.15252
UNIT K, SECTION 27, T22S-R37E
LEA COUNTY, NEW MEXICO
NMOCD INCIDENT ID #nAPP2436651000**

SITE REMEDIATION AND CLOSURE REPORT

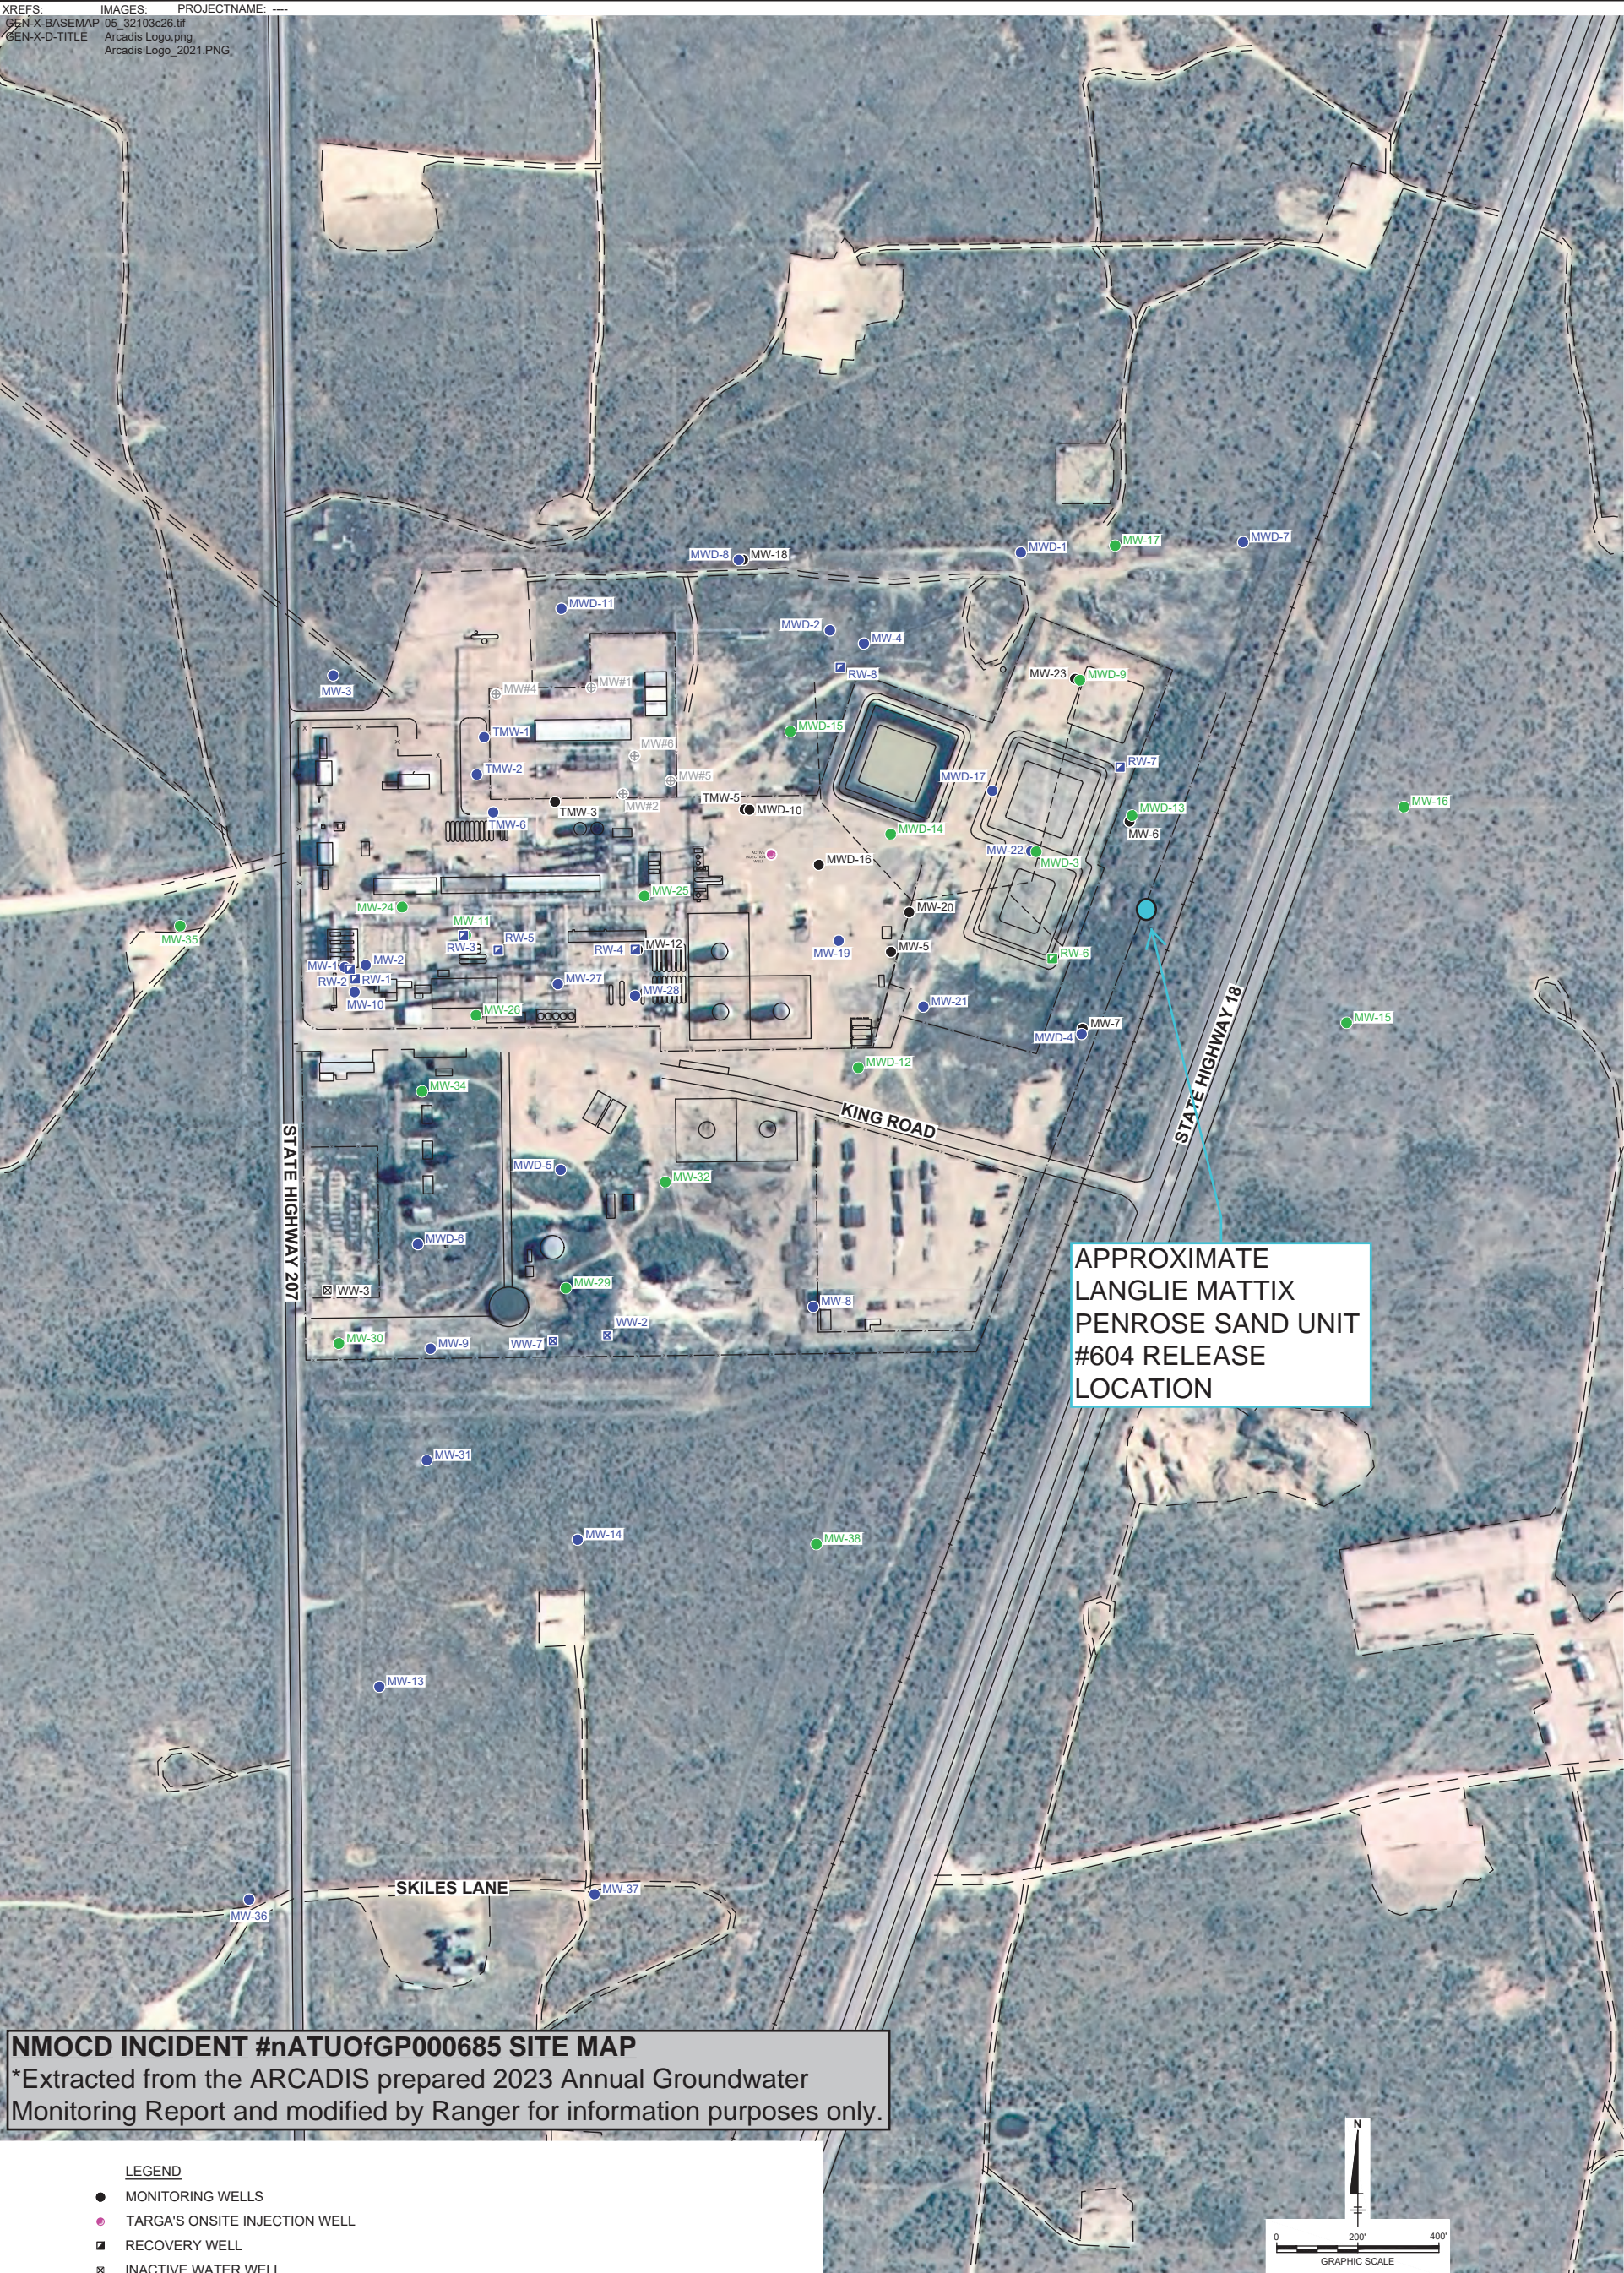
APPROXIMATE
LANGLIE MATTIX
PENROSE SAND UNIT
#604 RELEASE
LOCATION

NMOCD INCIDENT #nATUOfGP000685 SITE MAP
*Extracted from the ARCADIS prepared 2023 Annual Groundwater Monitoring Report and modified by Ranger for information purposes only.

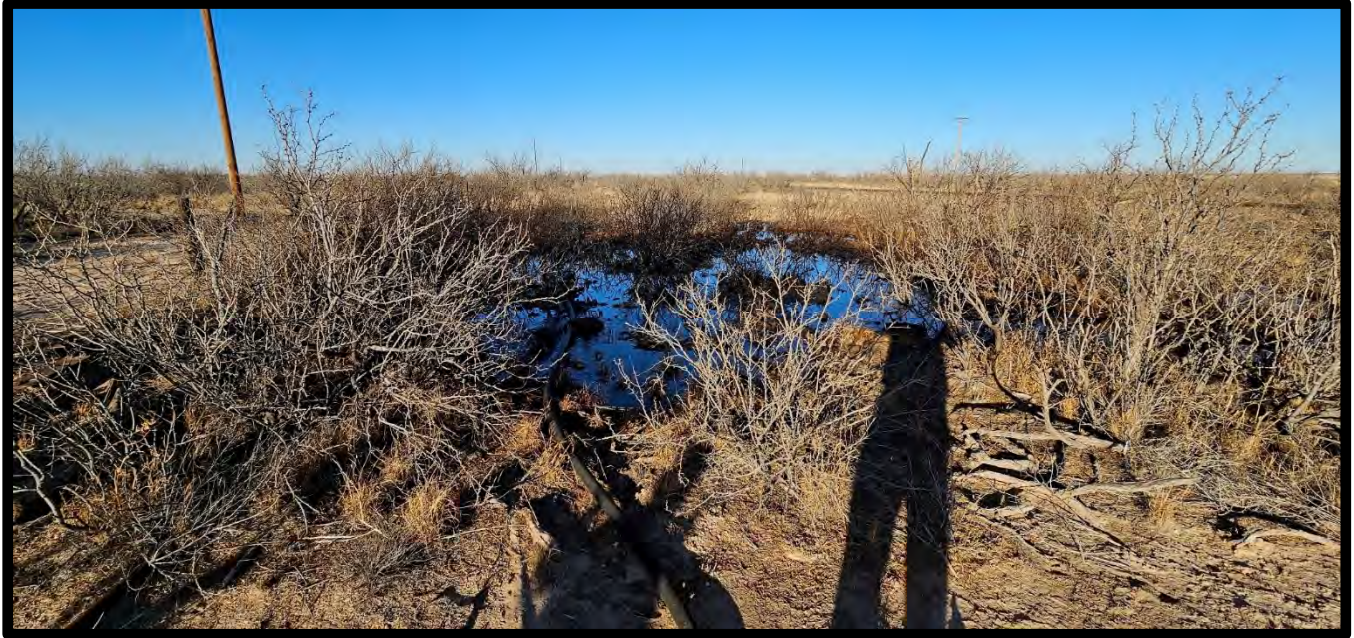
PHOTOGRAPH NO. 1 – A view of the release upon discovery. The view is towards the north.

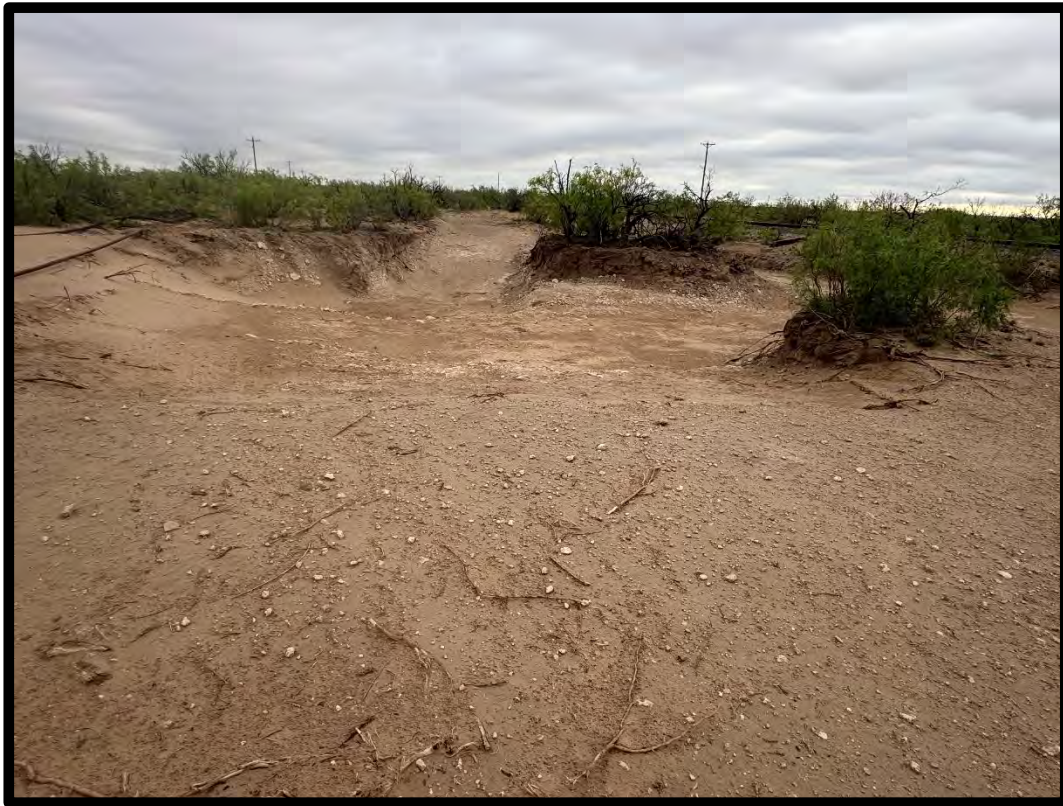
PHOTOGRAPH NO. 2 – A current view of the impact/excavation area in the vicinity of the release location. The view is towards the north.

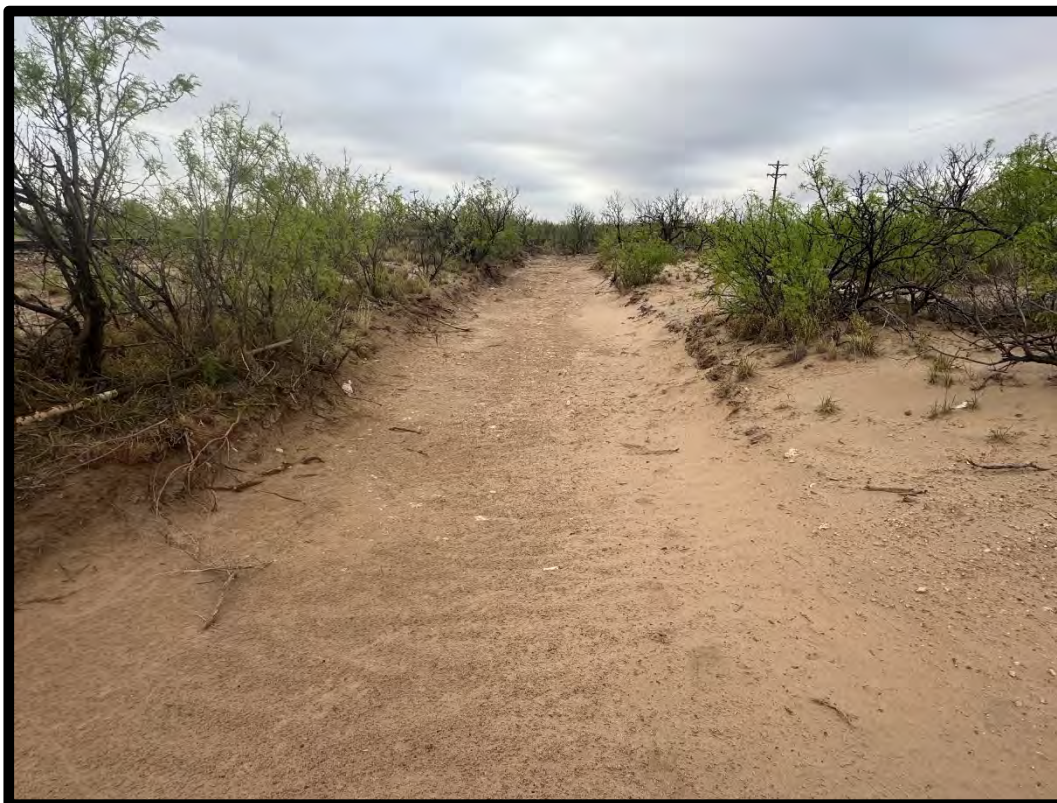
PHOTOGRAPH NO. 3 – A current view of the impact/excavation area. The view is towards the south.

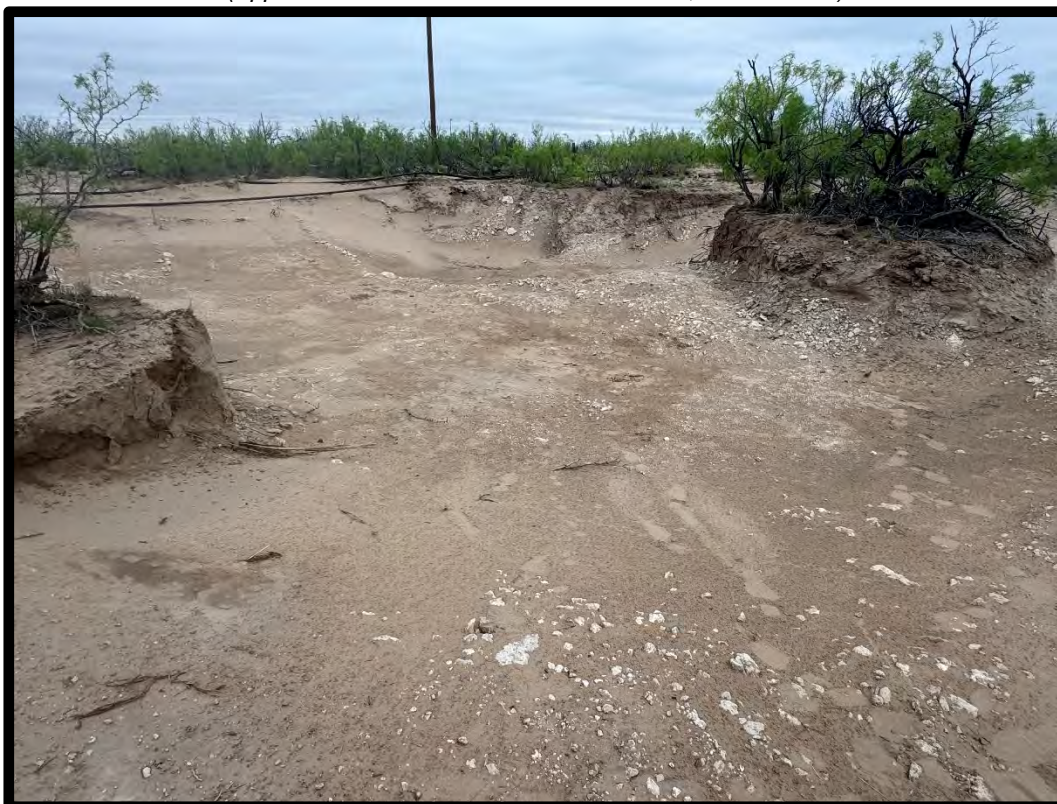
PHOTOGRAPH NO. 4 – An additional view of the impact/excavation area in the vicinity of the release location. The view is towards the southwest.

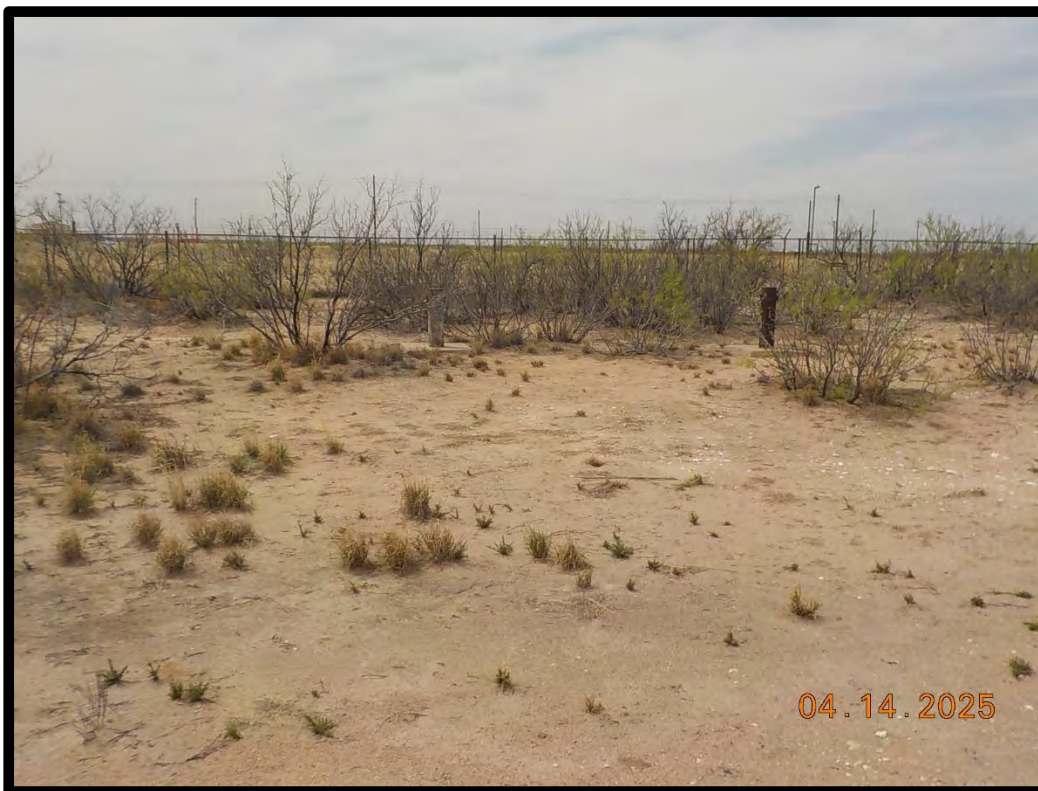
PHOTOGRAPH NO. 5 – A view of monitor wells in closest proximity to the release location. The view is towards the northwest.

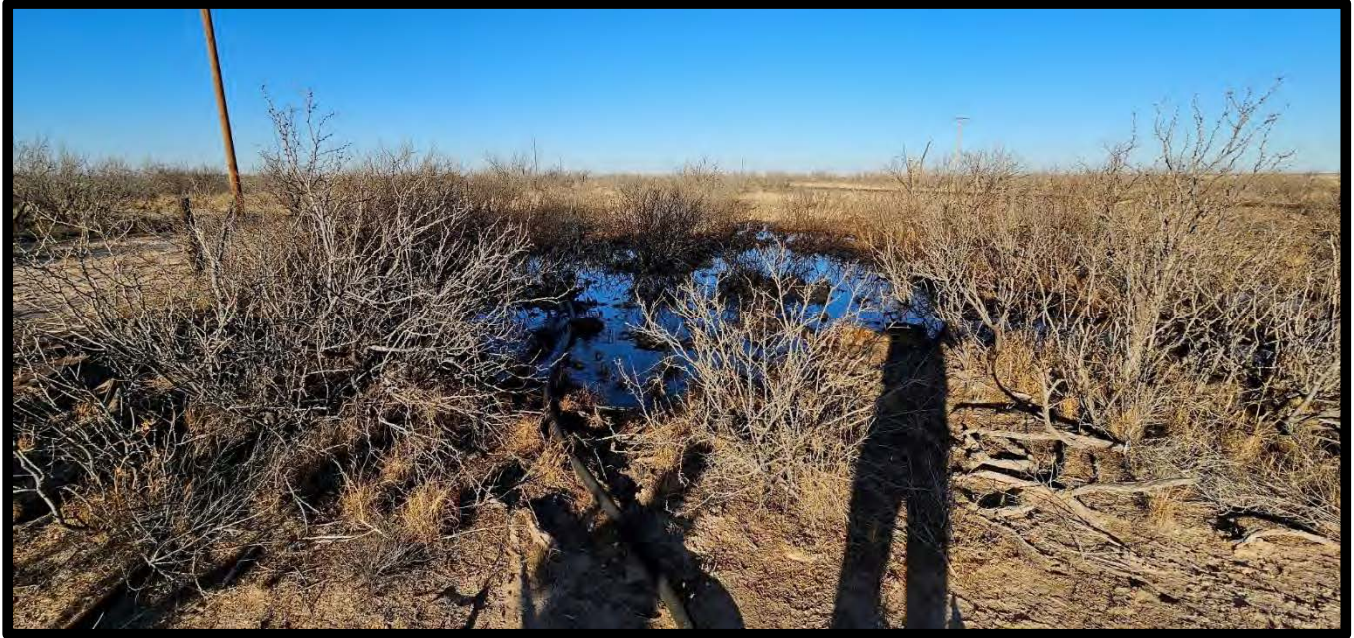
PHOTOGRAPH NO. 1 – A view of the release upon discovery. The view is towards the north. (Approximate GPS Coordinates: 32.362218, -103.152551)

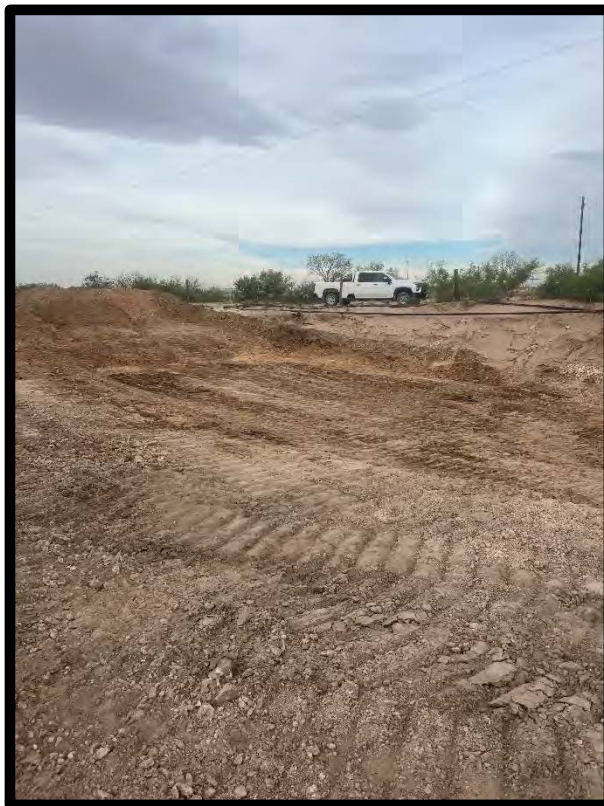
PHOTOGRAPH NO. 2 – A view of the excavation in the vicinity of the release location during the remediation process. The view is towards the southwest. (Approximate GPS Coordinates: 32.362242, -103.152408)

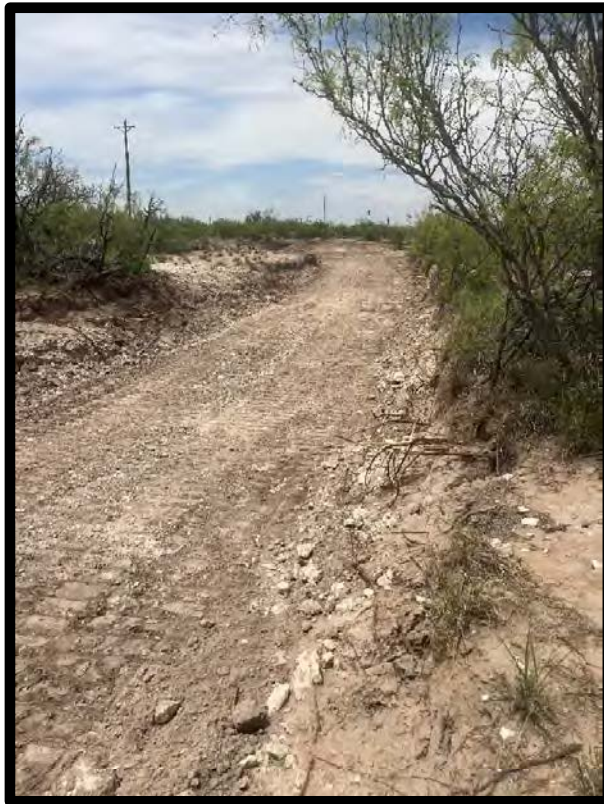
PHOTOGRAPH NO. 3 – An additional view of the remediation/excavation area. The view is towards the north. (Approximate GPS Coordinates: 32.362132, -103.152458)

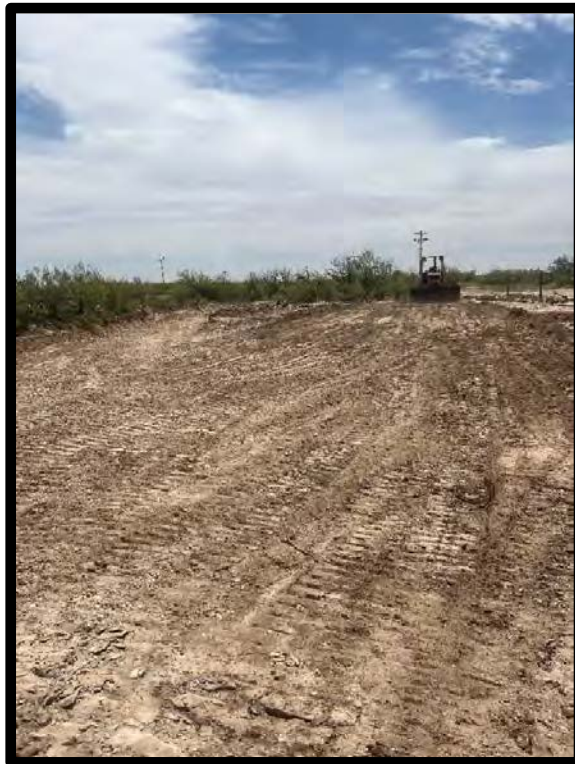
PHOTOGRAPH NO. 4 – A view of the impact/excavation area. The view is towards the south. (Approximate GPS Coordinates: 32.362284, -103.152480)

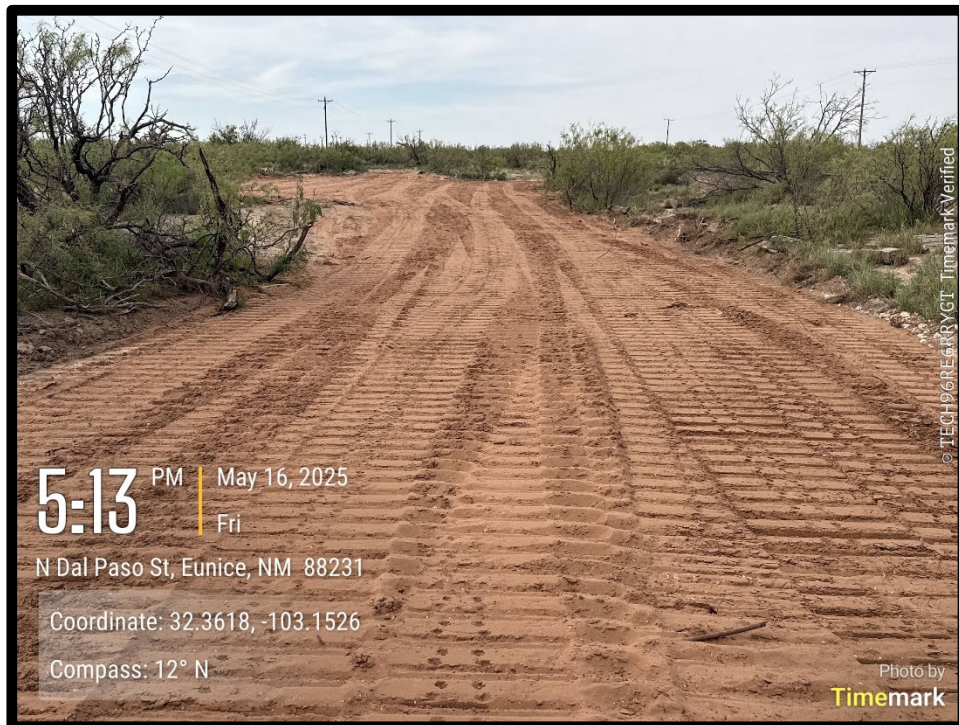
PHOTOGRAPH NO. 4 – An additional view of the backfilled excavation area. The view is towards the north.
