### Closure Report

**Salado Draw 23 Central Tank Battery (03.26.2025)**

**Incident ID: NAPP2508551061**

### Condensate Release

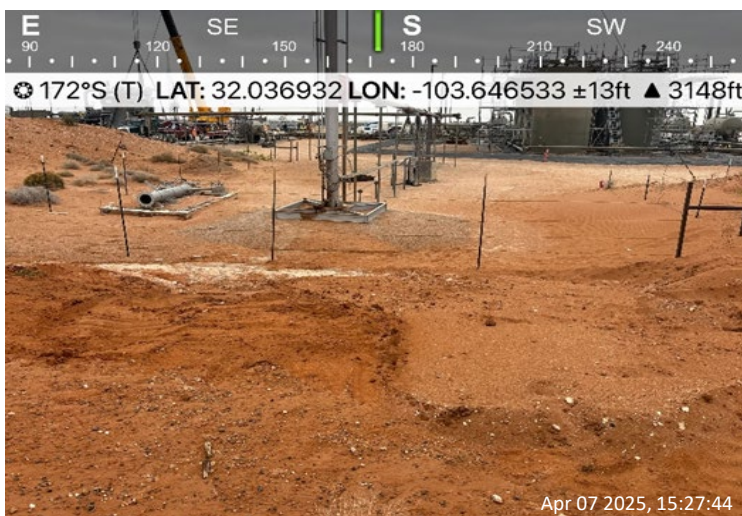
## Photograph No. 2

View South, area of CS-1 through CS-4.

Before collecting samples, a third-party company was onsite to conduct a surface scrape to remove any visibly stained soil, approximately 0.25 feet of soil was removed from an area of about 441 square feet, resulting in the removal of approximately 10 cubic yards of contaminated material.

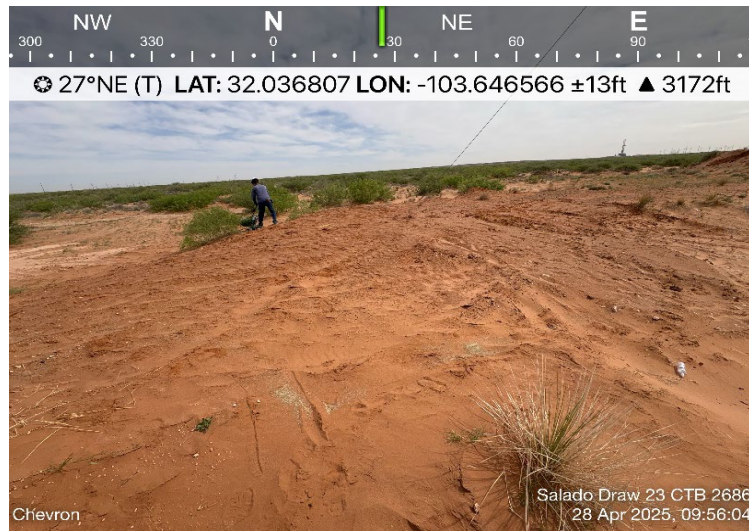
## Photograph No. 5

View Northeast of backfilled area and reseeding in progress.

Once the remediation activities were completed, the excavated areas were backfilled with clean material to surface grade. The backfill material was sourced from the local landowner located at 32.026201, -103.681488. Excess backfill material stockpiled nearby from a previous remediation project (nAPP2334143989) was utilized and was previously tested on March 19, 2025. See Table 1 for lab analysis on the backfill sample.

On April 28, 2025, the backfilled areas in the pasture were seeded via hand distribution with the appropriate pounds of pure live seed per acre. The topsoil was ripped with hand tools to aid the vegetation process. The seed mixture used was BLM #2 Sandy Mixture. The reclaimed and reseeded area is approximately 441 square feet. See Figure 4 for the reclamation area.

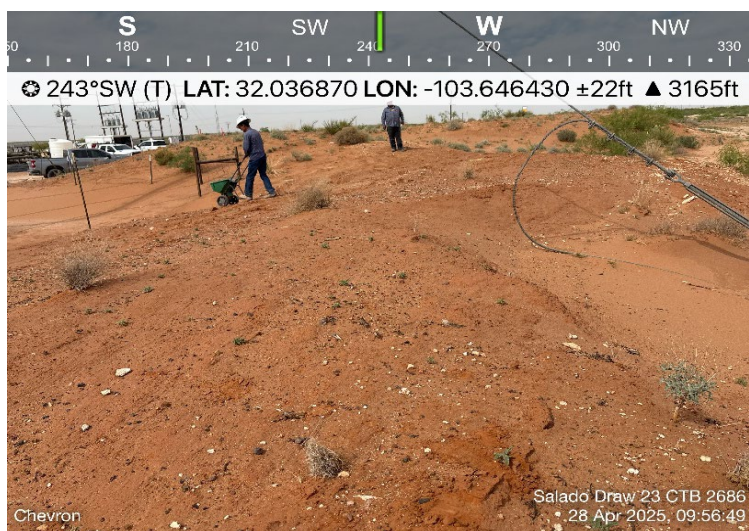
## Photograph No. 6

View Southwest of backfilled area and reseeding in progress.
