LEAK #3

Remediation Summary & Closure Report

NMOCD Incident No. nAPP2401146074
UL "N", Sec. 33, T21S, R37E
32.428661°, -103.17186°
Lea County, New Mexico

March 19, 2025

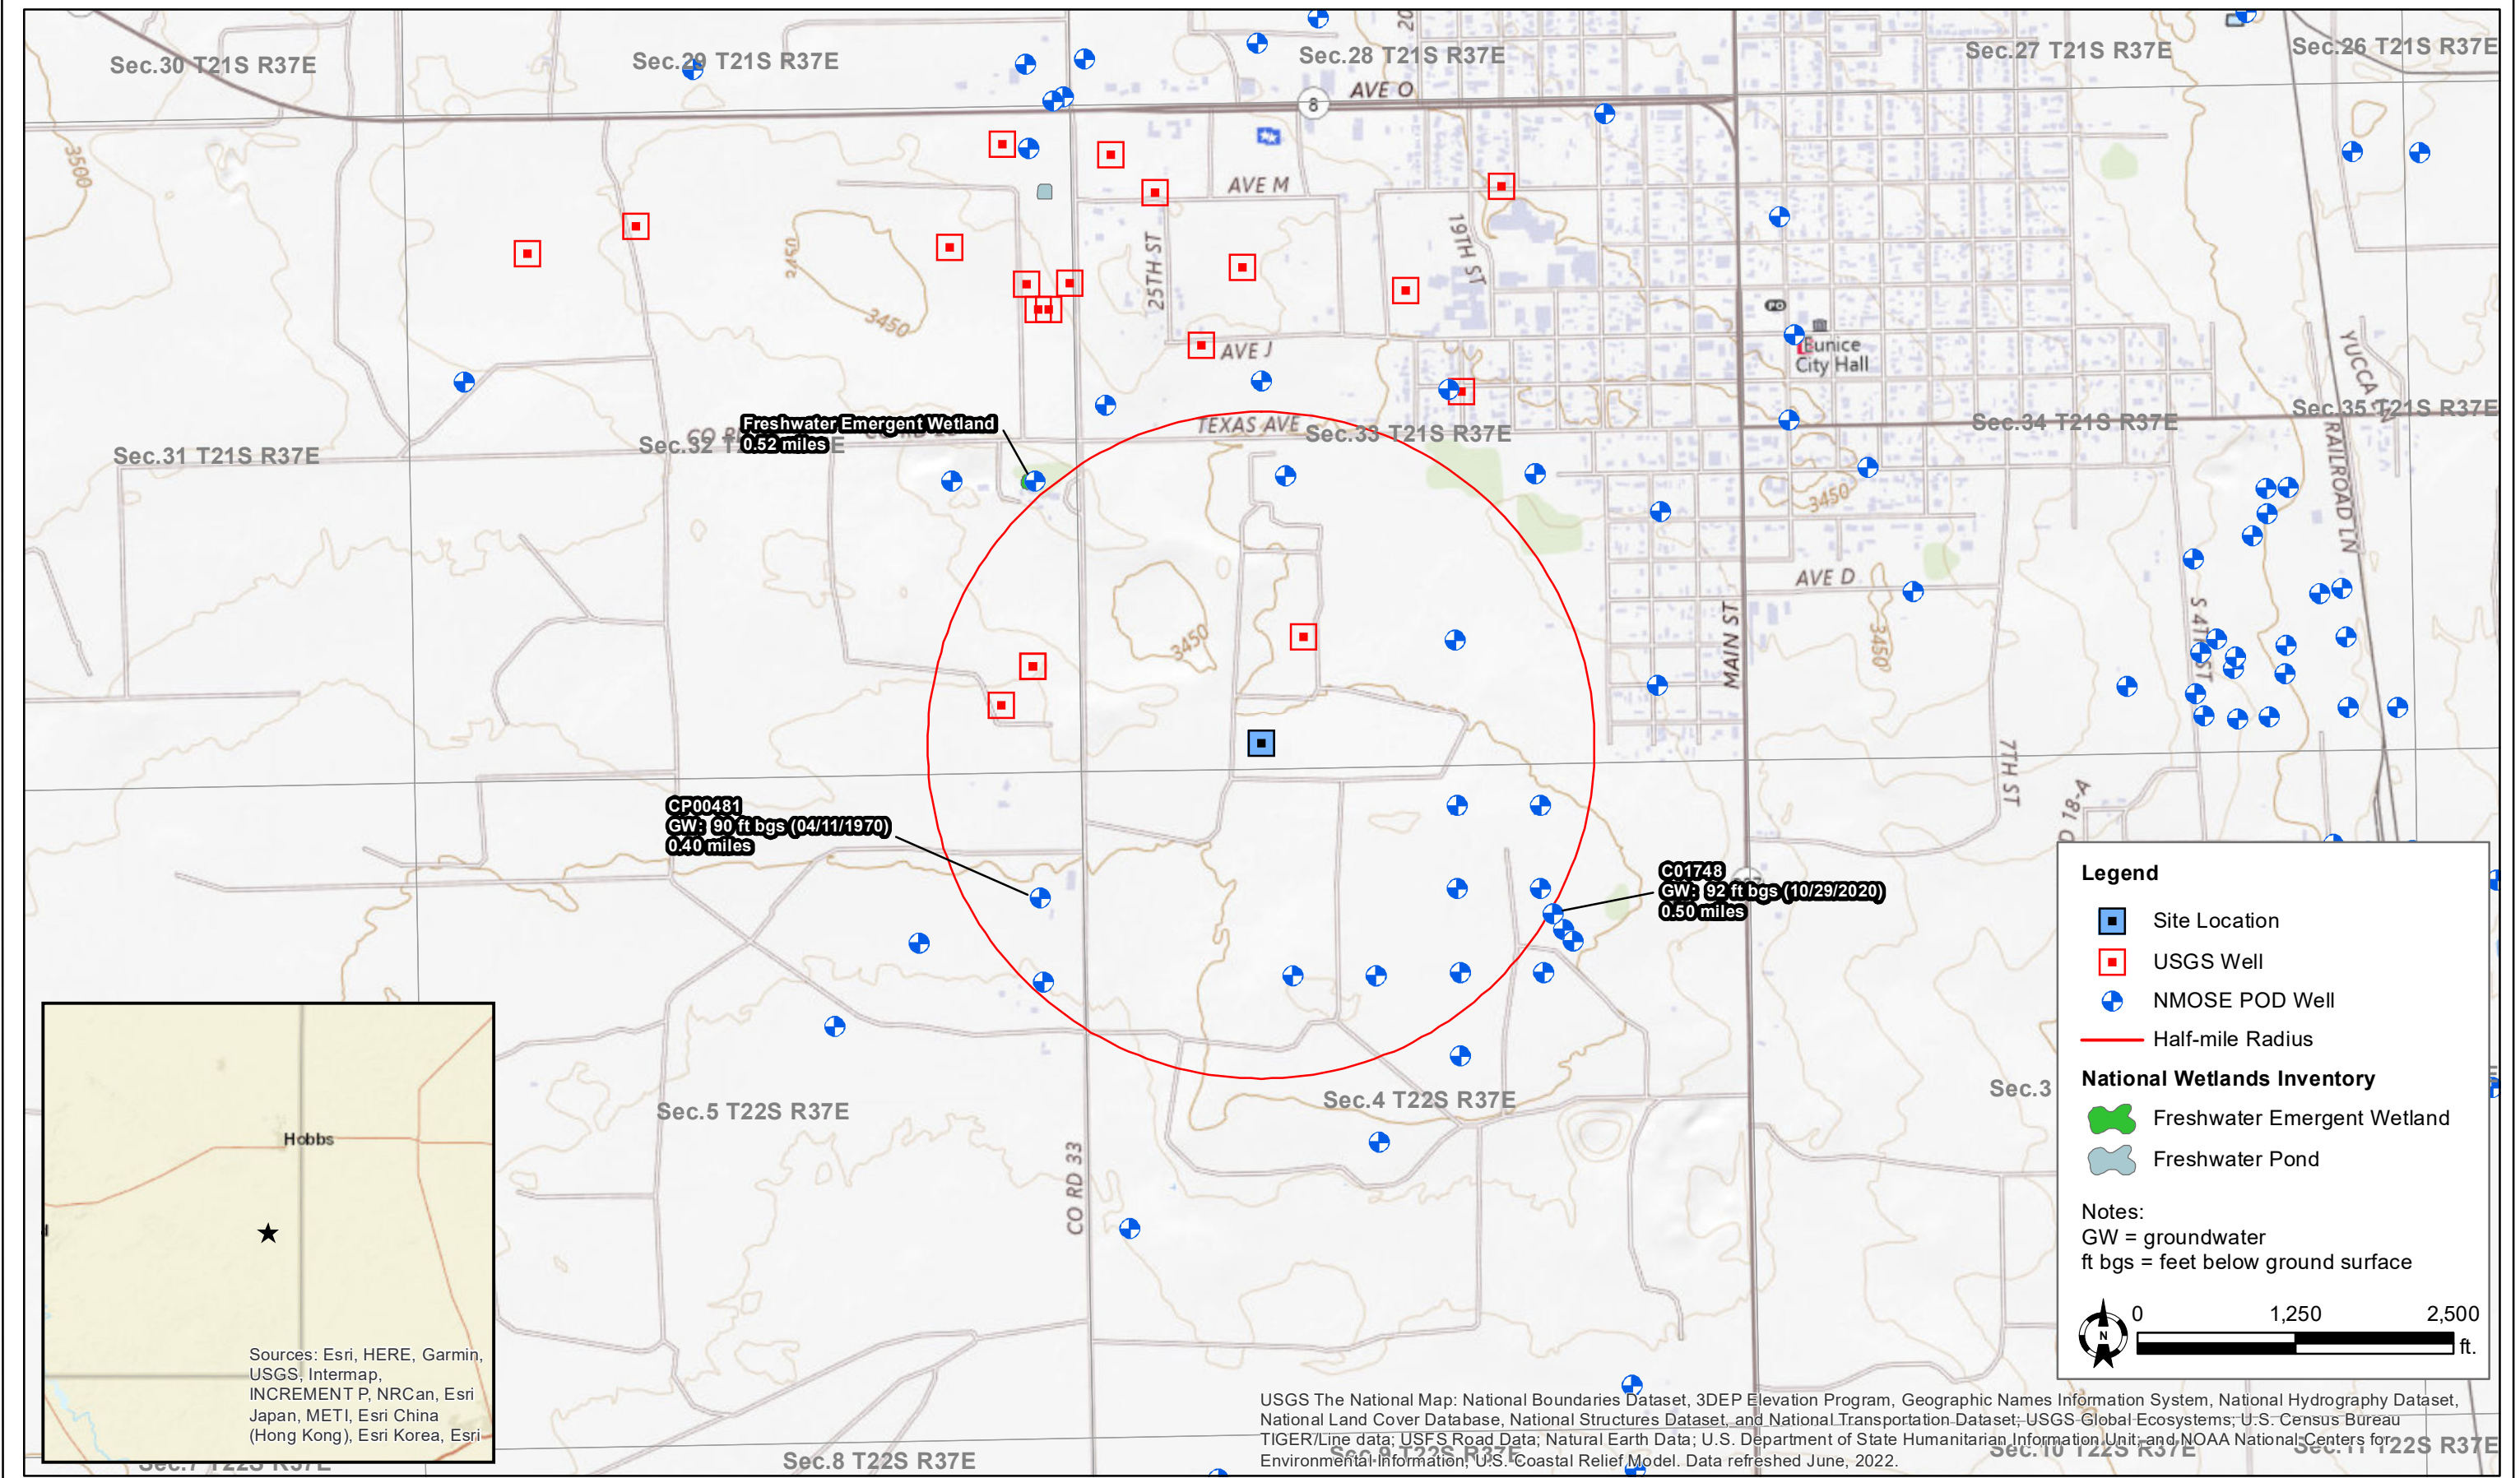
Figure
1

Site Location & Groundwater
Map

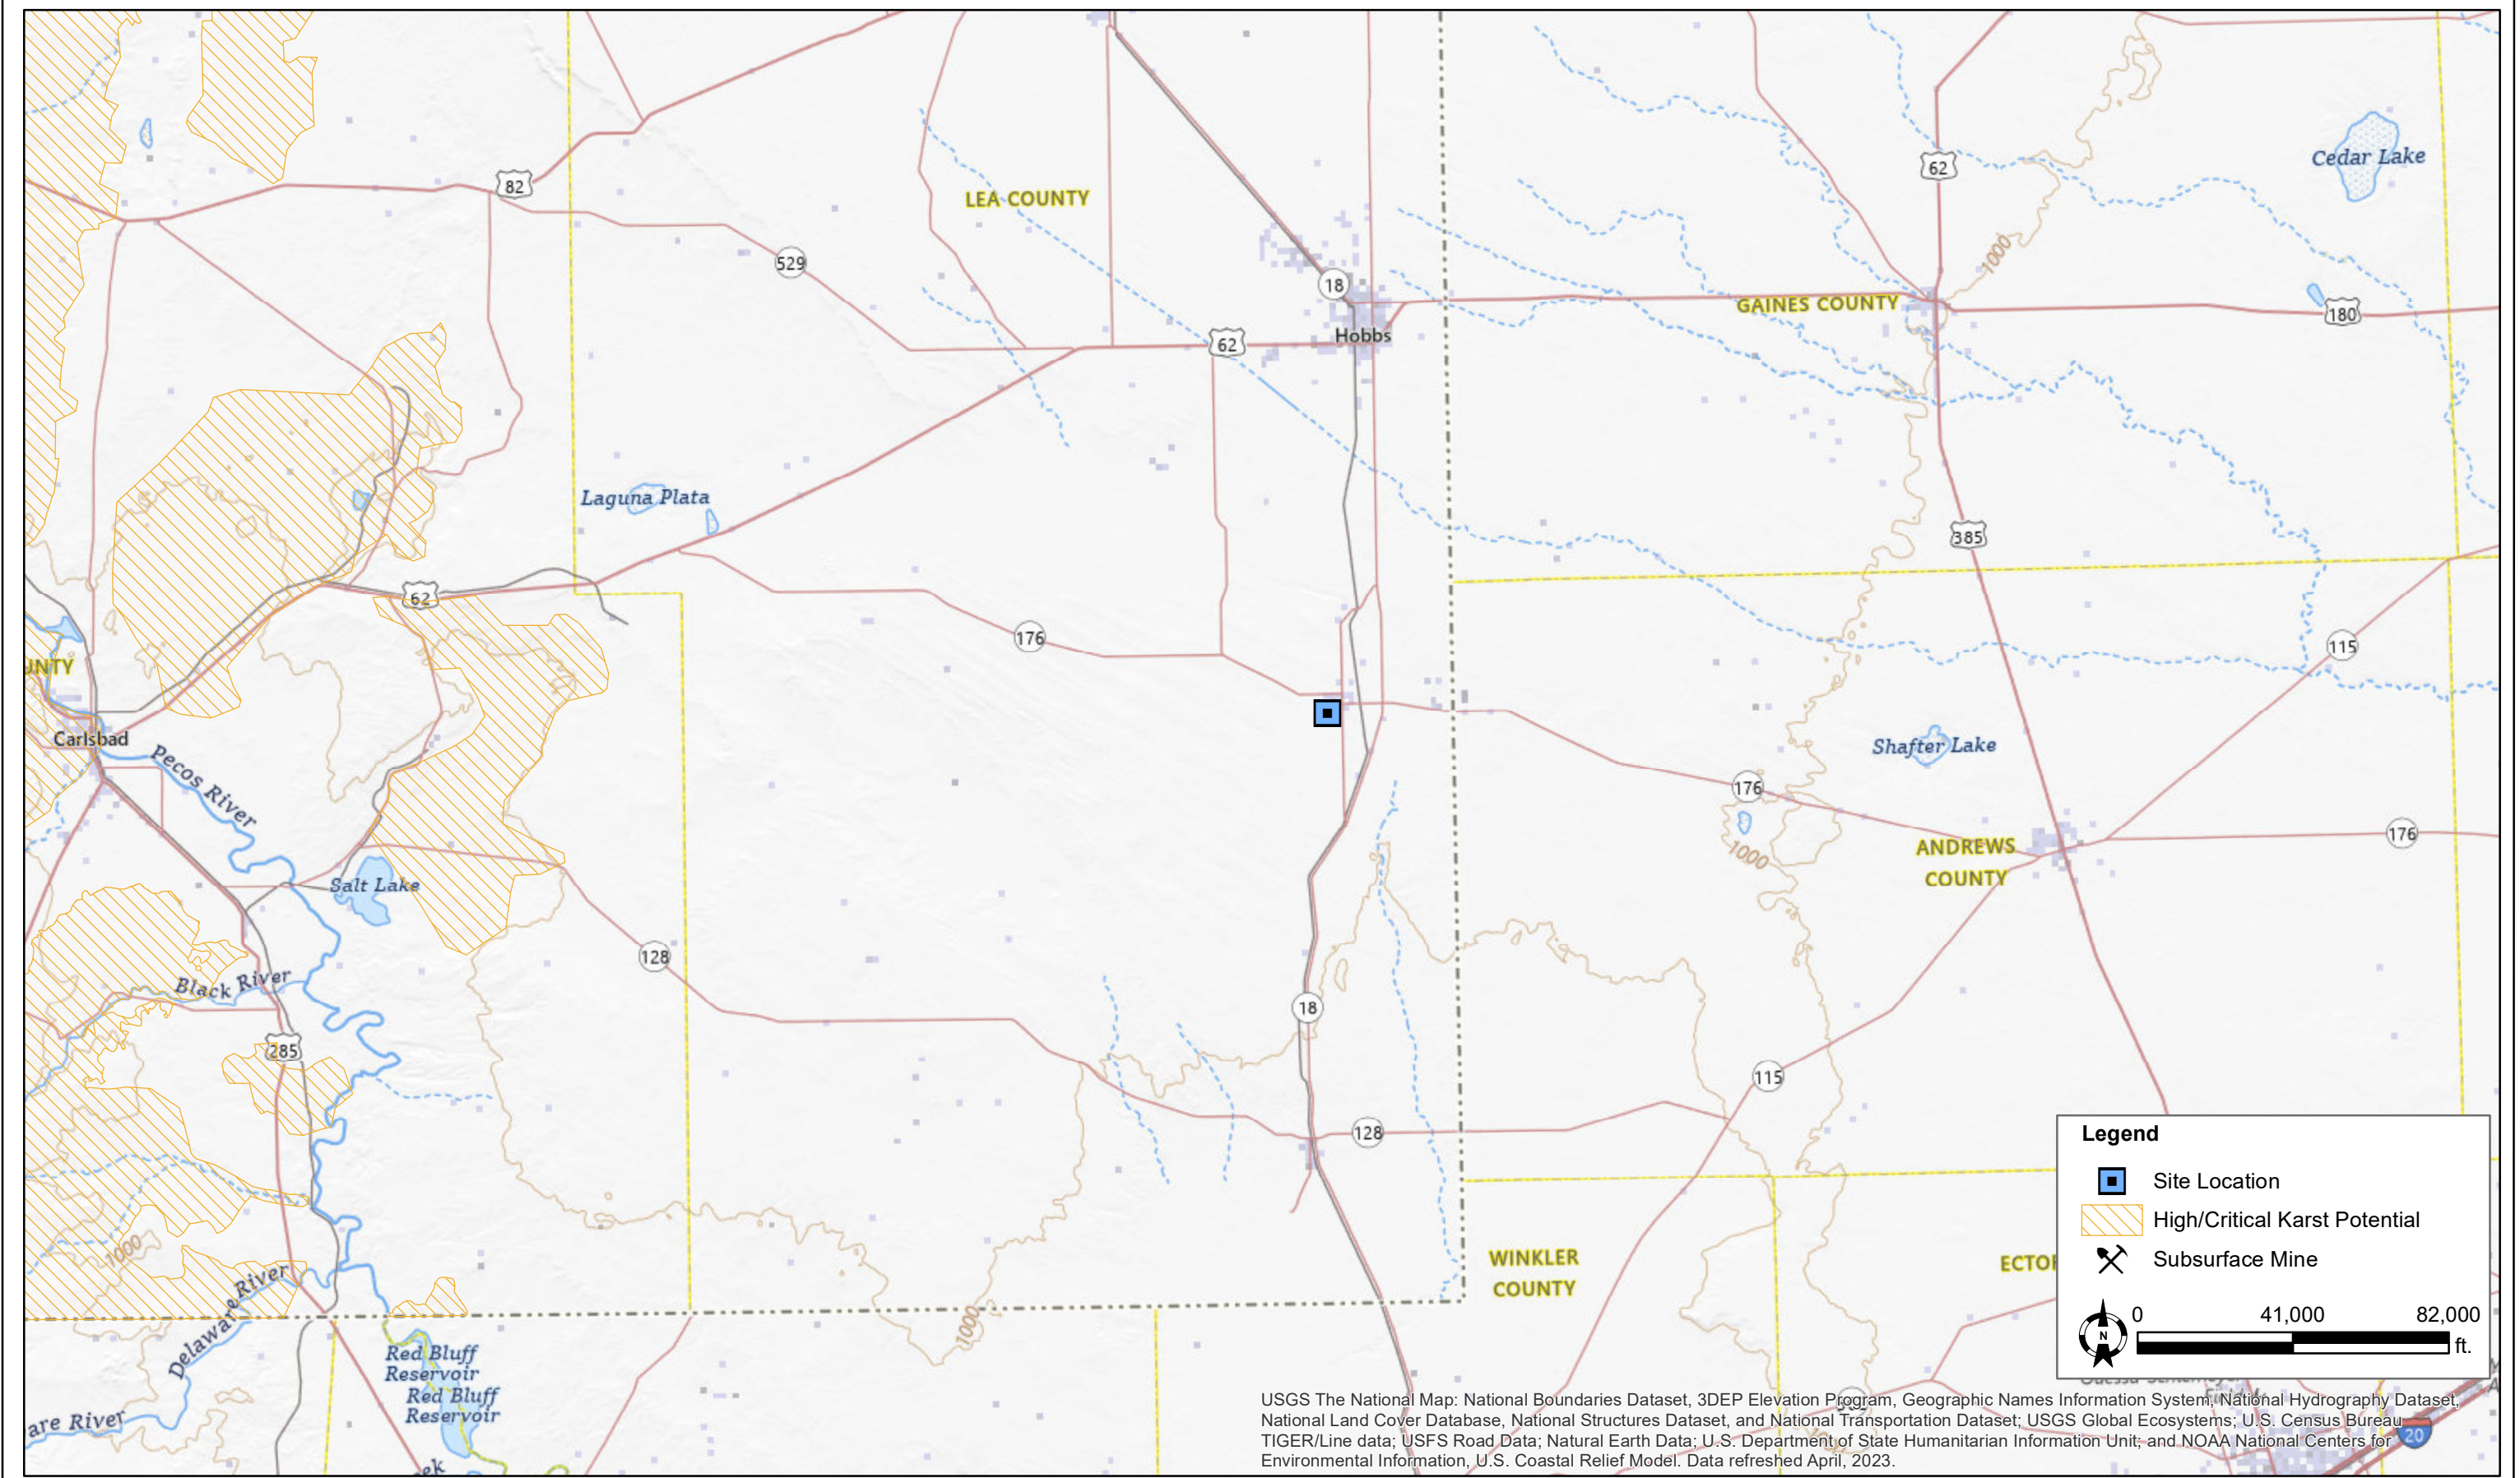
Figure
2

Karst Potential & Subsurface
Mine Map

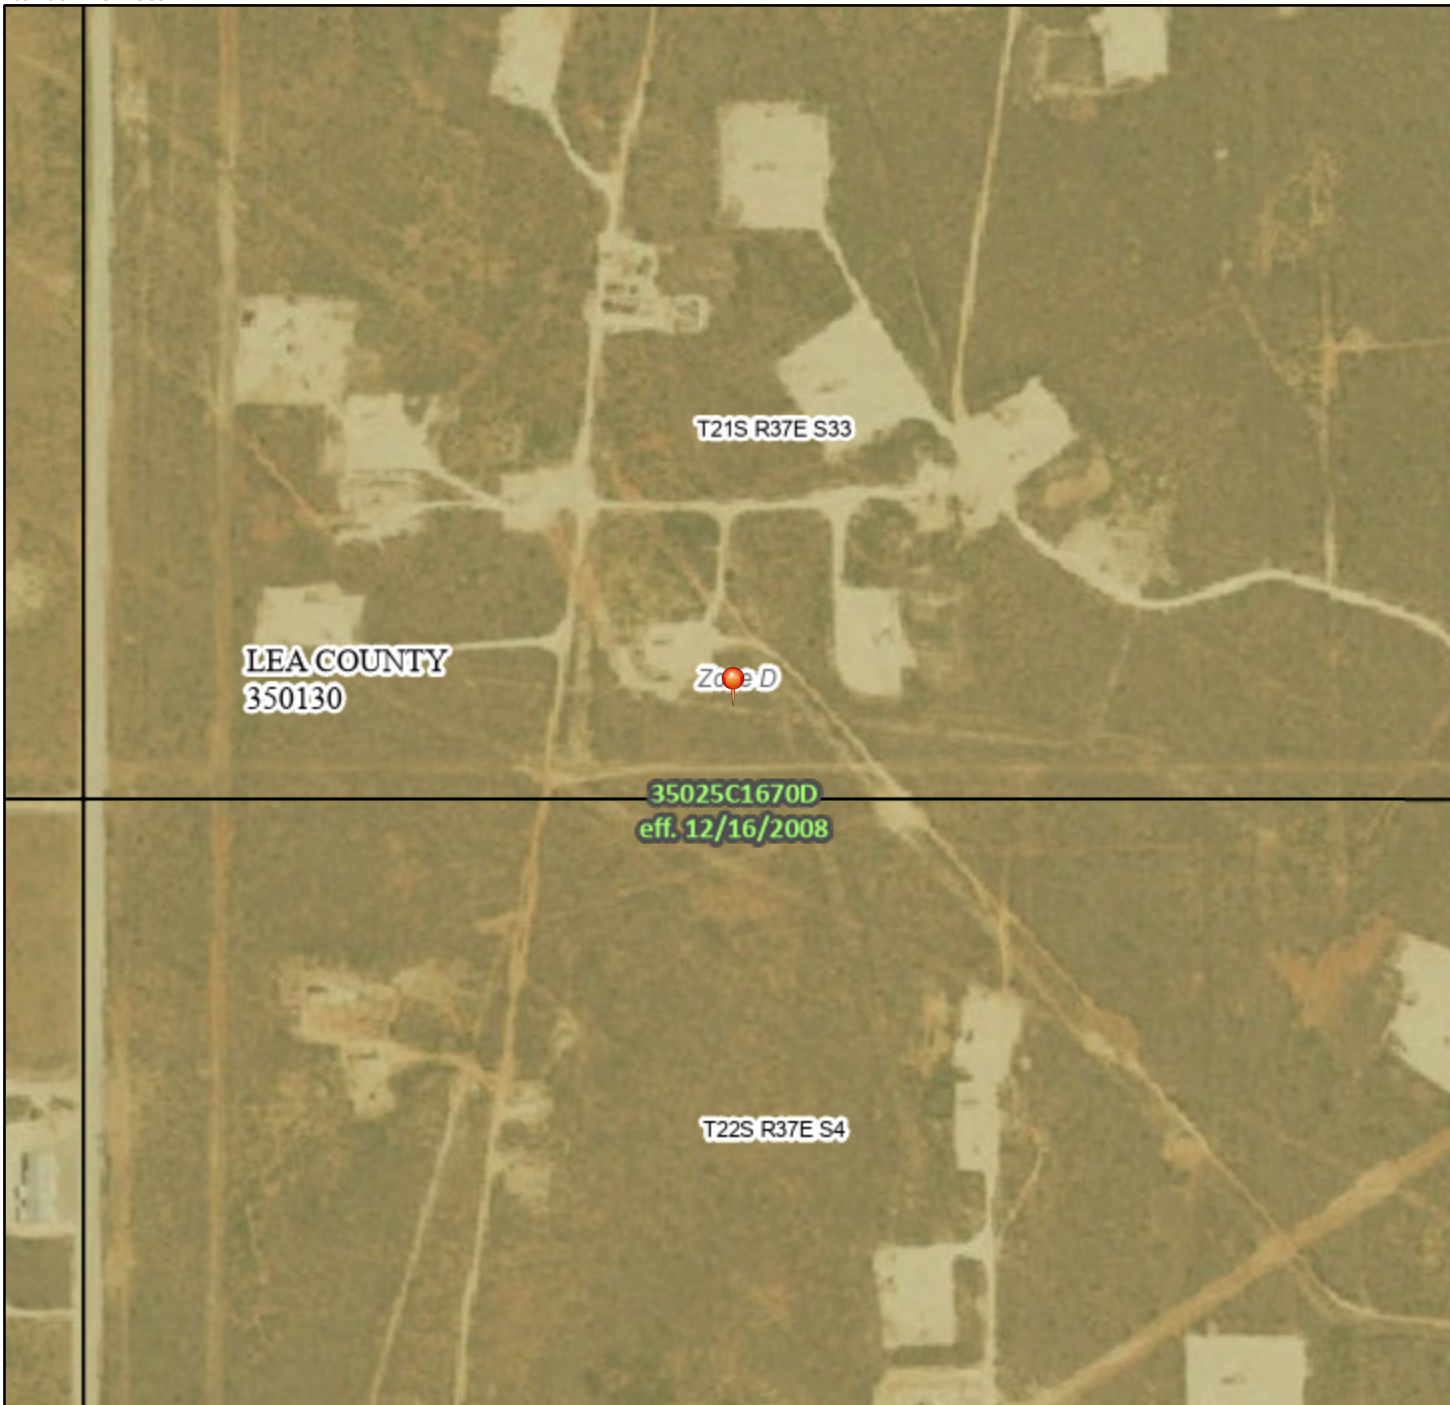
Review of flood map data published by the Federal Emergency Management Agency (FEMA) indicates the site is not located within a 100-year floodplain. A copy of the FEMA FIRMete Map can be found attached as Figure 4.

National Flood Hazard Layer FIRMette

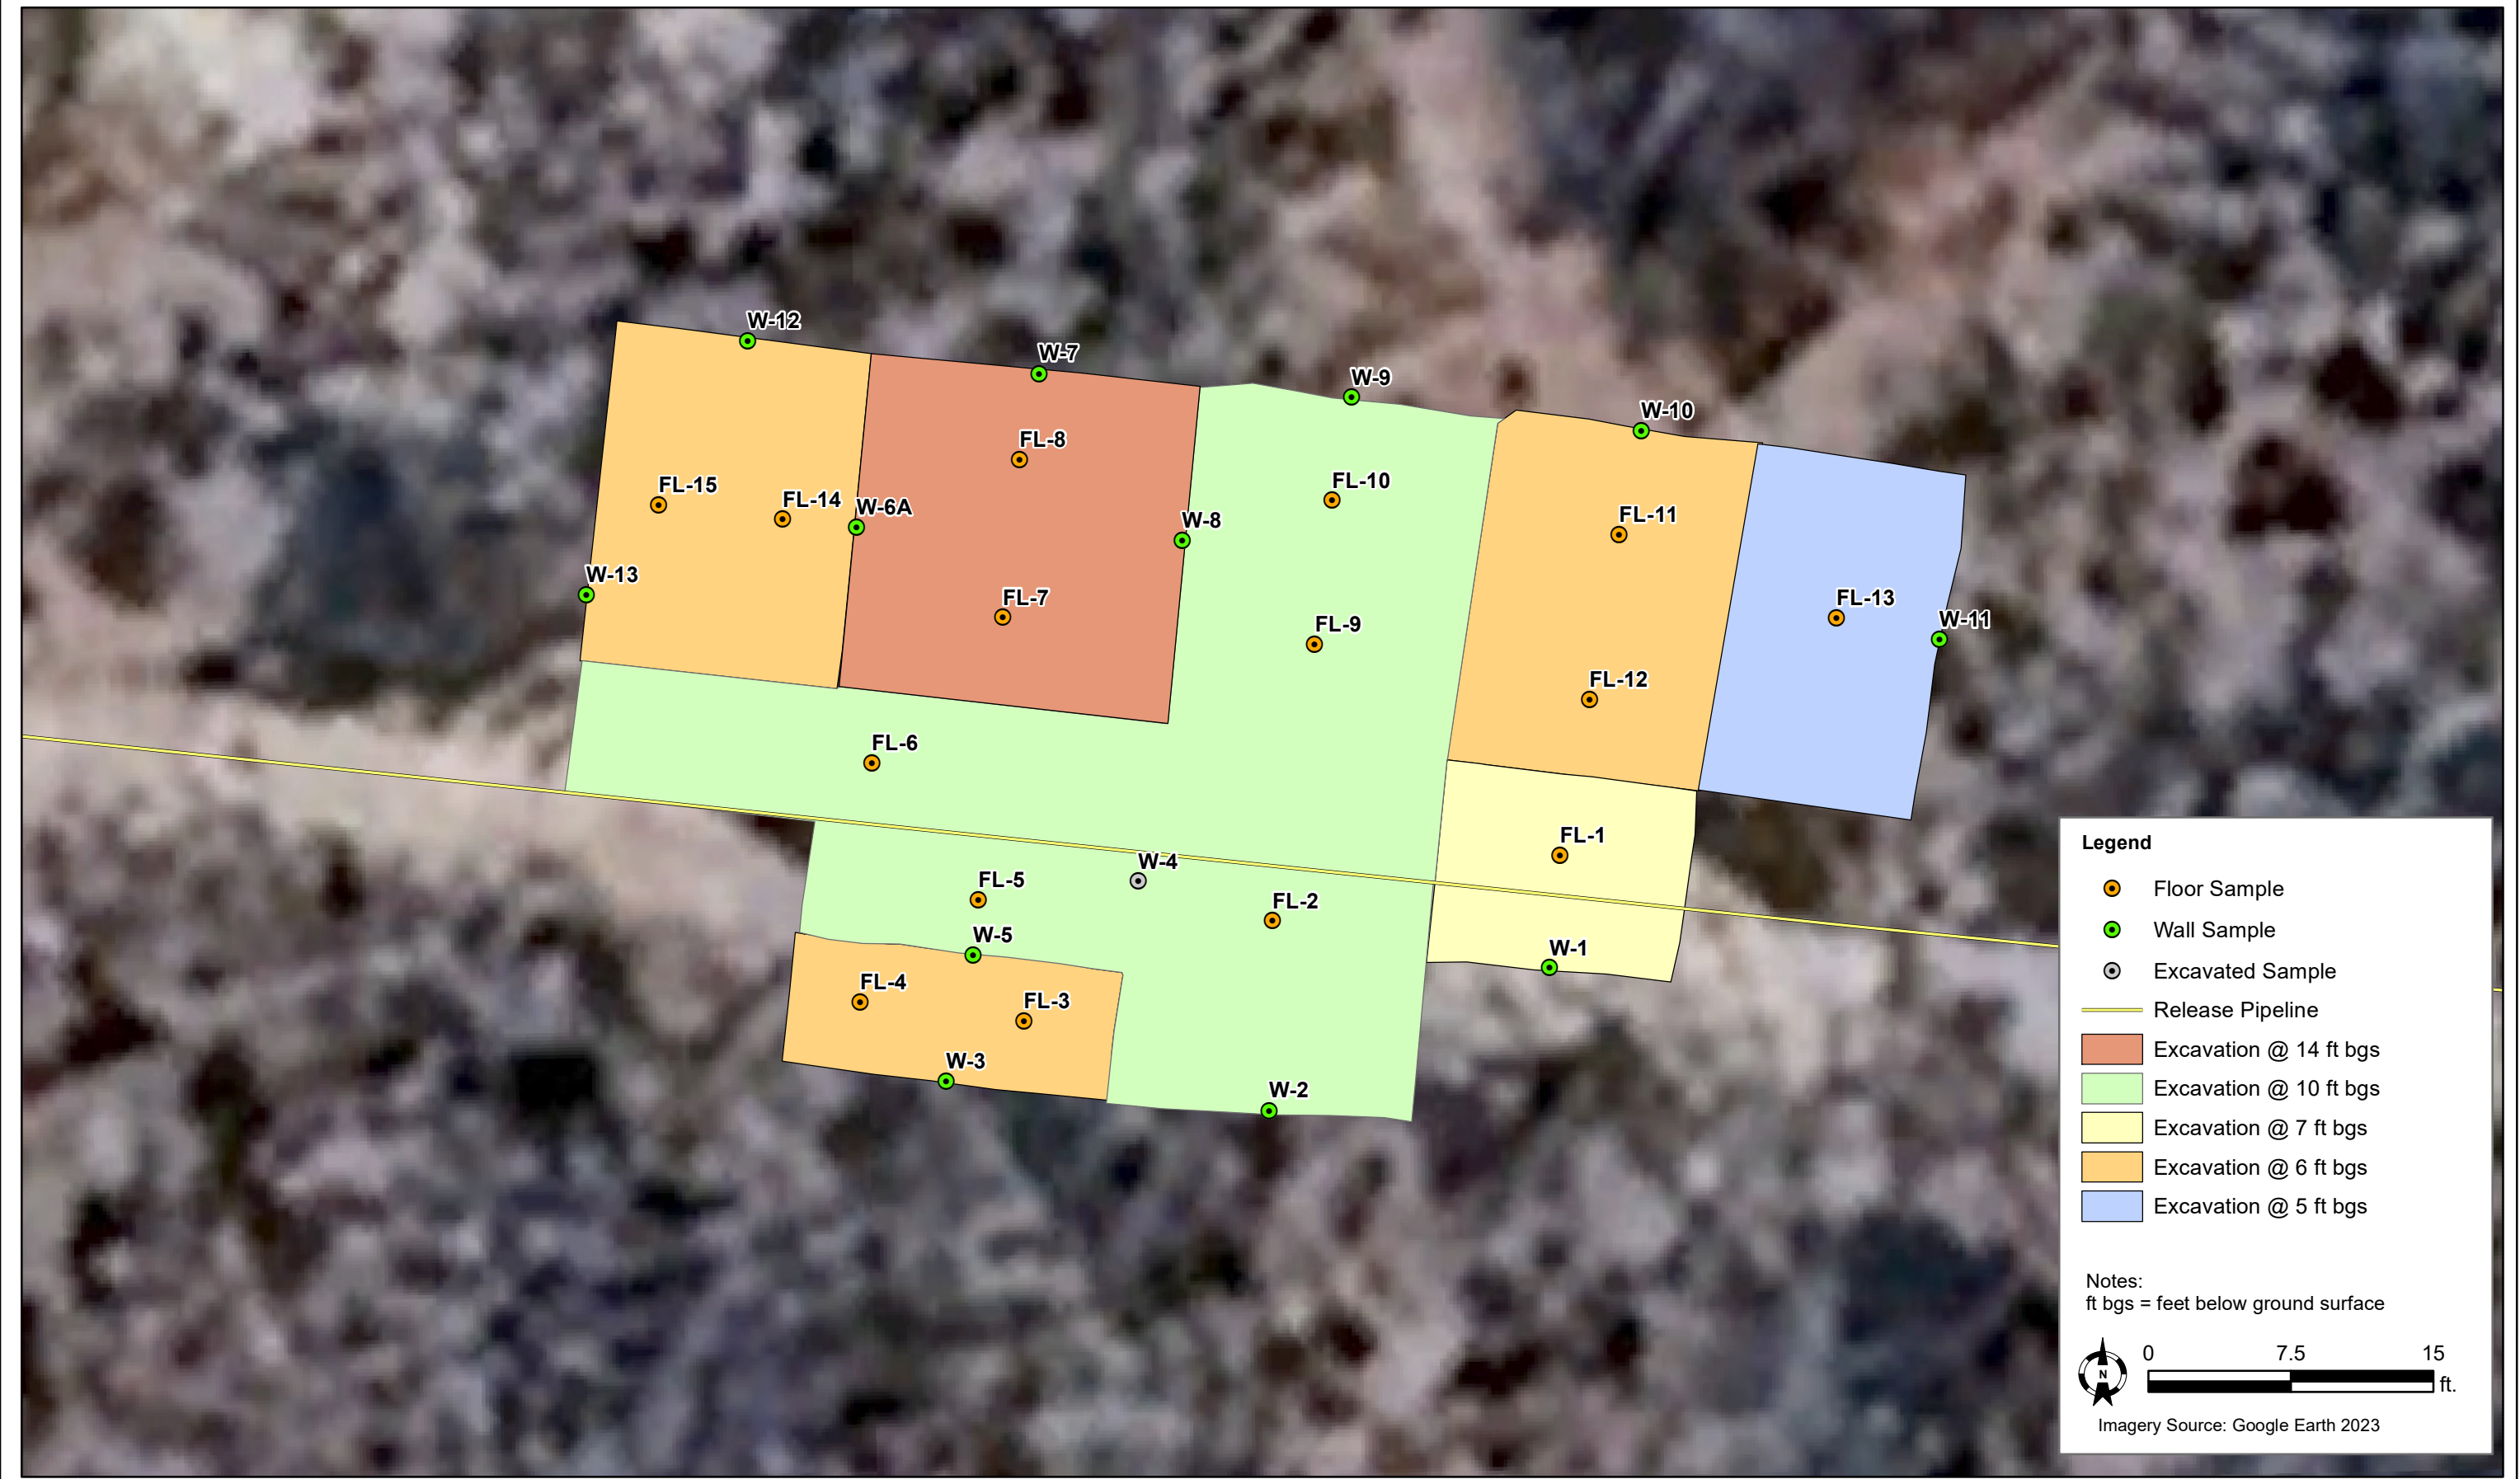
Targa Resources
Leak #3 - nAPP2401146074
UL “N”, Sec. 33, T21S, R37E
Lea County, New Mexico

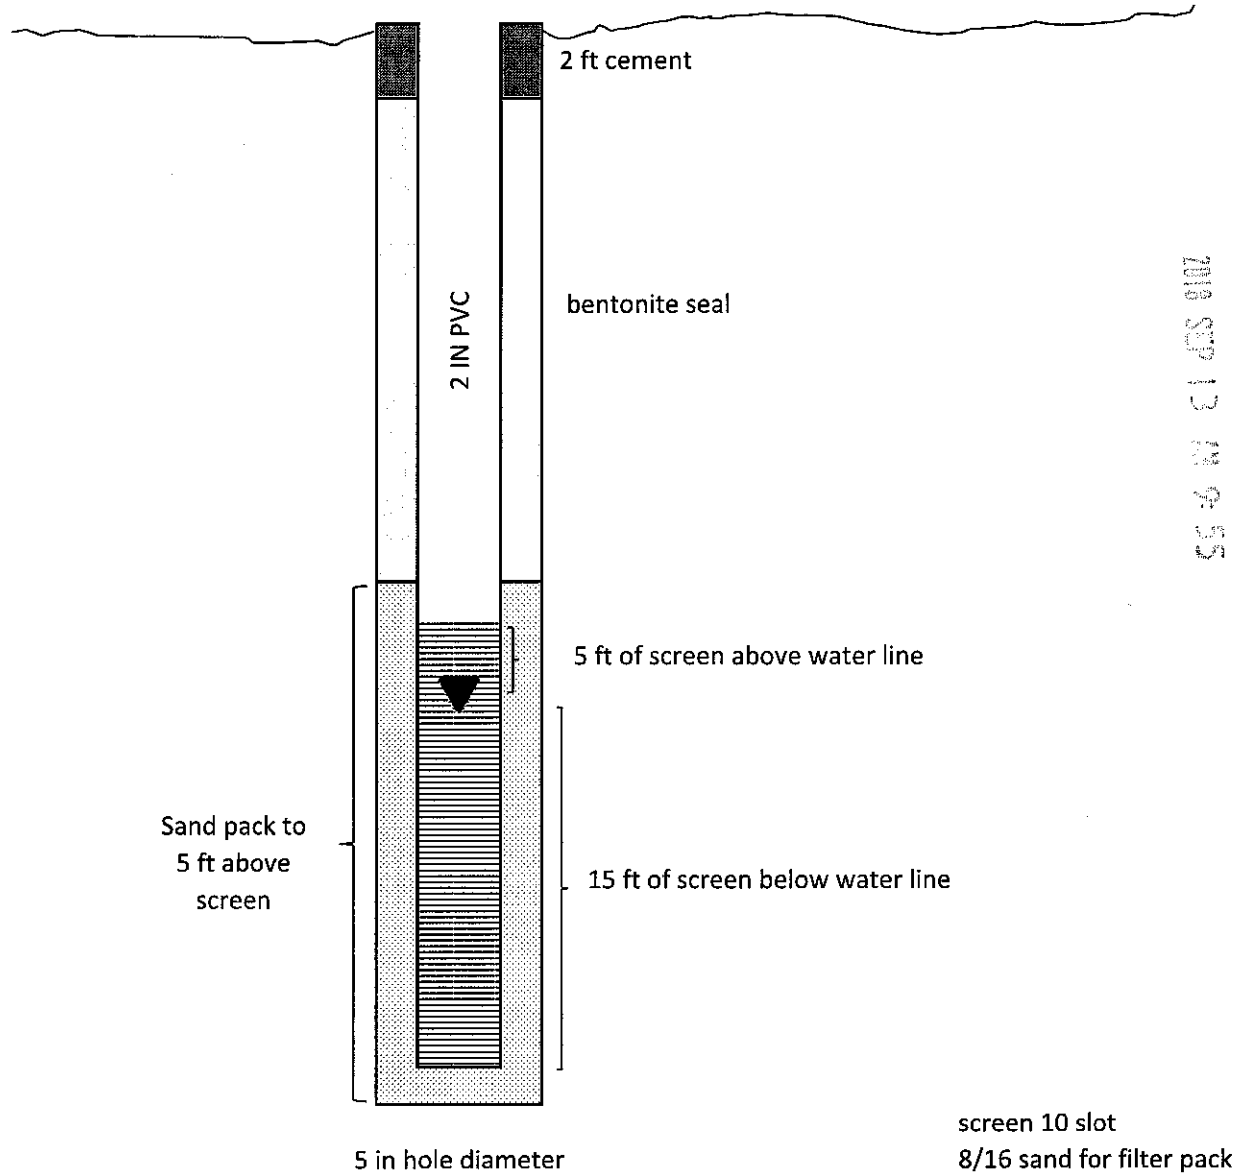
2 in Monitor Well Installation Diagram

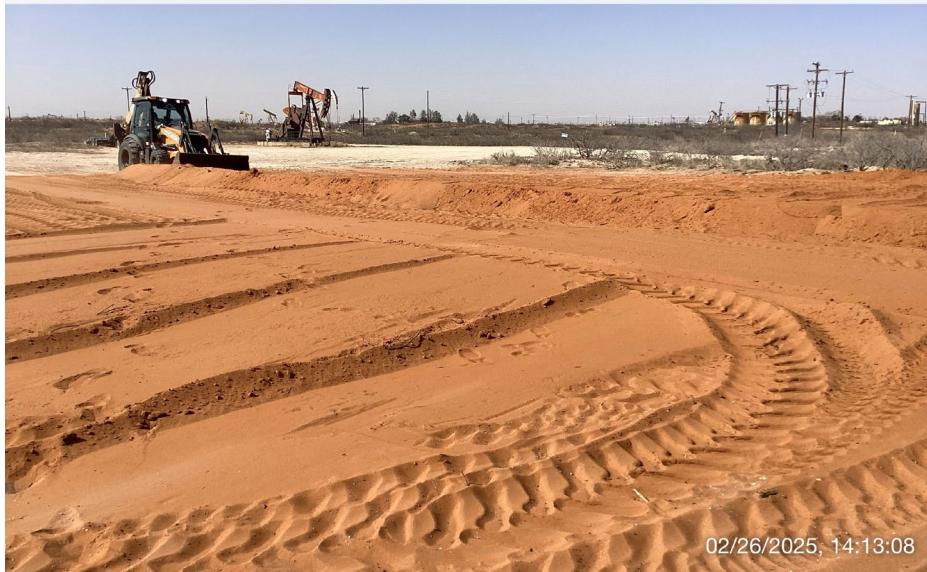
South East Elevation

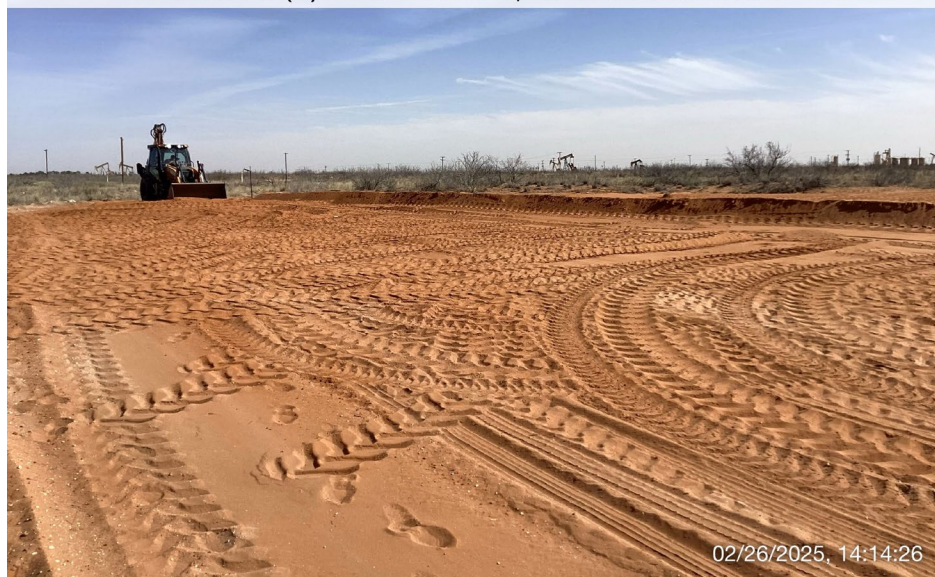
North Elevation
