Re: Reclamation Closure Report
Diamond PWU 22 CTB 1
API No. N/A
GPS: Latitude 32.651953 Longitude -104.070250
UL -- D, 22, T19S, R29E
Eddy County, NM
NMOCD Ref. No. NAPP2301930383

Pima Environmental Services, LLC. (Pima) has been contracted by Devon Energy Production Company, LP (Devon) to submit this Reclamation Closure Report for a produced water release that occurred at the Diamond PWU 22 CTB 1 (Diamond). The initial C-141 was submitted on January 23, 2023 (Appendix C). This incident was assigned Incident ID NAPP2301930383 by the New Mexico Oil Conservation Division (NMOCD).

**SITE PHOTOGRAPHS
DEVON ENERGY
DIAMOND PWU 22 CTB 1**

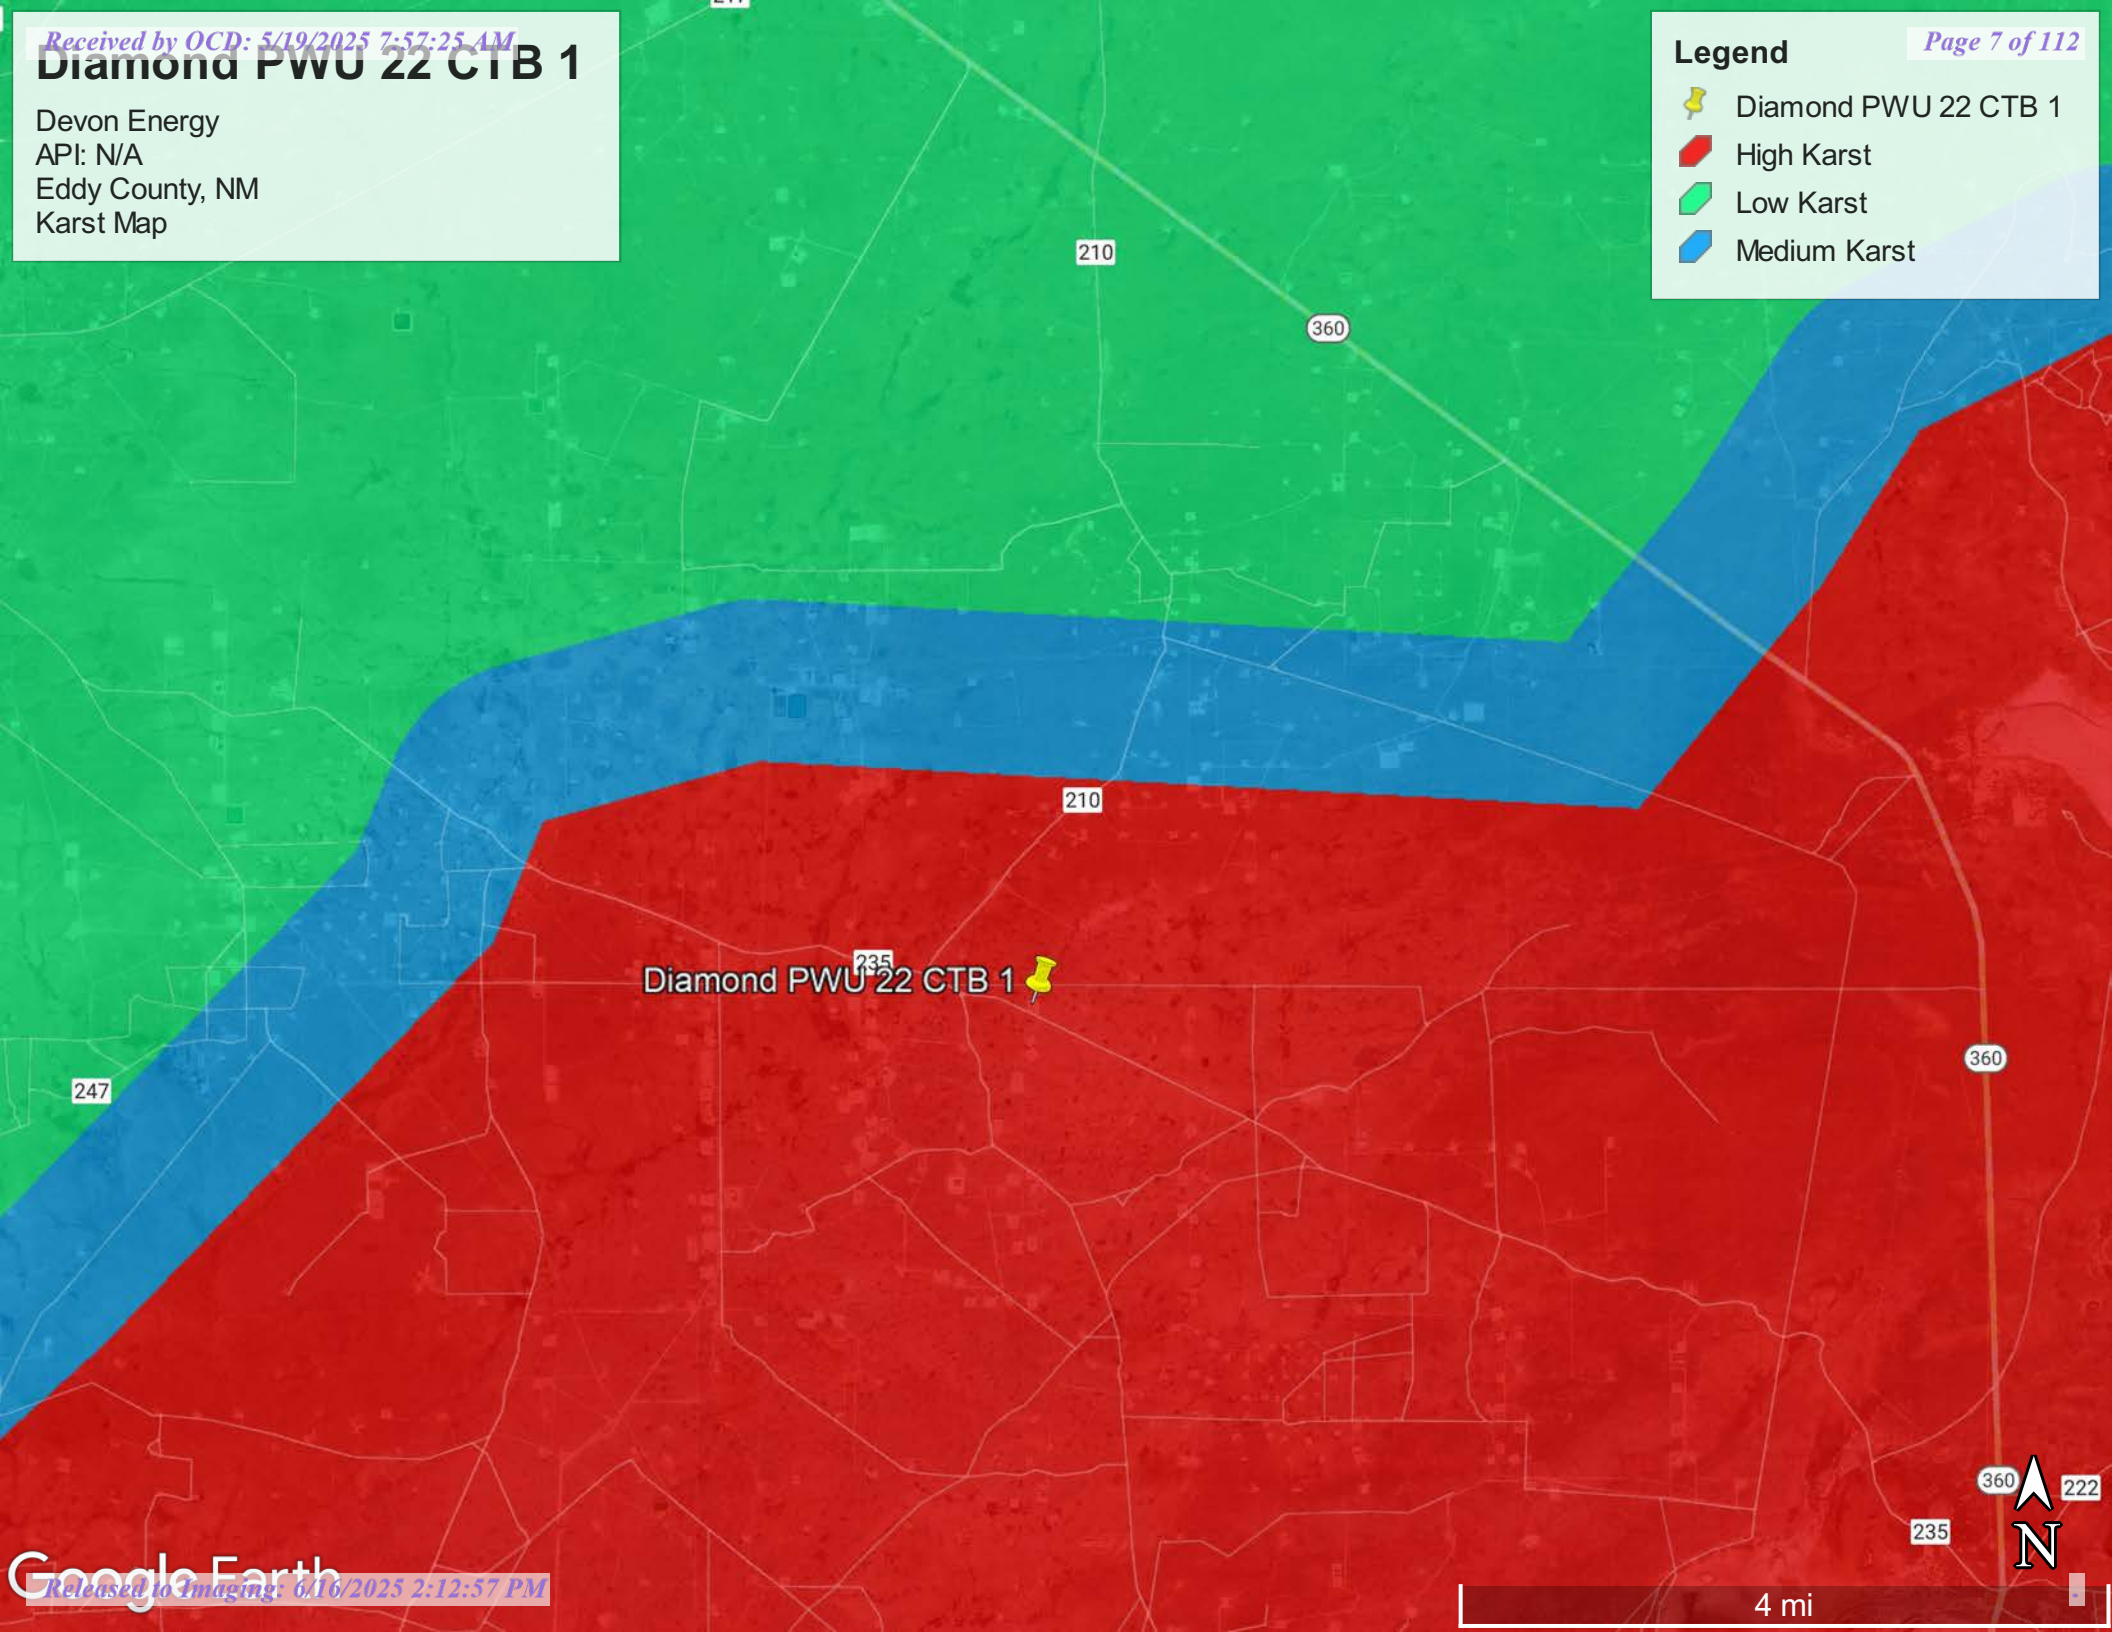
Devon Energy
API: N/A
Eddy County, NM
Karst Map

Per the New Mexico Bureau of Geology and Mineral Resources, the geology is made up of includes scattered lacustrine, playa, and alluvial deposits of the Tahoka, Double Tanks, Tule, Blanco, Blackwater Draw, and Gatuna Formations, the latter of which may be Pliocene at base; outcrops, however, are basically of Quaternary deposits. The soil in this area is made up of Kimbrough-Stegall loams, 0 to 3 percent slopes according to the United States Department of Agriculture Natural Resources Conservation Service soil survey (Appendix B). The drainage class in this area is well drained. There is a high potential for karst geology to be present around the Diamond (Figure 3). Reference Figure 2 for a Topographic Map.

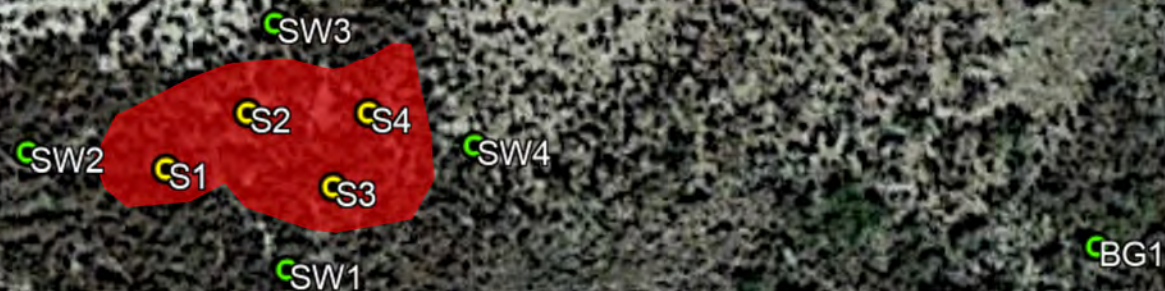
Devon Energy
API# N/A
Eddy County, NM
Site Map

March 3, 2023, Pima mobilized personnel to the site to begin collecting soil samples from spill area. The laboratory results of this sampling event can be found in the following data table. A Site Map can be found in Figure 4. Complete laboratory results can be found in Appendix E.

Spill Area Sqft 1,123

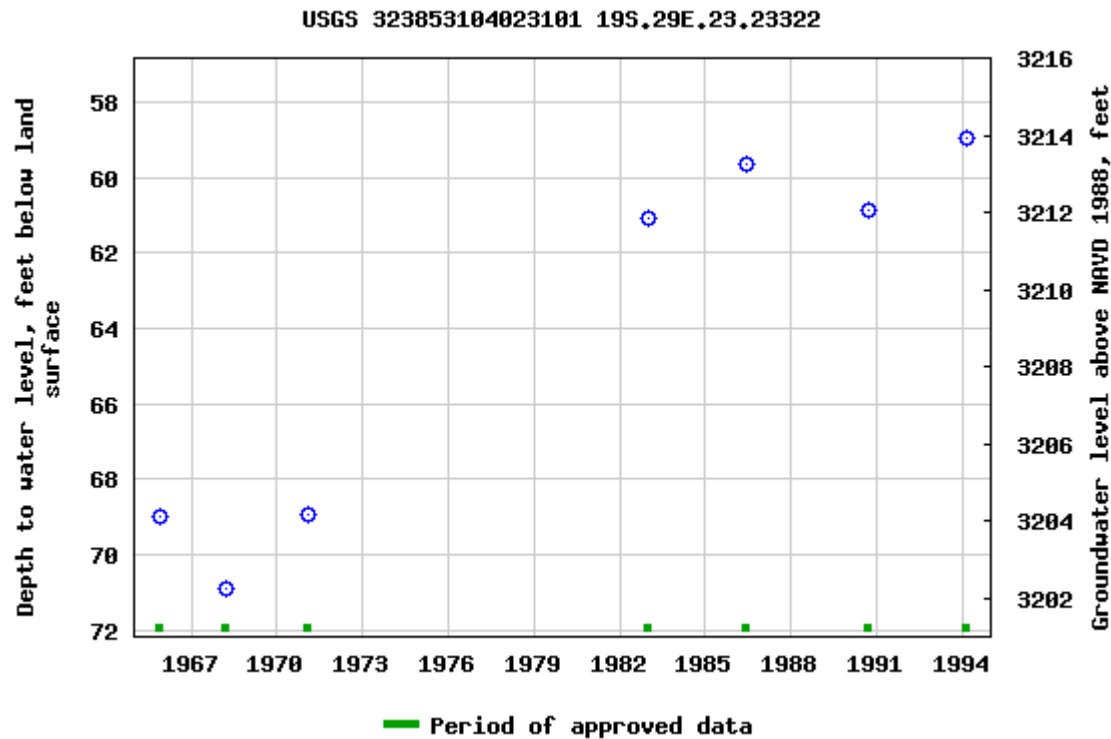
USGS 323853104023101 19S.29E.23.23322

The depth of the well is 85 feet below land surface.

This well is completed in the Other aquifers (N9999OTHER) national aquifer.

This well is completed in the Rustler Formation (312RSLR) local aquifer.

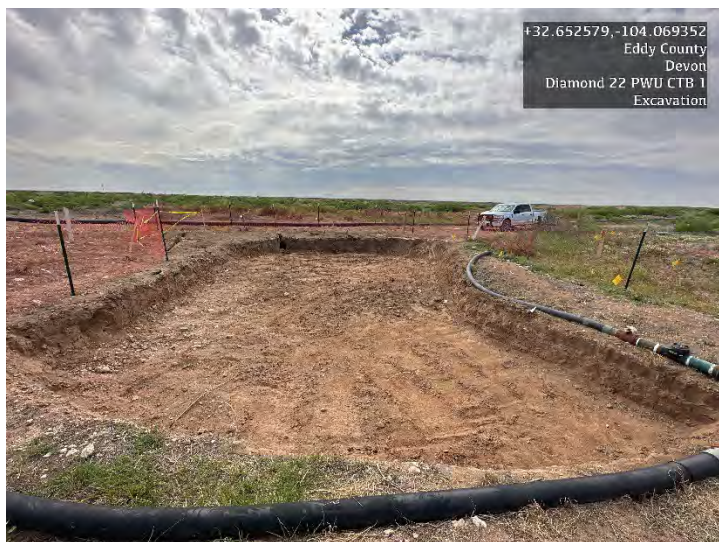
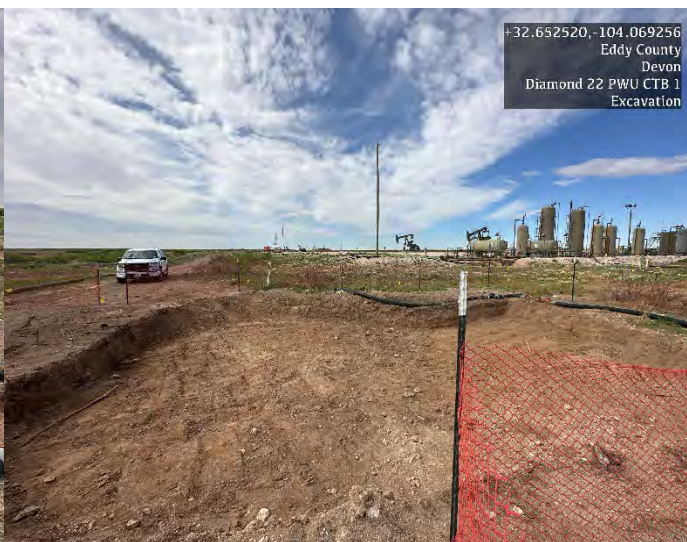
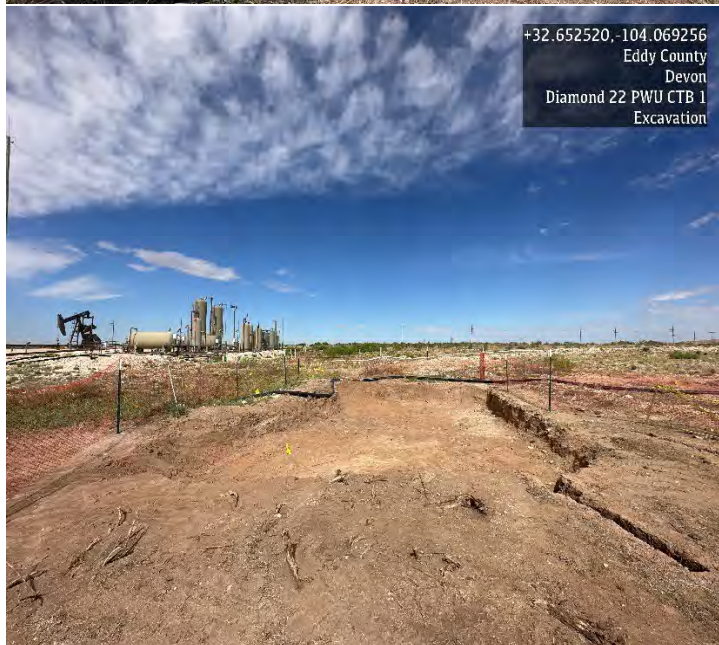
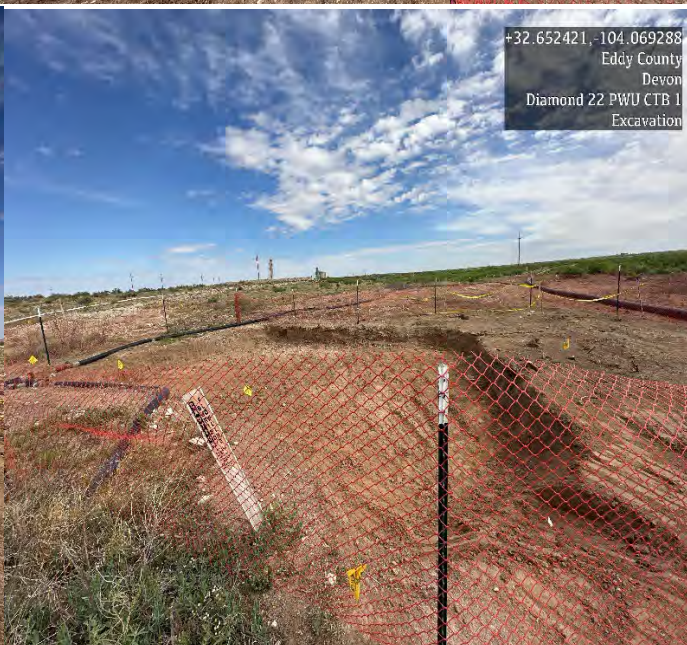
Excavation

On March 31, 2023, the Devon Construction Department mobilized personnel and equipment to begin remediation activities. They began excavating the area to a depth of 2' BGS. A total of 41 cubic yards of contaminated soil was hauled to an approved, lined disposal facility and clean backfill material was brought in.

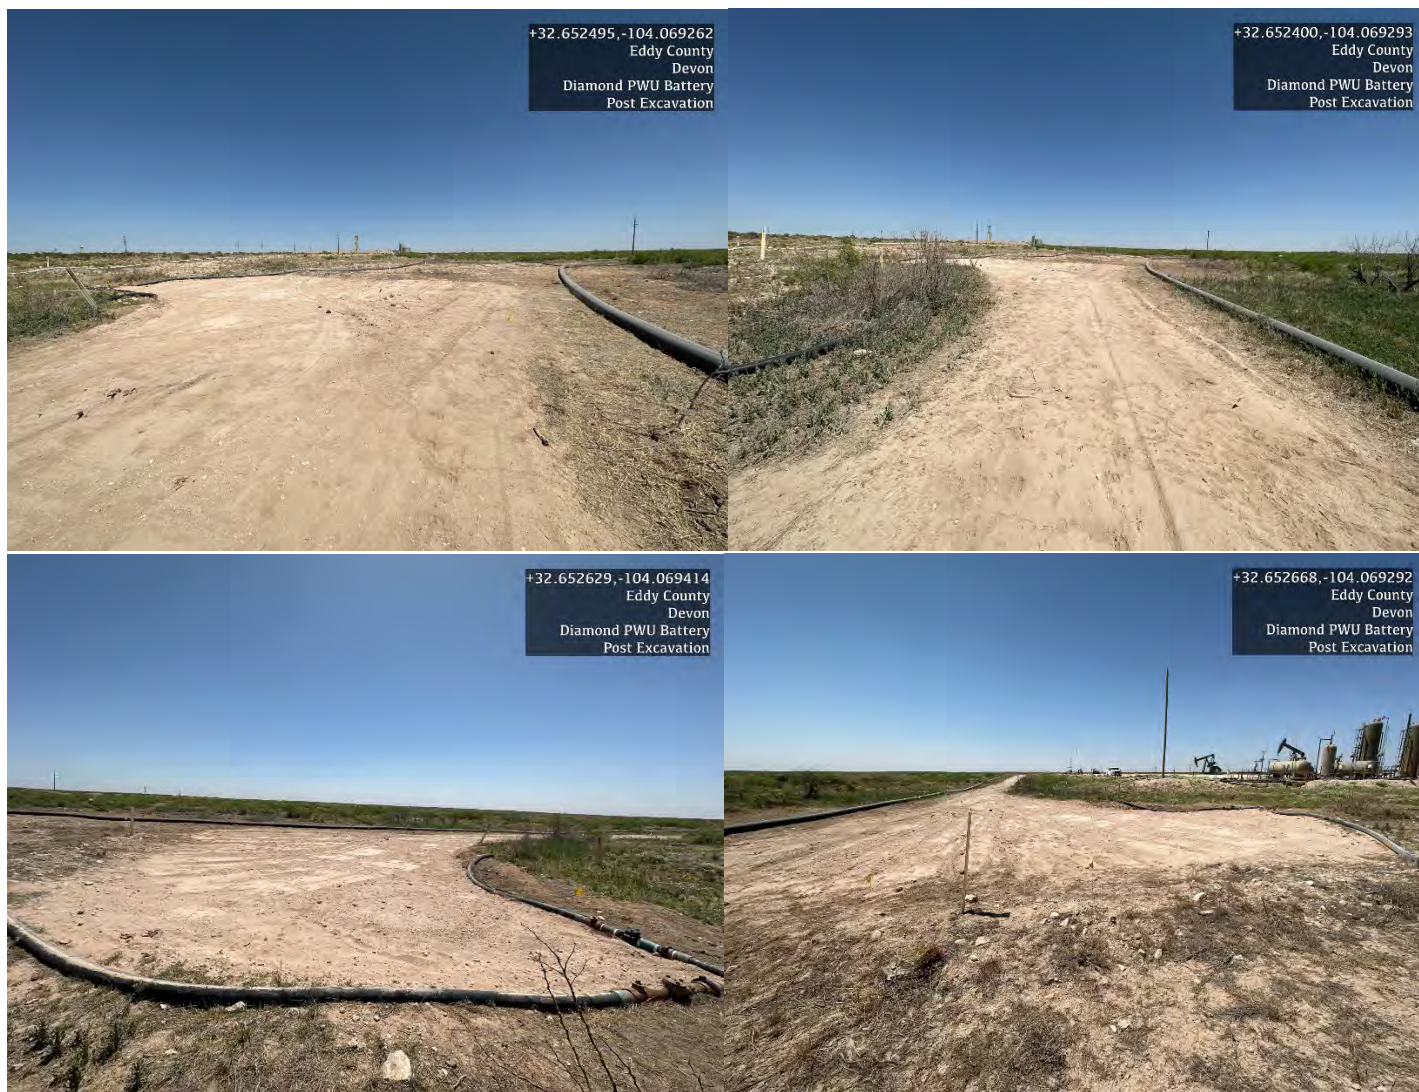
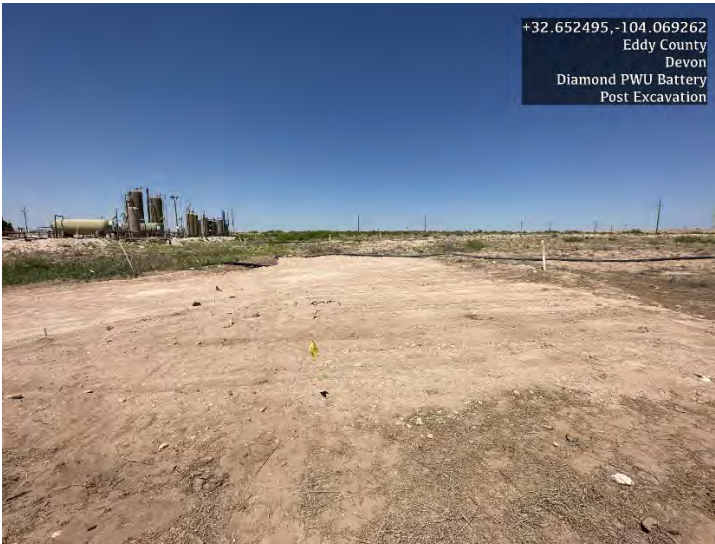
Post Excavation

On April 25, 2025, two 5-point composite samples were collected from the backfilled area. The results of this sampling event are provided in the following table. The lab results from this sampling event were received on May 5, 2025, and verified that the excavated area was backfilled with clean soil. Complete Laboratory Reports can be found in Appendix E.
